ON-SITE CERTIFIED ADVANCED 208- COMPLIANT VEHICLE INVESTIGATION

CASE NUMBER - IN-04-014
LOCATION - Texas
VEHICLE - 2004 FORD TAURUS
CRASH DATE - April 2004

1. <i>Report No.</i> IN-04-014		2. <i>Government Accession No.</i>		3. <i>Recipient's Catalog No.</i>	
4. <i>Title and Subtitle</i> On-Site Certified Advanced 208-Compliant Vehicle Investigation Vehicle - 2004 Ford Taurus SE Location - Texas			5. <i>Report Date:</i> March 17, 2005

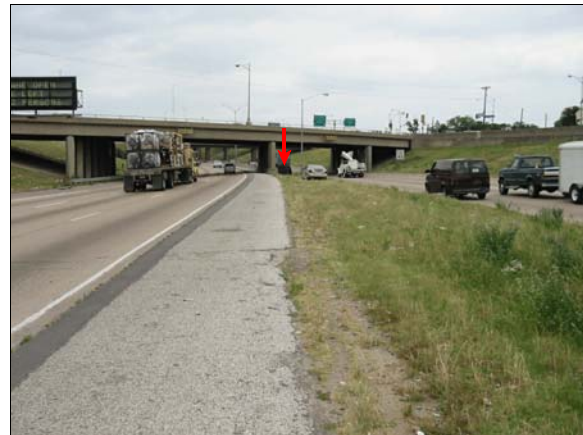
Figure 1: Overview of the trafficway and travel direction of the case vehicle to impact with the crash attenuator, indicated by arrow (case photo #01)

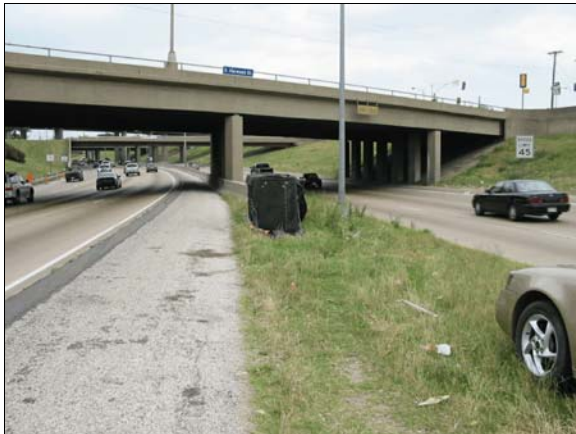
Pre-Crash: The case vehicle was on the north side of the median traveling east in the inside lane in a left curve at a driver estimated speed of about 88 km.p.h. (55 mph), and the driver was intending to continue eastbound. The case vehicle's driver was talking on his cellular telephone and departed the right side of the roadway and entered the median (**Figure 2** below). The driver

Figure 2: Approach of case vehicle to impact with the crash attenuator (case photo #04)

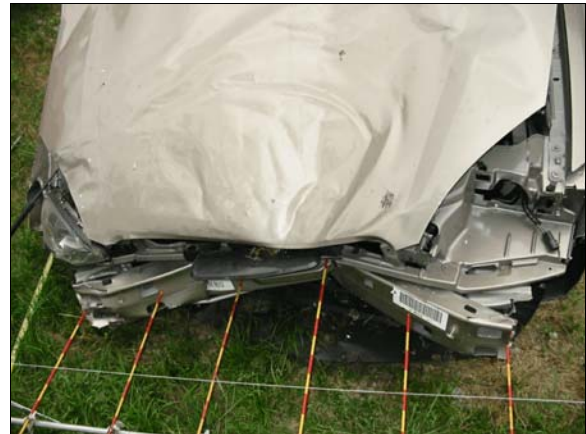
Figure 3: Damage to front of case vehicle from impact with crash attenuator; bumper cover, grille and left headlamp/turn lamp assembly were missing (case photo #10)

Crash: The front of the case vehicle (**Figure 3**) impacted the crash attenuator (**Figure 4**) causing the case vehicle's driver supplemental restraint (air bag) to deploy. The case vehicle's front right air bag did not deploy because that position had an occupant sensor and there was no front right occupant in the vehicle. The weight sensor in the front right seat properly determined the absence of a passenger and suppressed deployment of the front right air bag.

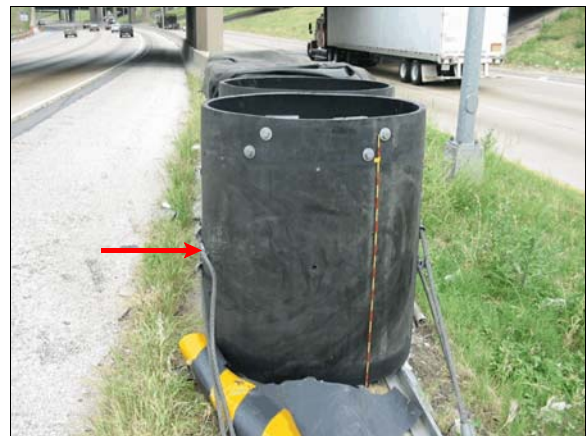
Figure 4: The crash attenuator impacted by the case vehicle, arrow shows plastic deposit from case vehicle's right headlamp, each stripe on rod is 5 cm (2 in) (case photo #06)

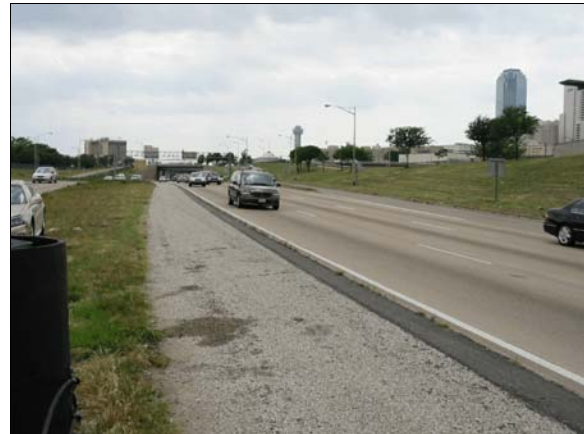
Post-Crash: As a result of the impact, the case vehicle rotated clockwise a few degrees. The case vehicle came to rest on the shoulder facing southeast (**Figure 5** below) with the front of the case vehicle in contact with the crash attenuator.

Figure 5: View west back to case vehicle's approach from the area of final rest (case photo #09)

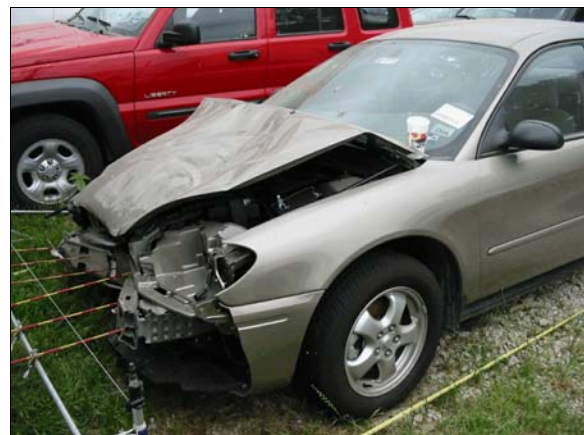
Exterior Damage: The case vehicle's front bumper cover, grille and left headlamp/turn lamp assembly were not present at the vehicle inspection (**Figure 6**). However, based on the 90 centimeter (35.4 inches) diameter of the crash attenuator's barrel and the damage to the case vehicle's bumper bar, hood, right fender and right front wheel, it appears that the case vehicle sustained direct contact across the majority of the front end, beginning at the right bumper corner. It appears the direct contact may not have involved the left bumper corner and left headlamp/turn lamp assembly. Additionally, the contact with the crash attenuator's cable assembly produced direct damage to the right headlamp/turn lamp assembly, right fender and right front wheel (**Figures 7 and 8** below).

Figure 6: Left front view of front damage to case vehicle from crash attenuator impact, front bumper cover, grille and left headlamp/turn lamp assembly were missing (case photo #12)

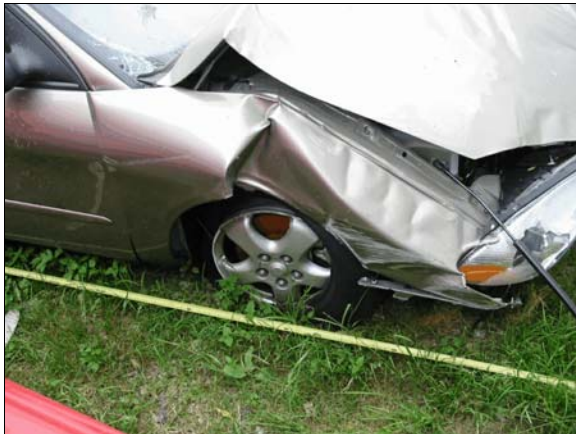
Figure 7: Damage to the right headlamp/turn lamp assembly, right fender and right front wheel from impact with the crash attenuator's cable assembly (case photo #19)

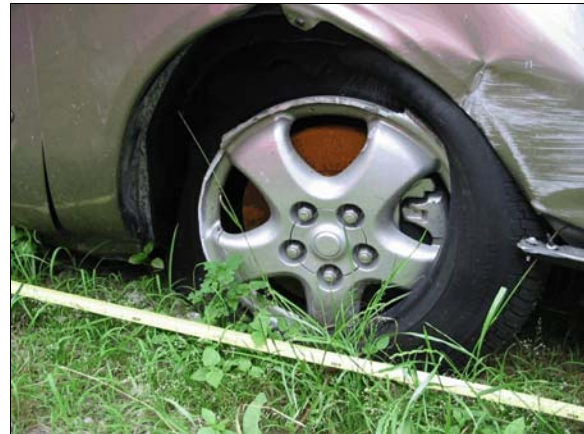
Figure 8: Close view of damage to case vehicle's right front wheel from crash attenuator's cable assembly (case photo #20)

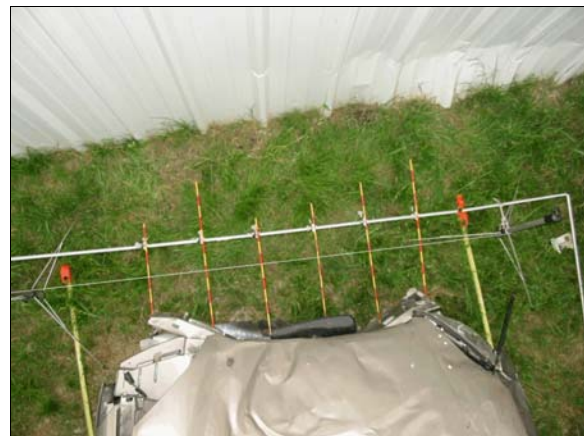
The crush measurements were taken at the front bumper bar (**Figure 9**). The residual maximum crush was measured as 22 centimeters (8.7 inches) occurring at C₃. The table below shows the case vehicle's crush profile

Figure 9: Top view of crush to front of case vehicle (case photo #22)

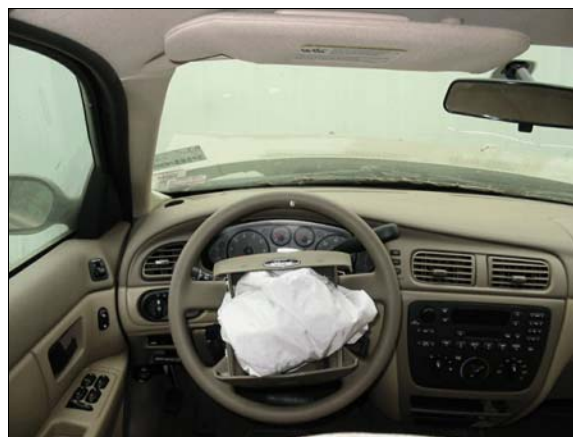
Figure 10: Overview of the steering wheel and air bag module flaps (case photo #27)

The case vehicle's driver air bag was located in the steering wheel hub. The air bag module cover flaps (**Figure 10** above) consisted of a rectangular upper flap 21.5 centimeters (8.5 inches) in width and 6 centimeters (2.4 inches) in height, and a slightly semi-circular lower flap 21.5 centimeters (8.5 inches) in width and 10 centimeters (4 inches) in height. Each of the flaps was made of thick vinyl. An inspection of the air bag module cover flaps and the air bag fabric revealed that the cover flaps opened at the designated tear points. There was no evidence of damage during the deployment to the air bag or the module cover flaps. The deployed driver's air bag (**Figure 11**) was round with a diameter of about 61 centimeters (24 inches). The air bag was designed with a single cone-shaped tether, 17 centimeters (6.7 inches) in diameter in the center of the air bag. It was sewn to the air bag with a double stitched seam about one centimeter (0.4 inch) wide. The driver's air bag had two vent ports (**Figure 12**), approximately 2.5 centimeters (1 inch) in diameter, located at the 11 and 1 o'clock positions. An inspection of the air bag fabric revealed a small yellow stain at the center left portion of the air bag (**Figure 13**) indicating contact by the driver's face. In addition, an area of very light blue or purple scuffing was observed at the top portion of the air bag immediately above the yellow stain. The origin of this scuff is not known.

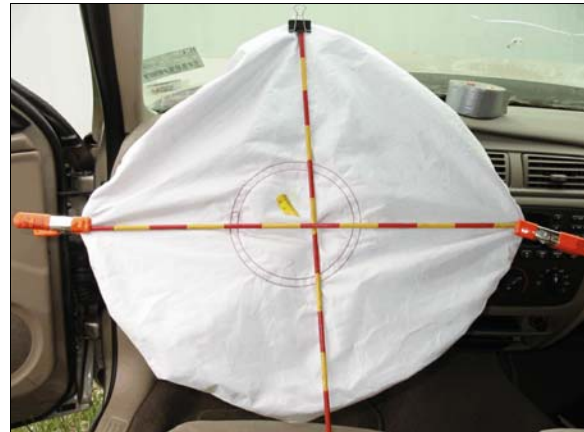
Figure 11: Overview of the driver's air bag, yellow tape shows location of yellow stain (case photo #28)

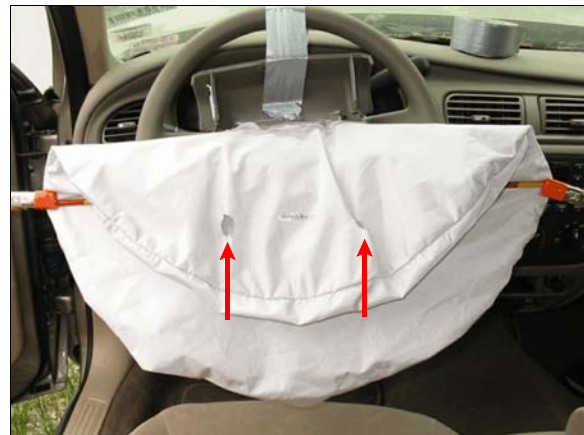
Figure 12: Driver's air bag vent ports, indicated by arrows (case photo #31)

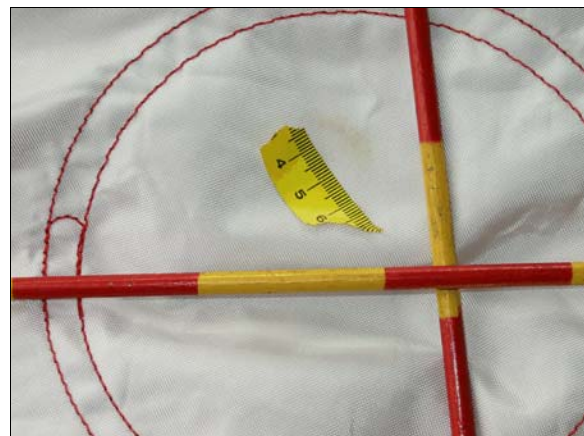
Vehicle Interior: Inspection of the case vehicle's interior revealed no evidence of occupant contact marks to the left instrument panel or other interior surfaces. However, there was a small yellow stain on the air bag due to contact by the driver's face. There was no evidence of compression of the energy absorbing steering column, and no deformation of the steering wheel rim was observed.

Figure 13: Close view of the yellow stain on the air bag to the right of the yellow tape (case photo #29)

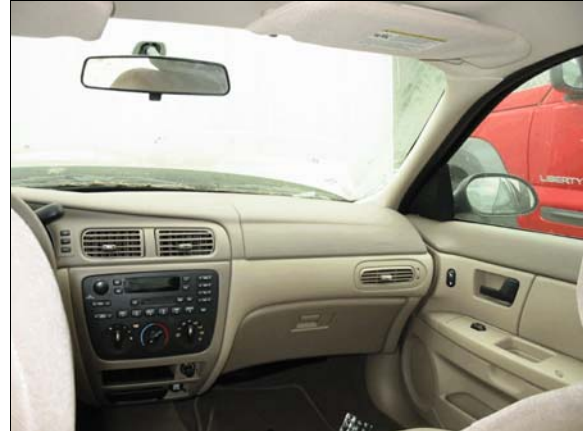
The front right passenger air bag was located on the top of the instrument panel (**Figure 14** below). The deployment of the front right air bag was properly suppressed by the case vehicle's advanced occupant protection system because there was no front right passenger in the case vehicle at the time of the crash.

Figure 14: Overview of the front right instrument panel, front right air bag located in top of instrument panel (case photo #40)

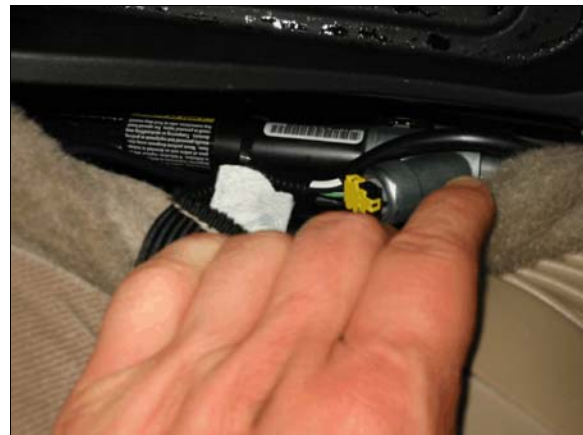
Based on this contractor's vehicle inspection and driver interview data, the driver was restrained by his available, active, three-point, lap-and-shoulder, safety belt system. The safety belt system was equipped with a buckle-mounted pretensioner (**Figure 15**), which had activated and compressed the buckle stalk cover (**Figure 16**). The pretensioner piston was observed to be flush with the end of the pretensioner barrel, a movement of about 5 centimeters (2 inches). Inspection of the seat belt assembly also revealed faint striations on the D-ring, but no load marks on the seat belt webbing or latch plate were observed.

Figure 15: Close view of the driver's seat belt pretensioner assembly (case photo #38)

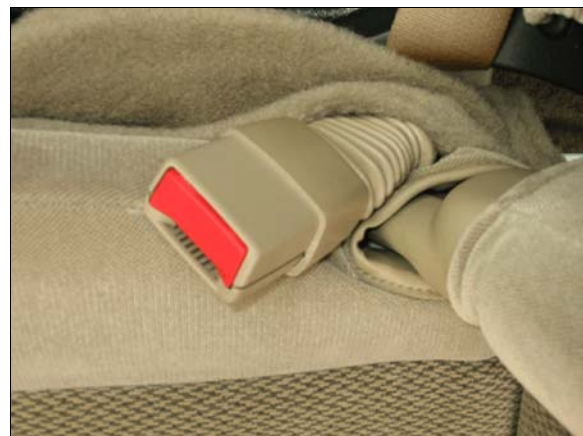
Figure 16: The driver's seat belt buckle showing compression of the buckle stalk due to the actuation of the pretensioner (case photo #37)
