On scene Investigation / Vehicle to Object
Dynamic Science, Inc. / Case Number: DS04019
2005 Ford Escape
Colorado
July, 2004

1. Report No. DS04019	2. Government Accession No.	3. Recipient Catalog No.	
4. Title and Subtitle On Scene Certified Advanced 208-Compliant Vehicle Investigation		5. Report Date April 27, 2005	6. Performing Organization Report No.

15. Supplemental Notes			
16. Abstract This on-site investigation focused on the performance of the Certified Advanced 208-Compliant air bag system in a 2005 Ford Escape XLT 4x4 sport utility vehicle. This two-vehicle crash occurred in July 2004 at 1539 hours in the state of Colorado. The crash occurred on a curved portion of a three-lane interstate roadway. The Ford Escape lost control on an interstate highway and struck a concrete barrier on the right side of the roadway. The impact resulted in sufficient longitudinal deceleration of the Escape to command the deployment of the frontal air bag system and actuation of the driver's seat belt pretensioner. The vehicle rotated out from the initial wall impact and was subsequently struck by a 1999 Freightliner tractor pulling a single trailer. The restrained 48-year-old male driver of

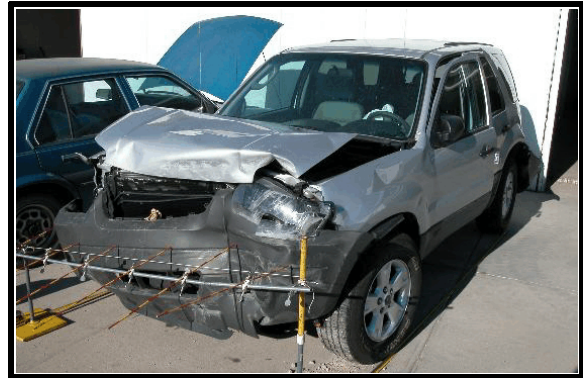
Figure 1. Front left, Ford Escape

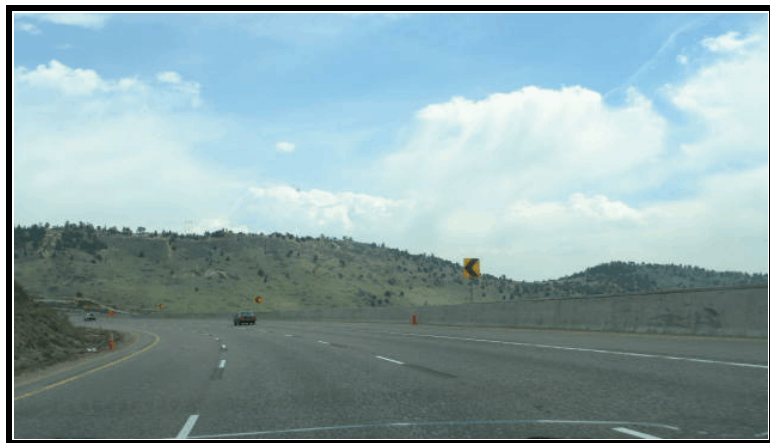
Figure 2. Overview of travel paths and impact areas—east

The Escape apparently drifted off the road on the left side for approximately 32.6 m (107.0 ft). The driver over corrected to the right and the vehicle went into a clockwise rotation. The Escape went across all three lanes of travel and struck a concrete barrier with its front end (CDC=11FDEW1). It appears that the front air bags in the Escape deployed at this time. The Escape continued its clockwise rotation and struck the barrier again with its rear end (CDC=04BYES1) approximately 15.5 m (51.0 ft) further east. At or near this point, the front of the Escape came into the right hand travel lane where it was then struck by the front of the Freightliner (CDC=Unknown).

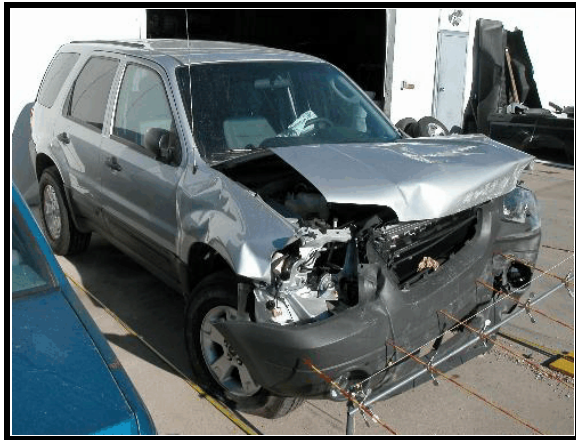
Damage Description: The Ford escape sustained moderate front end damage from the impacts with the barrier and the tractor trailer. There was minor sideswiping damage to the back right corner. The vehicle was towed from the scene due to damage and was later declared a total loss. The front right tire was flattened. The rear hatch was jammed shut.

Figure 3. Front right, Ford Escape

As a result of the front impact with the barrier and the overlapping damage from the impact with the other vehicle, the case vehicle sustained 147.0 cm (57.8 in) of direct damage along the front bumper beginning at the left bumper corner and extending to the right. Six crush measurements were documented along the front bumper as follows: C1=9.0 cm (3.5 in), C2=27.0 cm (10.6 in), C3=17.0 cm (6.7 in), C4=13.0 cm (5.1 in), C5=11.0 cm (4.3 in), C6=7.0 cm (2.8 in).

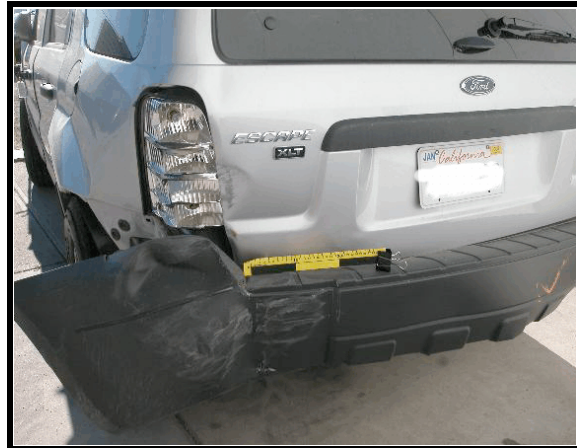
Figure 4. Rear left corner, Ford Escape.

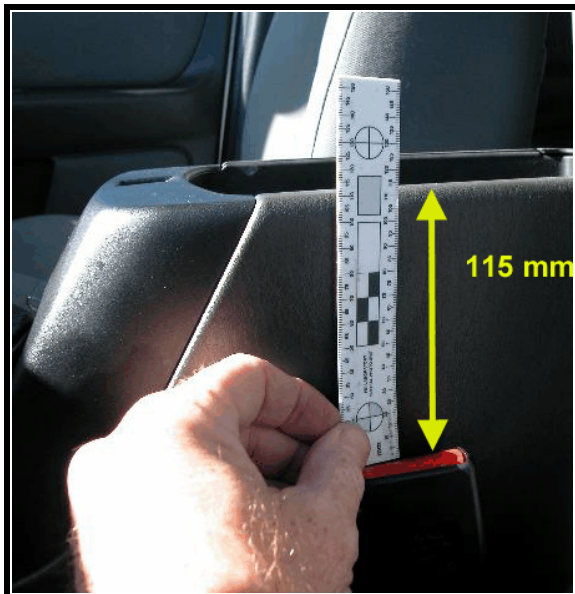
The driver's buckle mounted seat belt pretensioner actuated during the barrier crash. There was 6.0 cm (2.4 in) of stroke. There were loading marks found on the shoulder harness from the D ring. These measured 13.0 cm (5.1 in) in length and were located 103.0 cm (40.6 in) from the stop button. The front right passenger's pretensioner did not actuate.

Figure 5. Driver's side buckle retractor position. Pretensioner actuated.

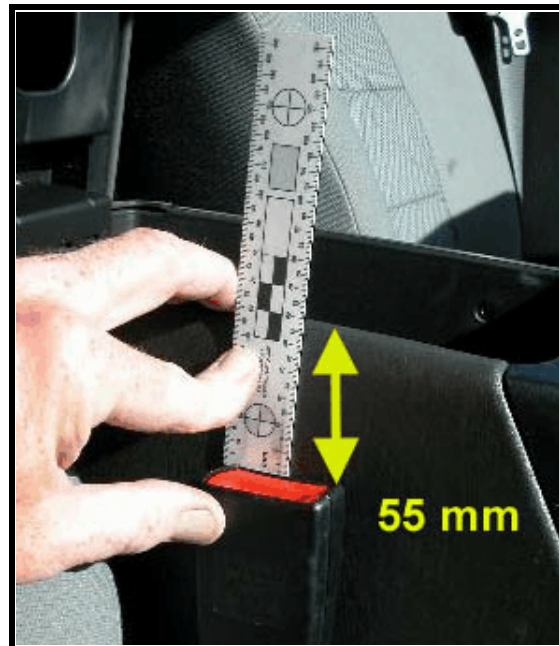
Figure 6. Front right passenger buckle retractor position. Pretensioner not actuated.

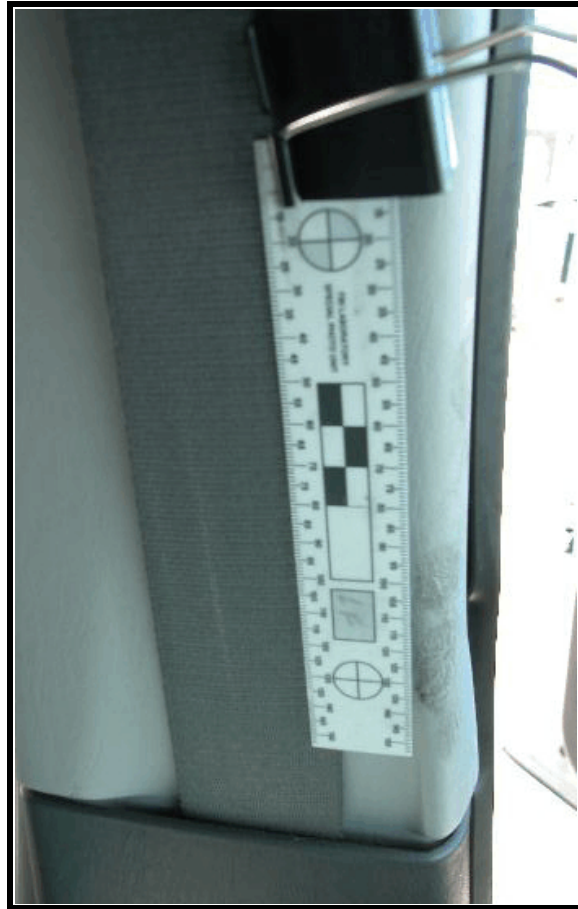
Figure 7. Loading to driver's seat belt webbing

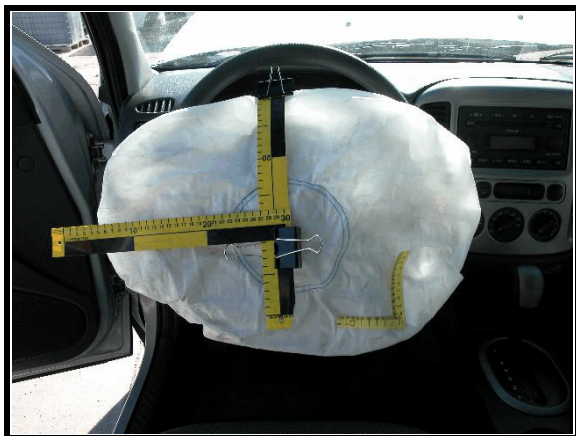
The driver's air bag was mounted in the center of the steering wheel hub. The air bag module had an H configuration. The top flap measured 13.5 cm (5.3 in) at the tear point by 7.5 cm (2.9 in) high. The bottom flap measured 13.5 cm (5.3 in) wide at the tear point by 5.5 cm (2.2 in) high. The air bag was circular in shape and measured 52.0 cm (20.5 in) in its deflated state. The air bag had a single internal tether. There were two circular vent ports on the back of the back at the 3 and 9 o'clock positions. Both vent ports were scorched along the edges. There was a single skin transfer/blood contact found in the lower right quadrant. The stain tested positive for blood. The front right passenger's air bag was a mid instrument mount and did not deploy.

Figure 8. Driver's air bag. Contact to right lower quadrant.

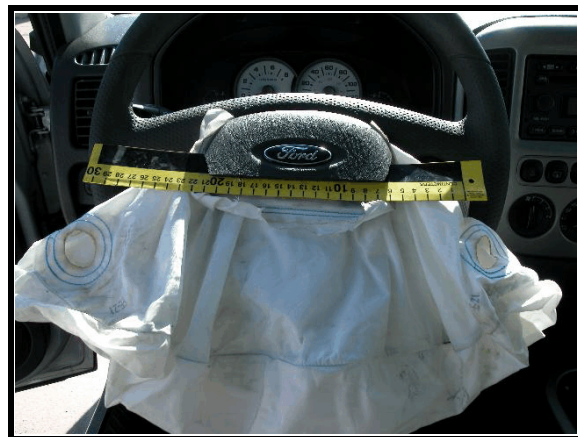
Figure 9. Driver's air bag. Scorched vent ports and top module cover.

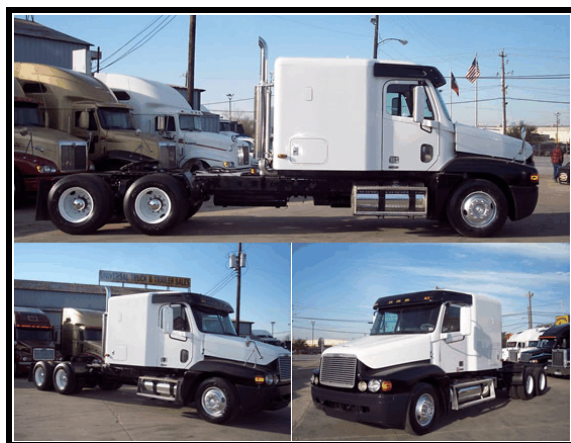
Damage Description: Police indicate some minor contact damage to the front right corner. Vehicle was driven from the scene.

Figure 10. Exemplar views of 1999 Freightliner FLC120 tractor

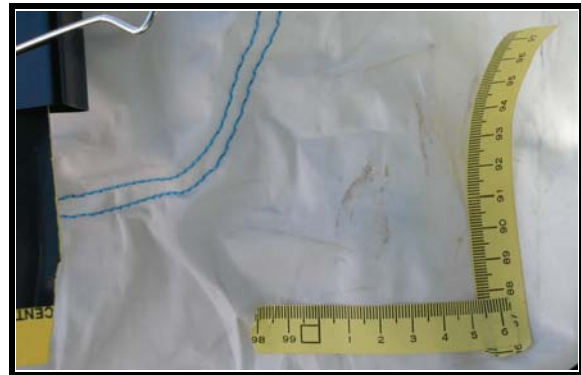
Driver injuries: Injuries based on the location and presence of blood and tissue on the driver’s air bag.

Figure 11. Skin/blood contact to face of driver's air bag

²Tested positive for blood using Hemident presumptive blood reagent kit.
