Side Air Curtain Investigation/ Vehicle to Vehicle
Dynamic Science, Inc. / Case Number: DS04022
2004 Saturn Vue Sport Utility Vehicle
Colorado
November, 2004

1. Report No. DS04022	2. Government Accession No.		3. Recipient Catalog No.	
4. Title and Subtitle Side Air Curtain Investigation			5. Report Date April 10, 2006

Dynamic Science, Inc.
Crash Investigation
Case Number: DS04022

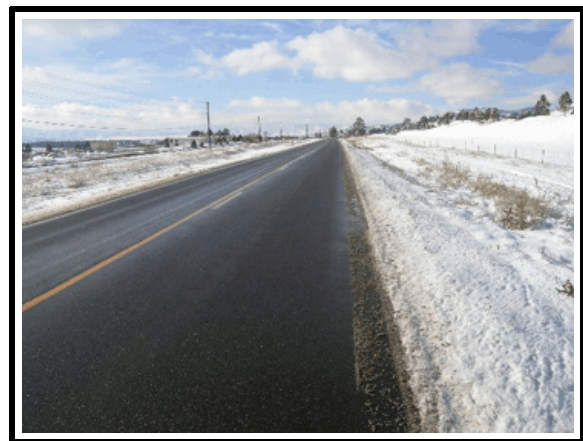
Figure 1. Direction of travel, and impact areas (west) case vehicle

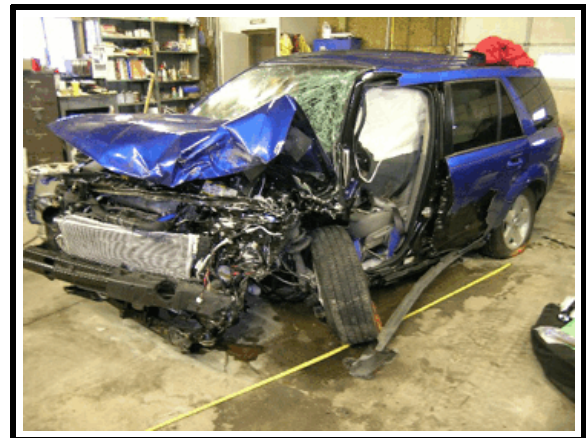
Figure 2. Front, left three-quarter view showing frontal deformation and “snagged” left front tire of case vehicle

Damage Description: The case vehicle sustained major damage to its frontal plane with direct contact deformation extending to the left rear door. The combined direct and induced damage length along the left side was 243.0 cm (95.7 in) in length. Both front doors were jammed shut and were subsequently opened by use of a hydraulic Hurst tool with interchangeable power shears. Rescue personnel completely removed the front, left door. The front, left side glazing disintegrated due to impact forces. Damaged components included the bumper fascia and reinforcement bar, upper and lower radiator supports, the grille area, hood, left front fender, windshield header, and roof panel. The laminated windshield glazing was cracked due to impact forces. The left wheelbase was reduced in length by 91.0 cm (35.8 in) while the right wheelbase was lengthened by 5.0 cm (1.9 in).

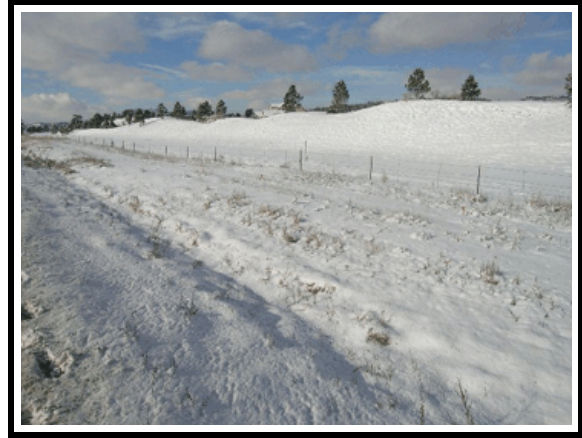
The case vehicle rotated counterclockwise, departed the north roadside as it traveled backwards in a northwesterly direction for approximately 15.5 m (51.0 ft.) before coming to rest in a dirt field facing in a southeasterly direction. The Prizm initiated a rapid counterclockwise rotation as it was thrust 5.2m (17.0 ft.) in a southwesterly direction before coming to rest straddling the south road edge line and facing southwest.

Figure 3. Final rest area (northwest) case vehicle

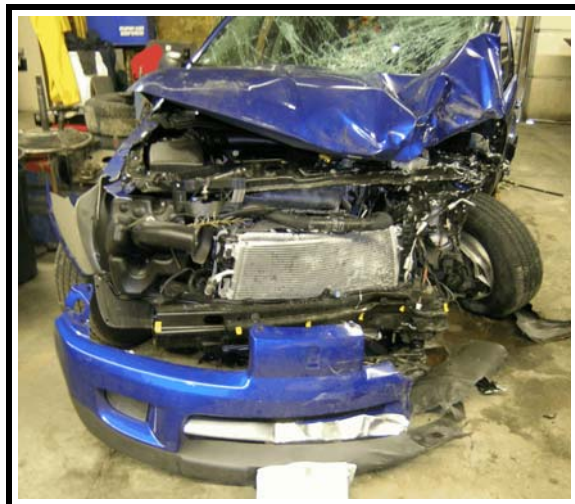
Figure 4. Front, 2004 Saturn Vue

CDC: 12FLEW4

C-measurements (crush profile): The combined direct and induced damage length was 120.0 cm (47.2 in) and involved the entire frontal plane. The direct contact damage was 48.0 cm (18.9 in.) in length and initiated 26.0 cm (10.2 in) left of the vehicle centerline. Six equidistant crush measurements were documented at the bumper bar level (fascia was missing) and the crush profile is as follows: $C_1 = 84.0$ cm (33.0 in), $C_2 = 80.0$ cm (31.5 in), $C_3 = 67.0$ cm (26.3 in), $C_4 = 47.0$ cm (18.5 in), $C_5 = 24.0$ cm (9.4 in), $C_6 = 2.0$ cm (0.8 in). The maximum crush depth was 84.0 cm (33.0 in) and was located at C_1 or at the front left bumper bar corner.

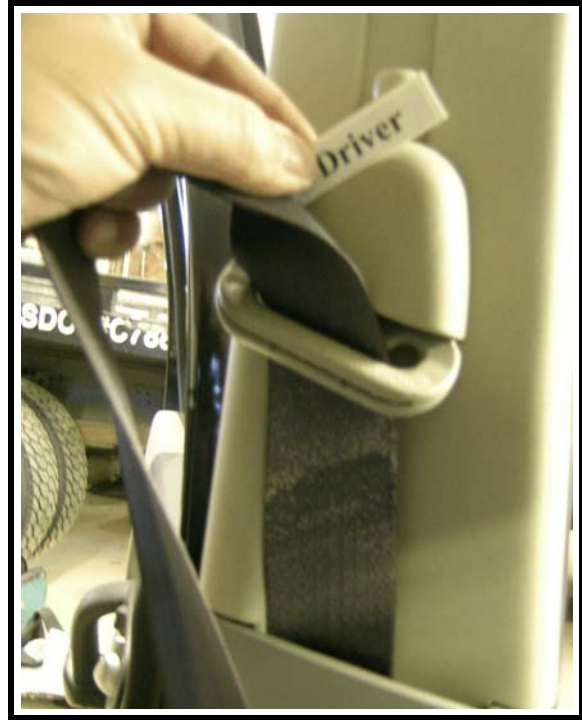
The driver's manual restraint system consisted of a continuous loop three-point lap and shoulder belt with a free sliding latch plate and an Emergency Locking Retractor (ELR). The shoulder belt adjuster was in the full down position. The driver's lap and shoulder belt webbing exhibited evidence of heavy occupant loading. The belt webbing was observed to have been stretched and plastic residue transfers were located on the shoulder belt webbing due to load forces applied on the D-ring. The pretensioners activated and locked the excess webbing in a spooled out position. In addition, the driver's lap and shoulder belt exhibited evidence of historical usage as scratching and striations were documented to the free sliding latch plate.

Figure 5. Loading to driver's seat belt

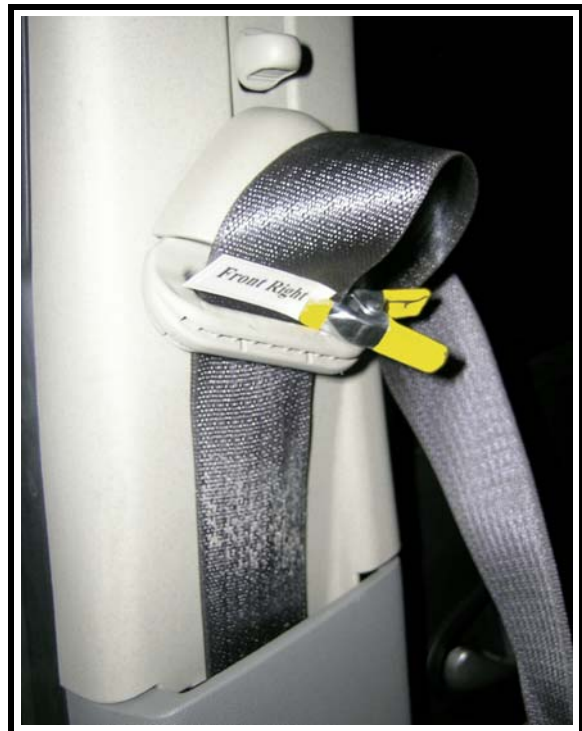
The front, right passenger's manual restraint system consisted of a continuous loop three-point lap and shoulder belt with a free sliding latch plate and an Emergency Locking Retractor (ELR). The shoulder belt adjuster was in the full down position. The driver's lap and shoulder belt exhibited evidence of heavy occupant loading. The belt webbing was observed to have been stretched and plastic residue transfers were located on the shoulder belt webbing due to load forces applied on the D-ring. The pretensioners actuated and locked the excess webbing in a spooled out position upon vehicle inspection. In addition, the driver's lap and shoulder belt exhibited evidence of historical usage as scratching and striations were documented to the free sliding latch plate.

Figure 6. Loading to front right passenger seat belt

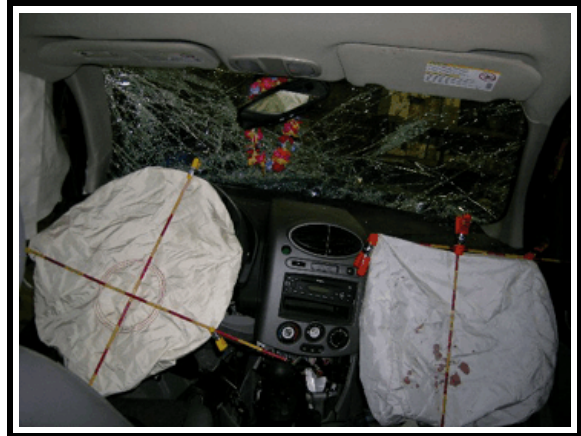
Both the driver's and front right passenger's air bags deployed during the crash. The driver air bag module was located in the center hub of the steering wheel rim with a vertically oriented flap tear seam (I-configuration). The diameter of the deflated circular air bag was 57.0 cm (22.4 in). It was equipped with three internal tether straps and had two vent ports (11 and 1 o'clock positions). The maximum deflated air bag excursion measured approximately 24.0 cm (9.4 in). There were no indications of any damage to driver's air bag or the module cover flaps. Blood was spattered along the top face, lower left and middle of the face of the air bag. There was grease deposits on the middle of the air bag.

The front right passenger air bag was a mid instrument panel mount module with a single module cover flap. The deflated air bag was rectangular in shape with a height of approximately 50.0 cm (19.7 in) and a width of approximately 43.0 cm (16.9 in). The maximum deflated air bag excursion measured approximately 56.0 cm (22.0 in). The air bag was not tethered, and had two vent ports at the 2 and 10 o'clock positions. There were no indications of any damage to front right passenger air bag. There was faint evidence of vinyl transfer to the membrane from expansion within the module along the top portion of the air bag. There was blood all distributed across the left side of the face of the air bag, as well as both sides. The single hinged module cover flap was rectangular in shape and measured 34.0 cm (13.4 in) wide by 20.0 cm (7.9 in) high. The center of the module cover flap was scuffed from probable front right occupant leg contact.

Figure 7. Driver and FR passenger air bags

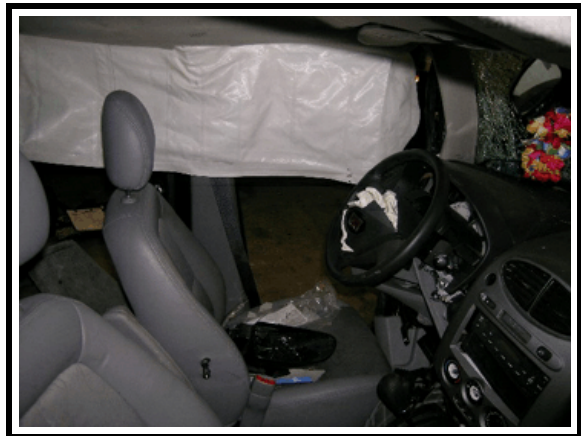
The left head curtain side air bag also deployed. The head curtain side air bag deployed downward from the roof cladding. The curtain was rectangular in shape and measured 41.0 cm (16.1 in) wide by 178.0 cm (70.0 in) long. It was attached to the A pillar by a single 58.0 cm (22.8 in) long tether, and to the roof railing 6.0 cm (2.4 in) from the C pillar by a 35.0 cm (13.8 in) long tether. The distance from the front of the curtain to the mid point of the B pillar was 38.0 cm (14.9 in). The head curtain side air bag comes down 49.0 cm (19.3 in) from the top window

Figure 8. Driver's head curtain side air bag

railing. Both left side windows were covered by the deployed head curtain side air bag. There was no damage or occupant contacts found on the left curtain.

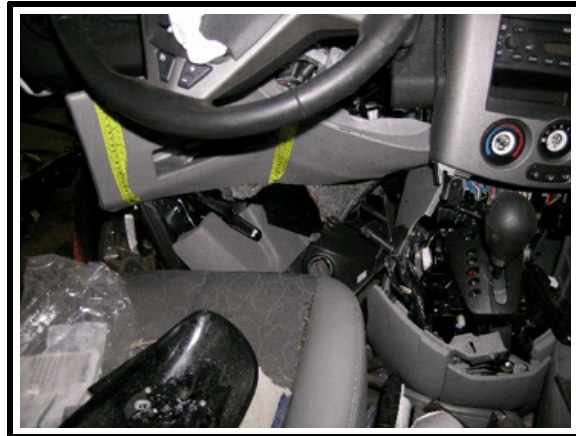
The interior greenhouse area of the case vehicle sustained intrusion which was isolated to the front, left seated area and greatly reduced that area due to the longitudinal and lateral displacement of numerous components. The windshield header, windshield, left A-pillar, instrument panel and toe pan were displaced longitudinally rearward. While the left front door panel and the side kick-panel located forward of the A-pillar, intruded laterally.

Position	Intruded Component	Magnitude of Intrusion	Direction
LF	A-pillar	36.0 cm (14.1 in)	Longitudinal
LF	Kick Panel	17.0 cm (6.7 in)	Lateral
LF	Instrument Panel	34.0 cm (13.3 in)	Longitudinal
LF	Door Panel	32.0 cm (12.6 in)	Lateral
LF	Roof	3.0 cm (1.2 in)	Vertical
LF	Toe Pan	20.0 cm (7.9 in)	Longitudinal
LF	Windshield	35.0 cm (13.8 in)	Longitudinal

Figure 9. View showing intrusion at drivers position and lower extremity contacts to deformed knee bolster
