Child Air Bag Related Fatality Investigation / Vehicle to Vehicle  
Dynamic Science, Inc. / Case Number: DS04024  
1997 Ford Crown Victoria  
Arizona  
December, 2004

1. Report No. DS04024	2. Government Accession No.	3. Recipient Catalog No.	
4. Title and Subtitle  Child Air Bag Related Fatality Investigation		5. Report Date April 28, 2005

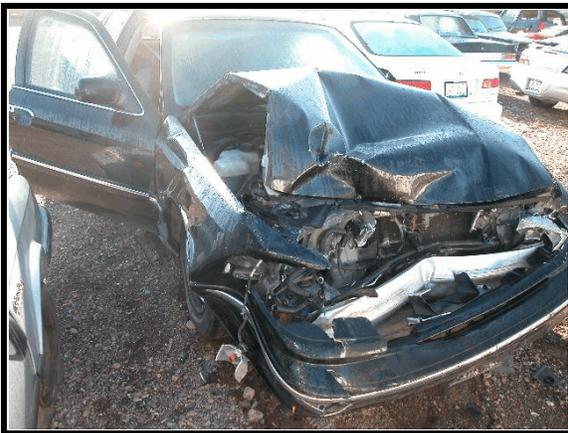
The 1997 Ford Crown Victoria sustained moderate front end damage as result of the first impact with the Chevrolet Blazer. The bumper was pushed rearward and the hood was buckled. All the doors remained closed and operational. The right wheelbase was shortened by 14.0 cm (5.5 in). There was windshield damage from an occupant contact. The direct damage from the initial impact began 14.0 cm (5.5 in) from the front right bumper corner and extended laterally 134.0 cm (52.7 in) along the bumper. Six crush measurements were documented at the backing bar level as follows: 1.0 cm (0.4 in), 20.0 cm (7.9 in), 41.0 cm (16.1 in), 46.0 cm (18.1 in), 35.0 cm (13.8 in), 25.0 cm (9.8 in). The Crown Victoria sustained minor left side damage as a result of the second impact with the Chevrolet Blazer. The direct damage began 60.0 cm (23.6 in) rearward of the front axle and extended 49.0 cm (19.3 in) rearward along the left side plane. The maximum crush was 2.5 cm (1.0 in).

**Figure 5.** Front impact to Crown Victoria

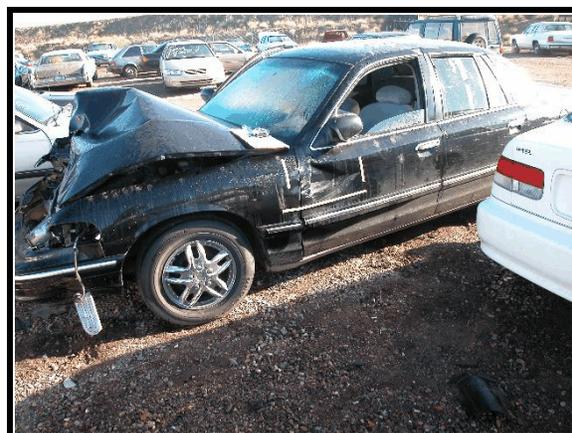
**Figure 4.** Left side, side slap impact

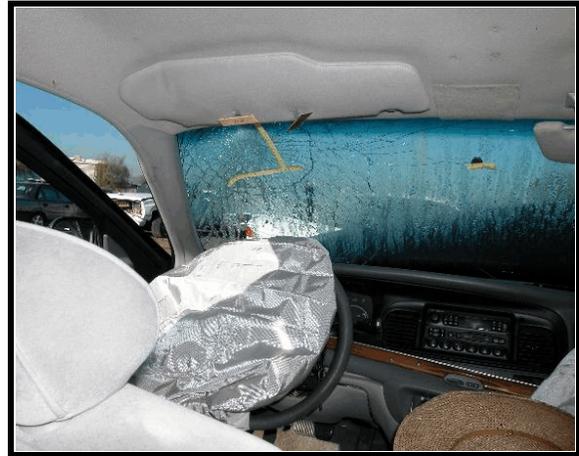
The 1997 Ford Crown Victoria sustained minor interior damage. There was the normal damage to the steering wheel and instrument panel found after air bag deployments. The left upper quadrant of the windshield was fractured by the driver's left hand. The center mirror was dislodged by the deploying passenger air bag.

**Figure 6.** Contact damage to windshield and dislodged center mirror

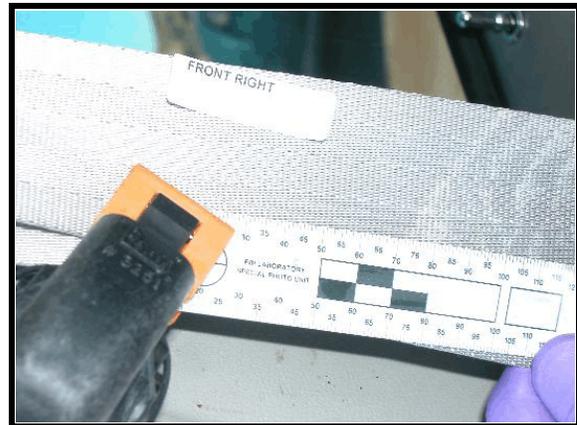
**Figure 7.** Load marks to front right seat belt webbing

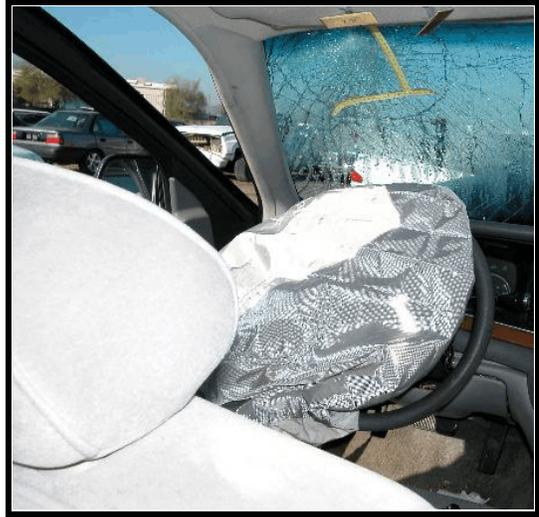
**Figure 8.** Driver's air bag / hand contact to windshield

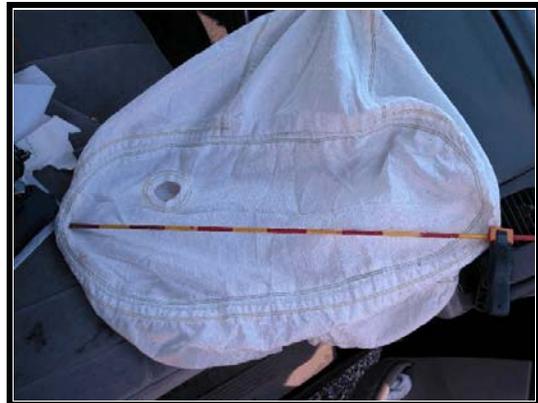
**Figure 9.** Left panel, front right passenger air bag

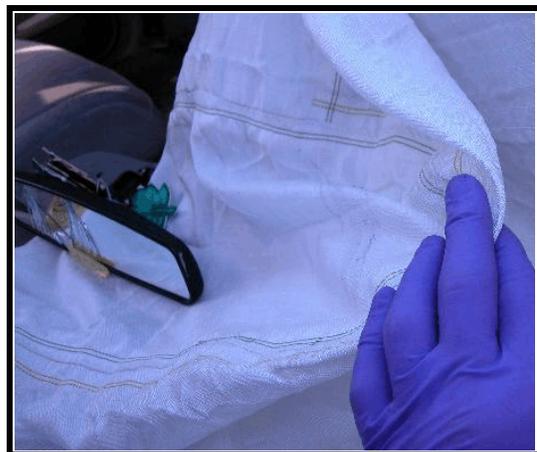
**Figure 10.** Left side panel, mirror and mirror contact

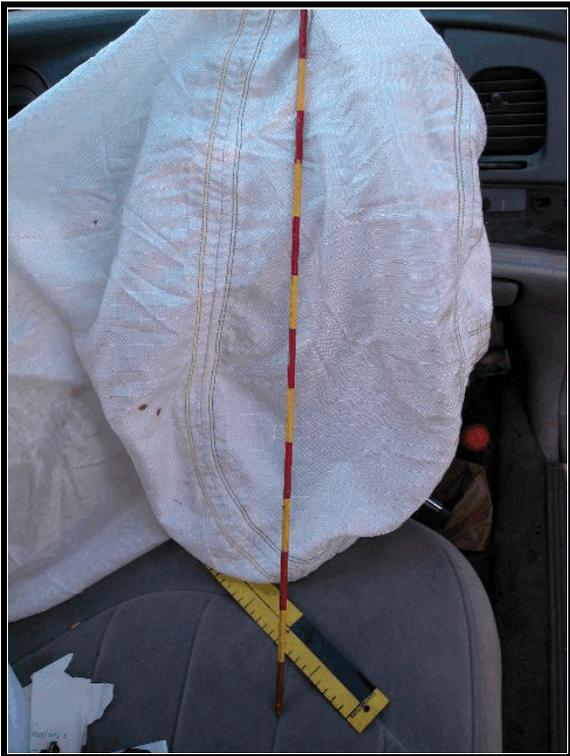
**Figure 11.** Blood drops along right hand seam

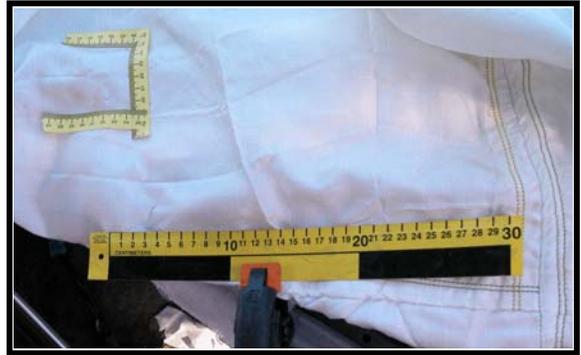
The front right passenger air bag module was a mid mount design which incorporated a horizontally oriented single flap tear seam at the bottom. The module cover measured 39.5 cm (15.6 in) wide, 15.5 cm (6.1 in) high in the center, and 14.0 cm (5.5 in) high at each end. The air bag face was roughly rectangular and measured 72.0 cm (28.3 in) wide seam to seam and 62.0 cm (24.4 in) high seam to seam. There were blood drops found near the right seam. There were side panels on the left and the right. The panels were both oval in shape and measured 52.0 cm (20.5 in) high by 30.0 cm (11.8 in) wide. There was a single circular vent port in the left side panel. The upper portion of the left side panel was abraded by the center mirror during the deployment. The mirror was knocked off. There was a skin contact found 12.0 cm (4.7 in) from the bottom seam and 30.0 cm (11.8 in) from the right seam. The skin contact was approximately 3.5 cm (1.4 in) in width.

**Figure 12.** Skin contact to bottom of front right passenger air bag

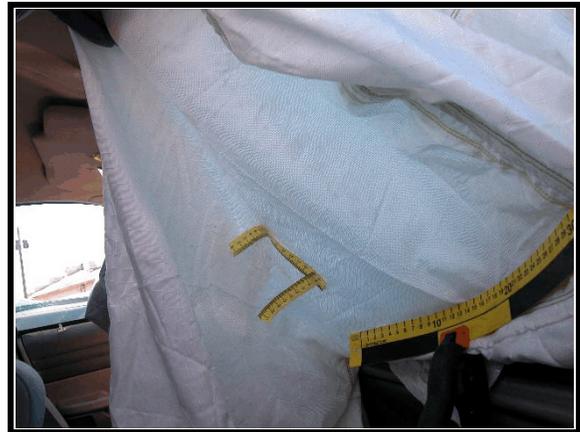
**Figure 13.** Lateral view of skin contact to bottom of front right passenger air bag

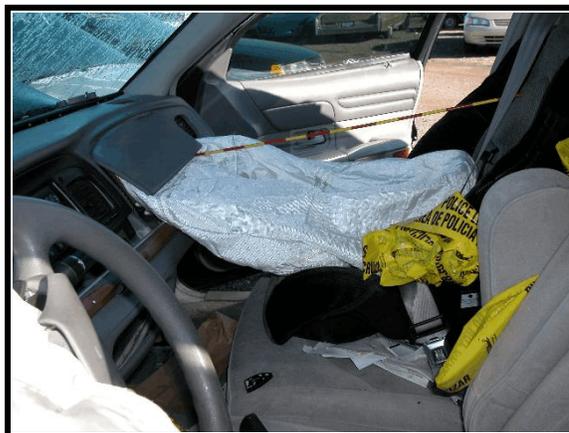
The front right passenger air bag had a maximum deflated excursion of 73.0 cm (28.7 in). The distance from the module face to CSS back and vehicle seat back were 68.0 cm (26.8 in) and 74.0 cm (29.1 in), respectively.

**Figure 15.** Overview of booster seat position relative to front right passenger air bag as viewed from left

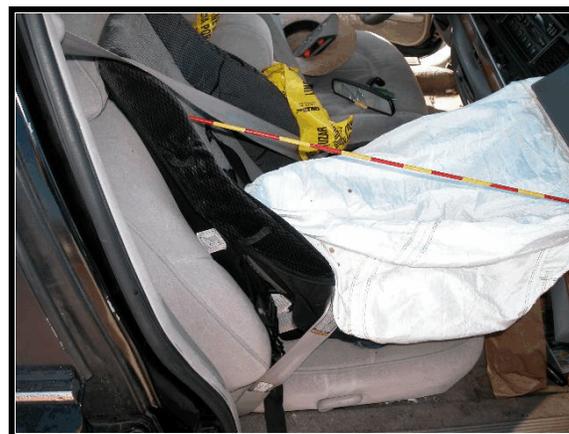
**Figure 16.** Overview of booster seat position relative to front right passenger air bag as viewed from right

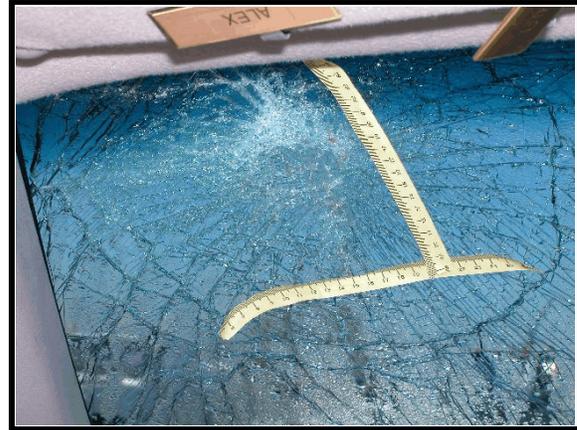
Figure 17. Driver hand contact to windshield

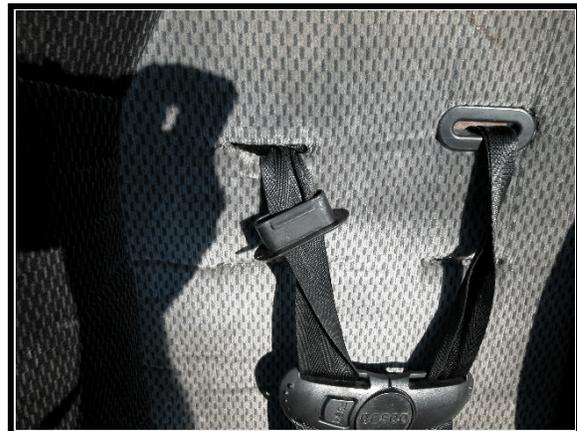
The 3-year-old male front right occupant was seated in a Cosco High Back Booster seat. He was wearing the five-point booster seat harness. This is based on information from emergency rescue personnel and the indications of loading at the right upper slot. The seat was anchored to the vehicle using the available lap and shoulder belt. The shoulder belt anchorage was adjusted to the full up position. It is not known if switchable lap and shoulder belt was in the ALR or ELR mode at the time of the crash. The booster seat was anchored to the fabric covered split bench seat. The seat back was slightly reclined. The seat track was found in the full back position (50.0 cm/19.6 in rearward of the toe pan). At impact with the Chevrolet Blazer, the child and child seat initiated forward and slightly left trajectories to the front. The child loaded the harness, likely causing the bilateral lung contusions and multiple torso abrasions. The child's head pitched forward to some degree and the child's neck engaged the child seat harness, possibly causing the horizontal anterior abrasion to the neck. The passenger side air bag deployed. The front right passenger air bag had a maximum deflated excursion of 73.0 cm (28.7 in). The distance from the module face

Figure 18. CSS harness loading
