## ON-SITE SIDE IMPACT INFLATABLE OCCUPANT PROTECTION INVESTIGATION

CASE NUMBER - IN-04-026

VEHICLE - 2002 LEXUS IS 300

CRASH DATE - May 2004

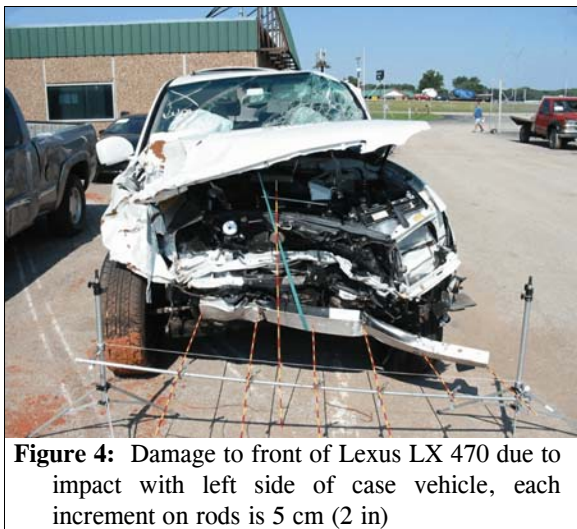
**Figure 4:** Damage to front of Lexus LX 470 due to impact with left side of case vehicle, each increment on rods is 5 cm (2 in)

**Crash:** The front of the Lexus LX 470 (**Figure 4**) impacted the left fender, left front wheel and left front door of the case vehicle (**Figure 5**) causing the case vehicle's driver and front right air bags to deploy. In addition, the impact caused the driver's seat back-mounted side impact air bag and side curtain air bag to deploy as well. As a result of the impact, the LX 470 rotated counterclockwise and the case vehicle rotated clockwise. The case vehicle's left quarter panel (**Figure 6** below) impacted the LX 470's right rear and right front doors (**Figure 7** below). The case vehicle continued rapid clockwise rotation due to the initial impact and the right portion of the back bumper and trunk lid impacted the LX 470's right rear corner. This third impact between the two vehicles is supported by the post-impact trajectory of the case vehicle shown on the police crash diagram and the corresponding damage to the case vehicle's back bumper and trunk lid (**Figure 8** below), and the damage to the LX 470's right rear corner (**Figure 9**) below. The height of the damage on right rear corner of the LX-470 indicates that during the spin-out phase of the crash, the back of the case vehicle was off the ground to some extent and the LX 470 was tilted

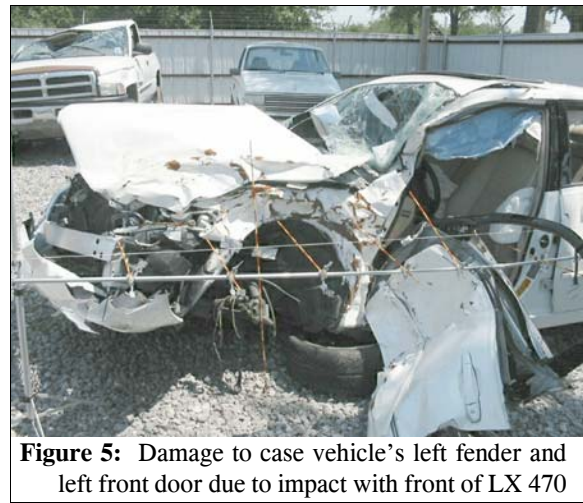
**Figure 5:** Damage to case vehicle's left fender and left front door due to impact with front of LX 470

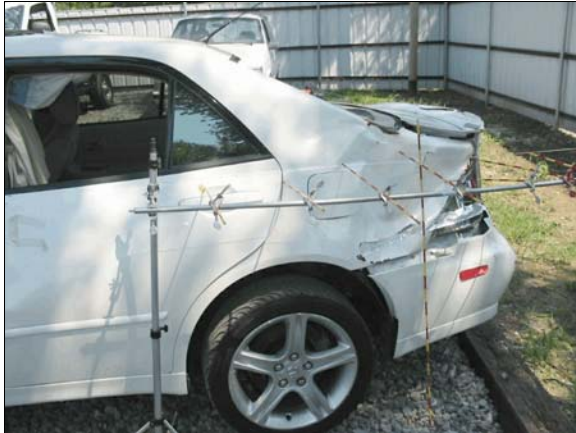
**Figure 6:** Damage to case vehicle's left quarter panel due to impact with LX 470's right side doors

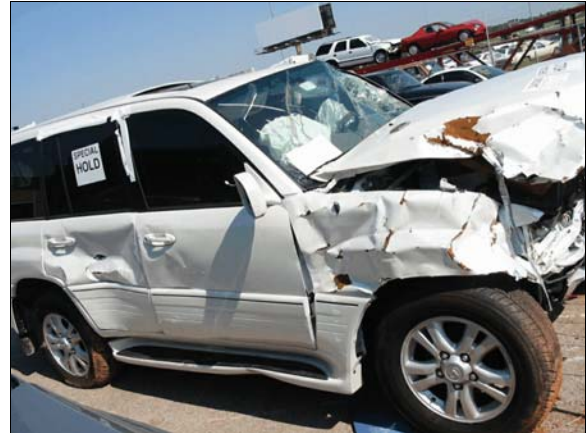
**Figure 7:** Damage to right side doors of LX 470 from impact with case vehicle's left quarter panel

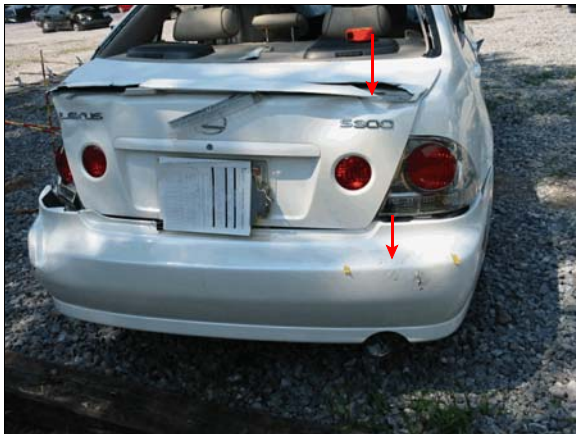
**Figure 8:** Damage to right portion of case vehicle's back bumper and trunk lid (arrows) from impact with the right rear corner of the LX 470

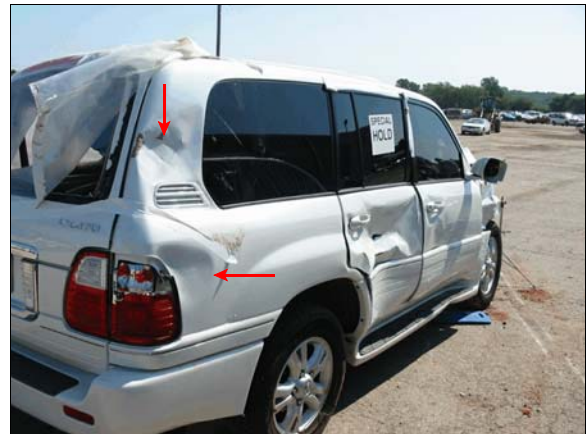
**Figure 9:** Overview of damage to right rear corner of LX 470 (arrows) due to impact with back of case vehicle

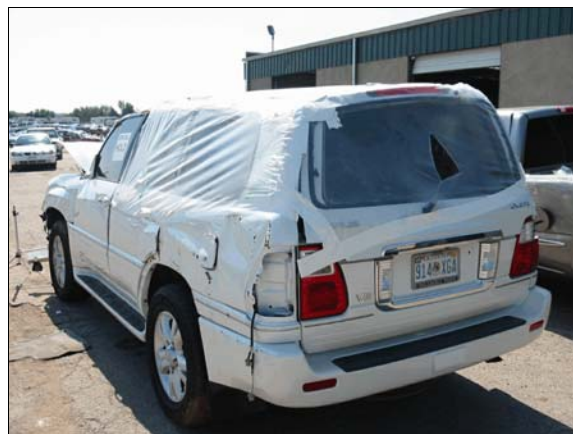
**Figure 10:** Overview of rollover damage to left side of Lexus LX 470

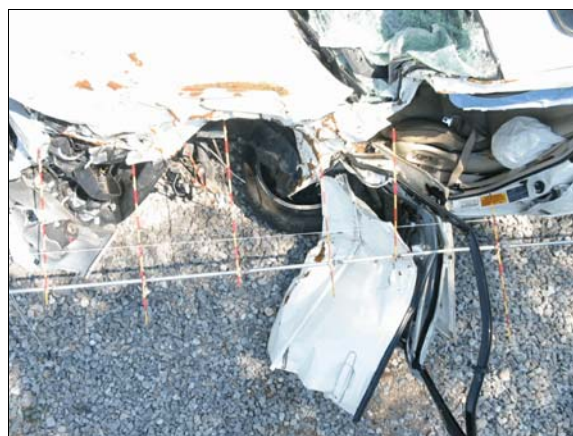
**Figure 11:** Top view of crush to case vehicle's left front side (driver's door also damaged by rescue activities), each increment on rods is 5 cm (2 in)

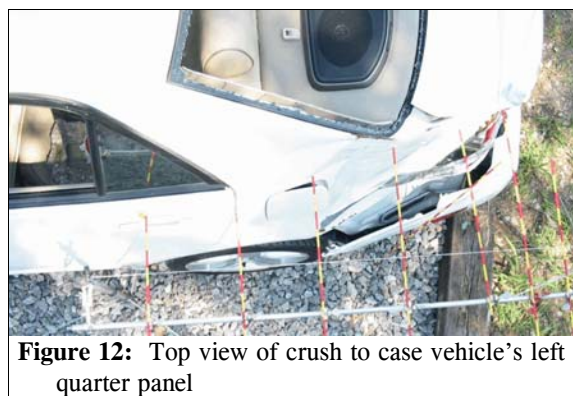
measured as 22 centimeters (8.7 inches) occurring at C<sub>2</sub> (**Figure 12**). The third impact with the LX 470 produced direct damage to the right portion of the case vehicle’s back bumper and trunk lid. The direct damage started 3 centimeters (1.2 inches) left of the right rear bumper corner and extended approximately 50 centimeters (19.7 inches) along the back bumper and trunk lid. There was no residual crush to the back bumper due to the recovery of the back bumper’s plastic fascia. However, there was about 3 centimeters (1.2 inches) of crush to the top right corner of the trunk lid. The table below shows the case vehicle’s crush measurements for the first impact.

**Figure 12:** Top view of crush to case vehicle’s left quarter panel

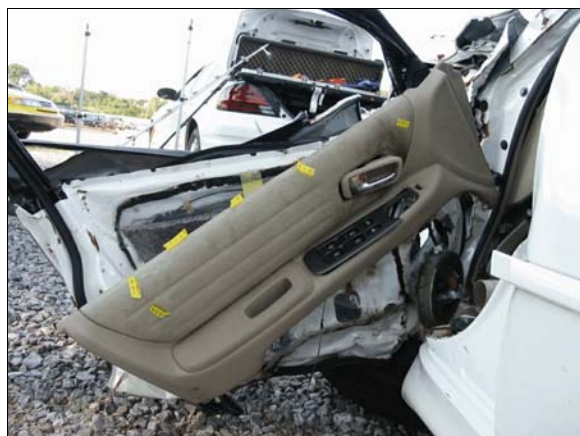
**Vehicle Interior:** Inspection of the case vehicle’s interior revealed occupant contact to the left front door panel and left arm rest (**Figure 13**). In addition, the driver most likely contacted her deployed front air bag as well as her deployed seat back-mounted side impact air bag, and front side curtain air bag. Blood spots were found on the driver’s front and seat back-mounted side impact air bags, but no other occupant contact marks were found on any of the air bags, and no other occupant contact evidence was found on the case vehicle’s interior. Numerous passenger compartment intrusions were observed including the driver’s door, left sill, left floor pan, left A-pillar, left side panel forward of the left A-pillar, steering assembly, left instrument panel (**Figure 14**) and left toe pan. There appeared to be compression of the energy absorbing steering column, but no deformation of the steering wheel rim was observed (**Figure 14**).

**Figure 13:** Occupant contact to case vehicle’s left front door (door has also been damaged from rescue activities)

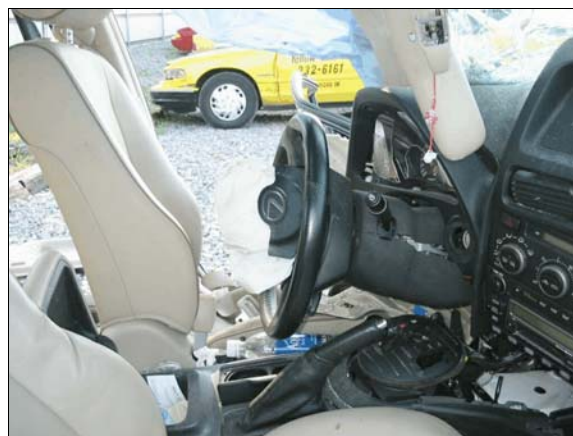
**Figure 14:** Steering wheel and instrument panel intrusion into case vehicle’s driver space, overview of steering assembly and top air bag module flap

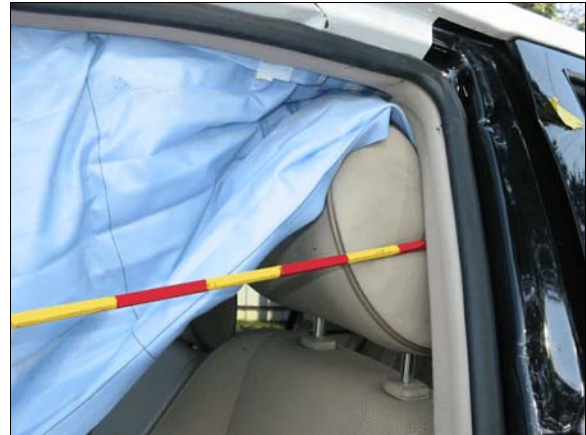
**Figure 21:** Case vehicle driver's head restraint obstructing driver's side curtain air bag

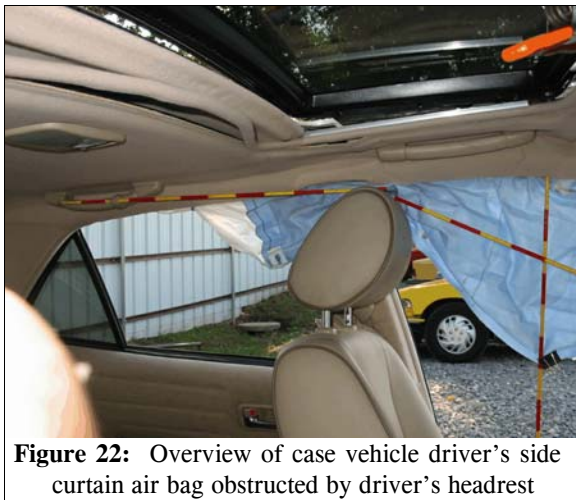
**Figure 22:** Overview of case vehicle driver's side curtain air bag obstructed by driver's headrest

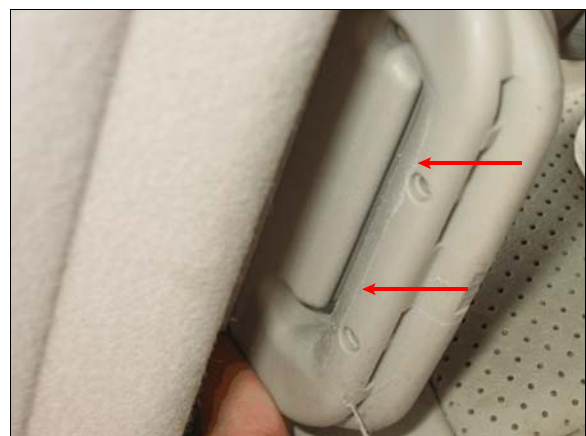
The case vehicle's driver was restrained by her manual, three-point, lap-and-shoulder safety belt system. Inspection of the safety belt assembly revealed heavy abrading on the D-ring (**Figure 27**), and abrading and stretching of the shoulder belt (**Figure 28** below). In addition, the safety belt system was equipped with a retractor-mounted pretensioner and load limiter, which activated as a result of the crash.

**Figure 27:** Abrasions on the case vehicle driver's D-ring (arrows)

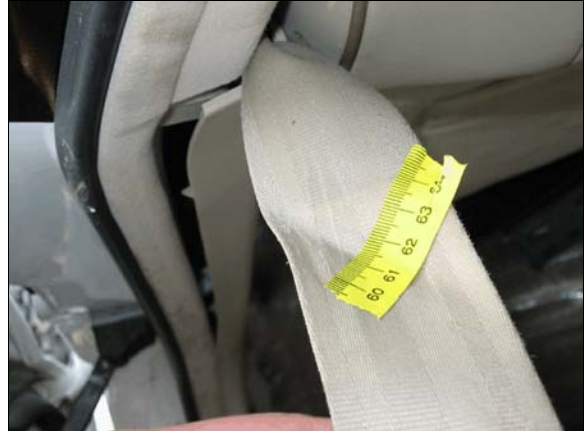
**Figure 28:** Case vehicle driver's shoulder belt, its stretched and abraded

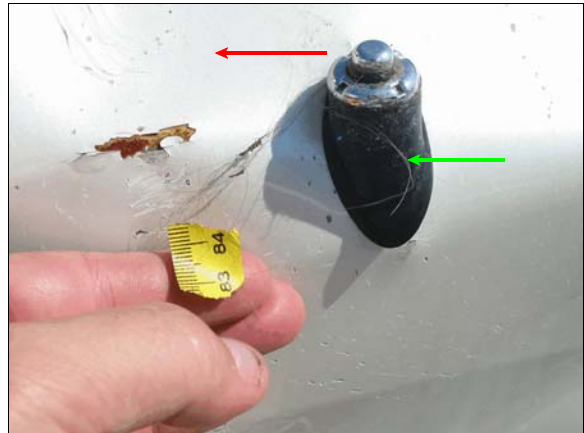
**Figure 29:** Dent in LX 470's right fender (arrow) and hair on antenna base (yellow tape and green arrow) due to case vehicle driver's head contact

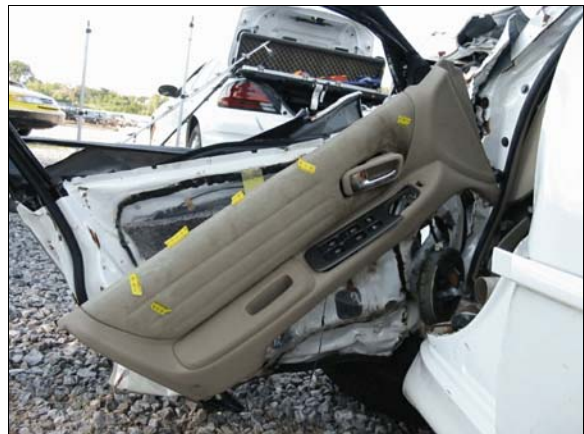
**Figure 30:** Occupant contact to case vehicle's left front door (door has also been damaged from rescue activities)

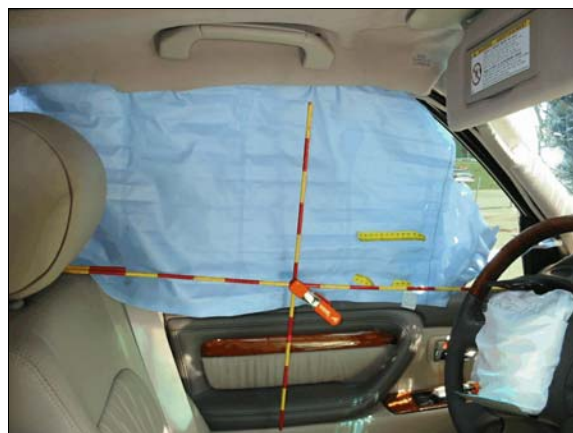
**Figure 34:** Driver's portion of the LX 470's left side curtain air bag, yellow tape shows possible driver occupant contact scuff on air bag
