**CALSPAN ON-SITE AIR BAG RELATED FATALITY CRASH
INVESTIGATION**

CASE NO: CA04-030

VEHICLE: 1997 MAZDA MIATA

CRASH DATE: SEPTEMBER 2003

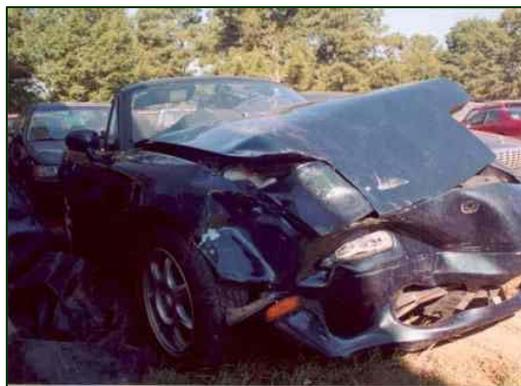
Figure 1. Frontal damage to the 1997 Mazda Miata.

impacted the front of the Pontiac, which resulted in the deployment of the frontal air bag systems in both vehicles. **Figure 1** is a front right view of the damage to the Mazda. The driver of the Mazda was not injured. The 9-year-old female front right passenger sustained police reported visible injuries and was transported by ambulance to a local hospital; however, there was no record of treatment for this passenger. The unrestrained 3-year-old male front right passenger was displaced forward into the path of the deploying front right air bag. The expanding front right air bag module cover flap impacted the upper facial region of the child resulting in fractures of the vault and base of the skull and a cervical subluxation with dislocation of the atlanto-occipital joint with an associated spinal cord injury. He was transported by ambulance to a local hospital where he was evaluated and stabilized prior to air transfer to a regional pediatric trauma center. He expired two days post-crash. Both vehicles sustained moderate severity damage and were towed from the crash site.

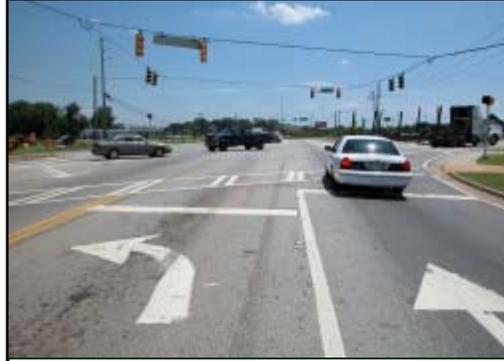
Figure 2. Overall view of the crash site from the southbound travel direction.

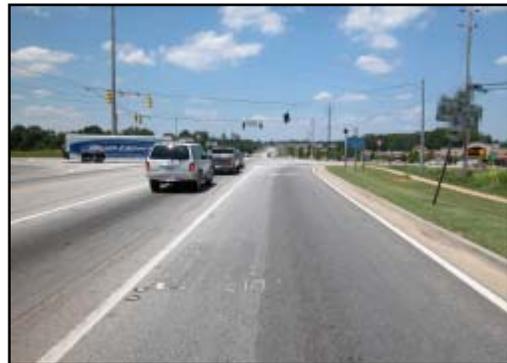
Figure 4. Pontiac's northbound approach to the intersection.

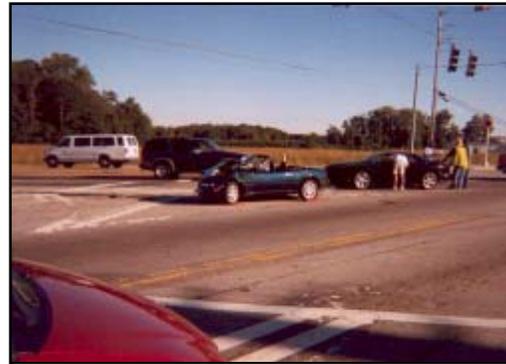
The Mazda was rotated approximately 125 degrees CCW and came to rest in a painted gore area at the northeast quadrant of the intersection facing a northeasterly direction. The Pontiac came to rest rearward of the Mazda. **Figure 5** is an on-scene view of the vehicles at final rest at the northeast quadrant of the intersection.

Figure 5. Final rest positions for both vehicles.

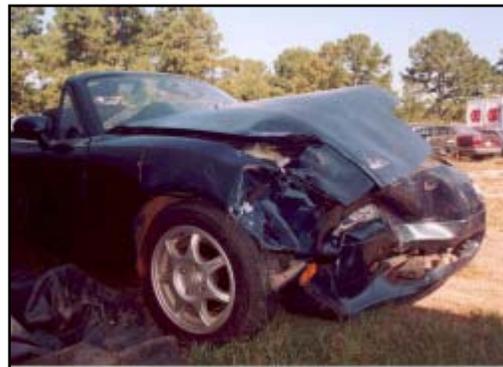
The 1997 Mazda Miata sustained moderate severity frontal damage as a result of the offset, head-on impact with the Pontiac (**Figure 6**). This damage assessment was based on the on-scene police images. The Mazda was located at a salvage yard nearly two years after the crash and inspected for this investigation. The vehicle was stripped of numerous components and the damaged front clip had been removed and crushed. A crush profile could not be obtained from the remaining chassis/body. The convertible roof was repositioned to the closed position at the salvage yard. **Figure 7 and 8** reflect the condition of the Mazda at the time of the SCI investigation.

Figure 6. Frontal damage to the Mazda Miata.

Based on the assessment of the police images, the direct contact damage began right of the centerline and extended to the front right corner. The damage involved the bumper fascia, hood, right hide-away headlamp assembly and the right front fender. Maximum crush was estimated at 15 cm (6") located at the right corner of the bumper beam. The lateral component of the 1 o'clock direction of force was evident in the lateral left displacement of the left front fender. A Collision Deformation Classification (CDC) of 01-FZEW-2 was derived from the police images.

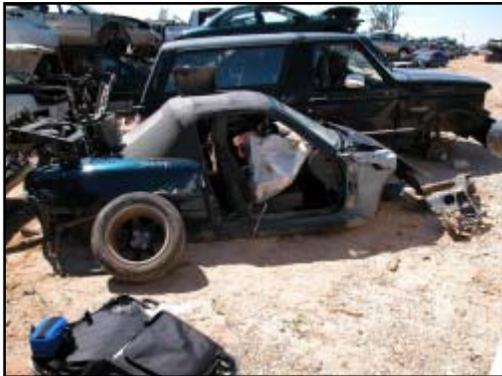
Figure 7. The condition of the Mazda at the time of the SCI inspection.

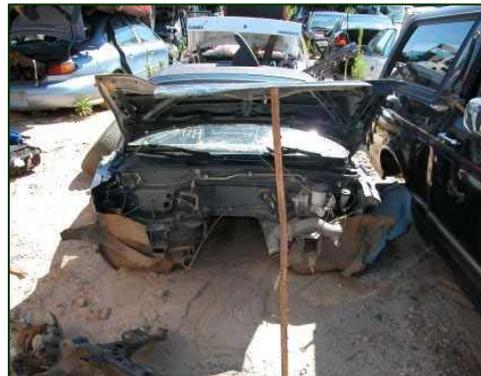
Figure 8. Dismantled frontal area of the Miata.

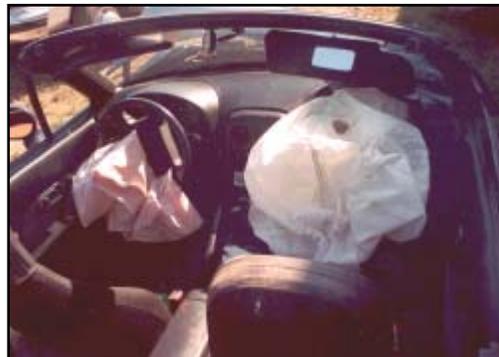
The 1997 Mazda Miata sustained minor interior damage as a result of frontal air bag deployment and possible occupant contact. There was no intrusion of the passenger compartment. **Figure 9** is an overall view of the interior that was taken by the investigating police officer. **Figure 10** is an overall view of the interior at the time of the SCI inspection. Three areas of possible occupant contact were noted to interior components. The glove box door was removed from its mounting points and was located within the vehicle's interior. Three scuffmarks were noted on the glove box door that were white in color. Given the time duration between the crash and the SCI inspection, it was unknown if these scuffmarks were directly related to the crash. The first scuffmark was located 15-24 cm (5.8-9.3") left of the right edge and 8-17 cm (3.3-6.5") above the bottom edge. The second scuffmark began 18 cm (7.0") left of the right edge and measured 5 cm (2") in width and extended upward 5 cm (1.8") from the bottom edge. The third scuffmark measured 4 cm (1.5") and began 1 cm (0.5") left of the right edge and 6 cm (2.3") above the bottom edge and extended upward 11 cm (4.5"). All three scuff marks were possible leg contact points from the child passengers.

Figure 9 - Police image of the Mazda's interior.

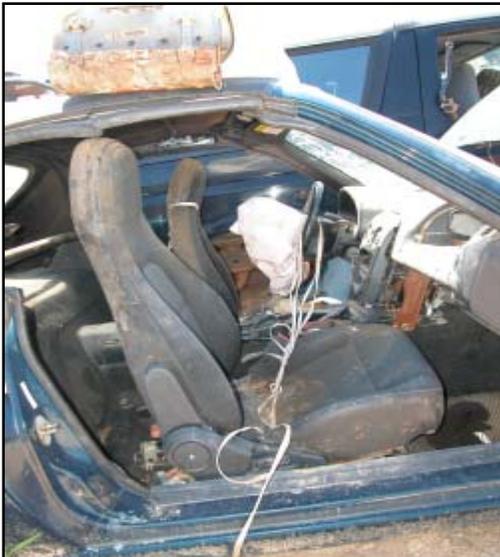
Figure 10. View of the Mazda's interior at the time of the SCI inspection.

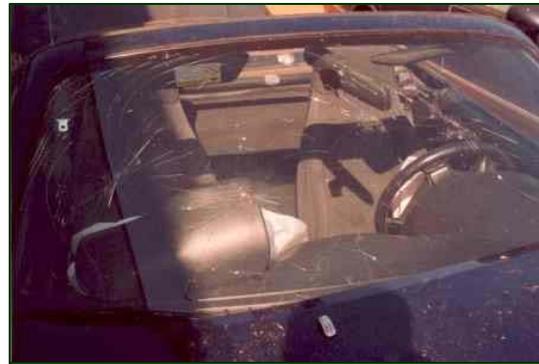
Figure 11. Multiple windshield cracks.

The windshield had five distinct impact points that resulted in cracking to the laminated glass (**Figure 11**). Two star-like cracks were located above the front right air bag module cover. The inboard crack was related to flap contact during the deployment of the passenger air bag. The outboard of the two cracks was possibly occupant contact or air bag induced. A large vertically oriented crack pattern was located adjacent to the right A-pillar. This resulted from stress applied at the right A-pillar area.

Two star-like fracture patterns were located forward of the driver's position. There was no contact evidence associated with these fractures.

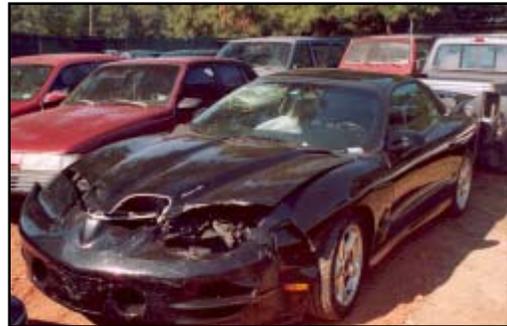
The 2000 Pontiac Trans-Am could not be located for this on-site investigative effort. The damage assessment was derived from the police images (**Figure 12**). The direct contact damage was located on the front bumper fascia, hood and left front fender. The bumper fascia concealed the structural damage; therefore, a crush profile could not be estimated from the images. The hood of the Pontiac was fiberglass and the left front fender was

composite. The right side of the windshield was fractured from contact by the front right air bag cover flap. The CDC for this impact was estimated at 11-FYEW-1.

Figure 12. Frontal damage to the Pontiac Trans Am.

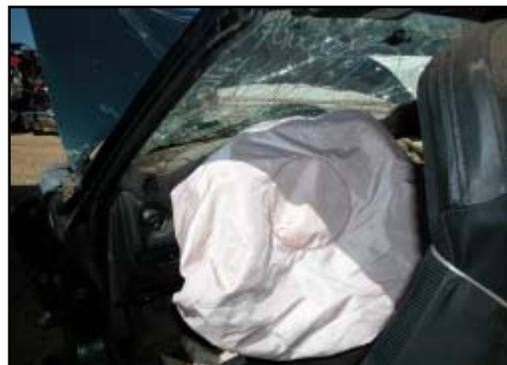
The 1997 Mazda Miata was equipped with frontal air bags for the driver and front right positions that deployed as result of the crash (**Figure 13**). The driver’s air bag was concealed by asymmetrical H-configuration module cover flaps. The top flap measured 18 cm (7.0”) in width and 9 cm (3.6”) in height. The lower flap was 17 cm (7.0”) in width at the horizontal tear seam and 7 cm (2.6”) in height. The driver’s air bag was tethered by two 8 cm (3”) wide internal tethers located at the 12 and 6 o’clock positions. These tethers controlled the deployment path and limited the excursion of the air bag. The bag measured 62 cm (24.5”) in diameter in its deflated state. The air bag was vented by two symmetrical ports that measured 3 cm (1.3”) in diameter. The ports were located at the 10 and 2 o’clock positions on the rear panel of the air bag. No occupant contact points or failures were noted to the driver’s air bag. The following information was stamped on the rear panel of the driver’s air bag at the 12 o’clock position:

Figure 13. Deployed driver's air bag.

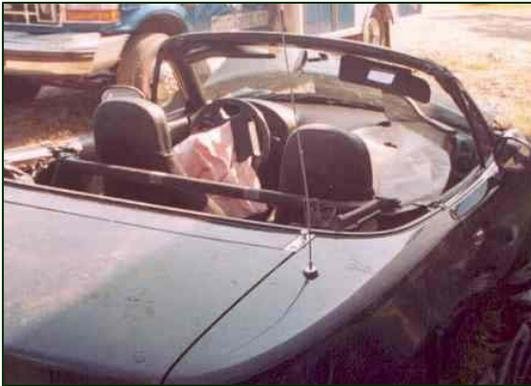
The module was concealed by a single cover flap that measured 35 cm (13.6”) in width and 19 cm (7.4”) in height. The flap was hinged at the top surface and reinforced by a sheet metal backer plate on the inside surface of the flap. Although the flap opened at the designated tear seams, the right side of the flap was deformed. The contour of the deformation was typical of an impeded deployment against an out-of-position passenger. That is, the flap opened against the head of the child passenger. The leading edge of the flap was deformed to an S-profile with the right side deflected downward approximately 8 cm (3”). **Figure 14** is a police image view of the deformed module cover flap. **Figure 15** is a close-up view of the deformed cover flap taken during the SCI inspection of the vehicle.

Figure 14. Deformed front right air bag module cover flap.

At impact with the Pontiac, the frontal air bag system in the Miata deployed. The front right air bag module cover flap opened in an upward direction. The right aspect of the flap contacted the child across the upper face at the level of the forehead. The cover flap was reinforced on the underside by a sheet metal backer panel. This contact fractured the orbital walls bilaterally with a fracture line that extended into the basilar skull through the petrous segment and into the left orbital roof. Additional fractures of the left temporal and parietal bones resulted from the cover flap contact. The child also sustained subdural hemorrhage over the frontal lobes bilaterally. The right aspect of the air bag module cover flap was deformed from the contact against the child's head.

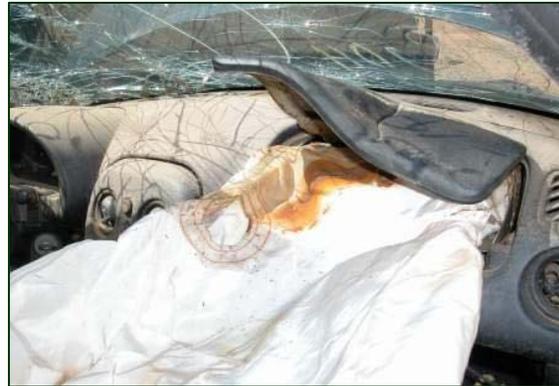
Figure 15. View of the deformed cover flap at the time of the SCI investigation.

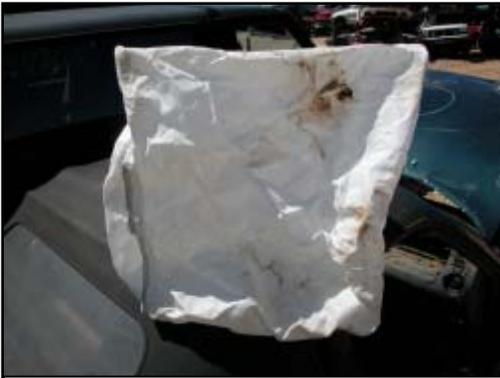
The air bag membrane measured 53 cm (21”) in width and 51 cm (20”) in height (**Figure 16**). The front right air bag was vented by two 6 cm (2.3”) diameter vent ports located on the top panel. The air bag was not tethered. The rearward excursion of the air bag measured 48 cm (19”) from the leading edge of the instrument panel (**Figure 17**). No occupant contacts or failures were noted to the front right air bag. A bar code with the following information was located on the air bag membrane:

Figure 16. Deployed front right passenger air bag.

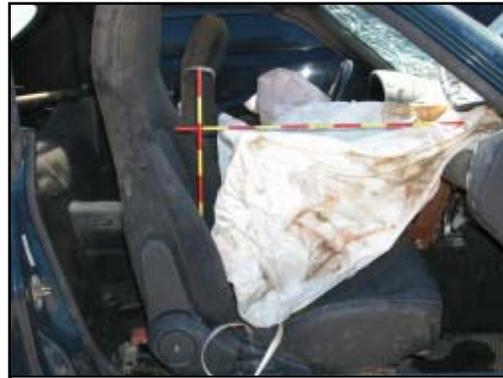
Figure 17. Rearward excursion of the front right air bag.

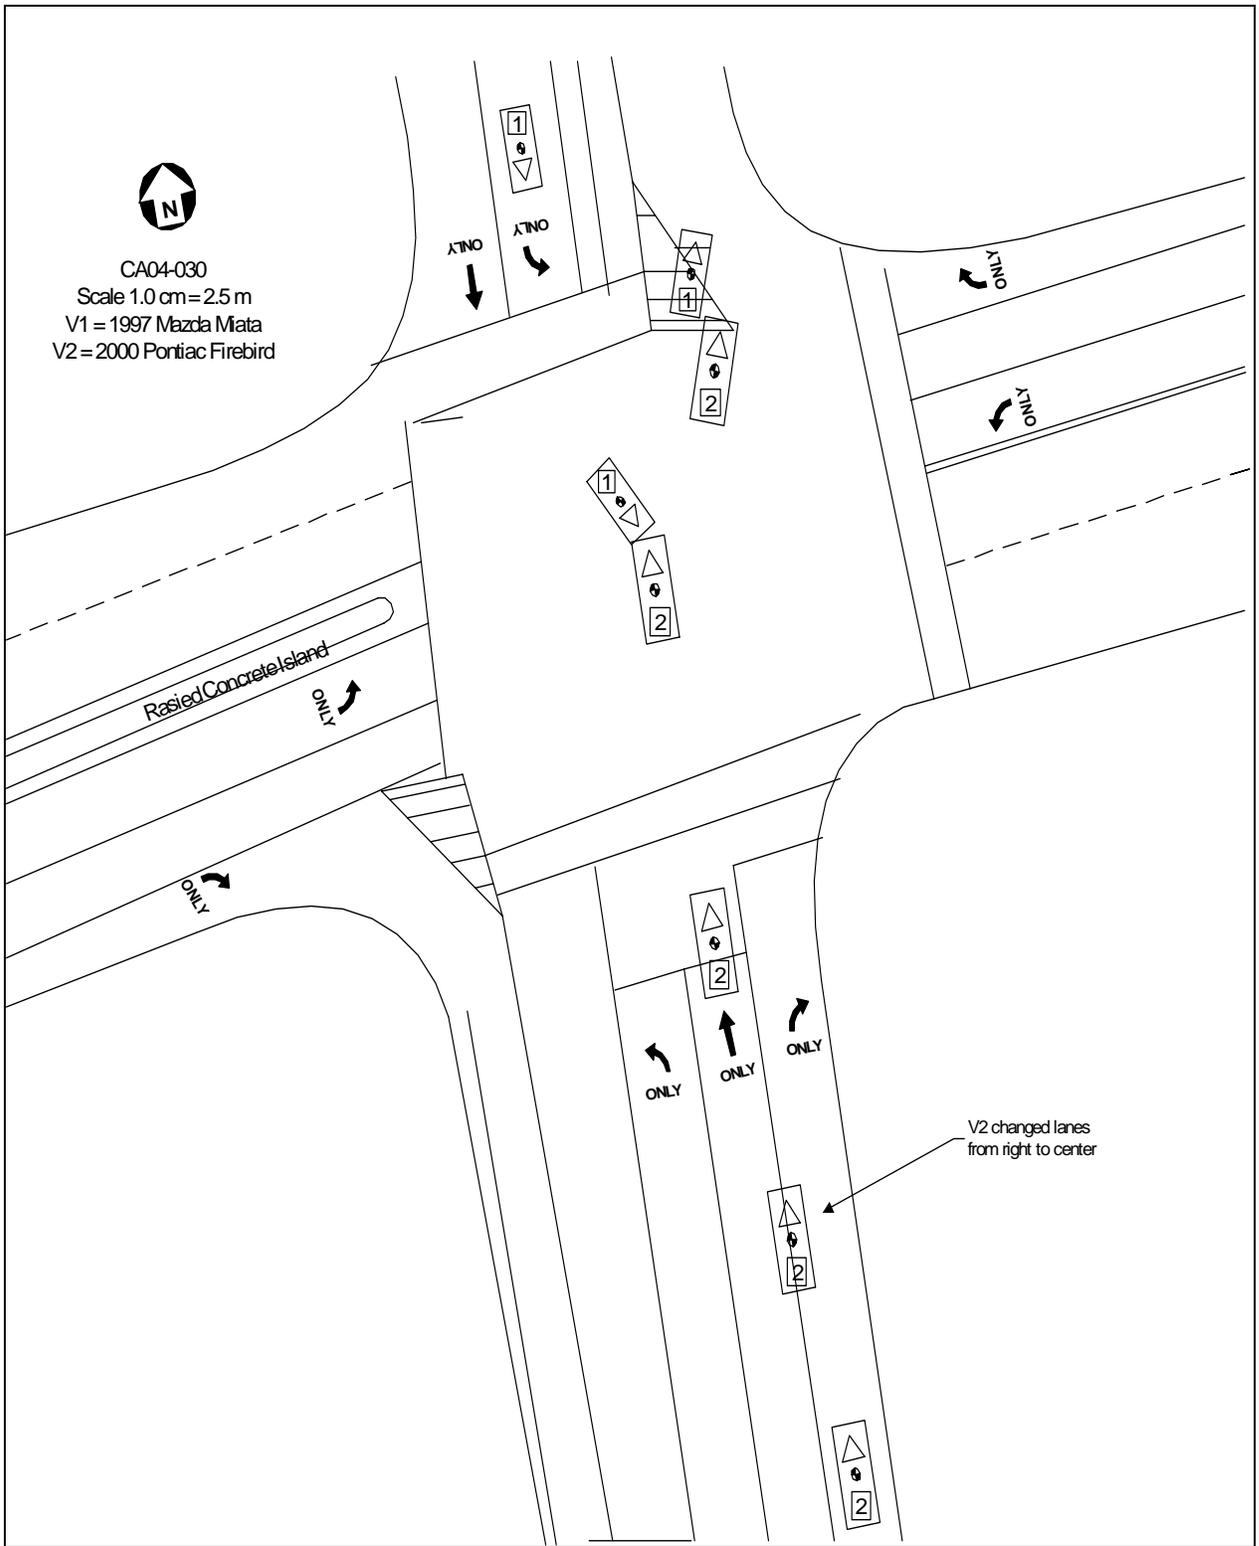
Figure 14. Scene Schematic

The crash occurred at a four-leg intersection of a state route and a local roadway. This intersection crash occurred during the daylight hours of September 2003. At the time of the crash, the weather was clear with no adverse conditions. The involved vehicles were traveling in opposite directions on the north/south state route, both approaching the intersection on a green signal phase. The south leg of the intersection was configured with one through traffic lane in each direction and a designated left and right turn lane for northbound traffic. The north leg of the intersection was configured with a through lane for both travel directions and a designated left turn lane for southbound travel (**Figure 2**). The travel lanes of the north/south legs were surfaced with asphalt and were delineated by solid white lane lines and double yellow centerlines. The east and west legs of the intersection were also configured with one through traffic lane, a left turn lane, and a right turn lane. Traffic flow through the intersection was controlled by overhead three-phase traffic signals. The posted speed limit for the north/south legs was 72 km/h (45 mph). The scene schematic is included as **Figure 18** of this report.
