TRANSPORTATION RESEARCH CENTER

ON-SITE CERTIFIED ADVANCED 208- COMPLIANT VEHICLE INVESTIGATION

CASE NUMBER - IN-04-031
LOCATION - TEXAS
VEHICLE - 2004 Lexus RX 330
CRASH DATE - August 2004

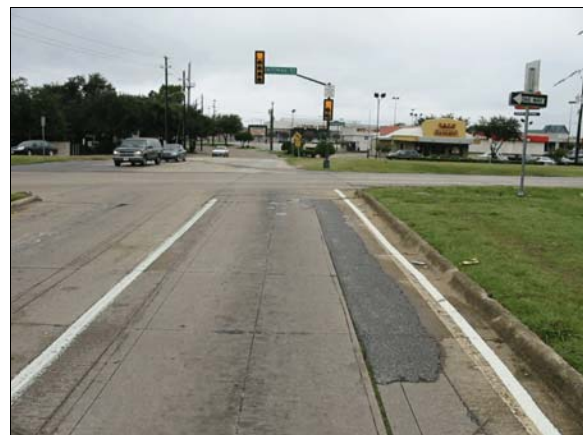
Figure 1: Approach of case vehicle westbound in outside lane and stopped for the traffic signal

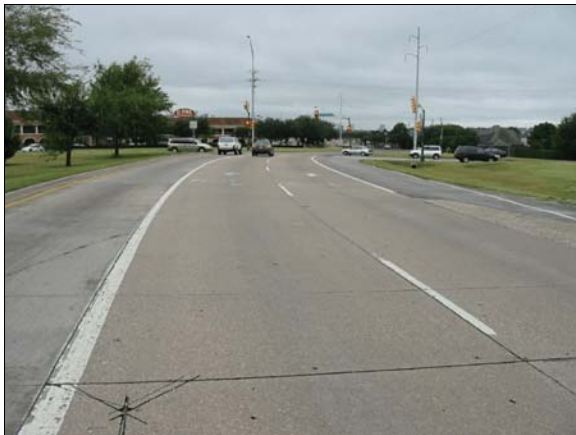
Figure 2: Approach of Nissan to the intersection, southbound in the inside through-lane

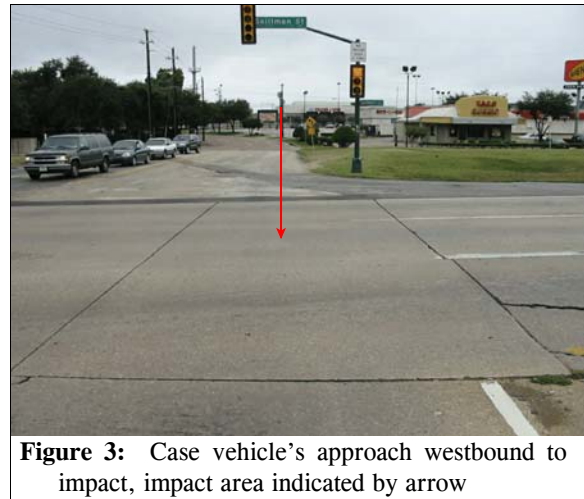
Figure 3: Case vehicle's approach westbound to impact, impact area indicated by arrow

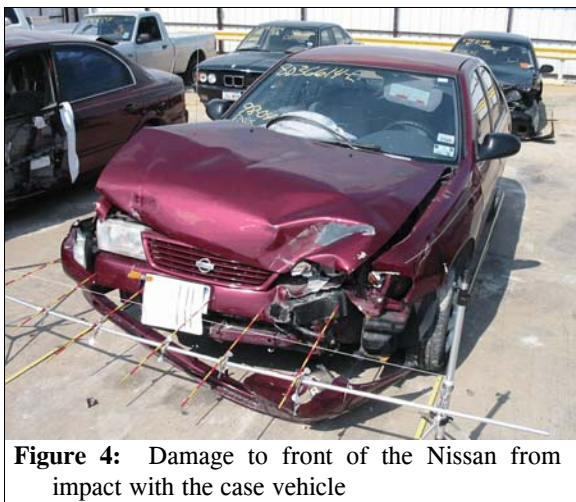
Figure 4: Damage to front of the Nissan from impact with the case vehicle

Exterior Damage: The Nissan's front impact with the case vehicle involved the full front end of the vehicle. The front bumper, hood, grille and front of the fenders were directly contacted and crushed rearward. The direct damage began at the left front bumper corner and extended 141 centimeters (55.5 inches) across the front end of the vehicle. The residual maximum crush was measured at 20 centimeters (7.9 inches) occurring at C₂ and C₃. The table below shows the Nissan's crush profile.

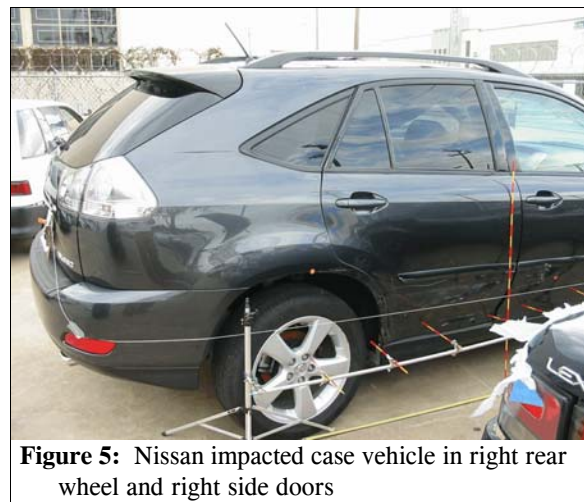
Figure 5: Nissan impacted case vehicle in right rear wheel and right side doors

Crash: The crash occurred as the case vehicle proceeded into the intersection. The front of the Nissan (**Figure 4**) impacted the right side doors and right rear wheel of the case vehicle (**Figure 5**) causing the case vehicle's right side curtain air bag to deploy. The case vehicle rotated clockwise and rolled over one quarter roll onto its left side (**Figure 6** below). The case vehicle's driver air bag, driver knee air bag, front right air bag, and front right seat back-mounted side impact air bag did not deploy because the case vehicle sustained no frontal impact and there was no front right occupant seated in the case vehicle. The weight sensor in the front right seat

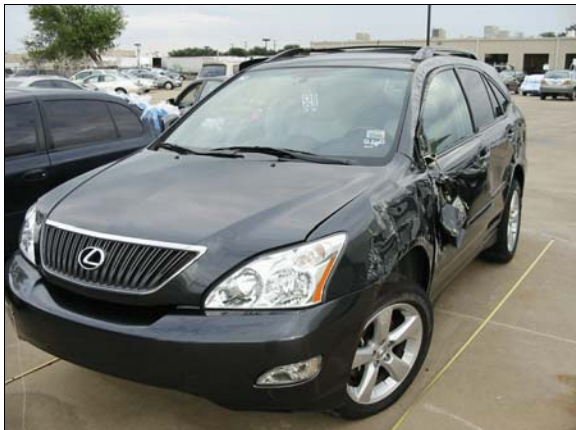
Figure 6: Overview of rollover damage to left side of case vehicle

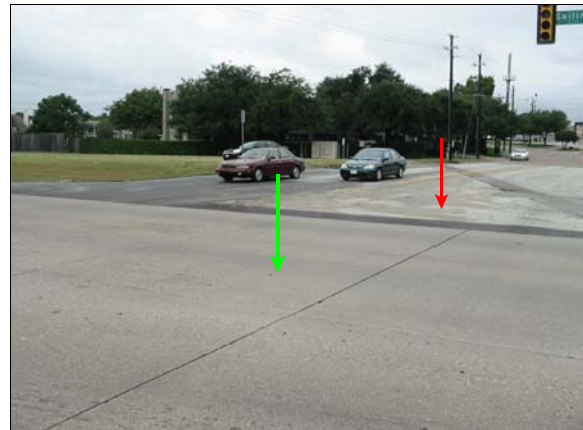
Post-Crash: The case vehicle came to final rest on its left side on the west side of the intersection across the two westbound lanes facing southwest (**Figure 7**). The impact caused the Nissan to rotate clockwise approximately 55 degrees. It came to final rest in the intersection facing southwest.

Figure 7: View southwest to area of final rest of case vehicle (red arrow) and Nissan (green arrow)

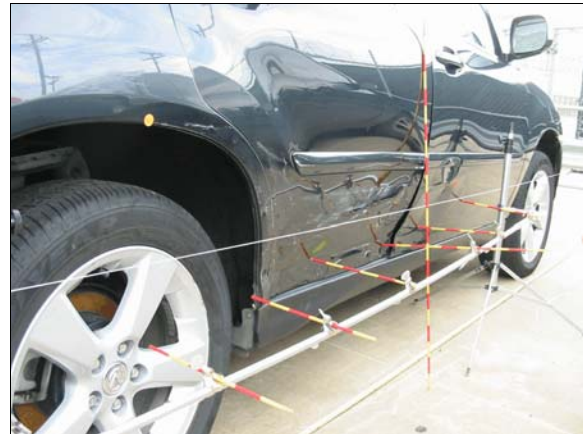
Exterior Damage: The case vehicle’s impact with the Nissan involved the right front door, right rear door, right quarter panel, rear portion of the sill, and the right rear wheel. The direct damage began 128 centimeters (50.4 inches) rear of the right front axle and extended 140 centimeters (55.1 inches) along the right side of the case vehicle (**Figure 8**). Crush measurements were taken at the lower door level. The maximum crush was measured as 4.0 centimeters (1.6 inches) occurring at C₄. The C₁ position was located at the right rear wheel, which had been directly impacted by the front left corner of the Nissan. There was no sheet metal crush at this position; however, the right rear wheel was bent in at the front about 3.0 centimeters (1.2 inches).

Figure 8: Damage to right rear wheel, right rear door, sill and right front door [each stripe on rods is 5.0 centimeters (2.0 inches)]

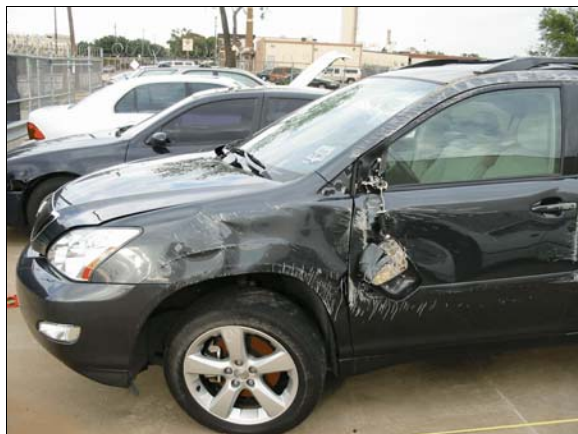
The case vehicle’s rollover involved the entire left side of the vehicle. The direct damage began immediately rearward of the left headlamp/turn signal assembly and extended down the entire left side of the vehicle (**Figures 9 and 10**). The left fender, left front wheel, left A-pillar, left front door, rear view mirror, left rear door, left roof side rail, left luggage rack, left quarter panel, and left rear wheel were all directly damaged.

Figure 9: Rollover damage to front half of the left side of the case vehicle

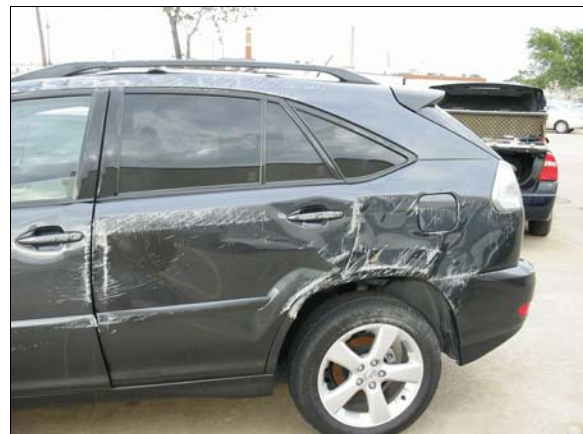
Figure 10: Rollover damage to back half of the left side of the case vehicle

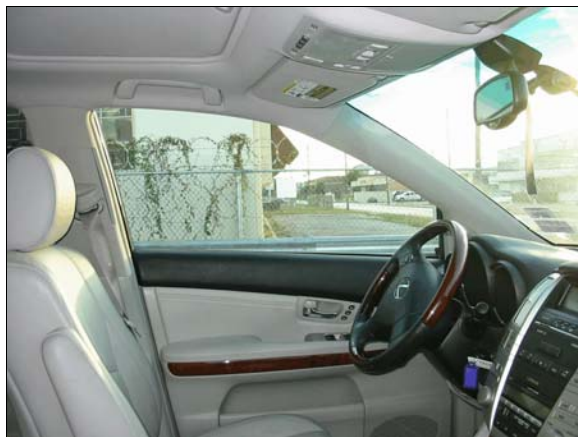
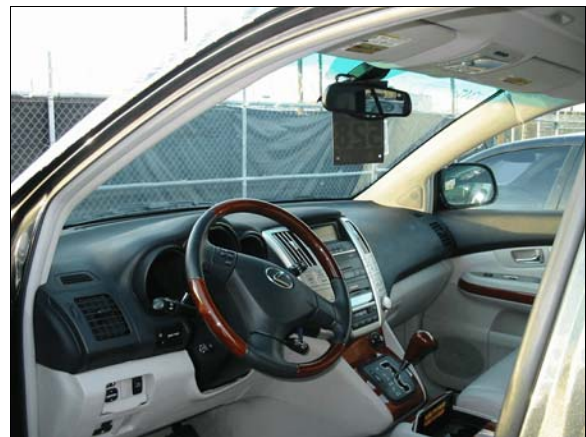
Interior Damage: Inspection of the case vehicle’s interior revealed no evidence of occupant contacts to any interior surfaces or components. No intrusion of the passenger compartment was observed (**Figures 11 and 12**). There was also no evidence of compression of the energy absorbing steering column and no deformation of the steering wheel rim (**Figure 13** below).

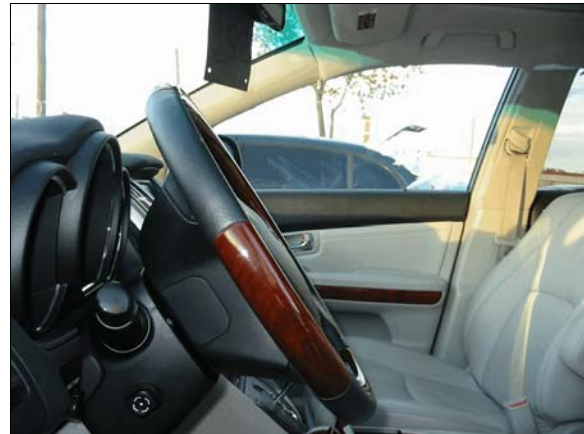
Figure 13: Left side view of case vehicle's steering column and steering wheel showing no damage

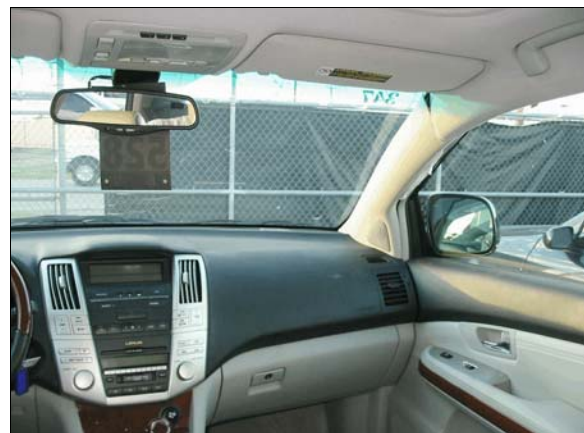
Figure 14: Case vehicle's front right air bag located in middle of instrument panel above glove box door

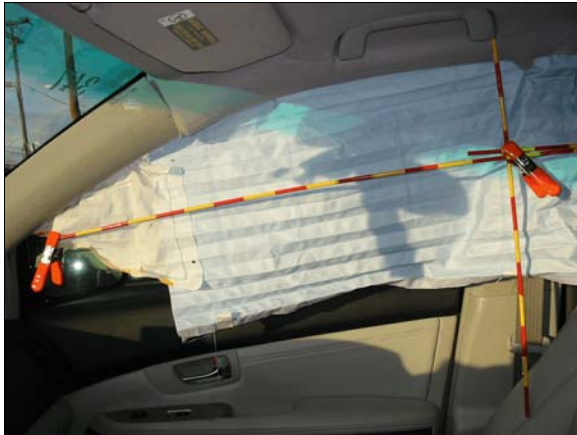
The case vehicle's right side curtain air bag was located in the right roof side rail and right A-pillar. The right side curtain air bag deployed due to the Nissan's impact to the right side of the case vehicle. There was no evidence of damage to the air bag due to the deployment. The deployed right side curtain air bag was rectangular in shape (Figures 15 and 16 below) with a width of approximately 173 centimeters (68.1 inches) and a height of approximately 36 centimeters (14.2 inches). The air bag was attached to the right A-pillar by a triangular shaped anchor strap that was approximately 30 centimeters (11.8 inches) in length at the bottom and was sewn to the front edge of the air bag (Figure 15 below). The air bag had horizontal creases in it indicating it was folded accordion style in its stowed position. The air bag stitching formed three pillow

Figure 15: Front portion of case vehicle's right side curtain air bag, each increment on rods is 5.0 centimeters (2.0 inches)

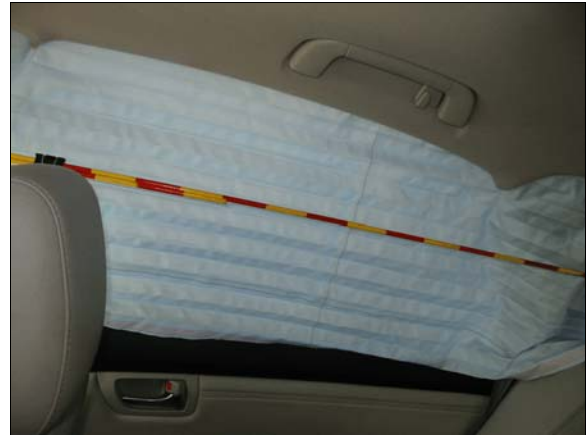
Figure 16: Back portion of case vehicle's right side curtain air bag
