ON-SITE CERTIFIED ADVANCED 208- COMPLIANT VEHICLE INVESTIGATION

CASE NUMBER - IN-04-033
LOCATION - Texas
VEHICLE - 2003 CHEVROLET SILVERADO
CRASH DATE - September 2004

IN-04-033

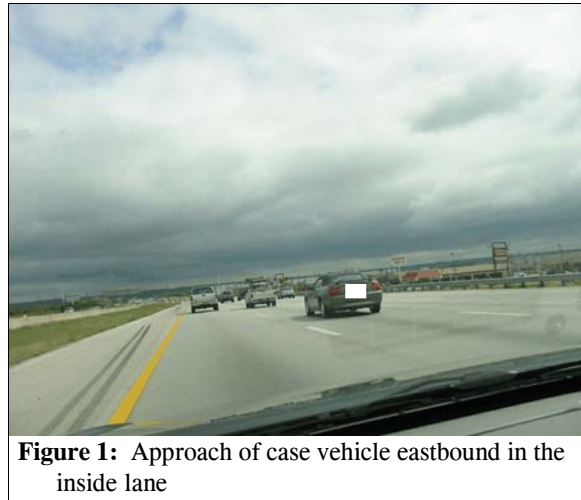
Pre-Crash: The case vehicle was traveling east in the inside lane, and the driver was intending to continue straight ahead (**Figure 1**). A tractor semi-trailer entered the case vehicle's lane from the inside middle lane. The case vehicle's driver braked and steered left in an attempt to avoid a crash. The initial impact occurred in the case vehicle's travel lane.

Figure 1: Approach of case vehicle eastbound in the inside lane

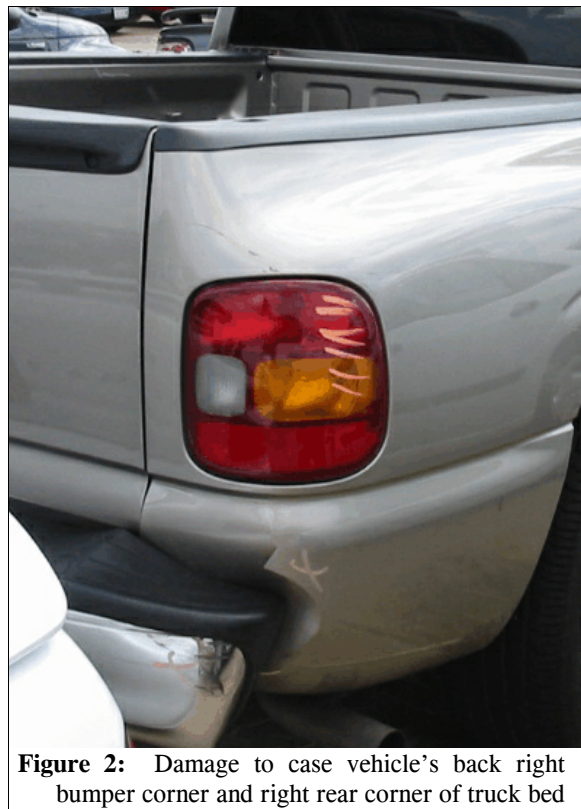
Crash: The tractor semi-trailer impacted the case vehicle's right rear corner (**Figure 2**). The tractor semi-trailer was not inspected, but it appears likely that the left rear wheel of the semi-trailer contacted the case vehicle's back right bumper corner, and possibly the mud flap contacted the right rear corner of the truck bed and taillight assembly. The case vehicle rotated counterclockwise, departed the roadway, and the front of the vehicle (**Figure 3** below) impacted the back slope of a ditch located in the middle of the median causing a first stage deployment of the case vehicle's driver air bag. In addition to the frontal impact, the case vehicle sustained an

Figure 2: Damage to case vehicle's back right bumper corner and right rear corner of truck bed

Exterior Damage: The case vehicle's impact with the semi-trailer's left rear wheel and mud flap involved the right corner of the back bumper and the right rear corner of the truck bed. There was direct damage with black transfer on the right corner of the back bumper, a black scuff on the right rear corner of the truck bed just above the taillight and scratches on the taillight assembly. There were also direct damage abrasions on the right front and right rear wheel rims and right rear tire sidewall. The case vehicle's contact with the back slope of the ditch involved the full width of the front bumper. The front bumper was off the vehicle, so the Field L was taken on the bumper/radiator support beam. Direct damage was measured on the displaced front bumper (**Figure 6**). It began 3.0 centimeters (1.2 inches) left of the front right bumper corner and extended 174 centimeters (69.7 inches) along the bumper. Residual maximum crush to the front was determined to be 14 centimeters (5.5 inches) occurring at C₁. The table below shows the case vehicle's front crush profile.

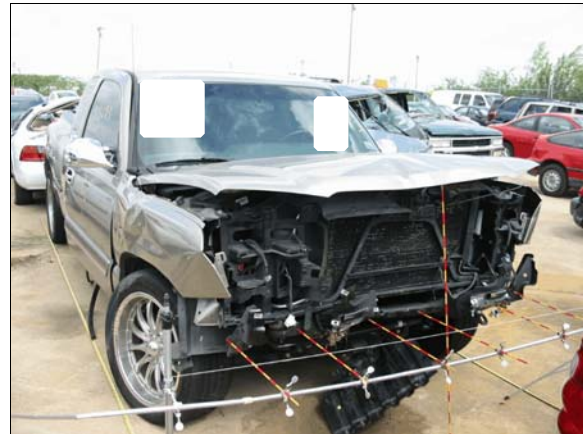
Figure 3: Overview of damage to front of case vehicle from impact with back slope of ditch, each stripe on rods in 5 cm (2 in)

Damage Classification: Based on the vehicle inspection, the CDCs for the case vehicle were determined to be: **03-RBEE-2** (80 degrees) for the impact with the tractor semi-trailer, **02-RFWN-1** (60 degrees) and **02-RBWN-1** (60 degrees) for the two right side wheel impacts, and **12-FDLW-1** (10 degrees) for the impact with the back slope of the ditch.

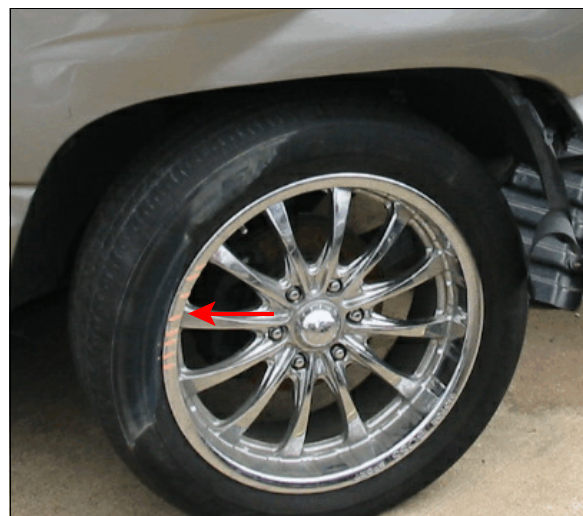
impact to the right front and right rear wheels (Figures 4 and 5 below) that damaged the rims of both wheels and abraded the sidewall of the right rear tire. However, the source of this damage could not be determined. Due to heavy traffic, a thorough inspection of the scene could not be conducted, and the specific location of the crash could not be identified. It appeared likely that the damage to the right side wheels was associated with this crash, and may have resulted from contact with the lip of the paved shoulder as the case vehicle yawed counterclockwise and departed the roadway.

Figure 4: Damage to case vehicle's right front wheel rim

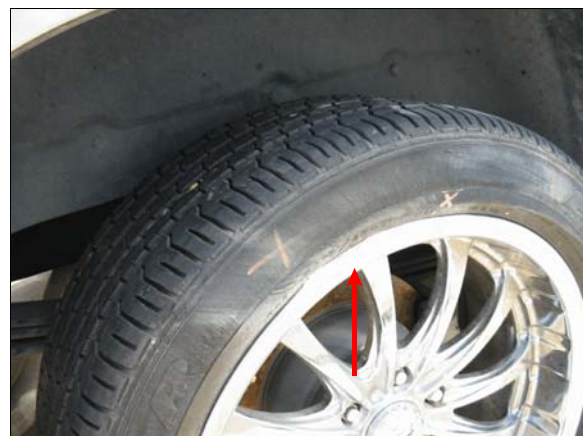
Figure 5: Damage to case vehicle's right rear wheel rim and tire

Tire	Measured Pressure		Recommend Pressure		Tread Depth		Damage	Restricted	Deflated
	kpa	psi	kpa	psi	milli-meters	32 nd of an inch			
LF	Unk	Unk	241	35	Unk	Unk	Unknown, not original	Unk	Unk
RF	138	20	241	35	4	5	Minor rim abrasion	No	No
LR	207	30	241	35	3	4	None	No	No
RR	165	24	241	35	3	4	Heavy localized rim abrasion, abrasion tire sidewall	No	No

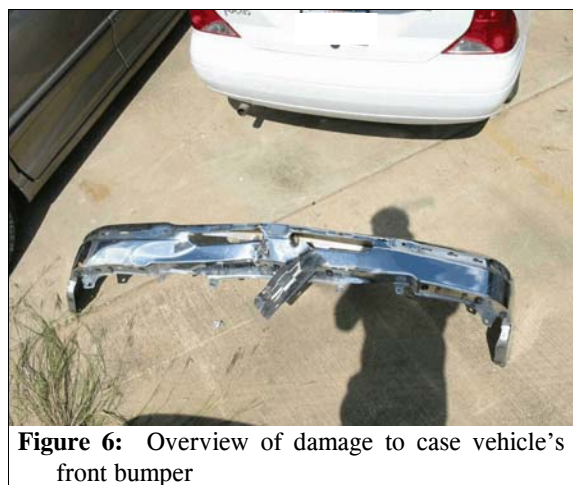
Figure 6: Overview of damage to case vehicle's front bumper

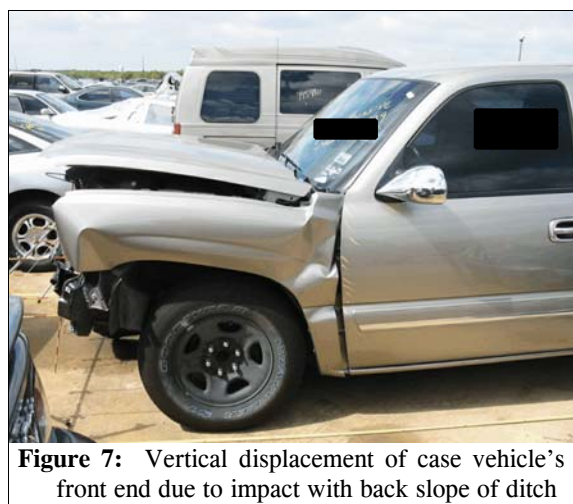
The wheelbase on the case vehicle’s left side was shortened 1.0 centimeter (0.4 inches) while the right side wheelbase was extended 7.0 centimeters (2.8 inches). Grass was jammed in the bottom of the front right center bumper support, and the case vehicle’s front end was displaced vertically (**Figure 7**). The front frame members were displaced vertically less than 13 centimeters (13.0 centimeters). Induced damage involved the grille, hood, both headlamp/turn lamp assemblies and both front fenders. In addition, there was induced contact between the back of the cab and the front of the truck bed that damaged the back of the cab.

Figure 7: Vertical displacement of case vehicle’s front end due to impact with back slope of ditch

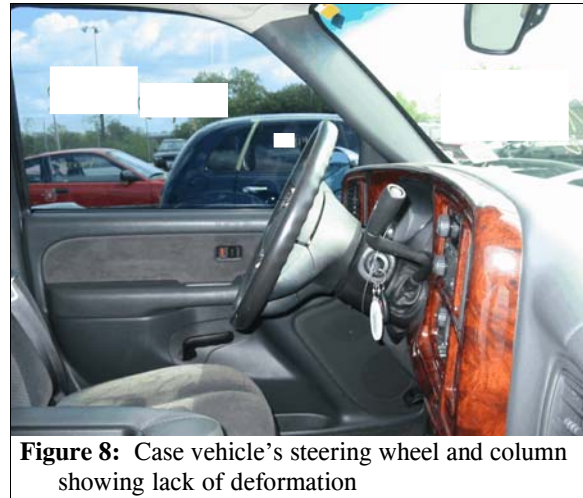
Vehicle Interior: Inspection of the case vehicle's interior revealed no obvious evidence of occupant contact on the interior surfaces. No occupant compartment intrusions were observed, and there was no compression of the energy absorbing steering column or deformation of the steering wheel (**Figure 8**).

Figure 8: Case vehicle's steering wheel and column showing lack of deformation

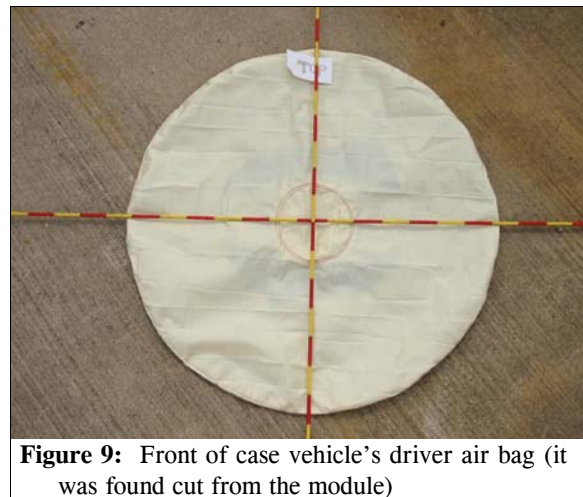
The case vehicle's driver air bag was located in the steering wheel hub. An inspection of the air bag module cover flaps and the air bag fabric revealed that the cover flaps opened at the designated tear points. There was no evidence of damage during the deployment to the air bag module cover flaps or the air bag. However, for some unknown reason, the air bag had been cut out of the module following the crash. The deployed driver's air bag (**Figure 9**) was round with a diameter of 70 centimeters (27.6 inches). The air bag was designed with two tethers, each

Figure 9: Front of case vehicle's driver air bag (it was found cut from the module)

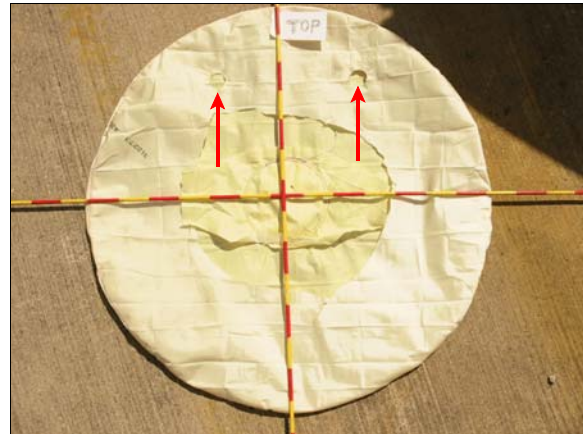
approximately 10 centimeters (3.9 inches) in width, and had two vent ports, each approximately 3 centimeters (1.2 inches) in diameter, located at the 10 and 2 o'clock positions (**Figure 10**). The air bag module cover consisted of symmetrical “I” configuration cover flaps (**Figure 11**) made of pliable vinyl. Each cover flap was approximately 7.3 centimeters (2.9 inches) in width at the top, 5.3 centimeters (2.1 inches) in width at the bottom and about 12 centimeters in height at the center tear seam. There was no evidence of any occupant contact on the air bag fabric.

Figure 10: Back of case vehicle’s driver air bag, arrows show vent ports

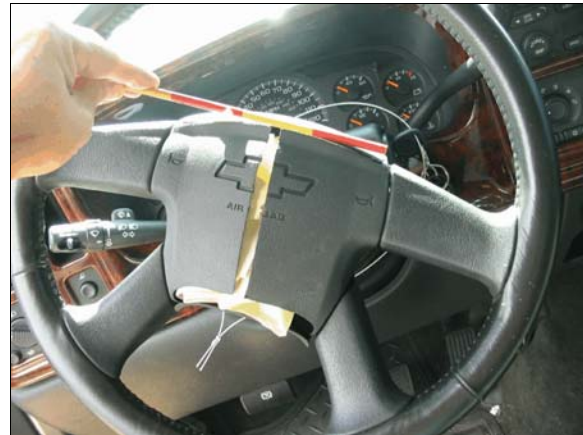
Figure 11: Case vehicle’s driver air bag module flaps

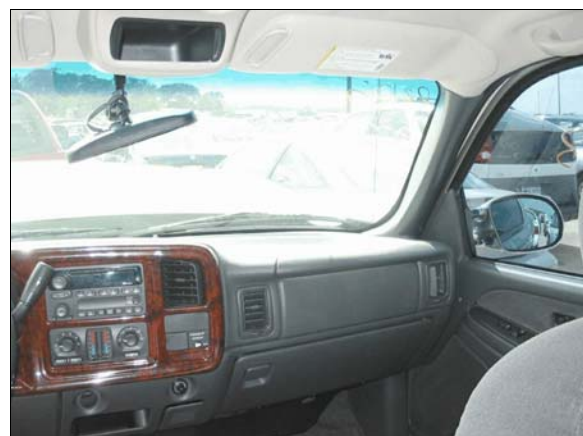
The front right passenger’s air bag was located in the middle of the instrument panel (**Figure 12** below). This air bag properly did not deploy. The case vehicle’s front right occupant detection system correctly determined the absence of a front right occupant and suppressed deployment of the air bag. The case vehicle was also equipped with a suppression switch for this air bag, which was set to the “Auto” position (**Figure 13** below).

Figure 12: Overview of front right air bag location in middle of instrument panel above glove box

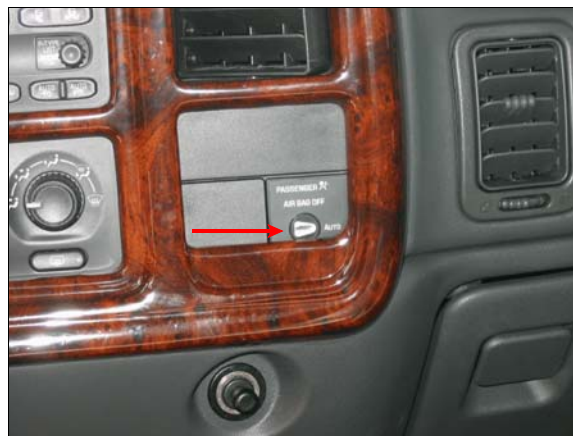
Figure 13: Front right passenger air bag suppression switch set to "AUTO"

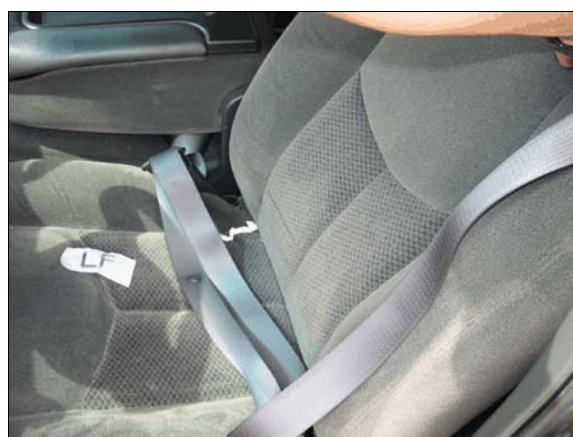
Based on this contractor's vehicle inspection and supported by the EDR data, the case vehicle's driver was restrained by her integral, three-point, lap-and-shoulder, safety belt system (**Figure 14**). Inspection of the driver's seat belt webbing, shoulder belt guide, and latch plate showed some trace evidence of loading.

Figure 14: Overview of driver's safety belt.

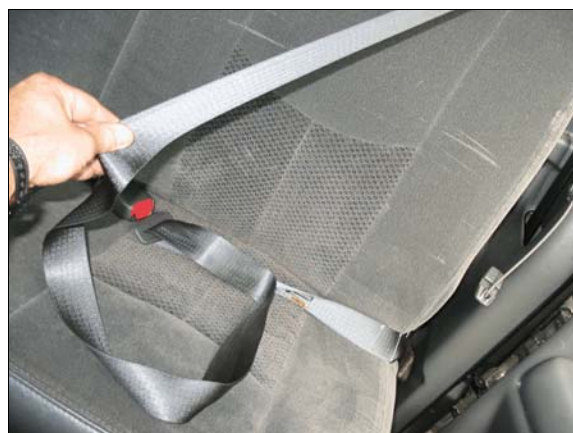
Based on the police crash report, the case vehicle's back left passenger was restrained by his manual, three-point, lap-and-shoulder, safety belt system (**Figure 15**). Inspection of the passenger's seat belt webbing, "D"-ring and latch plate showed trace evidence of usage.

Figure 15: Overview of back left passenger's safety belt.

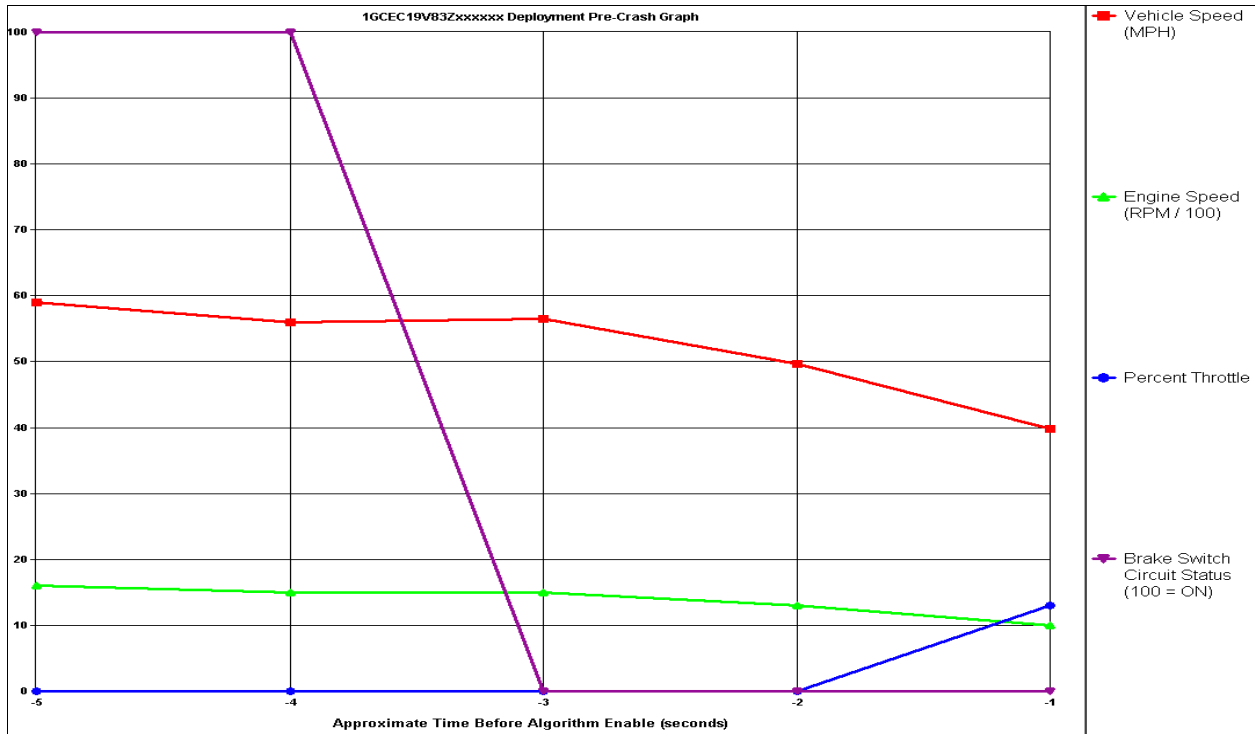
Figure 17: Case vehicle's Deployment Pre-Crash Graph

her foot from the throttle and applied the brake. The pre-crash data also indicate that the case vehicle had slowed to 64 km.p.h. (40 m.p.h.) one second prior to the deployment impact (i.e., impact with the back slope of the ditch), and the driver was not applying the brake at that point.

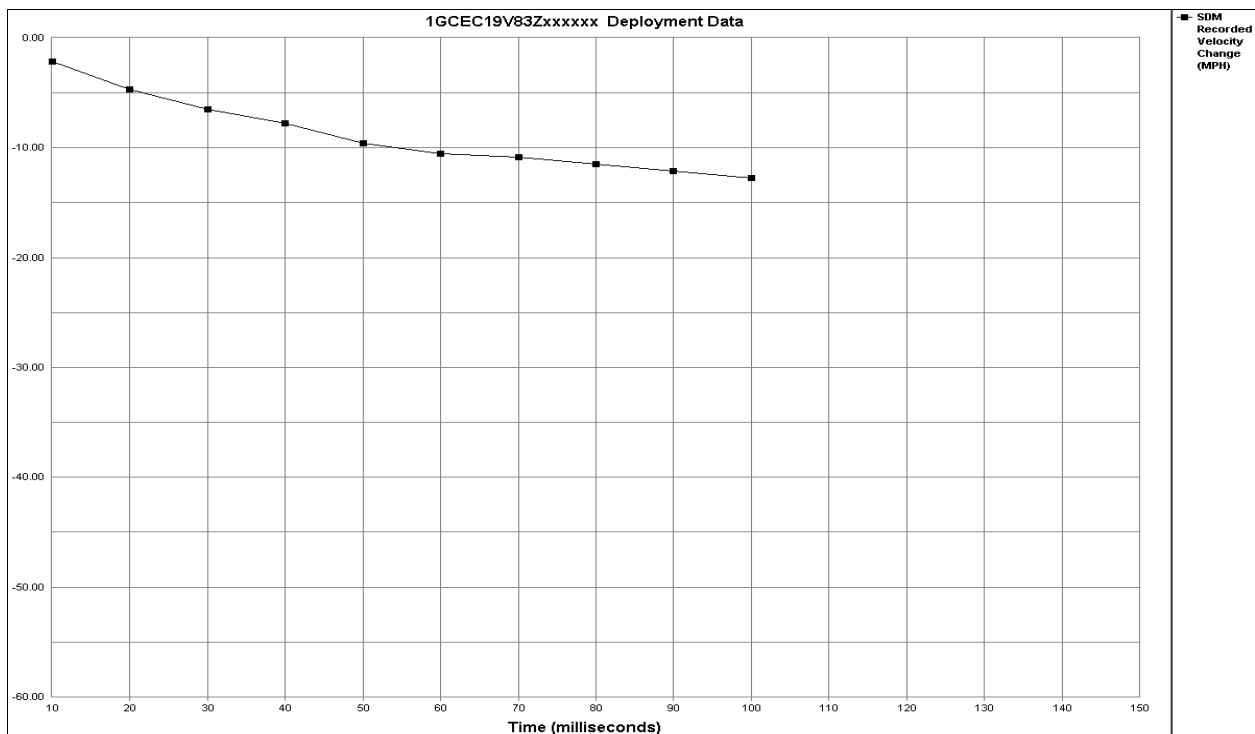
Figure 18: Case vehicle's deployment SDM Reported Velocity Change Graph

The WinSMASH reconstruction program, barrier algorithm, calculated the case vehicle's Total, Longitudinal and Lateral Delta Vs for the impact with the back slope of the ditch respectively as: 16.0 km.p.h (9.9 m.p.h.), -15.8 km.p.h. (9.8 m.p.h.) and -2.8 km.p.h. (1.7 m.p.h.). The EDR recorded a maximum longitudinal Delta-V of -21.85 km.p.h. (-13.58 m.p.h.) for this impact.

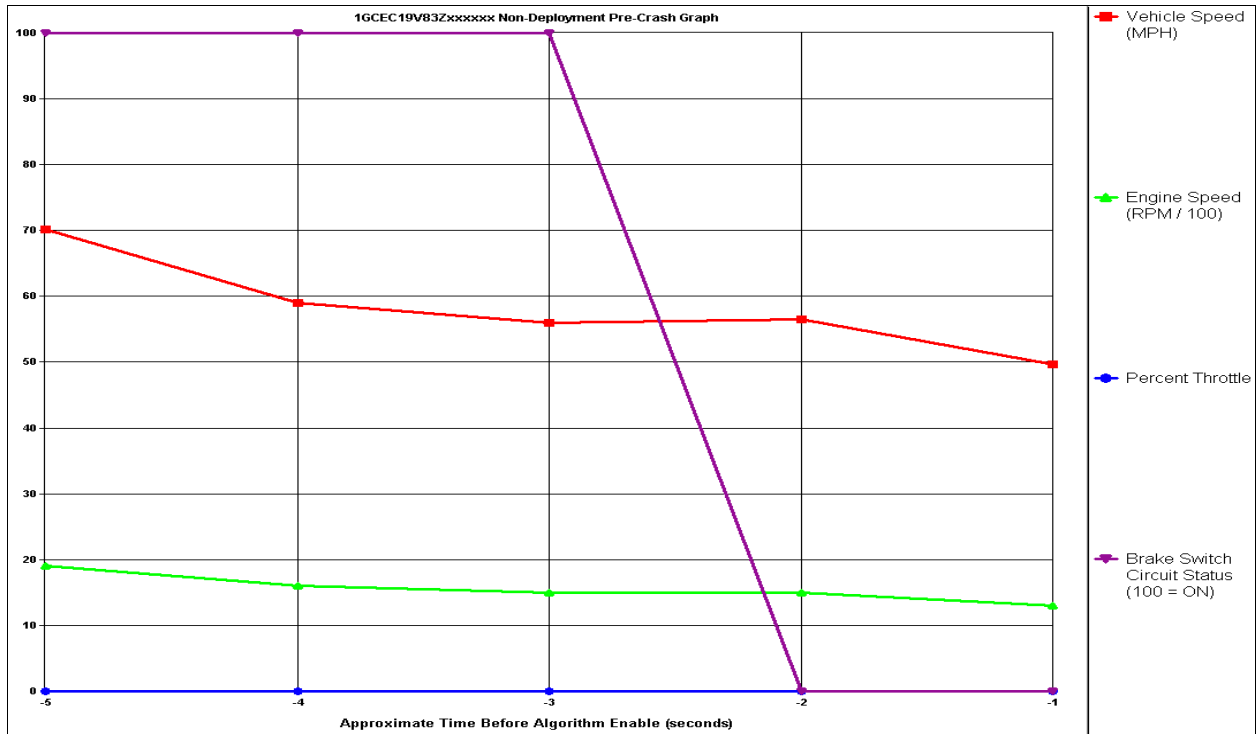
Figure 20: Case vehicle's Non-Deployment Pre-Crash Graph

The EDR pre-crash data indicate the non-deployment event occurred prior to the deployment event. The damage to the right rear corner of the case vehicle and the EDR data supports the likelihood that the non-deployment event was associated with an impact by the tractor semi-trailer as it encroached into the case vehicle's lane. The pre-crash data indicate that the case vehicle was traveling 113 km.p.h. (70 mph) five seconds prior to the impact with the tractor semi-trailer, and the case vehicle's driver had removed

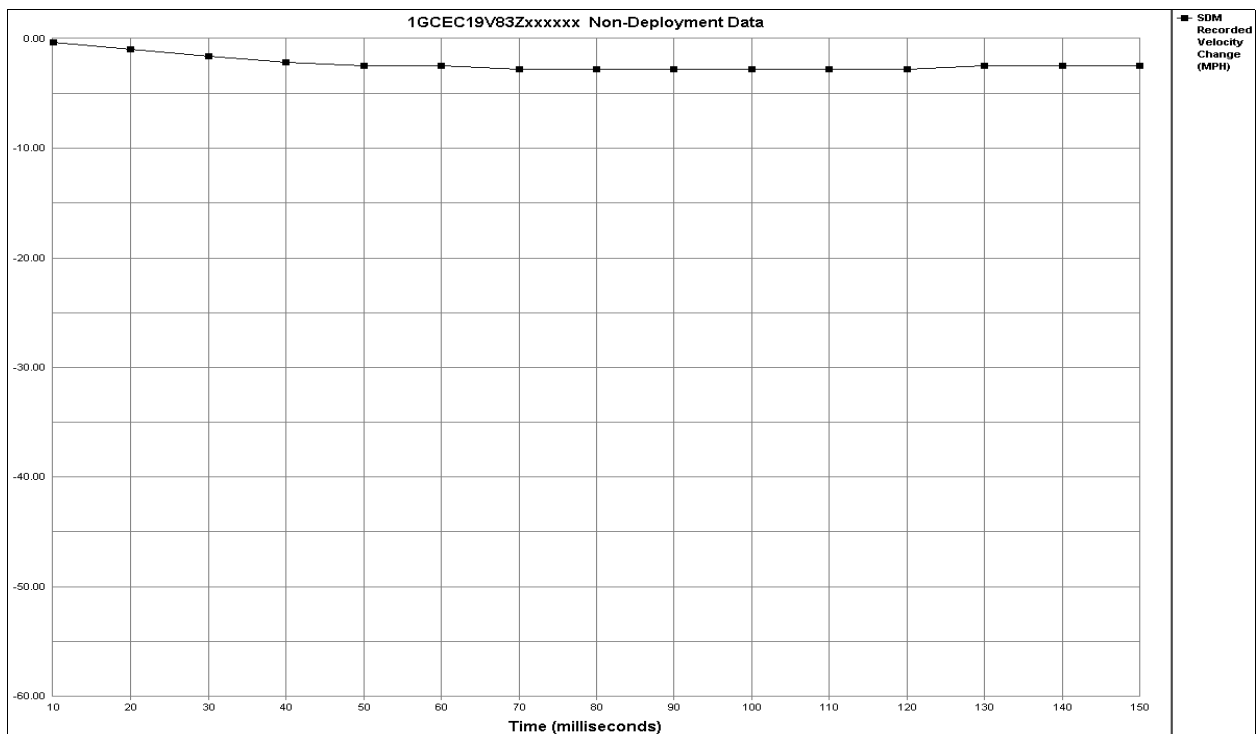
Figure 21: Case vehicle's Non-Deployment SDM Recorded Velocity Change Graph

The download of the case vehicle’s EDR was done during the vehicle inspection through direct connection to the SDM. The EDR recorded a deployment event and a non-deployment event. The EDR reports for both events are presented at the end of this report (**Figures 16-21**). The system status reports show that the SIR warning lamp was recorded as off, the driver’s safety belt switch circuit status was recorded as buckled and the front right passenger air bag was suppressed. The system status report for the deployment event indicates only a first stage deployment of the driver’s air bag was required, and the event recording was complete. The first stage deployment criteria was met at 5.0 milliseconds after algorithm enable (AE), and maximum recorded longitudinal velocity change was -21.85 km.p.h. (-13.58 m.p.h.) occurring 155 milliseconds after AE. The system status report for the non-deployment event indicates the maximum recorded longitudinal velocity change was -4.59 km.p.h. (-2.85 m.p.h.) occurring 72.5
