CALSPAN ON-SITE FORD CVPI SEVERE REAR CRASH INVESTIGATION

CASE NO: CA04-037

VEHICLE: 2003 FORD CROWN VICTORIA POLICE INTERCEPTOR

CRASH DATE: AUGUST 2004

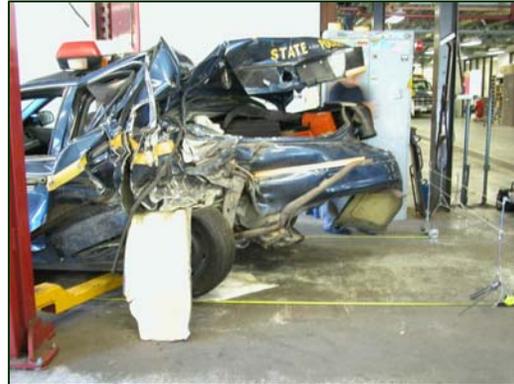
Figure 1. Damaged 2003 Ford CVPI

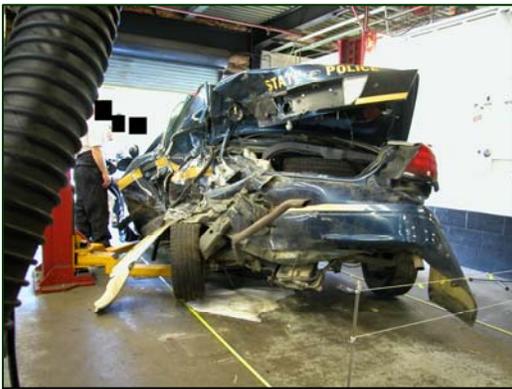
Primary - The back of the CVPI sustained severe damage, concentrated at the left corner area (**Figures 3 and 4**). Maximum crush was 134 cm (52.5”) located at the left corner of the bumper beam and at the back left corner of the sheet metal, at the junction of the rear trunk wall and left quarter panel. The direct contact damage began 18 cm (7.1”) right of center and extended 79 cm (31.25”) along the damage profile to the left rear corner. The impact deformed the full width of the back plane, resulting in a combined induced and direct damage length of 46 cm (18.0”) at the bumper beam. The crush profile at the level of the bumper beam using was as follows: C1 = 134 cm (52.6”), C2 = 129 cm (50.9”), C3 = 76 cm (29.9”), C4 = 24 cm (9.6”). A secondary set of crush measurements were documented at the rear edge of the trunk wall, above the bumper system and were as follows: C1 = 134 cm (52.6”), C2 = 125 cm (49.25”), C3 = 92 cm (36.0”), C4 = 31 cm (12.2”).

Figure 3. Damaged back plane of 2003 Ford CVPI.

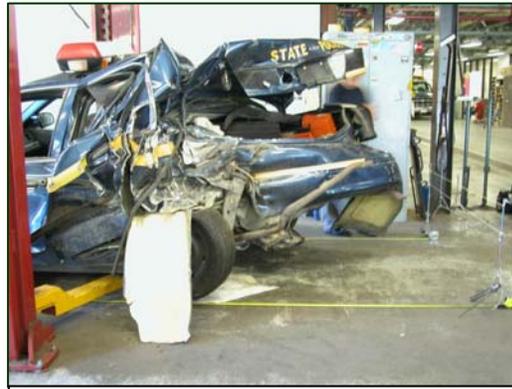
Figure 4. Lateral view documenting the extent of crush.

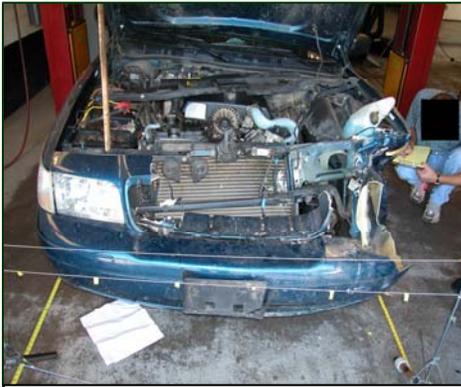
Secondary – The front left area of the CVPI impacted the back of the stopped Chevrolet Cavalier as it was displaced forward by the initial impact (**Figures 5 and 6**). The impact involved the bumper fascia and bumper beam, grille, left front fender, left headlamp assembly, hood, and the upper radiator support. Maximum crush was 13 cm (5.1”) at the left corner of the bumper beam and 31 cm (12.2”) at the left corner of the upper radiator support. Two crush profiles were documented at the bumper and upper radiator support levels. The profiles were as follows: Bumper – C1 = 13 cm (5.1”), C2 = 8 cm (3.0”), C3 = 8 cm (3.1”), C4 = 6 cm (2.25”), C5 = 4 cm (1.4”), C6 = 3 cm (1.0”); Radiator Support – C1 = 31 cm (12.2”), C2 = 24 cm (9.5”), C3 = 14 cm (5.5”), C4 = 3 cm (1.2”0), C5 = 0 cm C6 = 0 cm. The CDC for this event was 12-FYEW-2.

Figure 5- Damaged front plane of 2003 CVPI.

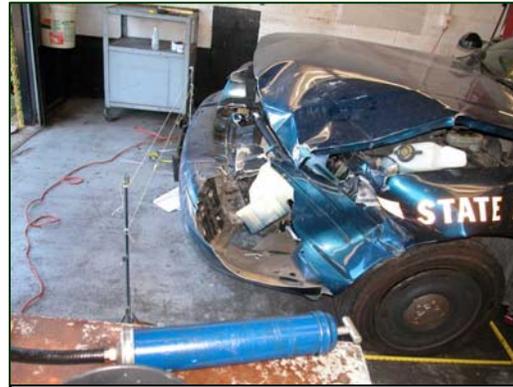
Figure 6. Lateral view documenting the extent of crush.

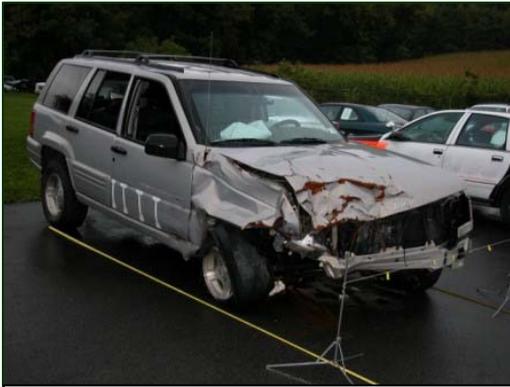
The Jeep Cherokee sustained moderate severity front right damage as a result of the front-to-rear impact sequence with the parked CVPI (**Figures 7 and 8**). Maximum crush was measured at 55 cm (21.5”) located at the front right corner of the front bumper beam. The bumper fascia was removed from the vehicle and placed in the rear cargo area of the vehicle. The direct contact damage began 29 cm (11.25”) right of center and extended 66 cm (26”) to the right corner. The impact deformed the full width of the frontal structure resulting in a combined induced and direct damage width of 119 cm (47”). Six equidistant crush measurements were documented at the level of the bumper beam and were as follows: C1 = 0 cm, C2 = 3 cm (1.2”), C3 = 14 cm (5.4”), C4 = 24 cm (9.3”), C5 = 29 cm (11.4”), C6 = 55 cm (21.5”). The CDC for this impact event was 12-FREW-3.

Figure 7. Overall view of 1998 Jeep Grand Cherokee.

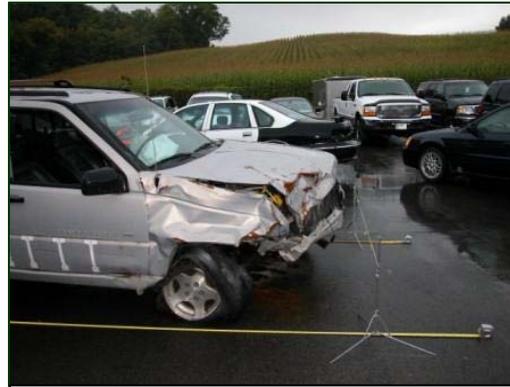
As the front bumper system crushed rearward, the front right tire and wheel assembly engaged the back plane of the CVPI. This resulted in fracturing of the alloy wheel, penetration of the tire, and a 30 cm (11.75”) reduction of the right wheelbase. The left wheelbase was elongated 9 cm (3.5”).

Figure 8. Frontal crush to the Cherokee.

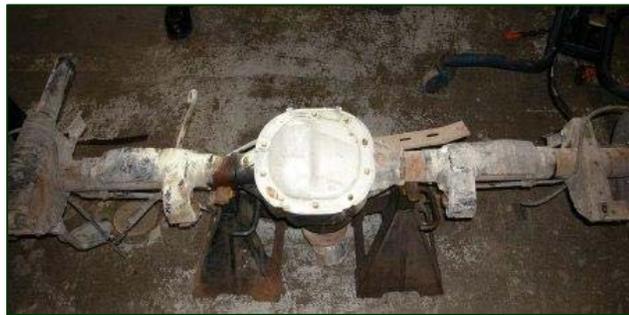
The fiberglass reinforced hard plastic shields that covered the sway bar brackets remained intact. These brackets were engaged by the tailpipes. The left shield was cracked 4 cm (1.75”) on the outboard aspect. The right shield was cracked at the inboard aspect, but remained intact. Both sway bar clamps released under the shields during the crash.

Figure 9. Rear axle and sway bar bracket shields.

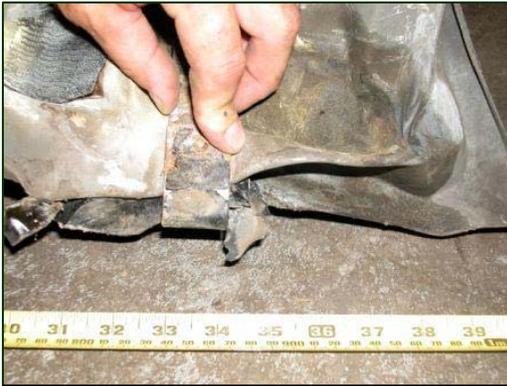
Figure 10. Tank engagement against strap.

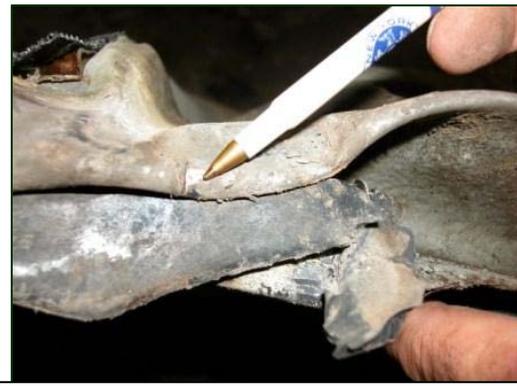
Figure 11. Strap puncture of fuel tank.

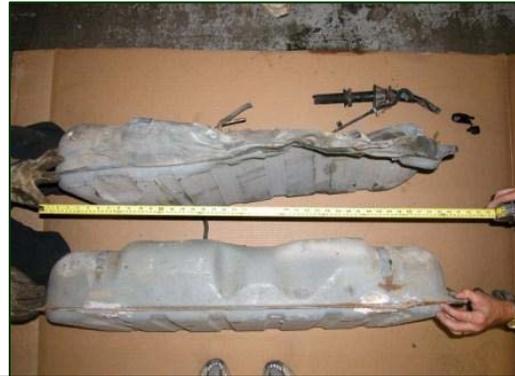
Figure 13. Damaged and exemplar fuel tanks.

The damaged fuel tank from this crash involved CVPI was positioned in a similar placement and filled with water. The punctures of the tank were sealed. Water was poured into the tank using the same calibrated container as the above exercise. Although crushed by damaged, the fuel tank was able to hold 64.8 liters (17.125 gallons) of water, a reduction of 13.7 liters (3.625 gallons). It should be noted that during the crash, the tank probably crushed to a greater extent, and rebounded due to the dynamic properties of the crash.

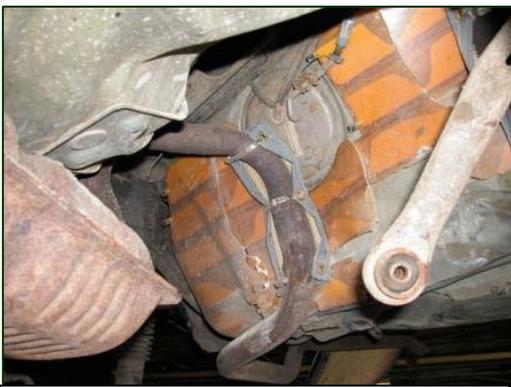
Figure 16. Damaged FirePanel.

The FirePanel involved in this crash remained engaged to the steel fuel tank post-crash (**Figure 16**). Due to the severe crush, the panel did engage the tailpipes and the differential cover. The panel cracked at both tailpipe locations and fragmented at the

location of the differential cover, disbursing approximately 50 percent of the fire retardant. Although cracked, the majority of the FirePanel remained intact in its cracked form against the fuel tank.
