ON-SITE CHILD SAFETY SEAT INVESTIGATION

CASE NUMBER - IN-04-038

LOCATION - OHIO

VEHICLE - 1997 HONDA ACCORD EX

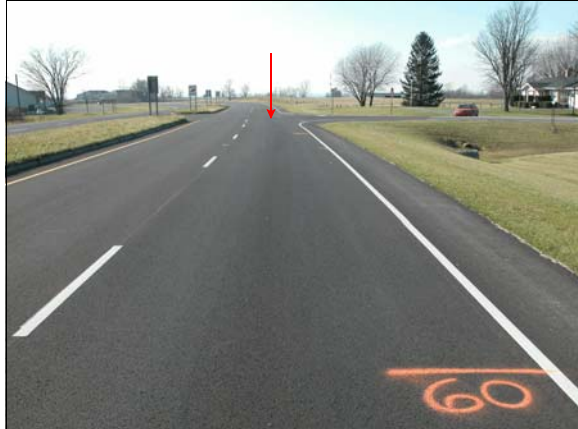
Figure 1: Approach of case vehicle westbound in outside lane , arrow shows area of impact, number shows meters to impact

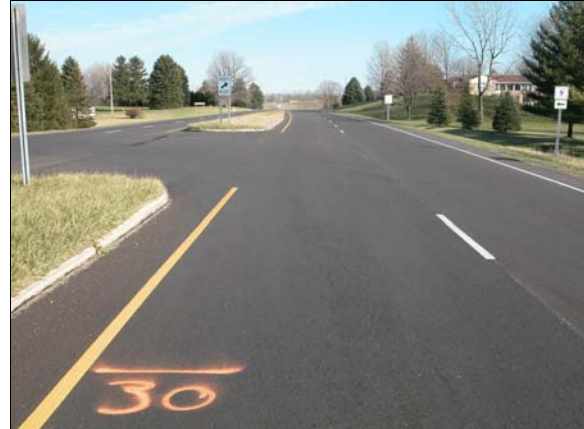
Figure 2: Approach of V2 eastbound to left turn through median cut, number shows meters to impact area

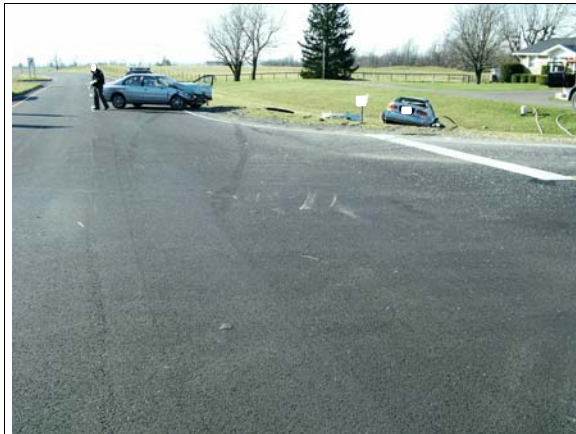
Figure 3: On-scene photo of impact gouges, post impact tire marks and final rest positions of case vehicle and V2

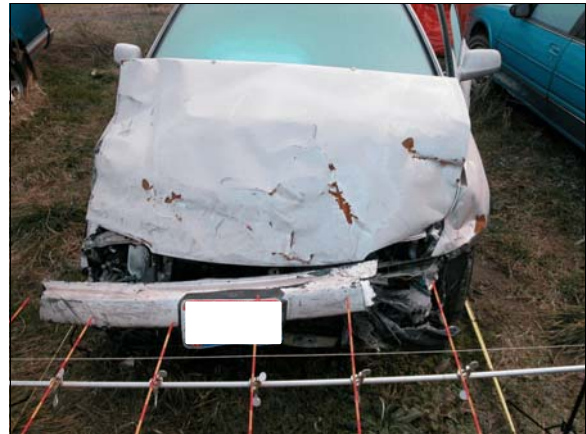
Figure 4: Damage to front of case vehicle due to impact with right side of V2, bumper placed back on vehicle for measurement

Exterior Damage: The case vehicle's impact with the Civic involved the full width of the front end. The case vehicle's front bumper, grille, hood, headlamp/turn lamp assemblies and both fenders sustained direct damage and were crushed rearward. Direct damage began at the case vehicle's left front bumper corner and extended 158 centimeters (62.2 inches) across the full width of the front bumper. Crush measurements were taken at the bumper level and hood level. The residual maximum bumper level crush was 19 centimeters (7.5 inches) occurring at C₃ (**Figure 8**). The residual maximum crush at the hood level was 44 centimeters (17.3 inches) occurring at C₆ (**Figure 9** below). There was a secondary impact to the front of the case vehicle's right fender and bumper corner by the Civic's right front bumper corner. There was no measurable crush from this impact due to overlapping damage from the front impact. The table below shows the average of the case vehicle's bumper level and above bumper level crush profiles.

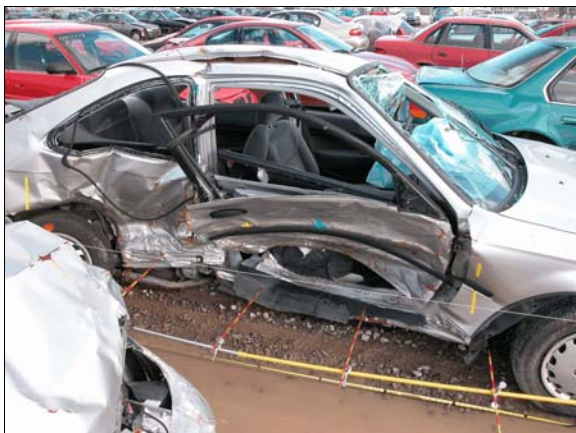
Figure 5: Damage to right side of V2, yellow tape below door handle is center of direct damage

Exterior Damage: The Civic’s initial impact with the case vehicle involved the right front door and right quarter panel. They were directly damaged and crushed inward, and the right side windows were broken out. Crush measurements were taken at the mid-door level and at the sill level due to separation of the right front door latch. Maximum residual crush at the mid-door level occurred between C₂ and C₃ (Figure 19) and was measured as 74 centimeters (29.1 inches). Maximum crush at the sill level occurred at C₃ and was measured

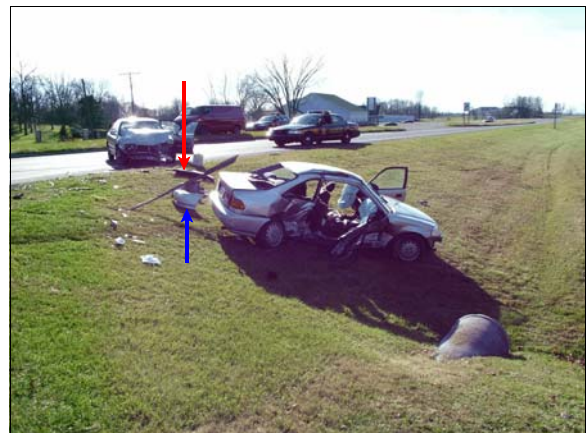
Figure 6: View southwest to rest position of case vehicle and V2, red arrow shows case vehicle's front bumper, blue arrow shows V2's front bumper cover

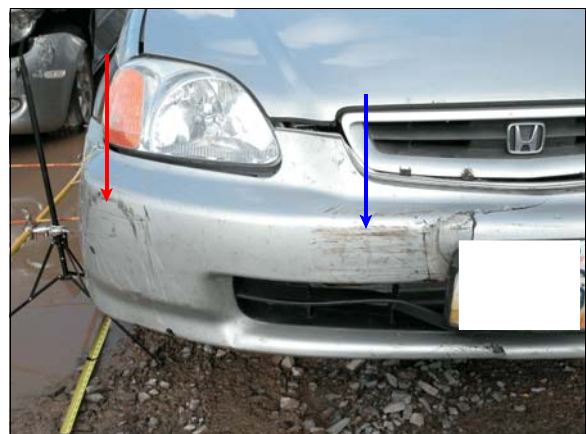
Figure 7: Damage to V2's front bumper from county road sign impact (blue arrow) and secondary impact to right fender and bumper corner of case vehicle (red arrow)

There was no measurable crush to the Civic’s right front bumper corner from the impact with the case vehicle’s right fender. The direct damage to the Civic’s front bumper fascia from the impact with the county road sign began 10 centimeters right of the Civic’s centerline and extended 26 centimeters to the left. The maximum crush to the bumper fascia occurred at C₄ and was measured as 1 centimeter (0.4 inch). The front bumper crush profile for the county road sign impact is shown in the table below.

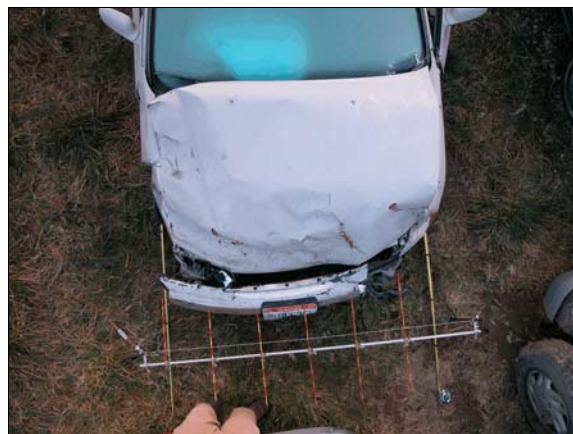
Figure 8: Top view of crush to case vehicle's front bumper, each increment on rods is 5 cm (2 in)

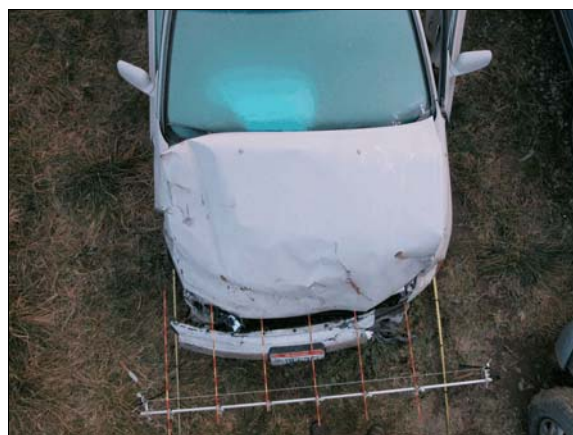
Figure 9: Top view of case vehicle's hood level crush

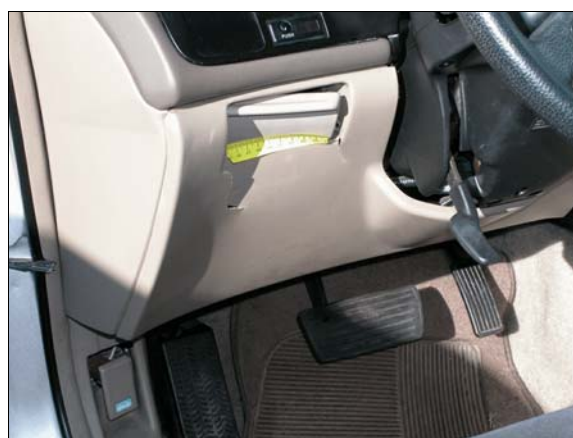
Vehicle Interior: Inspection of the case vehicle’s interior revealed occupant contact marks on the driver’s left and right knee bolsters (**Figure 10** and **Figure 11** below). In addition, the unrestrained driver had loaded the deployed air bag and displaced the steering assembly (**Figure 12** below). The steering column appeared slightly compressed and displaced upward. It was found partially jammed between its center and full up tilt position during the inspection. The driver stated she had the steering column adjusted to its full down position prior to the crash. There was no deformation of the steering wheel rim, and no other occupant contact evidence was found. Finally, there was no evidence of occupant compartment intrusion.

Figure 10: Damage to case vehicle’s left knee bolster from impact by driver’s left knee

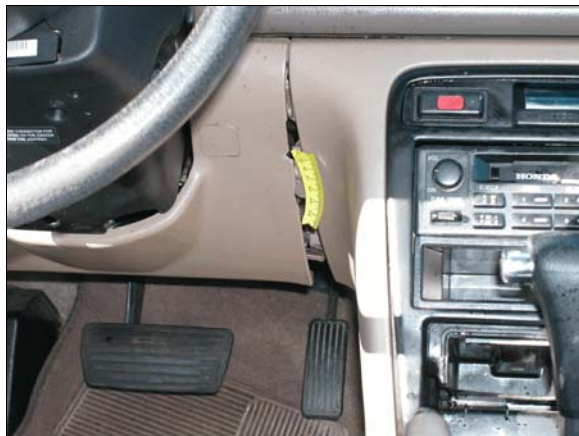
Figure 11: Damage to case vehicle's right knee bolster due to impact by driver's right knee

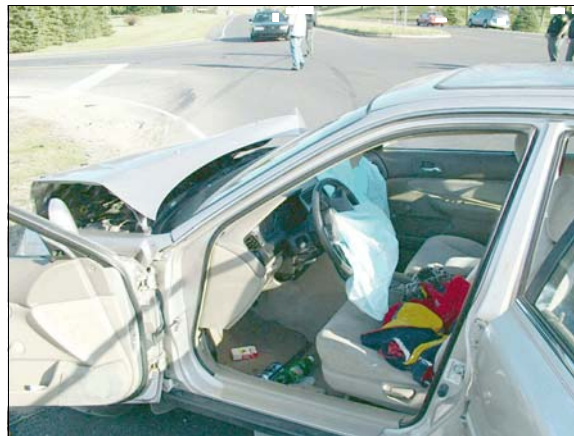
Figure 12: On-scene photo of case vehicle's driver air bag, steering wheel and steering column

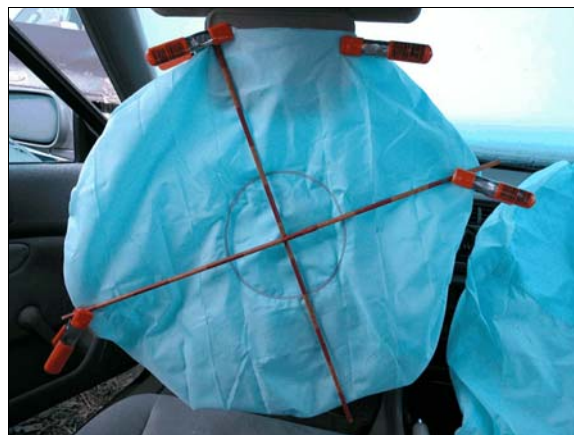
Figure 13: Case vehicle's driver air bag, steering wheel is rotated CW about 170 degrees

The case vehicle's driver air bag was located in the steering wheel hub. An inspection of the air bag module cover flaps and the air bag fabric revealed that the cover flaps opened at the designated tear points. There was no evidence of damage during the deployment to the air bag or the module cover flaps. The deployed driver's air bag (**Figure 13**) was round with a diameter of about 61 centimeters (24 inches). The air bag was designed with two tethers, each approximately 7

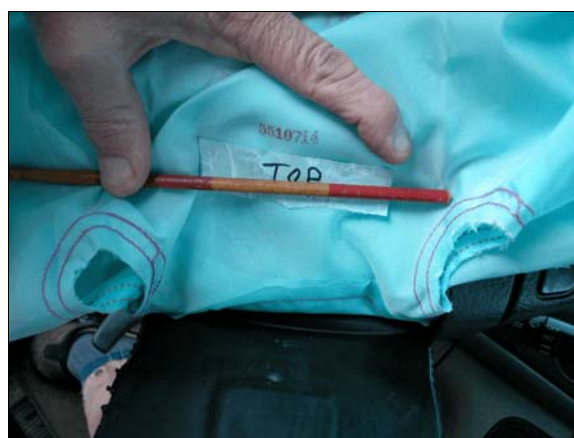
Figure 14: Case vehicle's driver air bag vent ports

centimeters (2.8 inches) in width and had two vent ports (**Figure 14** above), each approximately 4 centimeters (1.6 inches) in diameter, located at the 11 and 1 o'clock positions. The top air bag module cover flap was rectangular in shape and measured 14.5 centimeters (5.7 inches) in length and 12 centimeters (4.7 inches) in height. The bottom air bag module cover flap was irregularly shaped and measured 14.5 centimeters (5.7 inches) in length and 6 centimeters (2.4 inches) in height. The cover flaps were constructed of pliable vinyl. There were several small dispersed areas of black dirt or grease at the top of the air bag; however, these did not appear to be occupant contact marks.

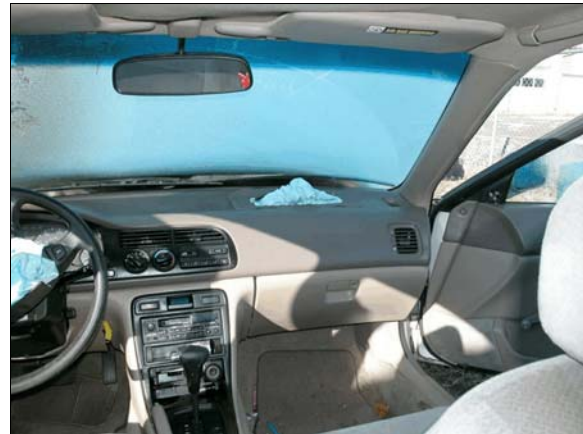
The front right passenger's air bag was located on the top of the instrument panel (**Figure 15**). The air bag module cover flap opened at the designated tear points, and there was no evidence of damage to the air bag or the module flap. The deployed front right passenger air bag (**Figure 16** below) was approximately 53 centimeters (20.9 inches) in width and about approximately 60 centimeters (23.6 inches) in height. The air bag was designed without tethers and had two vent ports, each approximately 8 centimeters (3.1 inches) in diameter (**Figure 17**) located at the 3 and 9 o'clock positions. There was a single rectangular-shaped, pliable vinyl air bag module cover flap measuring 25 centimeters (9.8 inches) in width and 7 centimeters (2.8 inches) in height. There was a small dispersed area of black dirt or grease at the top left quadrant of the air bag. There was no passenger seated in the front right seat.

Figure 15: Overview of case vehicle's front right instrument panel and location of front right air bag

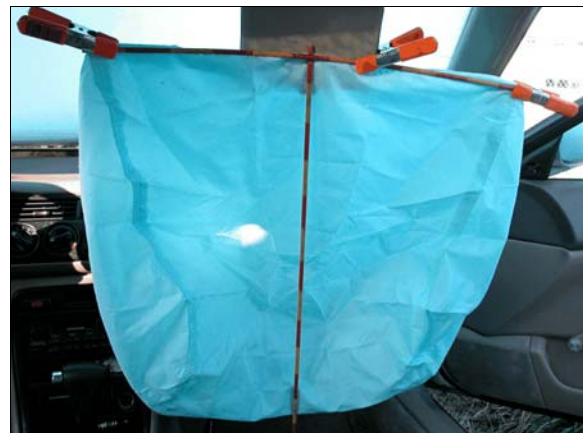
Figure 16: Case vehicle's front right passenger air bag

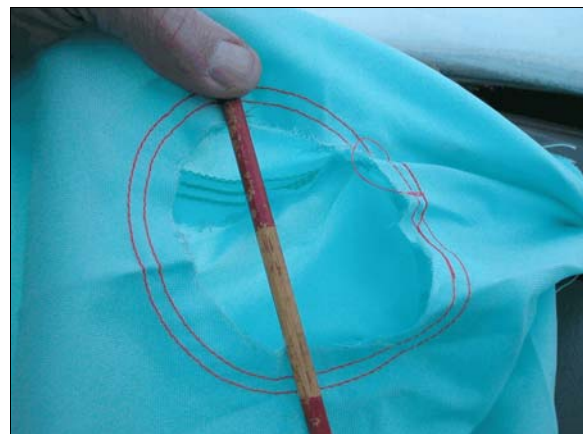
Figure 17: Right vent port of case vehicle's front right passenger air bag

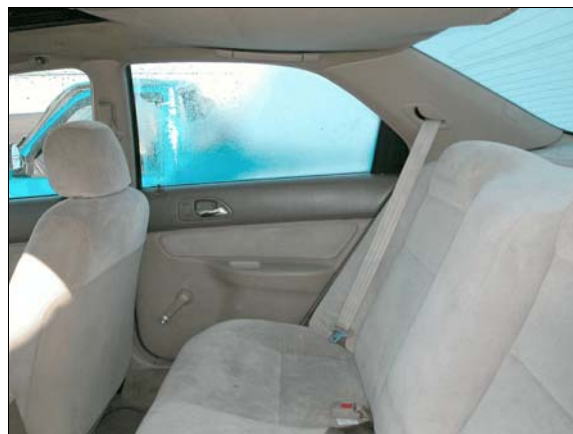
was equipped with a 5-point harness. It was positioned in the case vehicle's back right seat position (**Figure 18**) facing forward and was secured by the manual, three-point lap and shoulder safety belt. The harness straps were located in the middle slots and were positioned at the child's shoulder level. The harness retainer clip was buckled at the time of the crash and was positioned at the child's armpit level. There was about "one finger" of space between the harness and the child's chest, and the child was wearing a heavy coat at the time. The driver stated she could not figure out how to loosen the harness strap to allow more space. The driver purchased the child safety seat new and used it on a daily

Figure 18: Overview of case vehicle's back right seat position, child safety seat was secured here with lap-and-shoulder safety belt

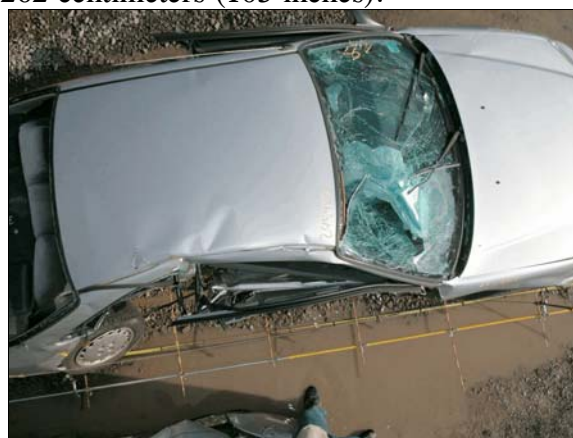
Figure 19: Top view of crush to right side of V2

as 42 centimeters (16.5 inches). The average of the Civic’s door level and sill level crush profiles is shown in the table below.

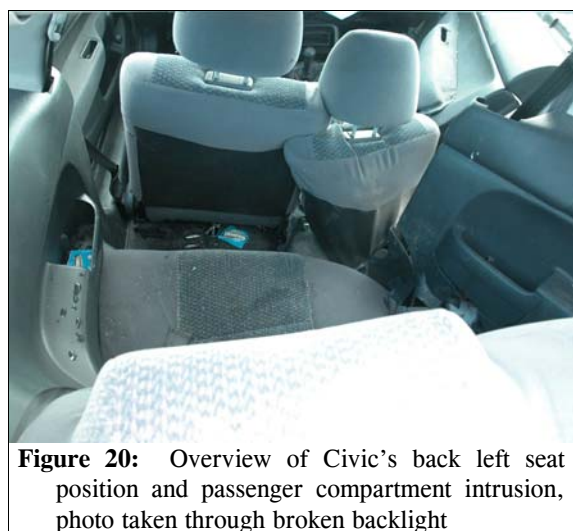
According to the police crash report, the Civic's back left passenger [6-year-old, (unknown race and ethnic origin) male] was restrained by his manual, three-point, lap-and-shoulder, safety belt system. The police crash report did not indicate an injury code for this passenger. However, the child was transported by medical helicopter to a children's hospital for treatment and, based on a local newspaper article, was placed on life support. There was severe intrusion into the back seat due to the impact with the case vehicle. The back left passenger most likely received his injuries from the intruding right side surface of the Civic (**Figure 20**).

Figure 20: Overview of Civic's back left seat position and passenger compartment intrusion, photo taken through broken backlight

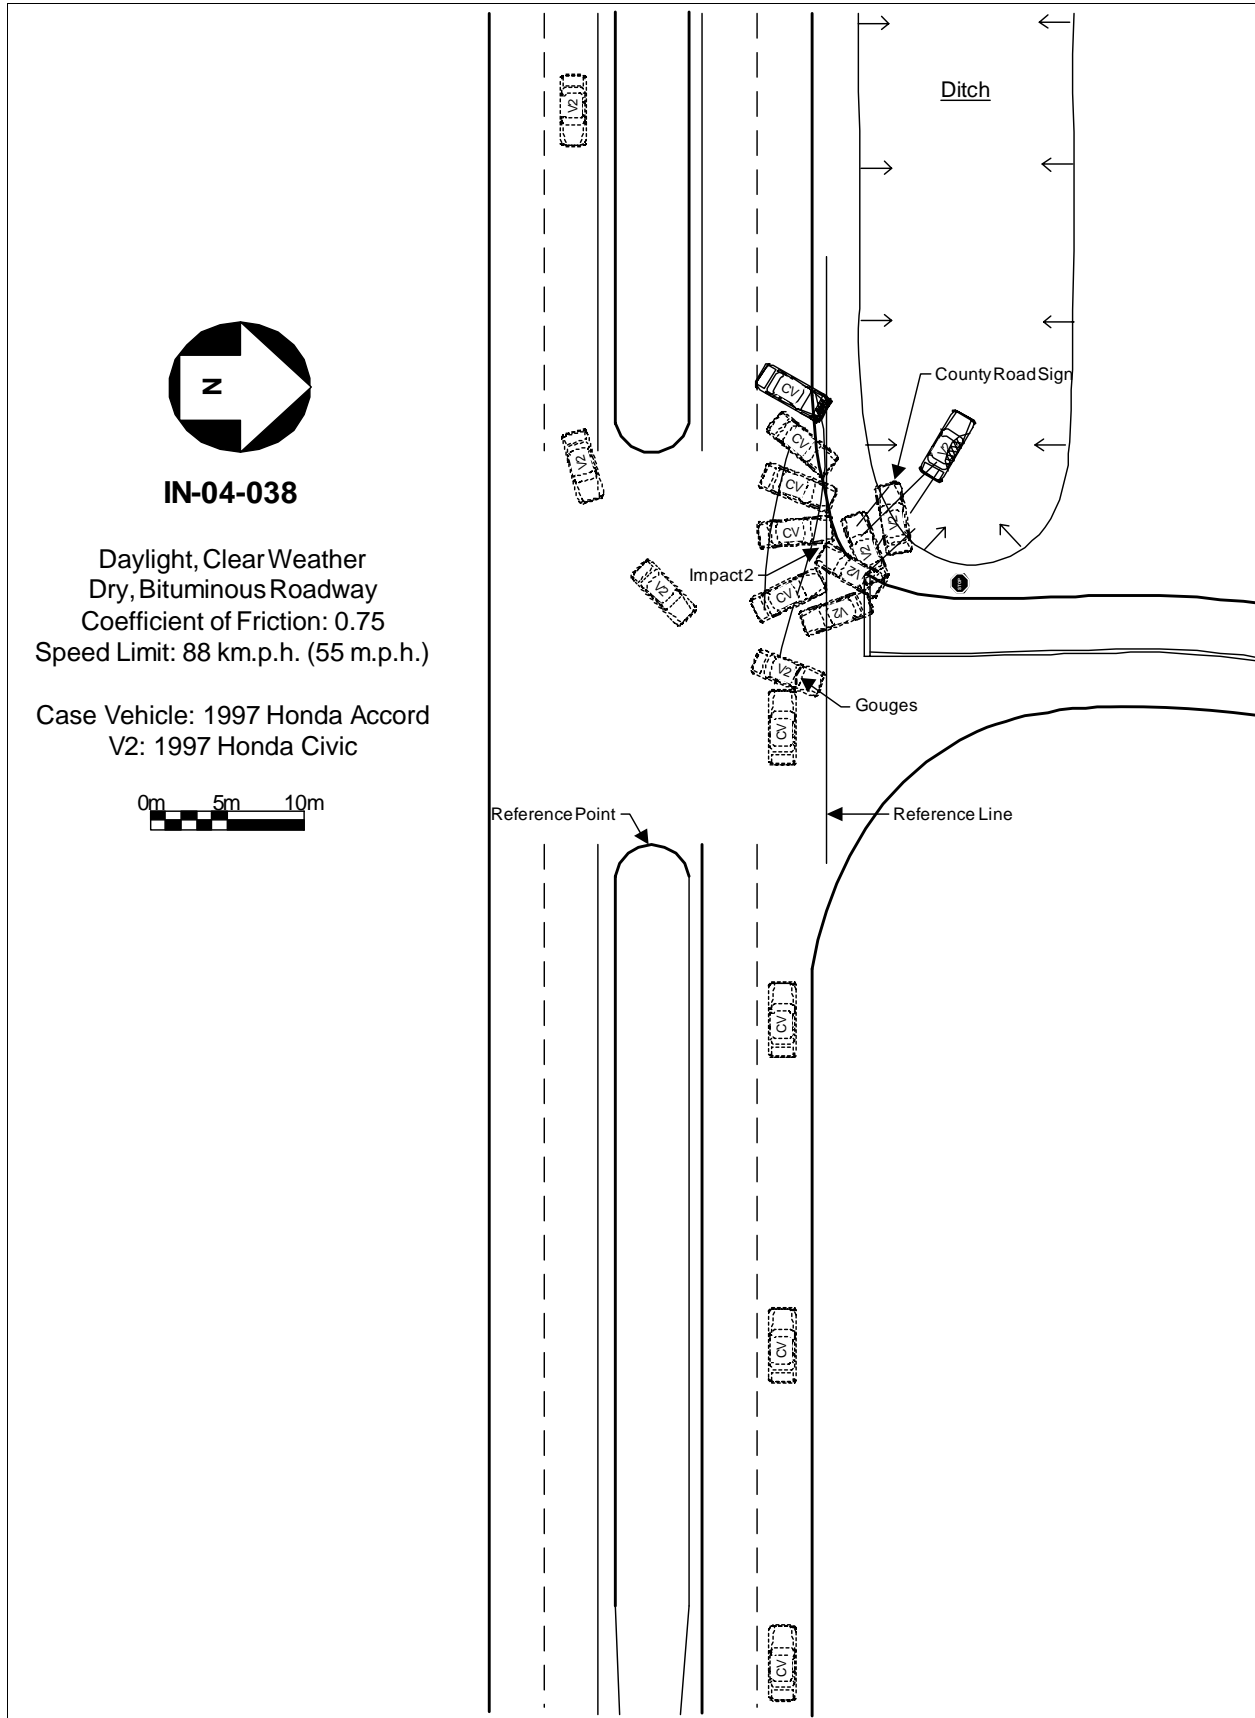
IN-04-038

Daylight, Clear Weather
Dry, Bituminous Roadway
Coefficient of Friction: 0.75
Speed Limit: 88 km.p.h. (55 m.p.h.)
