**CALSPAN ON-SITE CHILD SAFETY SEAT CRASH INVESTIGATION
COSCO VOYAGER HIGH BACK BOOSTER SEAT**

SCI CASE NO: CA04-040

**VEHICLE: 1995 CHEVROLET BERETTA
LOCATION: NEW YORK
CRASH DATE: SEPTEMBER, 2004**

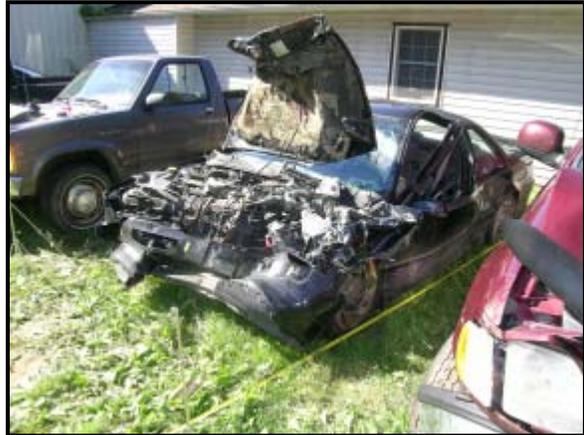
Figure 1: Left front view of the Beretta.

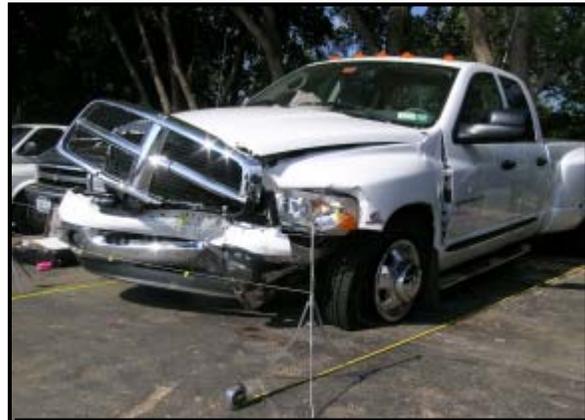
Figure 2: Left front view of the Dodge.

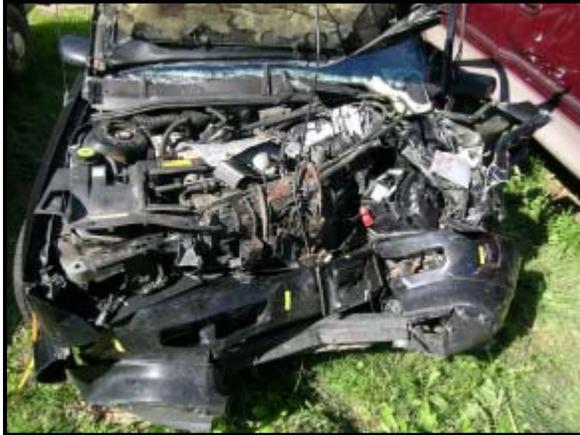
Figures 4 and 5 are the front and left lateral views of the Chevrolet's frontal damage. The vehicle's frontal plane exhibited a combined width of direct and induced damage that extended across the entire 150 cm (59.0 in) undeformed end width. The direct contact damage measured 100 cm (39.5 in). The direct damage began 25 cm (10.0 in) right of center and extended to the left corner of the front bumper. The collision resulted in severe frontal damage that was documented along the front bumper reinforcement bar. The measured residual crush profile was as follows: C1 = 82 cm (32.3 in), C2 = 105 cm (41.3 in), C3 = 89 cm (35.0 in), C4 = 74 cm (29.1 in), C5 = 60 cm (23.6 in), C6 = 40 cm (15.7in). The maximum crush was located 25 cm (10 in) left of center at C2. The base of the left A-pillar deformed rearward 14 cm (5.5 in). The roof buckled 5 cm (2 in) vertically upward above the driver position. The left door was jammed shut by the compressive force of the impact and buckled. The right door remained closed during the impact and was operational post-crash. The windshield was fractured by the rearward deformation of the hood. The left wheelbase was reduced 29 cm (11.4 in). The right wheelbase

dimension was unchanged. The Collision Deformation Classification (CDC) of the vehicle was 12-FYEW-4. The total delta V calculated by the Damage Algorithm of the WINSMASH collision model was 65 km/h (40.6 mph). The longitudinal and lateral delta V components were -64 km/h (-40 mph) and -11 km/h (-7.0 mph), respectively.

Figure 4: Front view of the Beretta.

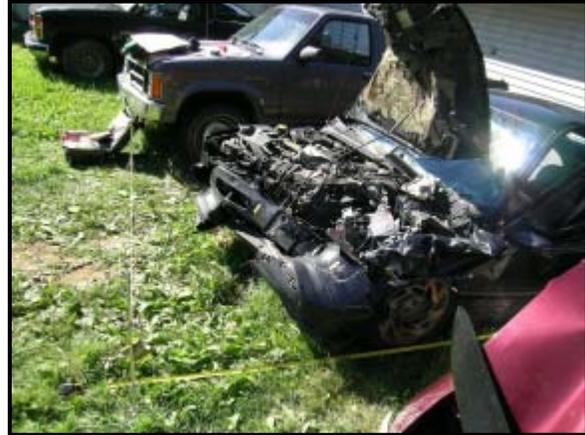
Figure 5: Left lateral view at the front plane.

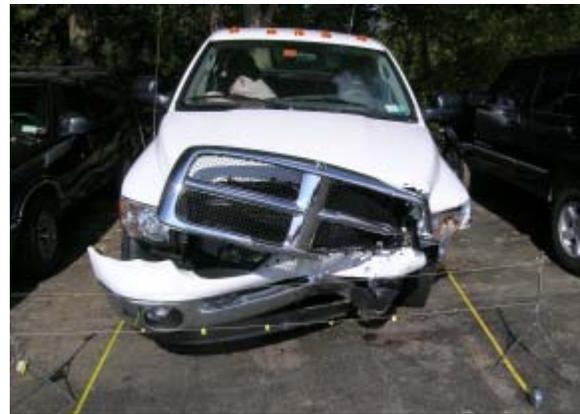
Figure 6 is a front view of the moderate frontal damage sustained by the Dodge. The front plane sustained a combined 168 cm (66.0 in) width of direct and induced damage that extended across the vehicle's undeformed end width. The direct contact damage measured 86 cm (34.0 in). The direct damage began 3 cm (1.0 in) right of center and extended to the left front bumper corner. The residual damage measured along the front bumper was as follows: C1 = 38 cm (15.0 in), C2 = 16 cm (6.3 in), C3 = 35 cm (13.8 in), C4 = 14 cm (5.5 in), C5 = 0, C6 = 0. The maximum crush was located at C1, the left front bumper corner. As a result of the offset collision, the left corner deformed rearward and inboard about the left frame rail. The left corner of the bumper impacted and deboned the left front tire. The left front fender was crushed longitudinally and deformed. The left wheelbase was reduced 5 cm (2.0 in). The right wheelbase dimension was unchanged. All four doors were operational post-crash. There was no damage to the windshield or side window glazing. The Collision Deformation Classification (CDC) was 12-FYEW-2. The total delta V calculated by the Damage Algorithm of the WINSMASH collision model was 28 km/h (17.1 mph). The longitudinal and lateral delta V components were -28 km/h (-17.1 mph) and 0.0 km/h (0.0 mph), respectively.

Figure 6: Front view of the Dodge.

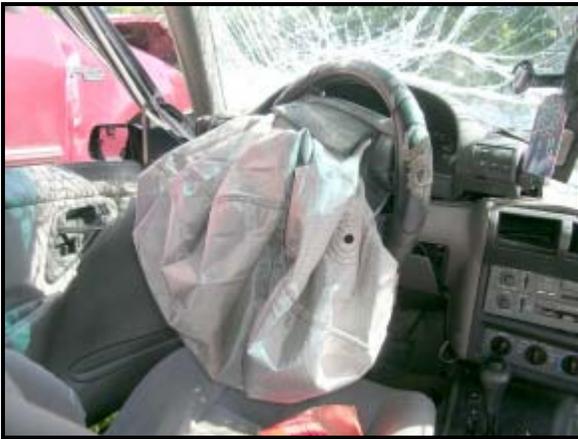
Figures 7 and 8 are interior views of the Chevrolet. The Beretta sustained moderate severity intrusion in the front left position as a result of the exterior crash force. The measured front left intrusion is identified in the table below. The intrusion into the front right position was limited to the toe pan and measured 6 cm (2.4 in). Additional interior damage consisted of the deployment of the driver (only) air bag and the identified driver's interior contacts. There were no identified interior contacts associated to the front right child passenger.

Front Left Intrusion		
<i>Component</i>	<i>Magnitude</i>	<i>Direction</i>
Left A-pillar	14 cm (5.5 in)	Longitudinal
Left instrument panel	11 cm (4.3 in)	Longitudinal
Driver knee bolster	11 cm (4.5 in)	Longitudinal
Toe pan – left	15 cm (5.9 in)	Longitudinal
Roof side rail - left	5 cm (2.0 in)	Vertical

Figure 7: Front left interior view.

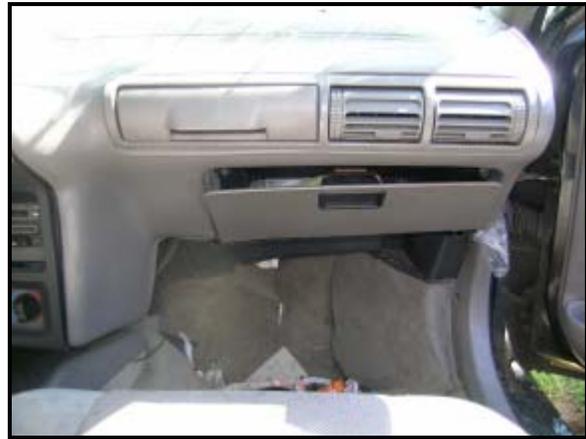
Figure 8: Front right interior view.

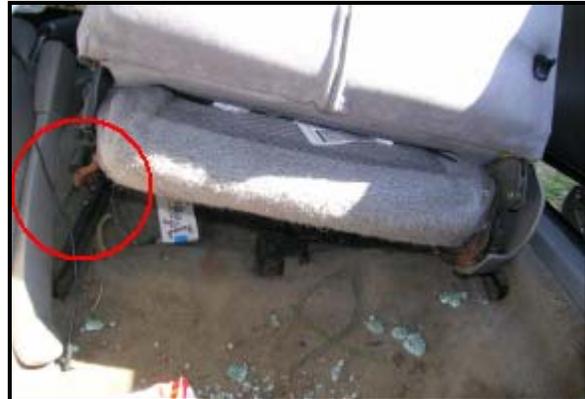
The front right seat was located in a mid-track position that measured 5 cm (2.0 in) rear of full forward. The total seat track travel measured 11 cm (4.5 in). The seat back recline angle measured 30 degrees. The horizontal distance from the seat back to the vertical face of the instrument panel measured 70 cm (27.5 in). In a manner similar to the driver seat, the inboard seat track roller had also disengaged from the seat track at sometime prior to the crash. **Figure 9** is a view of the disengaged roller and seat track. In the figure, the seat was pushed forward and the aft aspect of the seat elevated to facilitate the photograph.

Figure9: View of the front right seat and disengaged seat track roller.

The roller was attached to the inboard aspect of the seat by a formed metal bracket. Inspection of the assembly revealed that the formed bracket and the axle shaft of the roller were deformed. The direction of the deformation indicated that the resultant deformation would have occurred from a compressive load placed in the front right seat. This type of loading was inconsistent with dynamics of the crash; therefore, this damage pre-dated the crash.

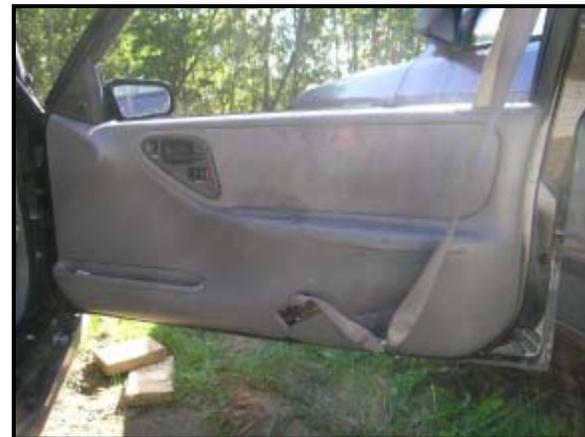
Figure10: Front right manual three-point restraint.

The first responder to the crash scene stated to the police that he unbuckled the safety belt from the child seated in the booster seat in the front right position. Examination of the front right manual restraint revealed crash related evidence indicative of use during the crash. An 8 cm (3 in) abraded region was identified on the lap belt webbing. The abrasion began 46 cm (18 in) above the latch plate and ended 53 cm (21 in) above the latch plate reference. This abraded area was related to a frictional interaction with the outboard aspect of the base of the booster seat. The face of the D-ring displayed a minor abrasion from contact with the shoulder belt. Examination of the latch plate revealed evidence of historical use. All the evidence gathered at the inspection determined the child was restrained by the manual safety belt. (Refer to the Child Safety Seat section of this report for greater detail regarding the routing of the belt.)

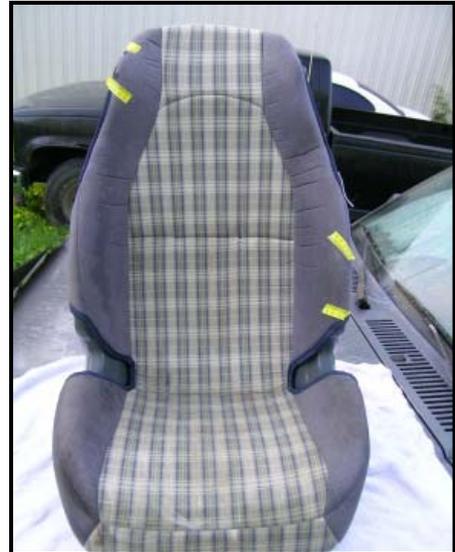
The three year old male was seated in a Cosco Voyager high-back belt positioning booster and restrained within the front right position of the Chevrolet. **Figure 11** is a front view of the Cosco booster seat, Model No: 02-452-WAL. The seat was manufactured on February 22, 2003. The seat was labeled for use by child from 14 kg to 36 kg (30 lb to 80 lb) and up 132 cm (52 in), as long as the mid-point of the child's head was not above the seat back. There were two warning labels on the seat that stated "Do not use with lap belt only". The seat's instruction manual was not present. Three shoulder belt positioning clips were designed into the respective outboard edges of the seat back. The purpose of the clips was to position the shoulder belt for a better fit to the seated height of the child. These clips were not in use at the time of the crash.

Figure11: Front view of the Cosco Voyager.

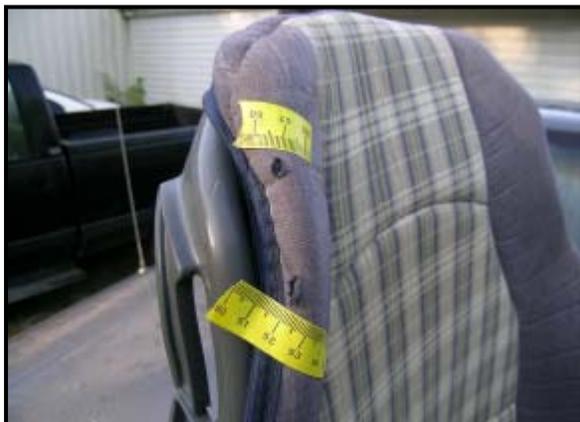
Inspection of the booster seat identified evidence related to loading of the locked (after ELR actuation) safety belt system at the time of the crash. The fabric cover of the seat was abraded and torn in two locations on its upper left aspect. The tears measured 6 mm (0.25 in) in diameter and were located 53 cm (21 in) and 58 cm (23 in) above the seat base, respectively. Inspection of the plastic shell underneath the fabric at that location revealed a 6 mm (0.25 in) long abrasion of the shell. **Figure 12** is a close-up view of the abraded fabric and shell. A minor 4 cm (1.5 in) long fabric abrasion was observed on the right lower aspect of the seat. This abrasion was located 28 cm (11 in) above the seat base. The bight of the booster seat was designed to position the lap belt during use. Abrasions to the shell were observed on both sides of the shell from the seat's interaction with the locked lap belt during the crash. **Figure 13** is a view of the shell's abrasion on the left side of seat.

Figure 12: Close-up view of the fabric and shell abrasions caused by the locked shoulder belt.

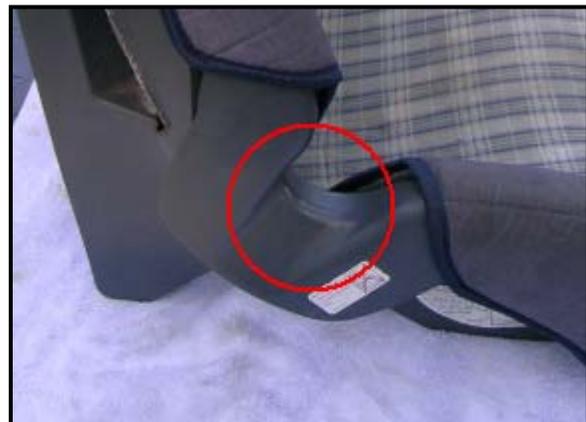
Figure 13: Close-up view of the left side shell abrasion caused by the locked lap belt.

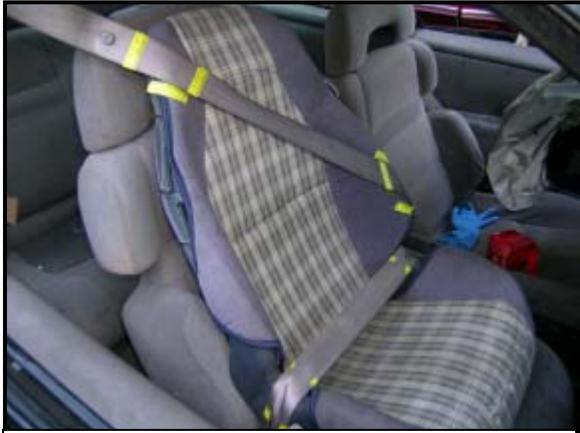
The crash-related safety belt evidence on the booster seat was used to reconstruct the probable usage position of the safety belt at the time of the crash. As evidenced by the abrasions, the designed belt positioning tabs were not in use. **Figure 14** is a view of the reconstructed position of the seat and safety belt taken at the time of the SCI inspection. In this position, the shoulder webbing crosses the centerline of the booster seat 42 cm (16.5 in) above the base, **Figure 15**.

Figure 14: View of the reconstructed position of the safety belt.

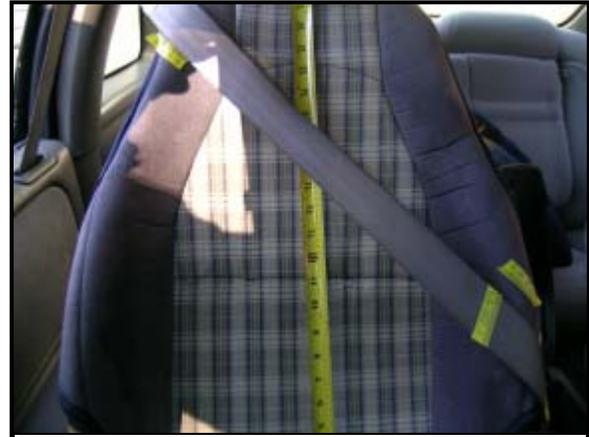
Figure 15: Reference view of the safety belt position.

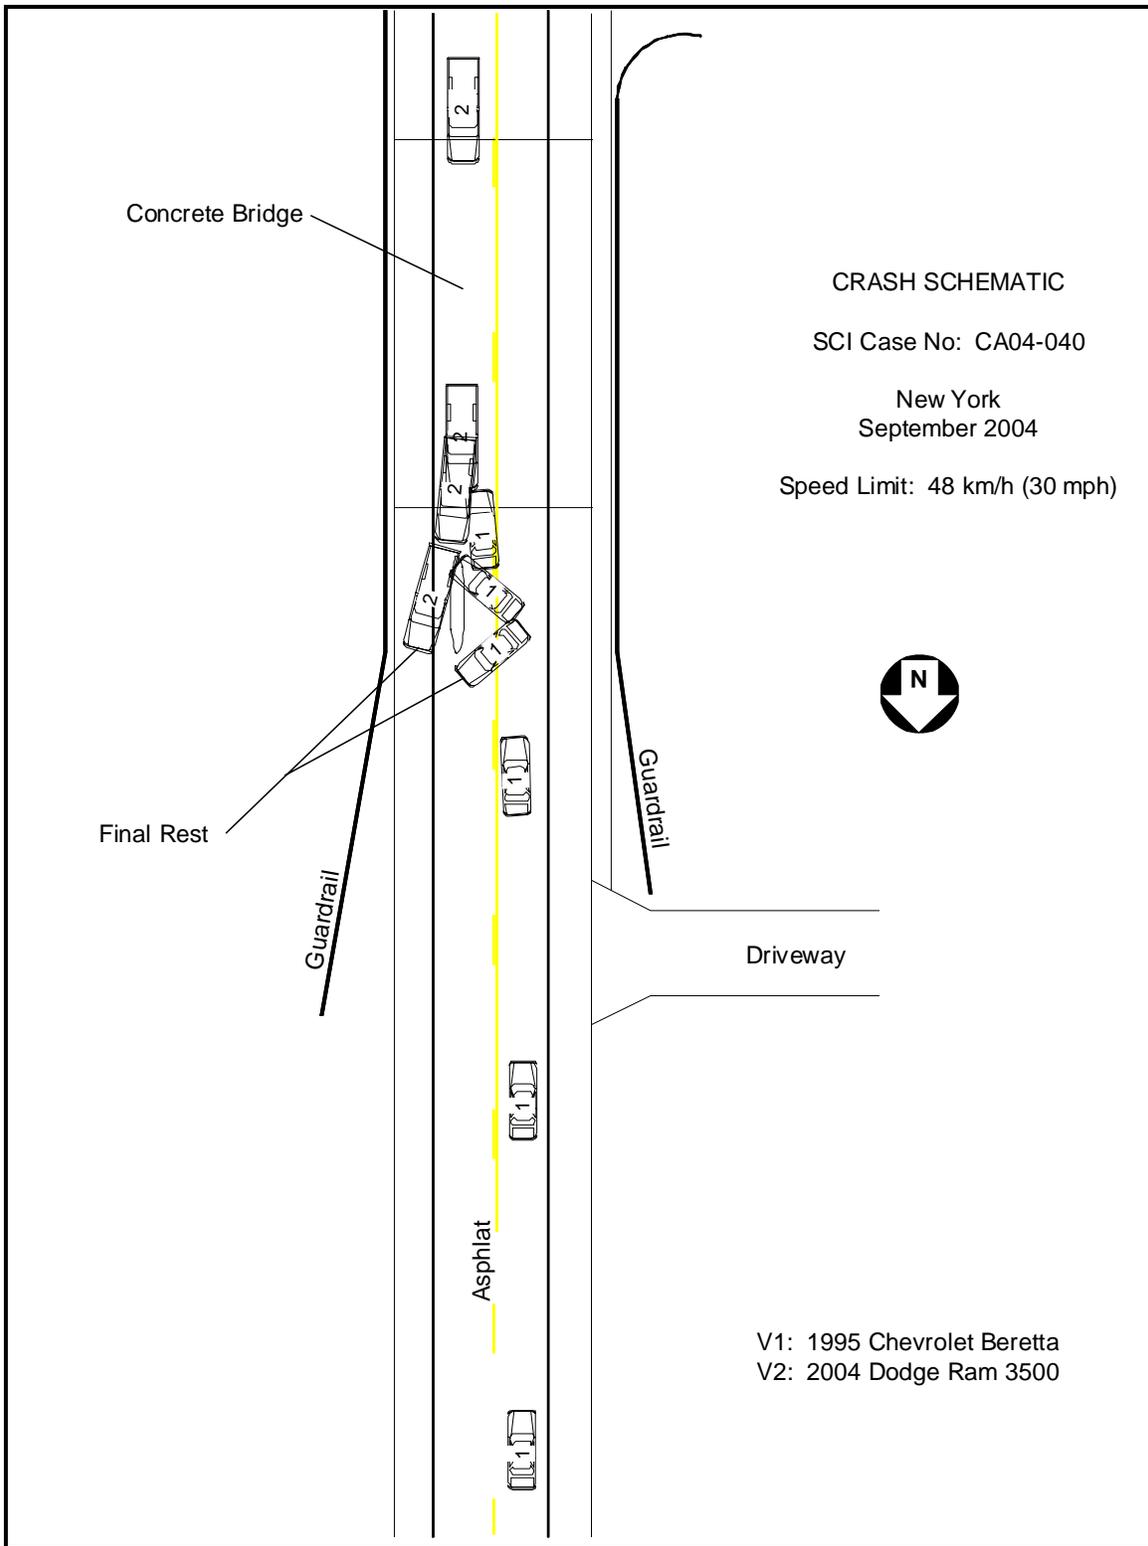
The force of the crash and the offset impact configuration caused the Chevrolet to initiate a counterclockwise rotation during separation and the northbound momentum of the Dodge reversed the travel direction of the Chevrolet. The Chevrolet came to rest facing northeastward straddling the centerline of the road 7.6 m (25.0 ft) north of the point of impact. The Dodge was deflected to its right by the force of the impact and came to rest facing northeast straddling the outboard fog line. A schematic of the crash is attached to the end of this report, **Figure 16**.

Figure 16: Crash schematic.
