**CALSPAN ON-SITE CERTIFIED ADVANCED 208-COMPLIANT
VEHICLE CRASH INVESTIGATION**

CASE NO: CA04-042

VEHICLE: 2004 LEXUS ES 330

CRASH DATE: AUGUST 2004

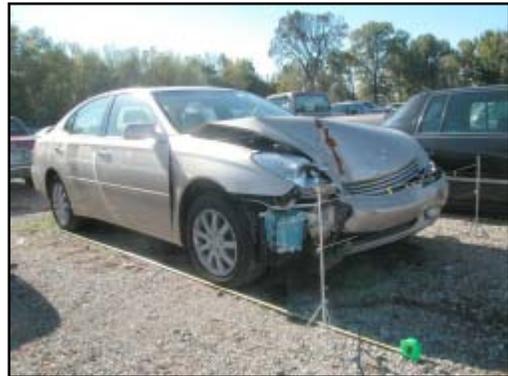
Figure 1. Damaged 2004 Lexus ES 330

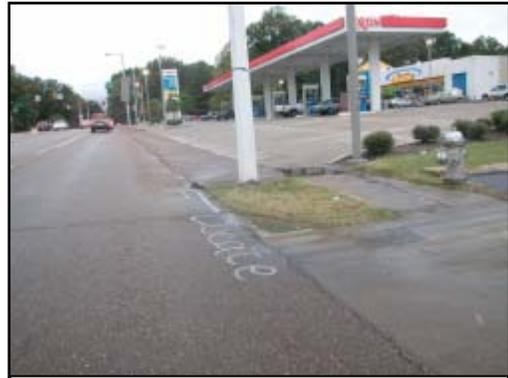
This single-vehicle crash occurred during the daylight hours of August 2004 in the state of Tennessee. At the time of the crash, the weather was clear and the asphalt roadway surface was dry. The crash occurred on the north roadside of a four-lane east/west municipal roadway approximately 100 m (328') east of a four-leg intersection. The struck pole was located 0.8 m (2.6') from the road edge between two driveways to commercial establishments (**Figure 2**). The struck concrete light pole measured 22.9 cm (9.0") square at the base and exhibited a slight vertical taper. The distance between the driveways measured 4.2 m (13.8'). The east/west roadway consisted of two travel lanes in each direction separated by a painted center left turn lane.

Figure 2. View of crash site and concrete light pole

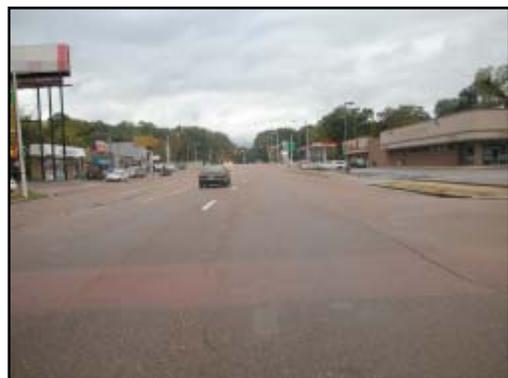
The 83-year-old female driver was operating the 2004 Lexus ES 330 in a westbound direction on the municipal roadway. She stated that her pre-impact speed was approximately 48 km/h (30 mph) and there were no distractions in the vehicle. The Lexus was traveling in the outboard westbound lane and the driver maintained the outboard lane as the travel lanes began to widen on approach to the intersection (**Figure 3**).

Figure 3. Westbound approach for the Lexus ES 330

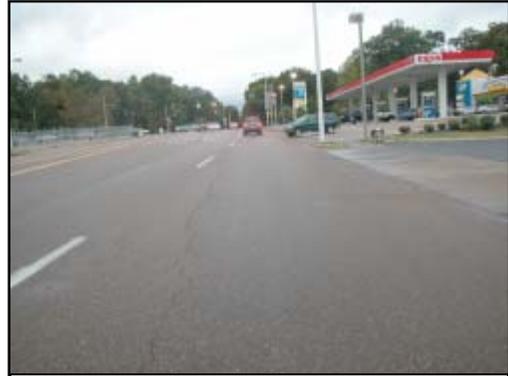
A non-contact vehicle traveling in the inboard lane passed the Lexus and initiated a rapid lane change to the outboard lane in front of the Lexus (**Figure 4**). According to the driver of the Lexus, the driver of the non-contact vehicle (NCV) immediately applied the brakes in front of the Lexus. She steered right in an attempt to turn into a driveway of a commercial establishment on the roadside and avoid a collision with the NCV. The driver was unable to negotiate the driveway and the Lexus departed the right roadside slightly west of the driveway toward the concrete pole.

Figure 4. Area where NCV passed the Lexus

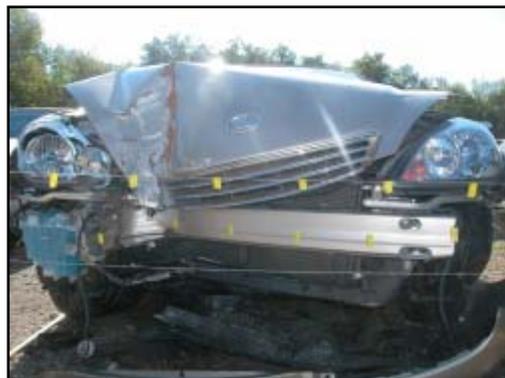
The 2003 Lexus ES 330 sustained moderate frontal damage as a result of the impact with the concrete light pole (**Figures 5 and 6**). The direct damage from the initial impact began 31.1 cm (12.3") right of the centerline and extended 35.6 cm (14.0") to the right. The front bumper fascia was fractured on the right aspect and was partially separated. Direct contact abrasions and concrete transfers were present on the right aspect of the hood, which was crushed and buckled rearward. The bumper beam sustained longitudinal crush, as did the upper and lower radiator supports. The maximum crush was located 31.1 cm (12.3") right of center and measured 40.6 cm (16.0").

Figure 5. Frontal view of damage

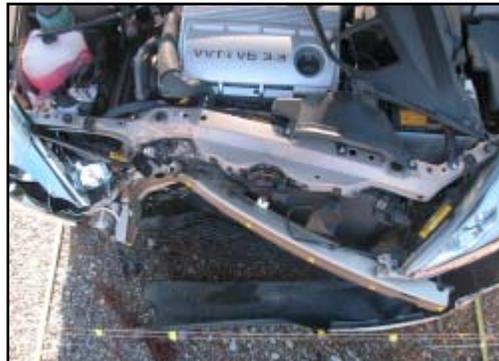
The combined direct and induced damage measured 94.6 cm (37.3") across the front bumper beam. The right front fender was displaced slightly rearward. Six crush measurements were documented along the front bumper beam and were as follows: C1 = 0.0 cm, C2 = 7.0 cm (2.8"), C3 = 18.1 cm (7.1"), C4 = 30.8 cm (12.1"), C5 = 40.0 cm (15.8"), C6 = 17.1 cm (6.8"). Six additional crush measurements were documented along the upper radiator support, but due to the lack of override were not included in the crush profile. The Collision Deformation Classification (CDC) for the initial impact with the concrete light pole was 12-FZEN-2

Figure 6. Overhead view of frontal crush

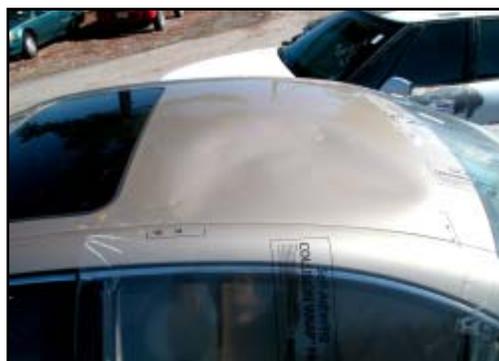
The Lexus sustained moderate damage as a result of the impact with the displaced luminaire. The left rear aspect of the roof sustained shallow punctures in the paint and the maximum vertical crush was located 27.9 cm (11.0") forward of the backlight header and 27.3 cm (10.8") inboard of the left roof side rail (**Figure 7**). The maximum crush measured 1.3 cm (0.5"). The combined direct and induced damage began at the backlight header, extended forward 55.9 cm (22.0"), began at the left roof side rail and extended laterally 54.6 cm (21.5"). The backlight glazing and left rear door glazing disintegrated as a result of the luminaire impact. The tempered glass sunroof was not damaged by this impact. The CDC for the roof impact was 00-TPYW-2.

Figure 7. Overhead view of left rear roof damage

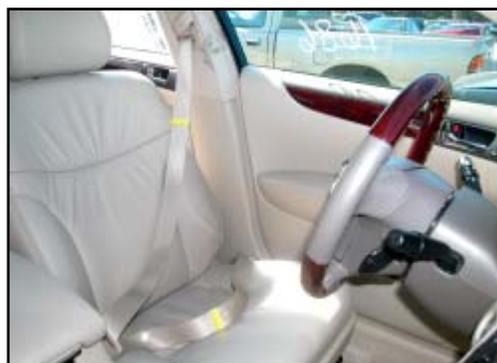
The 2004 Lexus ES 330 was configured with manual 3-point lap and shoulder belts for all five seating positions. The driver's safety belt was configured with a sliding latch plate, Emergency Locking Retractor (ELR), and an adjustable D-ring that was located in the full-down position at the time of the vehicle inspection. The driver's safety belt (**Figure 8**) was restricted in the used position as a result of the retractor pretensioner actuation. The total exposed webbing measured 177.2 cm (69.8") between the lower anchor and the D-ring. The driver's plastic-covered latch plate exhibited moderate abrasions as a

Figure 8. Driver's safety belt

result of the driver's loading to the safety belt. The driver's D-ring also sustained abrasions from the loading to the safety belt. Minor deformation was present on the webbing from driver loading. The deformation began 62.9 cm (24.8") above the lower anchor and extended 91.4 cm (36.0") up the webbing.

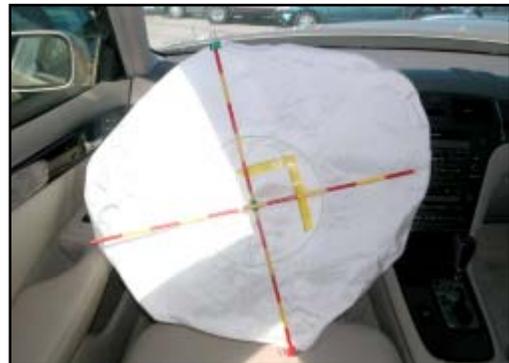
The driver's air bag (**Figure 9**) deployed from the center of the steering wheel that was configured with a triangular cover flap design with a horizontal tear seam that measured 14.9 cm (5.9") in width. The top cover flap measured 7.6 cm (3.0") in height and the contoured symmetrical bottom flaps measured 5.1 cm (2.0") in height. The air bag measured 66.0 cm (26.0") in diameter in its deployed state. Two circular ports that measured 2.5 cm (1.0") in diameter vented the air bag. The vent ports were located 7.6 cm (3.0") from the peripheral seam at the 1 and 11 o'clock positions on the top rear aspect of the air bag. Two internal straps that measured 12.7 cm (5.0") in width and were located at the 3 and 9 o'clock positions tethered the air bag.

Figure 9. Deployed driver's air bag

Makeup transfers were present on the face of the driver's air bag from contact with the driver's face. The transfer began 0.6 cm (0.3") left of the vertical centerline and 5.7 cm (2.3") above the horizontal centerline. The makeup transfer extended 6.4 cm (2.5") to the right and 12.1 cm (4.8") downward. A small lipstick transfer was present on the bottom aspect of the makeup transfer and was located 2.5 cm (1.0") right of the vertical centerline and 6.0 cm (2.4") below the horizontal centerline. The lipstick transfer measured 1.3 cm (0.5") in height and width. The transfers did not exhibit any smearing and suggested that the driver's face contacted the air bag after it was fully inflated. The driver's retractor-mounted safety belt pretensioner fired as a result of the frontal impact, in conjunction with the driver's air bag.

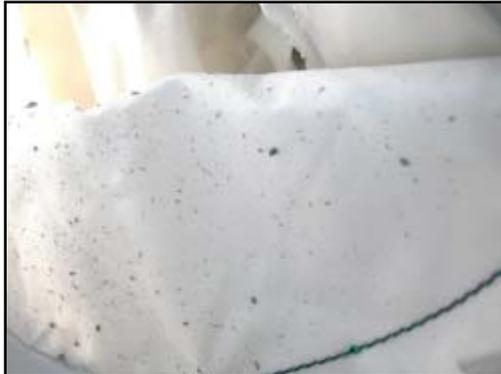
Interior inspection of the driver's air bag revealed small fragments of grey particulate that were fused to the interior aspect of the air bag fabric. **Figures 10 and 11** are views through the vent port showing the grey deposits on the interior aspect of the air bag fabric and below the inflator. There was no evidence to suggest that any of the grey deposits were exhausted through the vent ports, and the integrity of the air bag was not compromised.

Figure 10. View of grey deposits on interior of air bag fabric

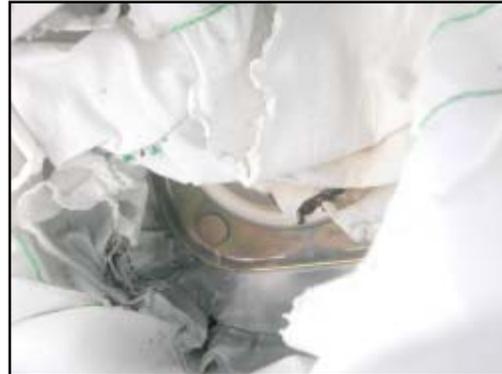
Figure 11. Bottom aspect of the inflator and grey deposits

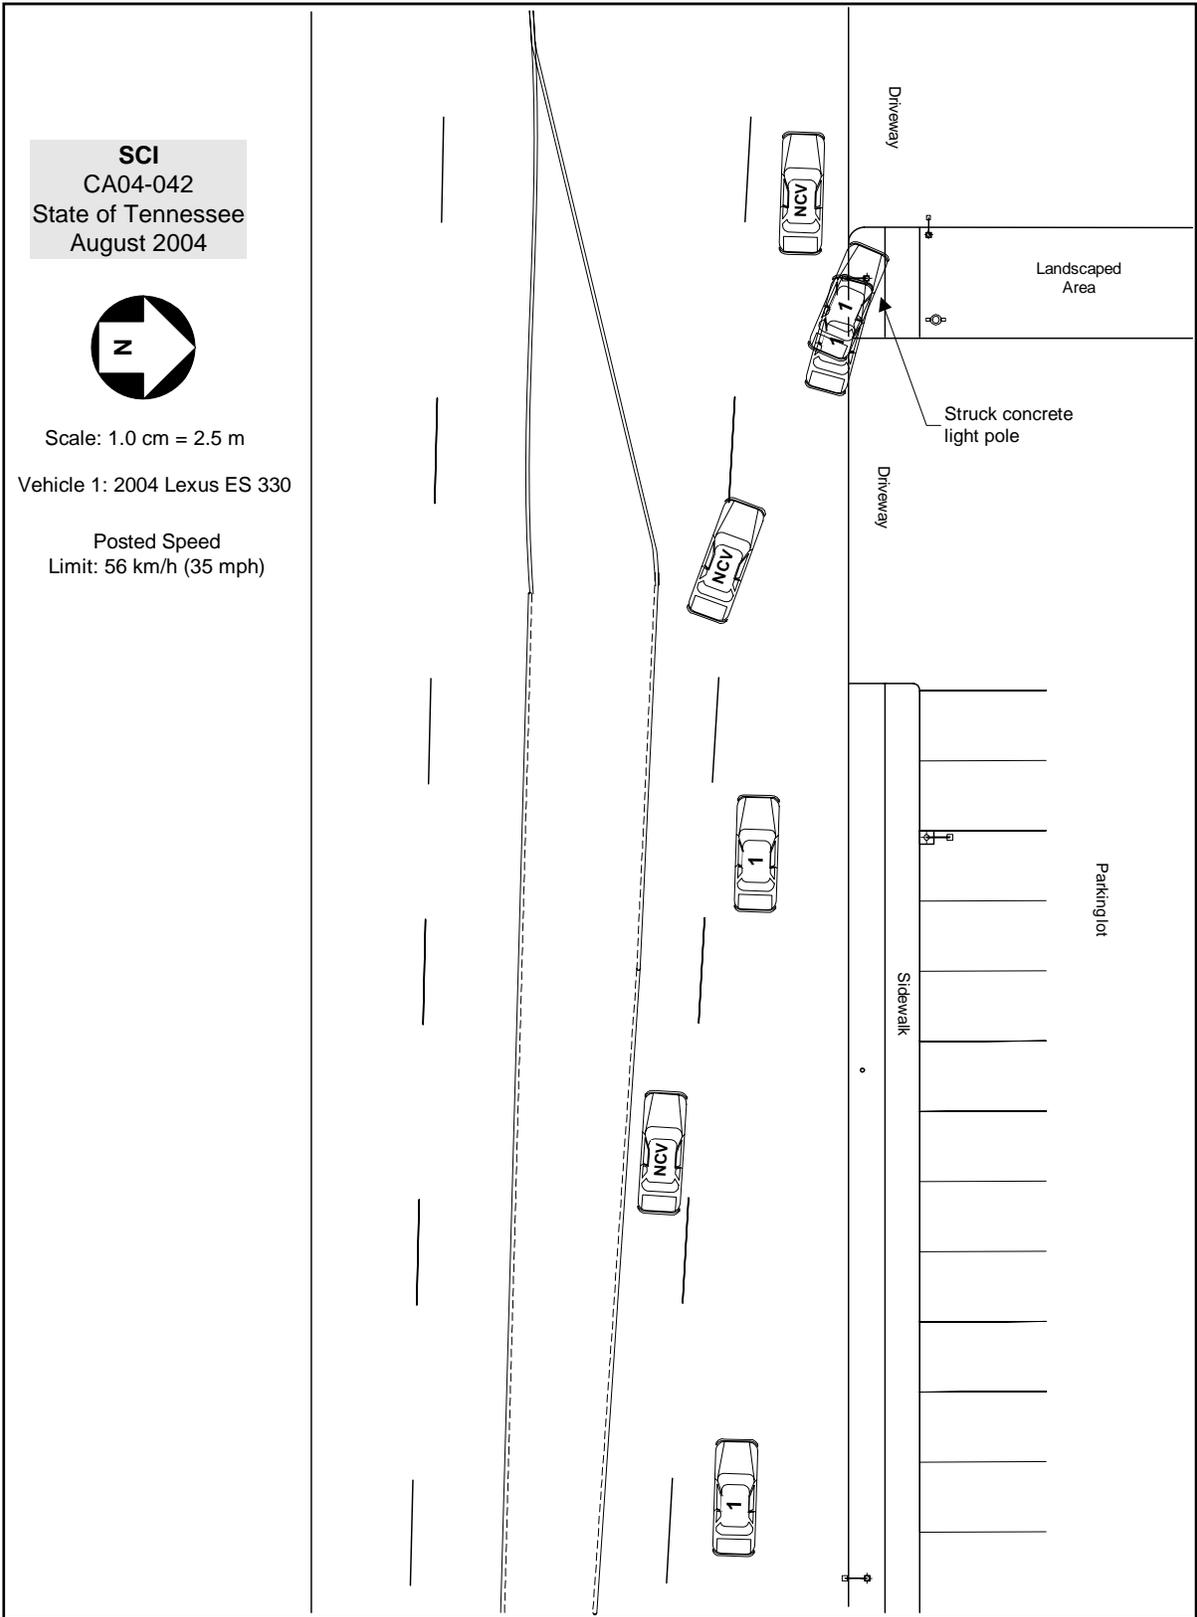
Figure 12. Scene Schematic

In the area of the crash, the westbound travel lanes widened to create two inboard left turn lanes at the mouth of the intersection in addition to the two 'through' travel lanes. Concrete curbs bordered the roadway; however, the north roadside curb height decreased on approach to the intersection, and was negligible at the crash location. Additional concrete light poles were present on the roadside beyond the crash location. The roadside environment consisted of commercial properties and parking lots, and the posted speed limit was 56 km/h (35 mph). The scene schematic is included as **Figure 12** at the end of this narrative report.
