**CALSPAN REMOTE SCHOOL BUS  
CRASH INVESTIGATION**

**CASE NO: CA04-047**

**VEHICLE: 2004 BLUE BIRD ALL AMERICAN SCHOOL BUS**

**CRASH DATE: NOVEMBER 2004**

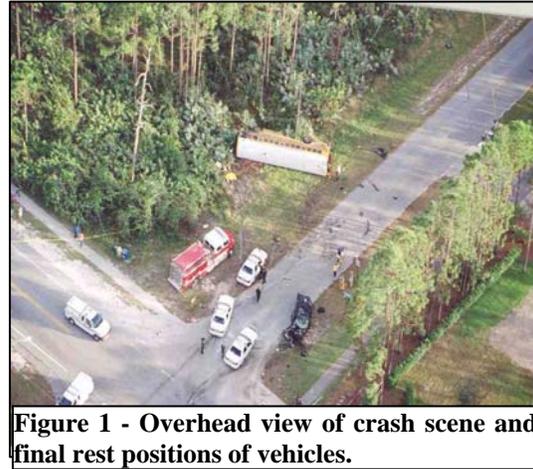
This remote investigation focused on the severity of the crash and the ejection portal of a 15-year old female student passenger of a rear-engine, 2004 84-passenger Blue Bird school bus that was involved in an intersection crash with a 2004 Dodge Ram 1500 pickup truck. The school bus overturned and ejected the 46-year old female driver and 15-year old female student through the double full view outward opening entrance door. **Figure 1** is an overhead view of the crash scene and final rest positions of the vehicles. At the time of the crash, the bus was occupied by an unrestrained driver and

**Figure 1 - Overhead view of crash scene and final rest positions of vehicles.**

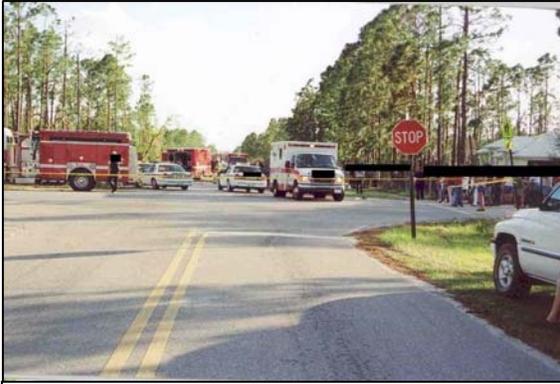
The 46-year old female driver of the 2004 Blue Bird school bus was operating her vehicle in the southbound direction and was approaching an intersection controlled by a stop sign (**Figure 2**). The 40-year old male driver of the 2004 Dodge Ram was operating his vehicle in an eastbound direction and was approaching the same intersection. **Figure 3** is an overhead view of the crash scene with directional arrows for both vehicles.

**Figure 2 - Southbound approach of bus.**

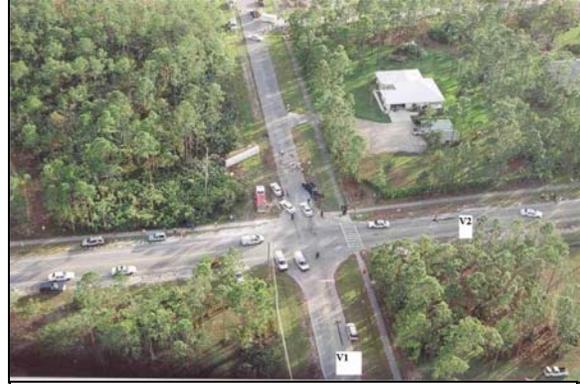
**Figure 3 - Overhead view of crash scene.**

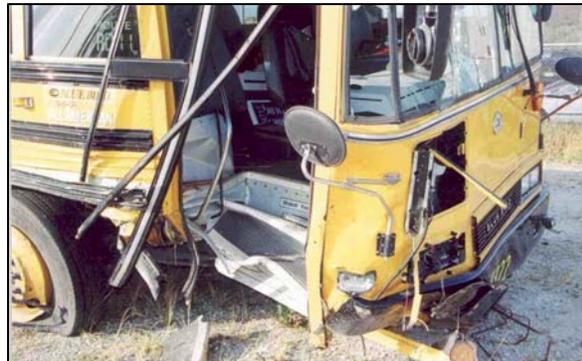
The 2004 Bluebird school bus sustained moderate damage from the impacts with the Dodge Ram and subsequent rollover. There was no on-site SCI inspection and this report is based largely on crash scene photographs provided by the investigative agency. Direct contact damage was present at the front right corner of the bus and extended down the right side a distance of approximately 80 cm (32"), terminating slightly aft of the front right wheel (**Figure 4**). The direct contact

**Figure 4 - Damaged front right corner of bus.**

damage also extended a distance of approximately 80 cm (32") across the 244 cm (96") front bumper of the bus. The front right wheel deflated and appeared to have been displaced slightly rearward. The tempered glass within the double full-view outward opening entrance door was shattered and the existing framework within the door was significantly damaged. The internal steps leading from the bus to the exit were crushed and deformed laterally. The lower aspect of the third row right split-sash window was shattered.

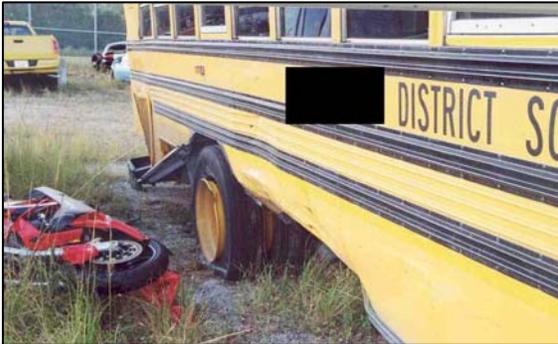
After the initial impact, the two vehicles side slapped resulting in moderate damage to the right side of the bus (**Figure 5**). The damage began approximately 150 cm (60") forward of the right rear axle and extended just beyond the wheel well. The right rear outboard tire was deflated and debeaded from the rim

**Figure 5 - Side slap damage to the right side of the bus.**

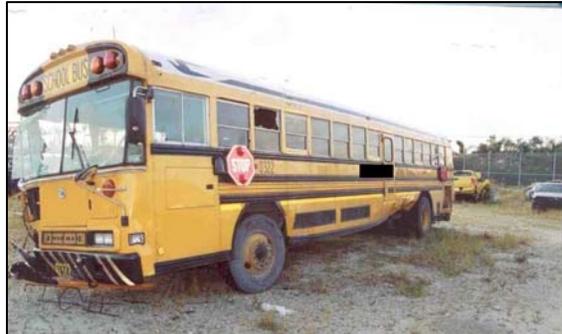
As the bus overturned, it sustained minor buckling damage to its roof and both side planes. The upper aspect of the 3<sup>rd</sup> row split-sash window was shattered. As the vehicle completed its 3<sup>rd</sup> quarter turn, the left rear area located forward of the axle impacted a

small diameter pine tree (**Figure 6**). The damage is approximately 100 cm (40”) in width and began approximately 15 cm forward of the left rear wheel. Associative bark transfers from the tree were embedded within the yellow paint on the vehicle’s left side.

**Figure 6 - Damage to the left side of the bus.**

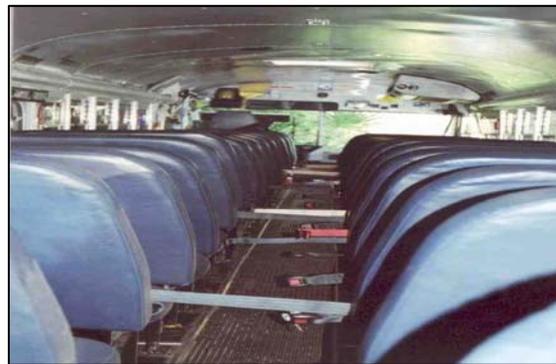
The photographic images revealed minor interior damage associated with the rollover event of the bus. Minor buckling was visible along the entire length of the roof; however, the damage was minimal and not to the level of being considered intruded. The internal steps leading from the bus to the exit door were crushed laterally and the aforementioned door damaged in the impact with the Dodge. The laminated windshield was also fractured probably during the rollover sequence. No discernable intruded components or contact points were observed. **Figure 7** is a view of the interior of the bus from the back aspect.

**Figure 7 - Interior of the bus.**

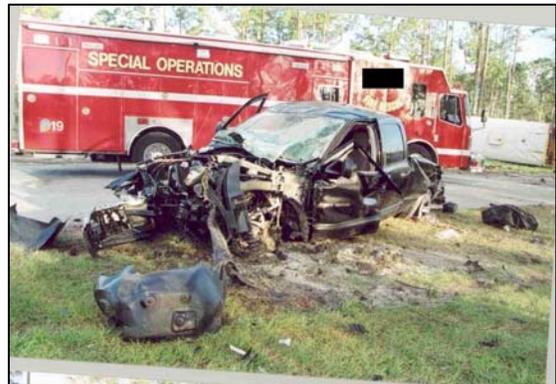
The 2004 Dodge Ram pickup truck sustained severe frontal and left side damage as a result of the multiple impacts with the bus (**Figure 8**). The front of the Dodge was shifted to the right and its chrome bumper sheared from the front end. The sheet metal and engine components forward of the base of the windshield were severely deformed. The damage along the forward aspect of the vehicle’s left side began at the left front bumper corner and extended rearward to the

**Figure 8 - Damaged 2004 Dodge Ram.**

base of the A-pillar. The left front wheel was also fractured from the axle and the left front door jammed closed. Induced damage was present on the front right door and fender. The Collision Deformation Classification (CDC) for this impact was incremented for the right shift and was estimated to be 70-LFAW-5.

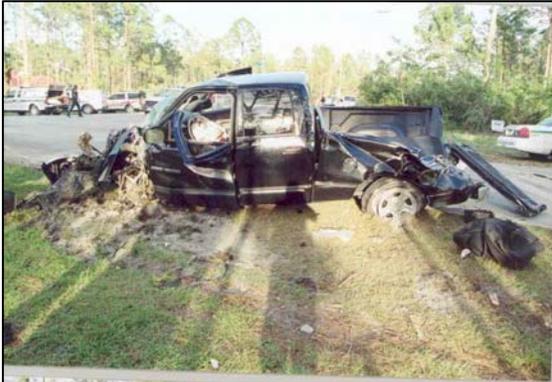
The Dodge also sustained damage to the left mid and rear from the subsequent side slap (**Figures 9 and 10**). This damage was located mostly to the pickup's bed, but began at the left C-pillar and extended rearward to the left rear bumper corner. The left rear wheel was deflated and the vehicle's lift gate was fractured and was found hanging from the vehicle connected only by the right side steel lift cable. The CDC for this secondary impact was 09-LZAW-3.

**Figure 9 - Left side of damaged 2004 Dodge Ram.**

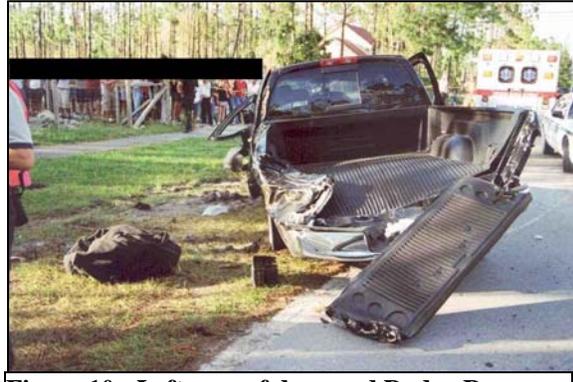
**Figure 10 - Left rear of damaged Dodge Ram.**

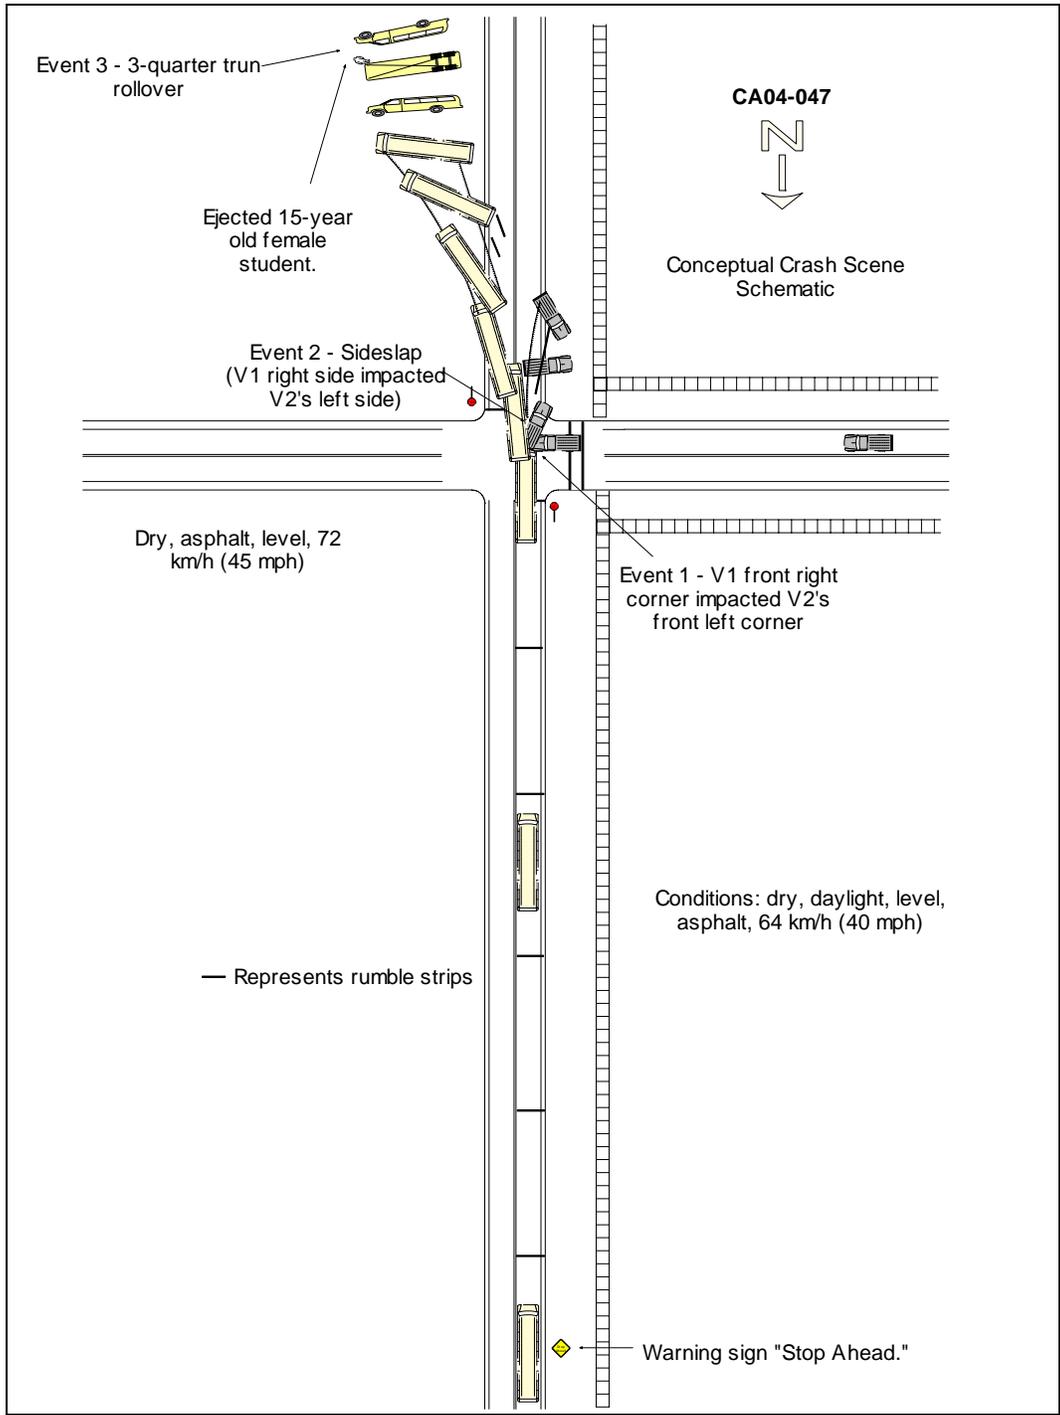
**Figure 11 – Conceptual Crash Scene Schematic**

This two-vehicle crash occurred during daylight hours of November of 2004 in the state of Florida. At the time of the crash, there were no adverse weather conditions and the asphalt road surfaces were dry. The crash scene consisted of a north/south roadway intersecting an east/west roadway. For traffic entering the intersection from north/south roadway, access was controlled by stop signs. Both roadways consisted of one lane in each direction and were delineated by solid double-yellow painted centerlines. Asphalt shoulders with white painted fog lines bordered both roadways. The contiguous environment consisted of grassy roadsides with concrete sidewalks surrounded by natural growth. The stop sign for southbound traffic was located on northwest corner and was clear of any sight obstructions. Solid white stop lines were also painted at the mouth of the intersection on the north and southbound lanes. A succession of five sets of rumble strips, centered on 18 m (60') intervals, were located on the southbound travel lane leading to the intersection. The rumble strips were designed to alert southbound traffic of the approaching controlled intersection with the last strip positioned approximately 30 m (100') prior to the intersection. Additionally, a yellow warning sign advising southbound traffic of the approaching stop sign was positioned on the west shoulder 100 m (330') feet prior to the intersection. Both roadways were straight and level. The north/south roadway had a posted speed limit of 64 km/h (40 mph) while the east/west roadway had a speed limit of 72 km/h (45 mph). An SCI crash schematic compiled after an analysis of the PAR and on-scene images is included as **Figure 11** at the end of this narrative report.
