CALSPAN ON-SITE AMBULANCE CRASH INVESTIGATION

CALSPAN CASE NO: CA04-048

VEHICLE: 2001 FORD E-350

CRASH DATE: NOVEMBER 2004

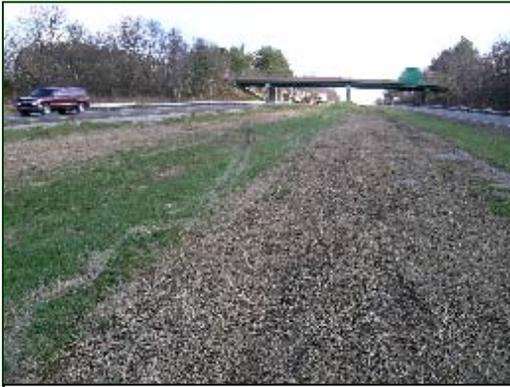
vehicles trajectory (**Figure 4**). Based on these tire marks, the ambulance traveled approximately 91.4 m (300.0') while traversing the 21.4 m (70.2') wide median.

Figure 4. Ambulance travel through the median.

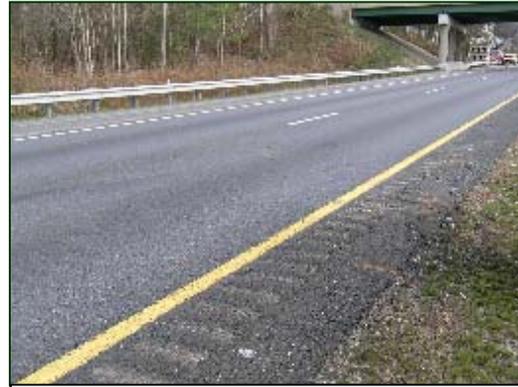
Figure 5. Area of impact between the Ambulance and tractor.

As the ambulance entered the westbound lane, it impacted the left side of the tractor-trailer unit (**Figure 5**). The initial impact involved the front left corner area of the ambulance against the left side area of the tractor unit. The ambulance engaged the leading edge of the sleeper berth and the aluminum sidesaddle diesel fuel tank of the tractor. As the vehicles crushed and continued on their forward trajectories, the front left area of the ambulance engaged the drive axles of the tractor. At this point of the crash phase, the plywood cargo on the trailer translated forward and engaged the cargo retention plate of the tractor and the front left corner area of the ambulance cab and patient compartment. Blue paint transfers from the edges of the plywood were present on the ambulance and the back aspect of the cargo retention plate and sleeper berth. The plywood cargo crushed the roof of the ambulance cab and engaged the left door and upper left B-pillar area of the ambulance. Due to the ambulance deformation, the plywood engaged the left upper B-pillar area of the ambulance and cut (shredded) the driver safety belt webbing at the location of the D-ring.

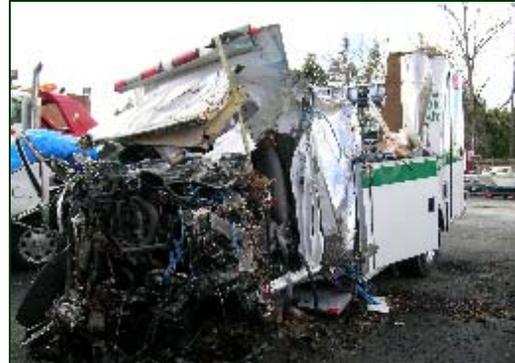
The ambulance sustained severe damage (**Figure 6**) from the impact with the tractor-trailer and its cargo. The initial contact involved the front left area of the chassis of the ambulance against the left side of the tractor's sleeper berth and the side saddle fuel (diesel) tank. The continued engagement against the drive axles of the tractor and subsequent CCW rotation of the ambulance resulted in separation of the front bumper, left front suspension, grille, radiator support, and the hood of the E-350 chassis. The only measurable frontal components that remained

Figure 6. Overall view of the damage to the ambulance.

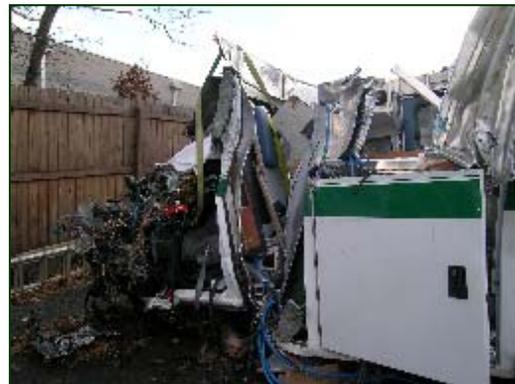
Figure 7. Damage to patient compartment area.

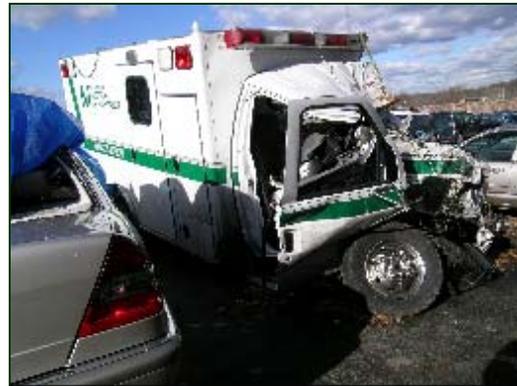
to document the extent of crush were the leading aspects of the frame rails. The left rail was displaced 82.0 cm (32.3”) rearward and the right rail was displaced 25.4 cm (10.0”) rearward. The subsequent engagement by the left rear trailer axles against the right front fender and tire/wheel of the ambulance resulted in lateral displacement of the fender and the entire frontal structure. The leading edge of the fender was displaced approximately 140.0 cm (55.0”) laterally to the left. Black tire transfers were prominent on the entire length of the right front fender with deformation of the steel wheel and exposed lug nuts (**Figure 8**).

Figure 8. Front right view of the ambulance.

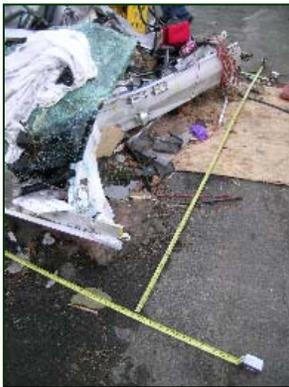
The plywood cargo impacted the left leading edge of the ambulance roof. The leading edge of the roof sustained an area of deformation (**Figure 9**) that was documented using the standard measurement protocol. Although the roof separated from the vehicle, the roof was found intact at the tow yard lying upside down filled with crash debris (**Figure 10**). A reference scale was established around the perimeter of the roof which yielded a maximum crush depth of 69.3 cm (27.3”) at the left leading edge. The overall width of the deformed roof panel was 203.2 cm (80.0”) and yielded a crush profile that was as follows: C1 = 35.6 cm (14.0”), C2 = 55.3 cm (21.8”), C3 = 60.9 cm (24.0”), C4 = 39.3 cm (15.5”), C5 = 25.4 cm (10.0”), C6 = 11.1 cm (4.4”).

Figure 9. Damage area to the roof.

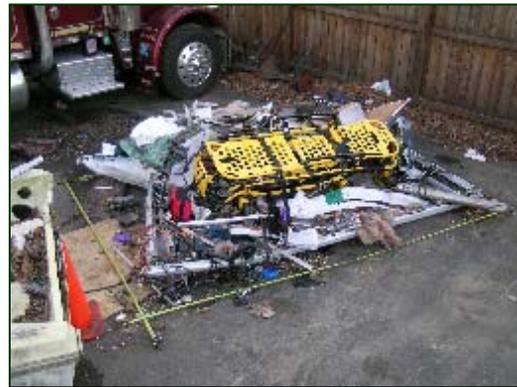
Figure 10. Overall view of the separated roof.

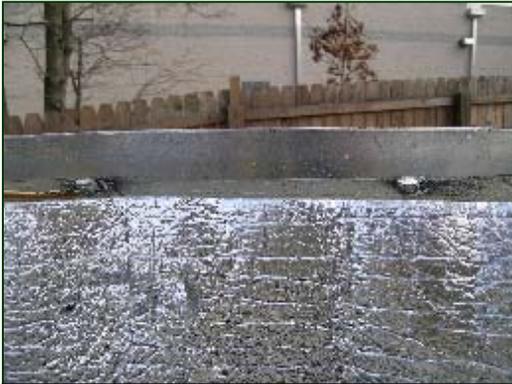
The roof consisted on a single panel that was formed to fit over the four walls of the patient compartment. The aluminum roof panel was welded to the aluminum sidewalls, the pillars, and vertical supports. All roof panel welds were located on the interior surface. At the forward (front) wall of the roof, ten welds were randomly spaced on 18-25 cm (7-10”) centers with each weld approximately 1.3 cm (0.5”) in length. All of these welds were fractured at the location of the joint (**Figure 11**).

Figure 11. Separated roof welds at the front wall.

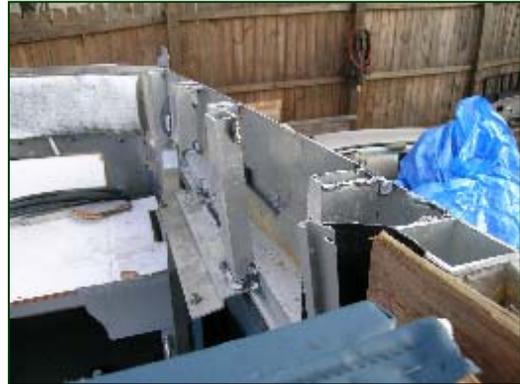
Figure 12. Separated right side roof welds.

The right side of the roof panel was welded to the sidewall with randomly spaced welds on 15-36 cm (6-14”) centers. Each weld was approximately 4-5 cm (1.5-2.0”) in length. All eight pillars, supports, and gussets for the roof were fabricated from 2.5x5.0 cm (1.0x2.0”) rectangular aluminum stock. All welds were fractured at the joint overlap (**Figure 12**).

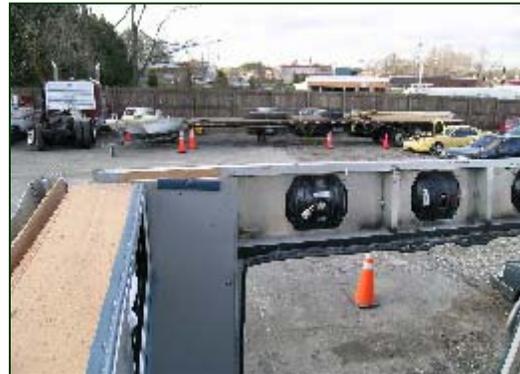
Figure 13. Fractured welds at the rear wall/roof juncture.

The rear wall and roof was welded with a series of five welds that ranged in length from 5.0-8.4 cm (2.0 to 3.3”). All welds fractured at the joint overlap (**Figure 13**).

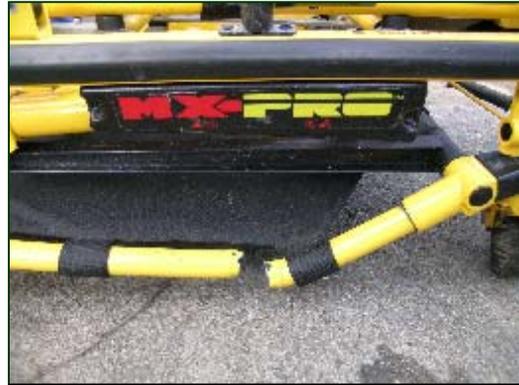
Figure 15. Fractured pin/tubing at the locking mechanism location.

At impact, the patient loaded the upright backrest of the cot. Her loading force and the force of the cot fractured the aft mounting pin of the antler bracket. In addition, the pin

on the cot and the tubular frame of the cot fractured, allowing the cot to translate forward. The investigating officer noted that the patient and the cot were wedged against the forward wall/partition of the patient compartment.

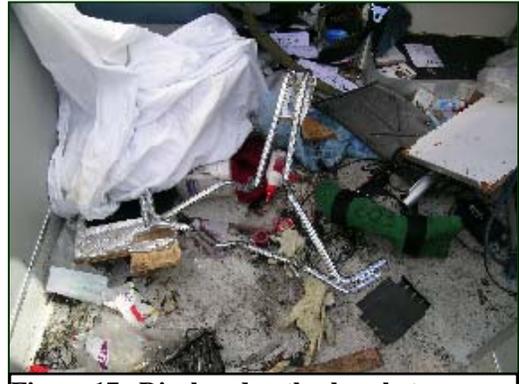
Figure 17. Displaced antler bracket.

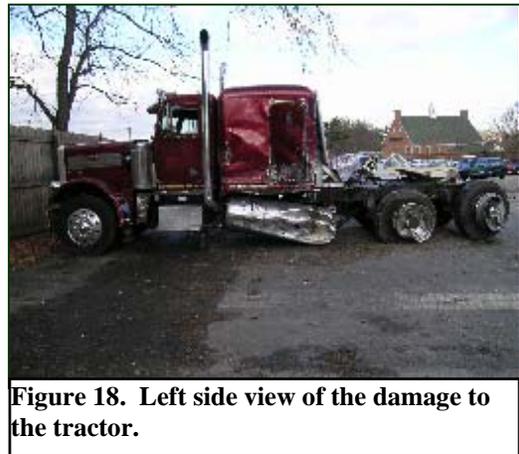
The Peterbilt tractor sustained severe damage as a result of the impact with the ambulance (Figure 18). The initial contact damage began at the forward left corner of the sleeper berth and extended onto the left side saddle fuel tank. The frontal structure of the ambulance penetrated the diesel fuel tank at two locations and crushed the aft aspect of the tank. Additionally, the rear tank strap was fractured. As the tractor continued forward, the ambulance engaged the left side of the sleeper berth and the drive axles of the tractor. The contact with the drive axles deformed the outboard alloy wheels to the center hubs and separated the tires from the wheels. The energy from this interaction fractured the six mounting bolts at the forward spring hanger for each axle. This resulted in rearward displacement of the left side axles. The outboard

Figure 18. Left side view of the damage to the tractor.

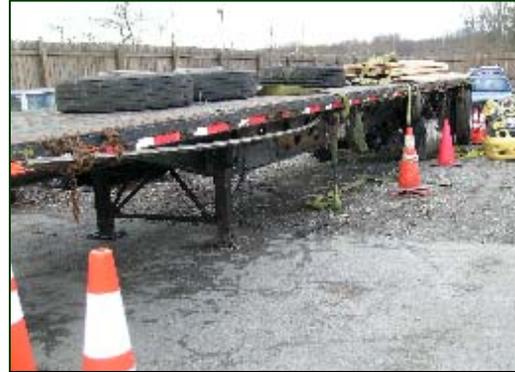
The ambulance engaged the left leading edge of the trailer as the tractor-trailer unit jackknifed in a counterclockwise direction. The left side of the trailer remained engaged against the ambulance as the ambulance rotated rapidly in a CCW direction. The ratcheting tie-down straps were deformed and several of the nylon straps were severed. The left side tires and wheels of the trailer impacted the right front fender and axle of the ambulance as the vehicles remained engaged. This interaction rotated the axles of the trailer in a CCW direction which contributed to the CCW jackknife of the unit. **Figure 19** is a left side view of the trailer damage. All of the plywood and lumber cargo on the trailer separated from the unit and was scattered onto the road surface.

Figure 19. Left side view of the trailer damage.

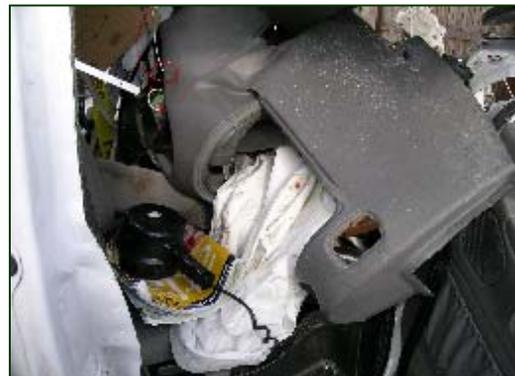
The 2001 Ford E-350 chassis was equipped with redesigned frontal air bags for the driver and front right passenger positions that deployed as a result of the frontal impact with the tractor-trailer. The driver's air bag was conventionally mounted within the steering wheel. Due to the severity of the crash and the gross intrusion of the driver's compartment, the deployed air bag was barely visible as the wheel rim was compressed against the driver's seat back. The front right passenger air bag was mounted within the mid instrument panel and was concealed by a single top-hinged cover flap (**Figure 21**). The flap separated from the instrument panel. Although there was no front right passenger and no driver involvement with the front right air bag, body fluid was present on the top surface of the bag.

Figure 21. Deployed front right passenger air bag.

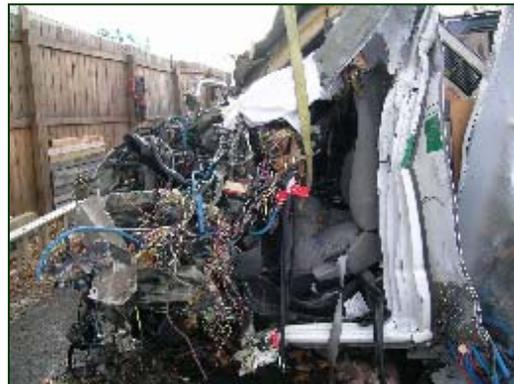
The driver was seated in a presumed mid track position based on her reported demographics. She was restrained by the manual 3-point lap and shoulder safety belt system. Due to the pre-crash travel of the ambulance, it was unknown if the driver was conscious or in an upright attitude at impact with the tractor-trailer. At impact, the redesigned frontal air bag system deployed. As the ambulance crushed and was engaged by the plywood cargo of the trailer, the left front door opened/separated from the E-350 chassis. The plywood cargo impacted the left B-pillar area at the location of the D-ring. The contact shredded the driver’s safety belt webbing. During this event, the steering column and the instrument panel intruded into the driver’s compartment (**Figure 22**). The driver loaded through the deployed air bag and was engaged by the intruding steering wheel rim which was deformed forward by driver loading. Additionally, the steering column shear

Figure 22. Crush/intrusion of the driver’s compartment.

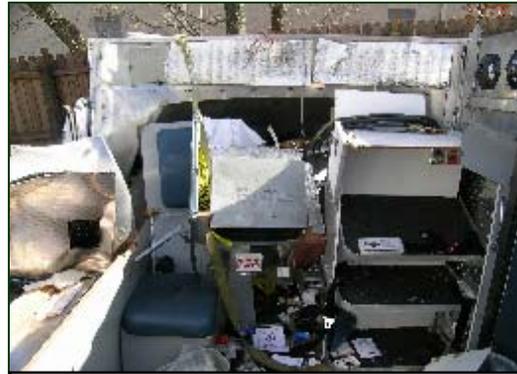
Figure 23. Position and damage surrounding the paramedics belted rear-facing position.

The heat/AC condenser that was mounted at the center of the forward wall at the roof dropped as a result of the roof separation. This component probably fell onto the paramedic, which resulted in the vertically oriented laceration of the posterior scalp, left ear laceration, and the left orbital floor fracture scalp. **Figure 23** is an overall view of the paramedic's position and contact points.
