**CALSPAN REMOTE ADULT AIR BAG RELATED FATALITY
INVESTIGATION**

NASS/SCI COMBO CASE NO: 2005-41-039B

VEHICLE: 1999 MITSUBISHI MIRAGE

CRASH DATE: MARCH 2005

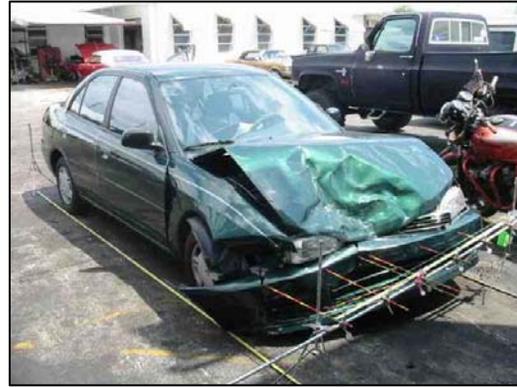
Figure 1 - Damaged 1999 Mitsubishi Mirage

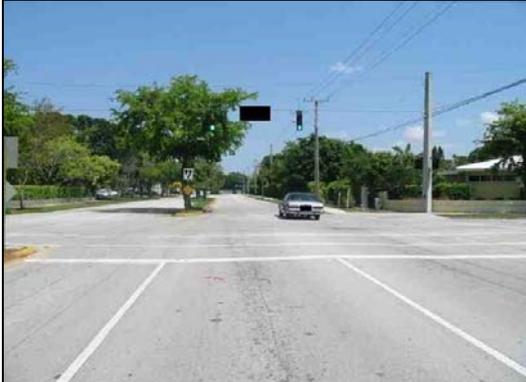
Figure 2 - Northbound view of the area of impact.

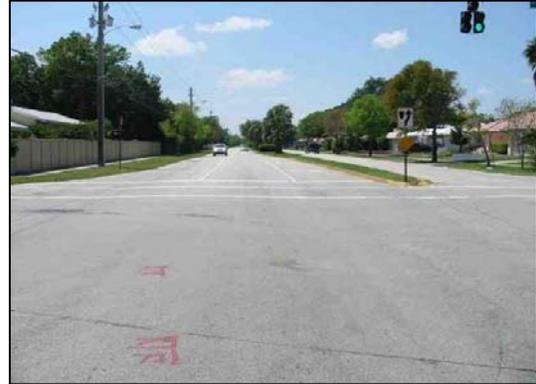
Figure 3 - Southbound view of the area of impact.

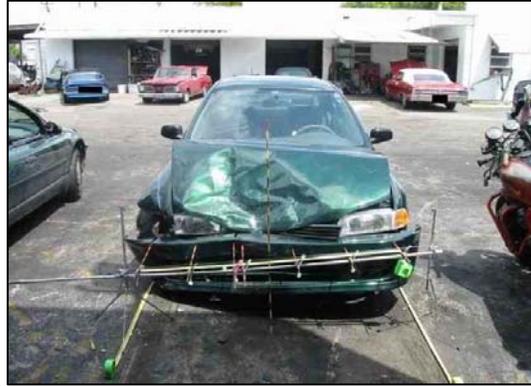
The 1999 Mitsubishi Mirage sustained moderate damage as the result of the front-to-rear impact with the Toyota Corolla (**Figure 4**). The NASS investigation revealed that the direct contact damage began at the front right bumper corner and extended 89 cm (35”) to the left. The direct and induced damage encompassed the entire front end and measured 142 cm (56”) in width. The hood buckled and was deflected rearward. The maximum crush was located at the front right bumper corner and was 30 cm (11.8”) in depth. The Collision Deformation Classification (CDC) for the impact with the Corolla was 12-FZEW-2. Six equidistant crush measurements

Figure 4 - Damaged 1999 Mitsubishi Mirage.

were documented along the front bumper and were as follows: C1 = 0 cm, C2 = 4 cm (1.6”), C3 = 13 cm (5.1”), C4 = 25 cm (9.8”), C5 = 25 cm (9.8”), C6 = 30 cm (11.8”).

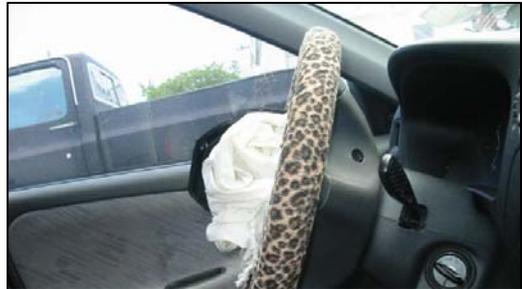
1999 Mitsubishi Mirage sustained minor interior damage as the result of the impact the Corolla. The knee bolster cover panel slightly separated from its base possibly from contact with the driver’s knees. No correlative knee injuries were diagnosed at the medical facility. There were no intrusions associated with this impact. Based on the available images, there was no bending of the steering wheel rim or any compression of the steering column (**Figure 5**).

Figure 5 - Lateral view of undamaged steering wheel rim.

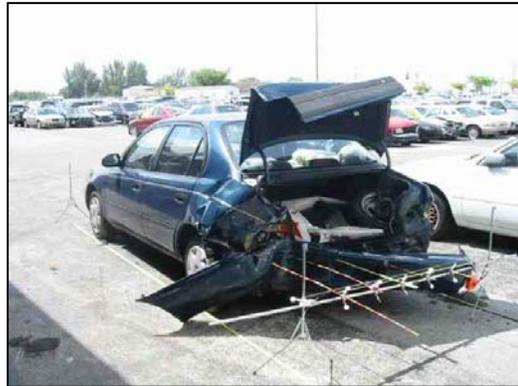
The 1993 Toyota Corolla sustained moderate severity rear damage from the impact with the 1999 Mitsubishi Mirage (**Figure 6**). The NASS vehicle inspection revealed that the direct contact damage began at the left rear bumper corner and extended 66 cm (26”) to the right. The combined direct and induced damage encompassed the entire rear plane and measured 115 cm (45.2”) in width. The bumper cover was deformed and shifted to the left while the left quarter panel was buckled outboard of the vehicle’s bodyline. The maximum crush was located 35 cm (13.8”) left of the vehicle’s centerline and measured 65 cm (25.6”) in depth.

Figure 6 - Damaged 1993 Toyota Corolla.

The CDC for the rear impact with the Mirage was 06-BYEW-4. Six equidistant crush measurements were documented along the rear bumper and were as follows: C1 = 0 cm, C2 = 0 cm, C3 = 17 cm (6.7”), C4 = 39 cm (15.4”), C5 = 65 cm (25.6”), C6 = 64 cm (25.2”).

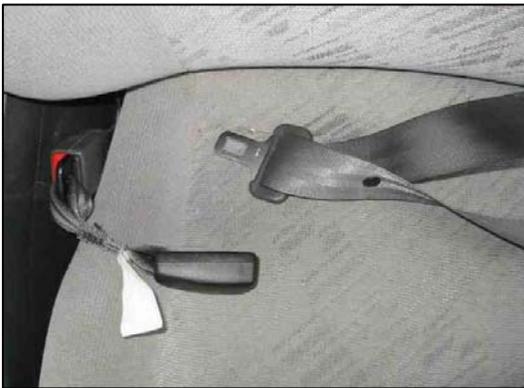
Figure 7 - Engaged safety belt extender.

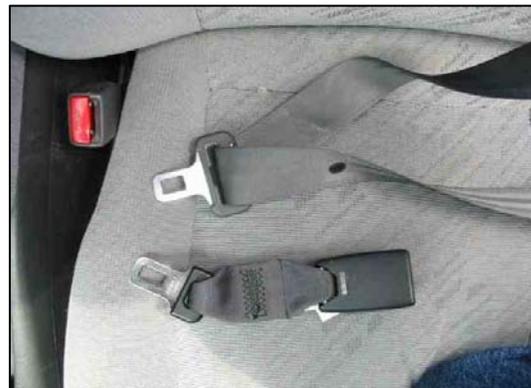
Figure 8 - Disengaged safety belt extender.

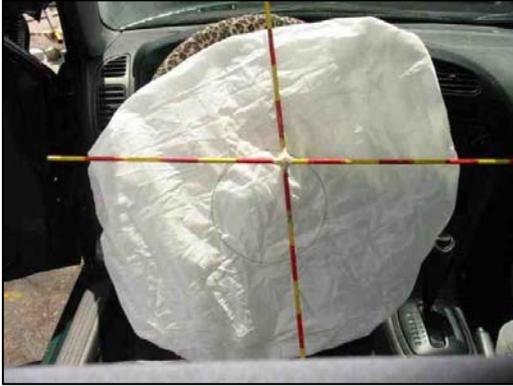
The 1999 Mitsubishi Mirage was equipped with redesigned frontal air bags for the driver and front right passenger seating positions. The driver’s air bag deployed (**Figure 9**) from a trapezoidal top-mounted single cover flap. The top aspect of the cover flap was 17 cm (6.7”) in width and the bottom aspect was 8 cm (3.1”). The cover flap was 12 cm (4.7”) in height. The deployed driver’s air bag was 70 cm (27.6”) in diameter in its deflated state. The air bag reportedly contained one tether strap the location of which was not recorded. The air bag was vented by two ports located in the 11 and 1 o’clock positions. The NASS inspection was unable to locate any discernable occupant contact on the air bag.

Figure 9 - Driver's air bag.

At impact, the frontal air bag system deployed. Due to the front-to-rear engagement between the vehicles, the frontal air bag system in the Mitsubishi could have deployed late in the crash sequence. The deploying driver's air bag contacted the driver in the chest which resulted in symmetrical bilateral rib fractures 2-6 with hemothorax. The driver responded to the frontal crash forces by initiating a forward trajectory and loading the manual safety belt system. Her loading force against the belt at the area of the latch plate resulted in a severe liver laceration. The autopsy report identified the liver laceration as 12-15 cm (4.7-5.9") in length and 3 cm (1.2") in depth.

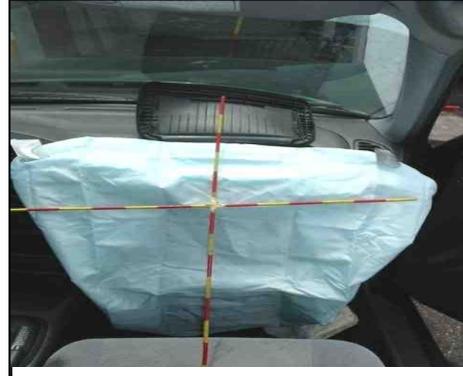
The front right air bag (**Figure 10**) deployed from a mid mount module cover flap that measured 32 cm (12.6”) in width and 18 cm (7.1”) in height. The cover flap was a single ply molded vinyl flap that was hinged at the top surface, which allowed the flap to open

in an upward direction. The deployed front right air bag measured 70 cm (27.6”) vertically and 80 cm (31.5”) horizontally. The air bag reportedly was not tethered and was vented by two ports located in the 3 o’clock and 9 o’clock positions.

Figure 10 - Front right passenger's air bag.
