### SCI/NASS COMBINATION 208-COMPLIANT VEHICLE INVESTIGATION

CASE NUMBER - NASS-2005-49-105C

LOCATION - Texas

VEHICLE - 2005 NISSAN ALTIMA

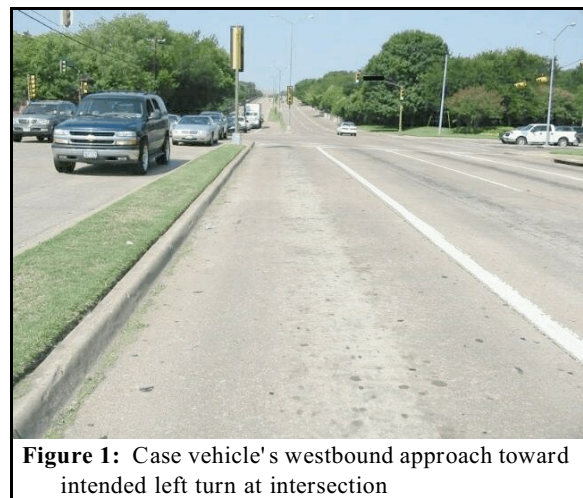
The case vehicle had been stopped, heading west in the westbound left turn lane of a four-lane roadway that was part of a divided trafficway (three through lanes plus a left turn lane in each direction, separated by a curbed, grass median), waiting to make a left turn to travel south (**Figure 1**). The Acura was traveling eastward in the center eastbound through lane of the same trafficway, approaching the same intersection, intending to continue eastward (**Figure 2**). The Buick was stopped, heading north, in the center northbound through lane of the intersecting divided trafficway. It was daylight, the weather was clear and the concrete road surface was dry and free of defects with a slight downhill grade for westbound traffic, and the speed limit was 64 km.p.h. [40 m.p.h.]. The case vehicle accelerated, attempting to make the intended left turn. Neither the case vehicle's driver nor the Acura's driver attempted any avoidance maneuvers prior to the crash. The crash occurred in the center through lane of the eastbound roadway, within the four-leg intersection of the two trafficways.

**Figure 1:** Case vehicle's westbound approach toward intended left turn at intersection

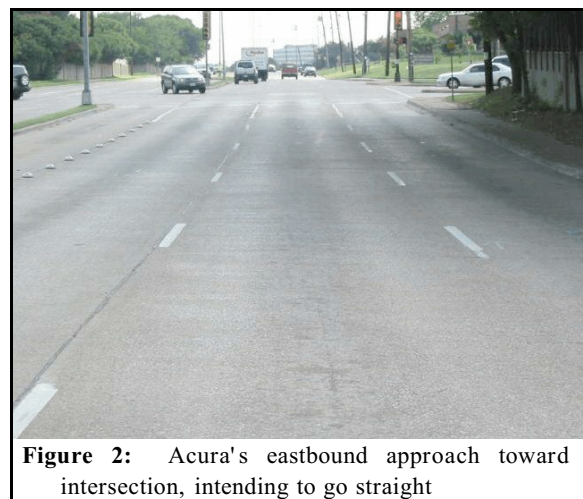
**Figure 2:** Acura's eastbound approach toward intersection, intending to go straight

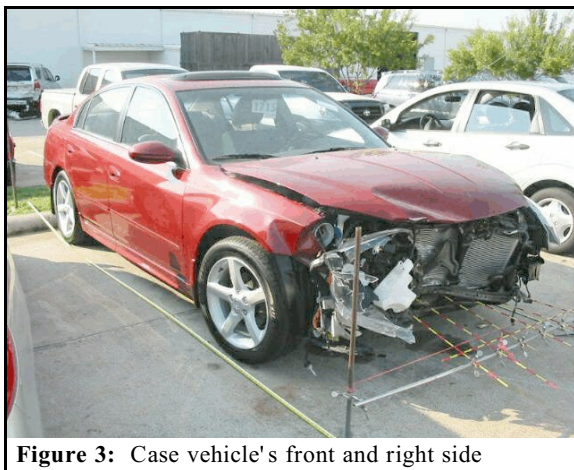
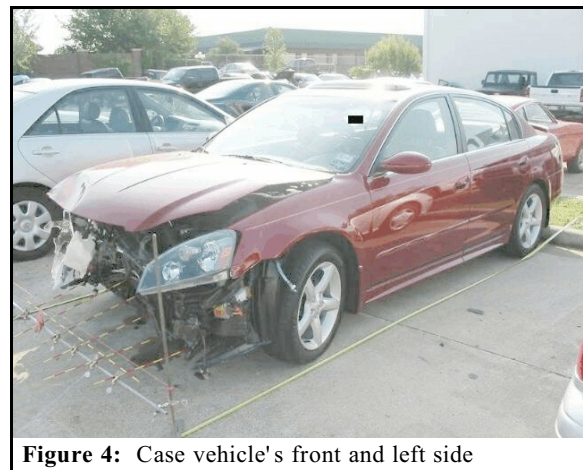
The case vehicle sustained direct contact damage that began slightly inboard of the right headlamp/turn signal assembly and continued across the front for 82 centimeters [32.3 inches] (Figures 3 - 5). The bumper cover was torn off, and the right headlamp/turn signal and the grille were shattered and broken away. The steel bumper was crushed rearward against the bottom of the radiator and the radiator was crushed rearward. The left headlamp/turn signal assembly was displaced but intact. The engine hood was dented on the right portion of the leading edge. The

leading edge of the right fender was crushed rearward and the left fender sustained induced damage. Both front tires were restricted by deformed body panels in the wheel wells, and the wheelbase was shortened by 2 centimeters [0.8 inches] on the right and 1 centimeter [0.4 inches] on the left. None of the tires was deflated. The windshield was cracked along the lower edge and there was no other glazing damage.

The crush measurements were taken along the steel bumper because the bumper cover was torn off. Maximum crush was documented as 32 centimeters [12.6 inches] at C5, slightly to the right of center. The CDC was determined to be **01-FZEW-2 (30 degrees)**. The WinSMASH reconstruction program, damage-only algorithm based on the measured crush profiles of the case vehicle and the Acura, was used on the case vehicle's single impact. The total, longitudinal and lateral delta-Vs for the case vehicle are, respectively: 22 km.p.h. [13.7 m.p.h.], -19 km.p.h. [-11.8 m.p.h.] and -11 km.p.h. [-6.8 m.p.h.]. This is a borderline reconstruction because the Acura sustained two impacts with some overlapping damage, but the results appear reasonable. This was a crash of low severity (14-23 km.p.h. [9-14 m.p.h.]) for the case vehicle.

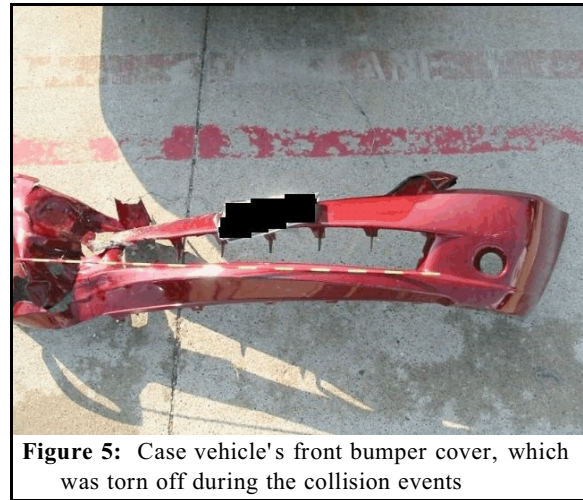
Figure 5: Case vehicle's front bumper cover, which was torn off during the collision events

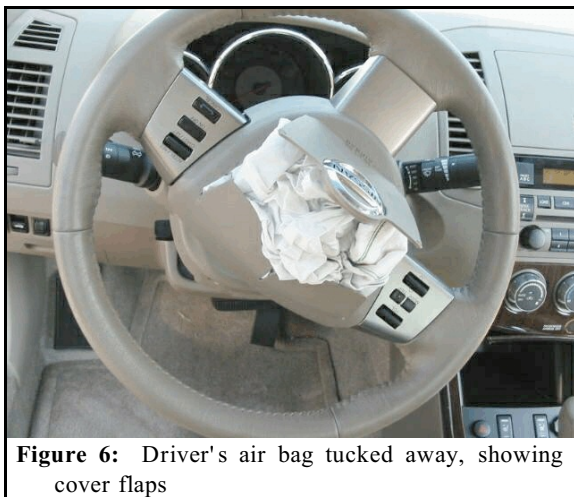
Figure 6: Driver's air bag tucked away, showing cover flaps

The driver's air bag was mounted in the steering wheel hub with the cover flaps in the H-configuration (**Figure 6**). The flaps measured 13 centimeters [5.1 inches] laterally, with the upper and lower flaps, respectively, 4 centimeters [1.6 inches] and 6 centimeters [2.4 inches] vertically. The cover flaps opened at the designated tear points and there was no evidence of damage to the cover flaps or the adjacent structures. The driver's air bag was round with a diameter of 62 centimeters [24.4 inches] (**Figure 7**). There were routine deployment smudges on the front of the air bag fabric, with no evidence of occupant contact or damage to the air bag.

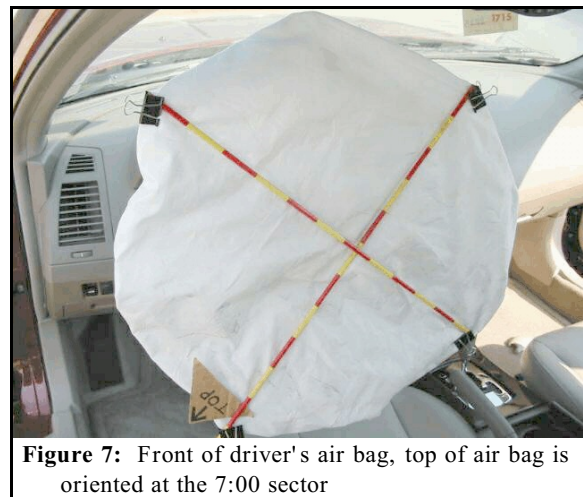
Figure 7: Front of driver's air bag, top of air bag is oriented at the 7:00 sector

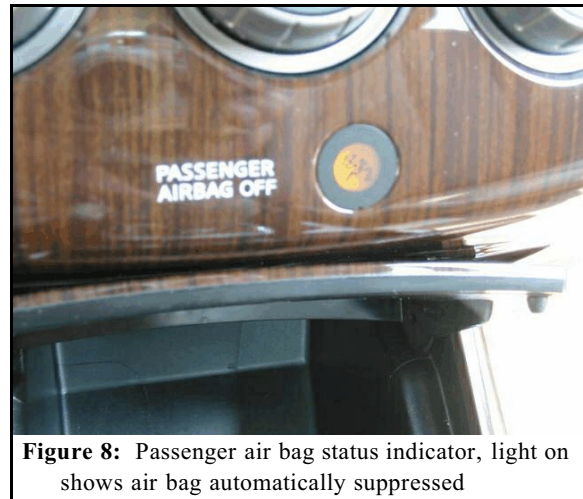
The front right passenger's air bag was mounted in the top of the instrument panel on the right and did not deploy because the seat weight sensor correctly detected that there was no occupant in the front right seat. The case vehicle was equipped with an indicator light in the center instrument cluster (**Figure 8**) that displayed the front right air bag's automatically-determined status.

**Figure 8:** Passenger air bag status indicator, light on shows air bag automatically suppressed

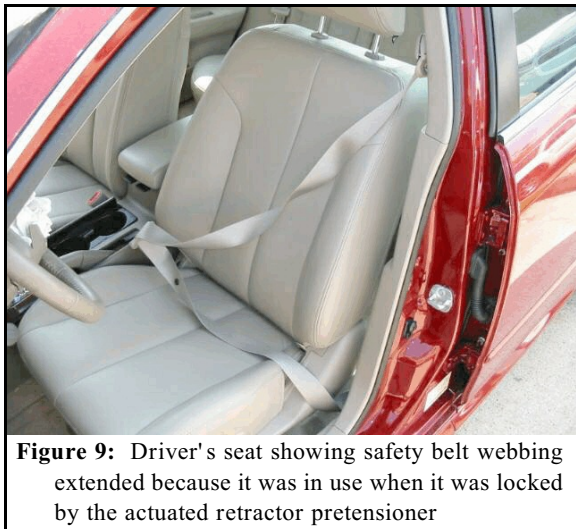
The case vehicle was equipped with retractor-type safety belt pretensioners for the two front seats that actuated for both seats. The driver's safety belt, which was in use at the time of the crash, was locked with the webbing extended (**Figure 9**). There was no passenger in the front right seat position and the safety belt webbing was pulled taut against the right B-pillar (**Figure 10**).

**Figure 9:** Driver's seat showing safety belt webbing extended because it was in use when it was locked by the actuated retractor pretensioner

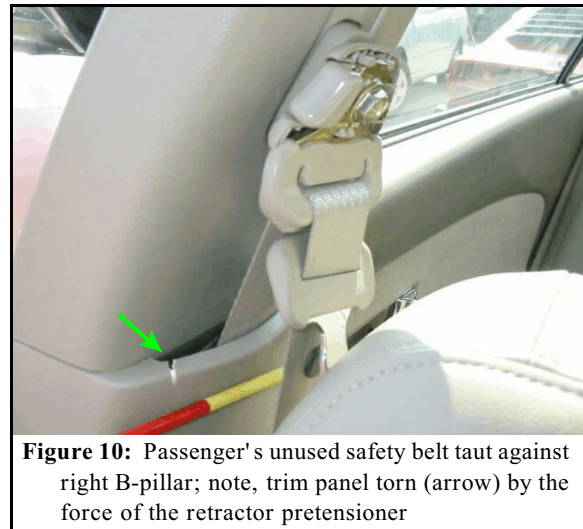
**Figure 10:** Passenger's unused safety belt taut against right B-pillar; note, trim panel torn (arrow) by the force of the retractor pretensioner

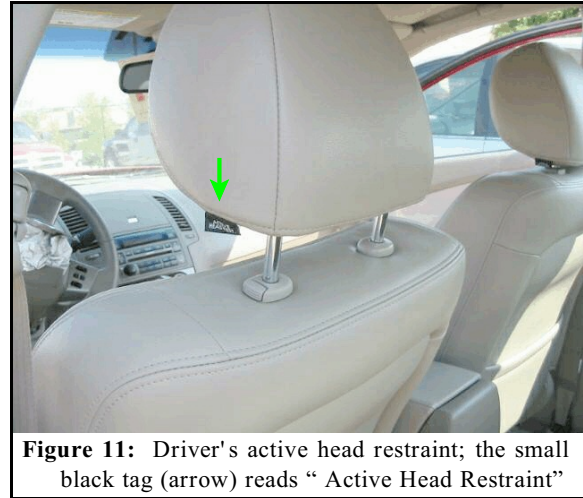
The driver's active head restraint (**Figure 11**) did not show any evidence of its action because the system is entirely mechanical. The padded head restraint is connected to a pressure plate in the backrest of the seat. The system uses the force of the occupant's body against the seat back to move the head restraint forward, and when this force is relaxed the system returns. There was probably some slight movement of the driver's active head restraint when the driver rebounded into his seat as the case vehicle rotated counterclockwise to final rest.

**Figure 11:** Driver's active head restraint; the small black tag (arrow) reads "Active Head Restraint"

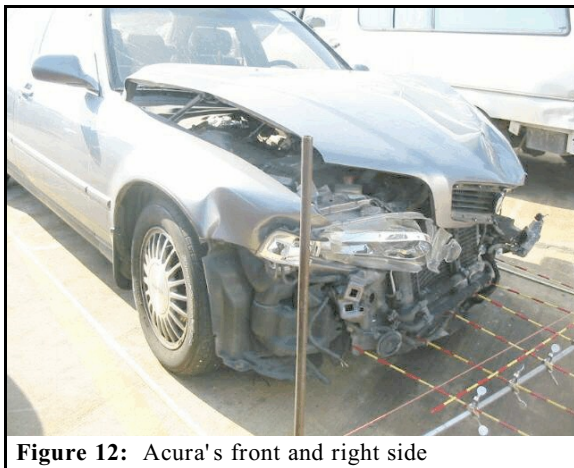
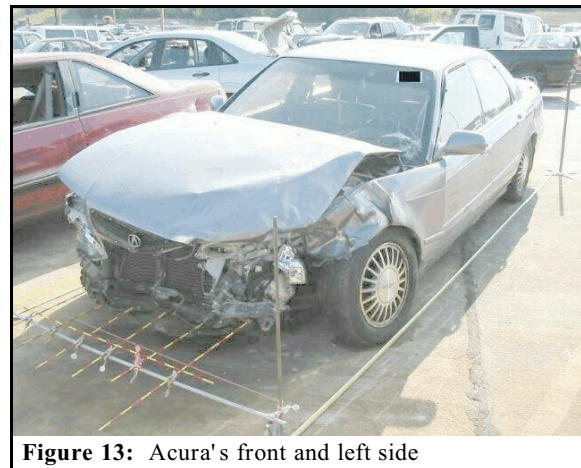
**Figure 12:** Acura's front and right side

**Figure 13:** Acura's front and left side

The Acura sustained direct contact damage across its entire front (**Figures 12 and 13**), with the heaviest damage at the front left corner. The left fender was crushed inward with substantial induced damage extending to the left A-pillar, the left side of the engine hood was crushed inward and bent downward, the left headlamp/turn signal assembly and grille were shattered and broken away, and the bumper cover was torn off. The steel bumper was crushed rearward against the bottom of the radiator and the radiator was crushed rearward against the engine. The right headlamp/turn signal assembly was shattered but did not break away and the leading edge of the right fender was crushed rearward. The wheelbase was shortened by 12 centimeters [4.7 inches] on the left and was unchanged on the right. The left front wheel/tire assembly was displaced rearward and was restricted against the trailing edge of the left wheel well. The right front wheel was restricted by deformed body panels in the right wheel well. The hood shifted rearward and impacted the windshield, causing extensive cracking, and there was no other glazing damage.

Because the bumper cover was torn off, the crush profile was measured along the steel bumper. Maximum crush was measured as 19 centimeters [7.5 inches] at the front left corner.

The CDC for the Acura's first impact, with the case vehicle, was determined to be **11-FYEW-1 (340 degrees)**. The WinSMASH reconstruction program, damage-only algorithm based on the measured crush profiles of the Acura and the case vehicle, was used on the Acura's most severe (first) impact. The total, longitudinal and lateral delta-Vs for the Acura are, respectively: 20 km.p.h. [12.4 m.p.h.], -19 km.p.h. [-11.8 m.p.h.] and + 7 km.p.h. [+ 4.3 m.p.h.]. This is a borderline reconstruction because the Acura sustained two impacts with some overlapping damage, but the results appear reasonable. This first impact was of low severity (14-23 km.p.h. [9-14 m.p.h.]) for the Acura.
