Child Safety Seat Investigation / Vehicle to Vehicle
Dynamic Science, Inc. / Case Number: DS05003
1991 Toyota Corolla
California
February, 2005

1. Report No. DS05003	2. Government Accession No.		3. Recipient Catalog No.	
4. Title and Subtitle Child Safety Seat Investigation		5. Report Date April 19, 2006

**Dynamic Science, Inc.
Accident Investigation
Case Number: DS05003**

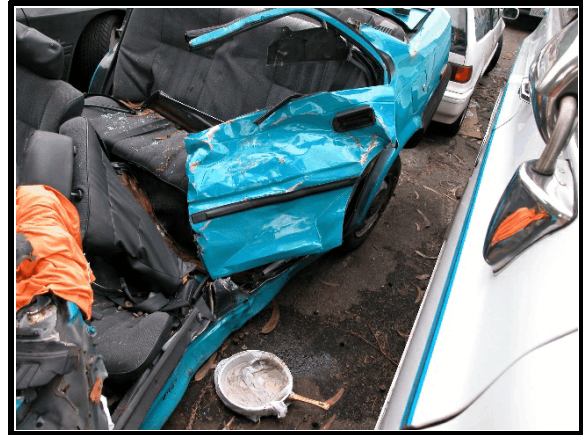
Figure 1. Left side damage to 1991 Toyota Corolla

The Toyota Corolla lost control on an interstate highway, departed the roadway, and struck a tree with its left side (see Figure 1). The driver of the Corolla sustained a blunt force injury to her head and was fatally injured. The front right occupant sustained head trauma, a pulmonary contusion, rib fractures, and a splenic laceration. She was transported by ambulance to a local trauma center for treatment and admitted. The second row left seat occupant sustained lacerations to the left leg and left side of the head, and a fractured right femur. He was transported by ambulance to a local trauma center and admitted for treatment. The second row middle occupant sustained a left femur fracture, a neck fracture, a liver laceration and multiple lacerations and abrasions. She was transported by ambulance to a local trauma center for treatment and was hospitalized. The second row right side occupant sustained femur and facial fractures. She was transported by ambulance to a local trauma center for treatment and was hospitalized.

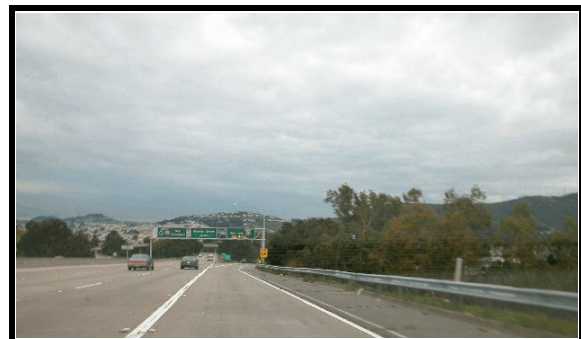
This single vehicle, off-road crash occurred in February, 2005 at 0750 hours. The crash occurred near an interstate interchange between a northbound interstate highway and connector ramp to a second interstate highway (see Figure 2). The northbound approach to the interchange is comprised of three northbound travel lanes and a right hand exit lane. The northbound lanes are separated from the southbound lanes by a concrete

Figure 2. Approach to area of road departure (North)

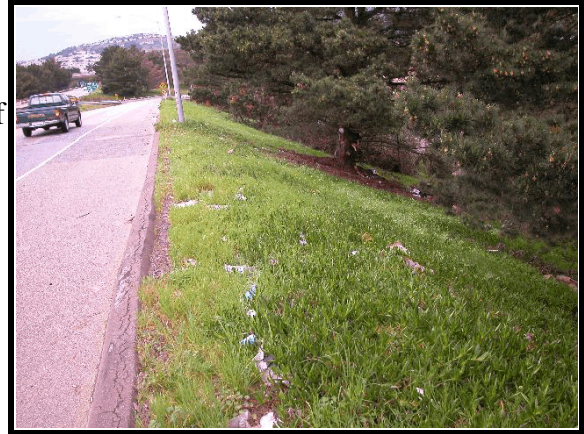
Figure 3. Area of road departure (North)

The Toyota Corolla was traveling northbound. It appears that the driver of the Corolla was initially intending to continue straight north, but at the last moment decided to use the connector ramp. The driver lost control and the vehicle began a clockwise rotation. The Corolla left the initial lanes of travel and entered the connector ramp. The vehicle crossed the connector ramp and departed the roadway to the right (see Figure 3). The vehicle continued its left side leading rotation and it began to travel down the embankment.

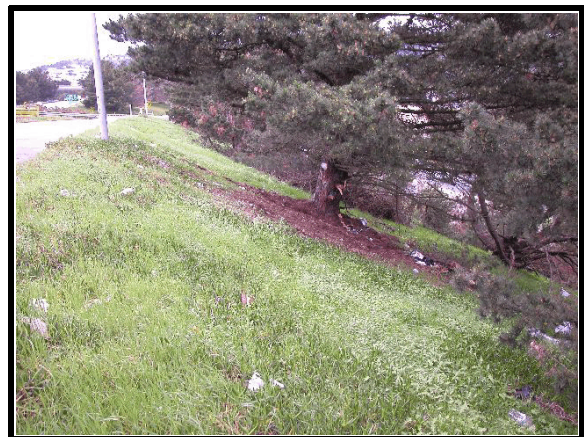
The Corolla was at a 40-45 degree roll angle and approximately 80 degree yaw angle when it struck the tree with its left side (see Figure 4). The barrier routine of the WinSmash program computed a total delta V of 28.0 km/h (17.4 mph) based on the Corolla's left side crush profile. The longitudinal and lateral components were -4.9 km/h (-3.0 mph) and 27.6 km/h (17.1 mph), respectively. The Corolla came to rest on the embankment while still in contact with the tree.

Figure 4. Impact with pine tree

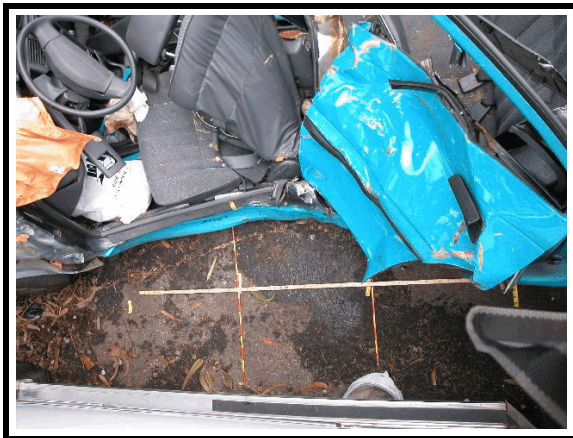
The 1991 Toyota Corolla sustained major left side damage as a result of the impact with the tree. The direct damage began 15.0 cm (5.9 in) forward of the left rear axle and extended 271.0 cm (106.7 in) forward along the left side plane and terminated at the front left bumper corner. The maximum lateral crush at the sill level was 30.0 cm (11.8 in) and was located between C2 and C3. Both left side doors were jammed shut. The roll angle at impact was 40-45 degrees. Because of the impact angle and the vehicle roll post impact, the direct damage to the front left door extended upward and included approximately 2/3 of the roof (see Figure 5). There was 46.0 cm (18.1 in) of longitudinal direct contact to the roof that began 36.0 cm (14.2 in) forward of the backlight. It measured 56.0 cm (22.0 in) from the left side rail measured laterally. The left wheelbase was shortened by 17.0 cm (6.7 in). Six crush measurements were documented at the sill level as follows: C1=0 cm (0 in), C2=25.0 cm (9.8 in), C3=28.0 cm (11.0 in), C4=0 cm (0 in), C5=0 cm (0 in), C6=0 cm (0 in).

Figure 6. Left side crush, overhead view

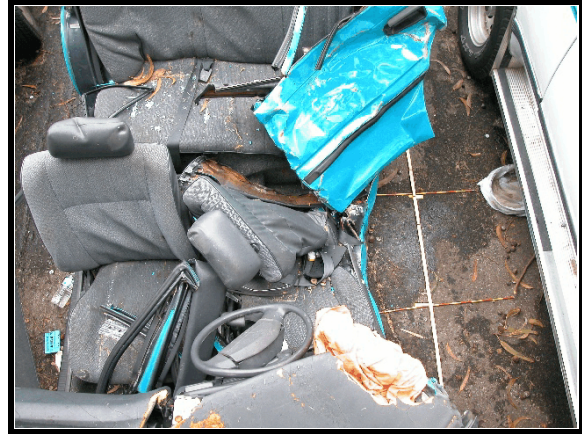
The 1991 Toyota Corolla sustained major interior damage primarily as a result of passenger compartment intrusion. The left side doors, left B pillar, and left roof components sustained lateral intrusion. As a result of the lateral intrusion, the front left seat back intruded into the seating space and was pushed nearly into the front right seating area and the left rear seat bottom was compressed laterally.

Figure 8. Overview of left side intrusion damage

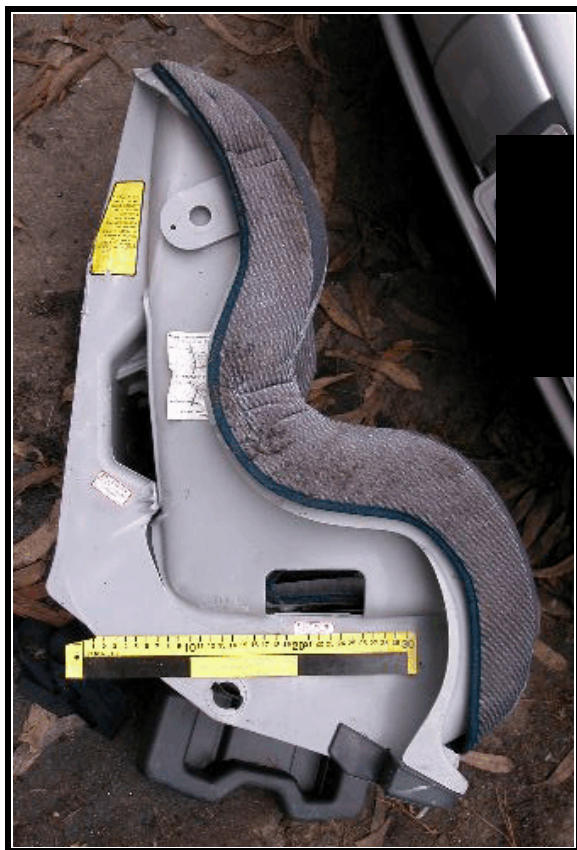
Figure 10. Right side, Evenflo child safety seat

The Evenflo Horizon seat sustained considerable damage during the crash. The tray shield had been broken off at the seat back attachment points. There was a longitudinal fracture that begins at the front left and extends 15.5 cm (6.1 in) rearward into the rear facing belt path guide. The left side of the seat back had moved laterally to the right 3.0 cm (1.2 in). There were blood and hair transfers to the outer edge of the left portion of the tray shield. There was a fracture that ran from the forward facing belt path guide to the rear facing belt path guide. This was in an “L” configuration and measured 12.0 cm (4.7 in) vertically and 13.0 cm (5.1 in) laterally. There was a 14.0 cm (5.5 in) angled fracture in the seat bottom. The reclining base had been crushed

laterally and had broken away from its connection points. There was blood on both the top and bottom of the shield. There was also blood and hair transfers found on the outside portion of the left seat back. The crotch strap had been cut by emergency personnel 12.0 cm (4.7 in) from the attachment point.

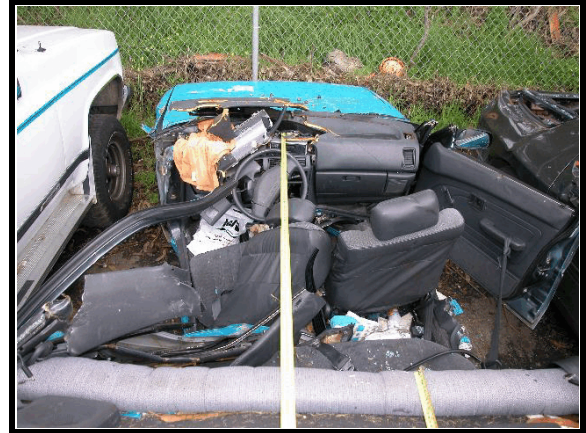
Figure 13. Overview of vehicle interior showing lateral intrusion

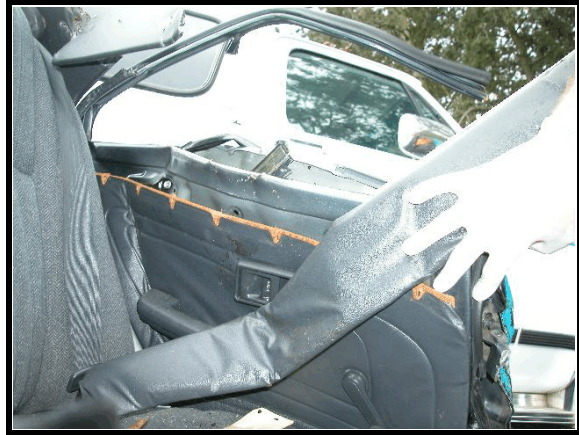
Figure 14. Interior view of left rear door

The 7-year-old male second row left occupant was likely seated in a forward facing fashion on the fabric covered bench seat. The non-adjustable seat back had a 72 degree angle and the seat bottom had a 7 degree angle. He was wearing the available lap and shoulder belt. The seat belt was equipped with an emergency locking retractor and a sliding latch plate. Prior to impact, the vehicle was in a clockwise rotation. This motion likely brought this occupant closer to the left side of the vehicle. As the vehicle left the roadway and proceeded down the embankment, the vehicle was pitching downward and leaning to the left. At impact, this occupant initiated a sharp trajectory to the left in response to the 280 degree direction of force and engaged the rear door panel as it intruded into the passenger compartment. He sustained a left leg laceration from contact with the door. As the intrusion continued he was pushed laterally into the middle occupant seat position and engaged the child seat with his torso, hip, and thigh. He sustained right femur fracture as he engaged the child seat. He was removed from the vehicle by rescue personnel and transported to a local trauma center for treatment and admission.

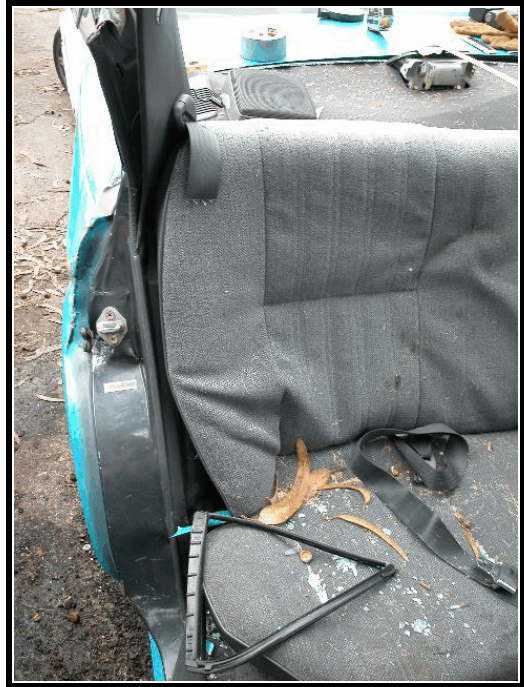
Figure 15. Second row right seat position

The 11-year-old female second row right occupant was likely seated in a forward facing fashion on the fabric covered bench seat. The non-adjustable seat back had a 72 degree angle and the seat bottom had a 7 degree angle. She was wearing the available lap and shoulder belt. The seat belt was equipped with an emergency locking retractor and a sliding latch plate. Prior to impact, the vehicle was in a clockwise rotation. This motion likely brought this occupant closer to the installed child safety seat. As the vehicle left the roadway and proceeded down the embankment, the vehicle was pitching downward and leaning to the left. At impact, this occupant initiated a sharp trajectory to the left in response to the 280 degree direction of force and engaged the child seat with the left part of her face—causing the left orbit fracture and eyelid laceration. As the intrusion continued she was pushed laterally into the right rear door—causing a right femur fracture. She was removed from the vehicle by rescue personnel (seat belt was cut off of her) and transported to a local trauma center where she was admitted.
