ON-SITE CHILD SAFETY SEAT INVESTIGATION

CASE NUMBER - IN-05-003

VEHICLE - 1999 HYUNDAI ELANTRA GL

CRASH DATE - December 2004

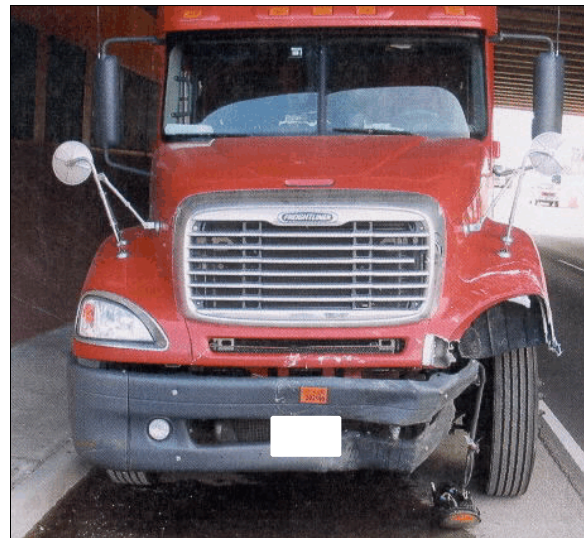
Based on the police on-scene photographs of the damage to the Freightliner, the TDC was estimated to be: **12-FYEW-2**. The Freightliner was towed due to damage.

Figure 3: Overview of damage to front of Freightliner from impact with back of case vehicle

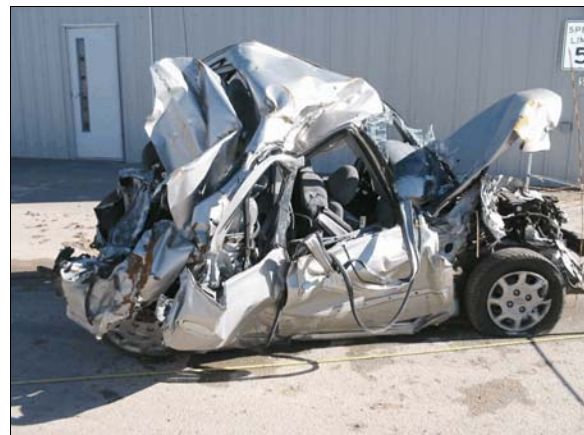
Crash: The front of the Freightliner (**Figure 3**) impacted the back of the case vehicle (**Figure 4**). The Freightliner stayed in contact with the case vehicle and pushed it into the back of the GMC. The front right of the case vehicle (**Figure 5** below) impacted and underrode the back left of the GMC (**Figure 6** below). The Freightliner impact to the back of the case vehicle caused the case vehicle to rapidly rotate counterclockwise as it underrode the GMC, and case vehicle's right front side impacted the GMC's back right corner (**Figure 7** below). This impact crushed the case vehicle's cowl and lower right A-pillar inward and damaged the front portion of the right front door

Figure 4: Right side overview of damage to back and front of the case vehicle

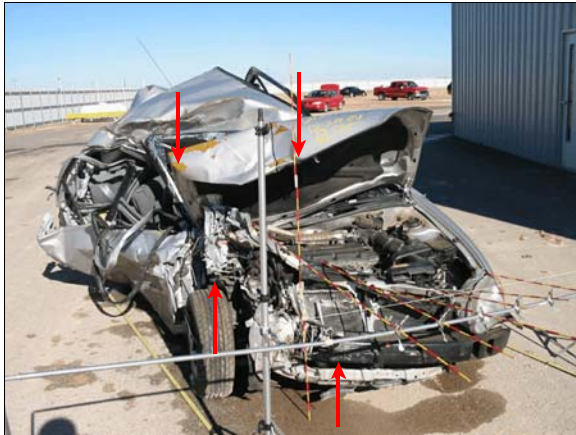
Figure 5: Direct damage to front right of case vehicle (arrows) due to impact with the back left of the GMC, each stripe on rods is 5 cm (2 in)

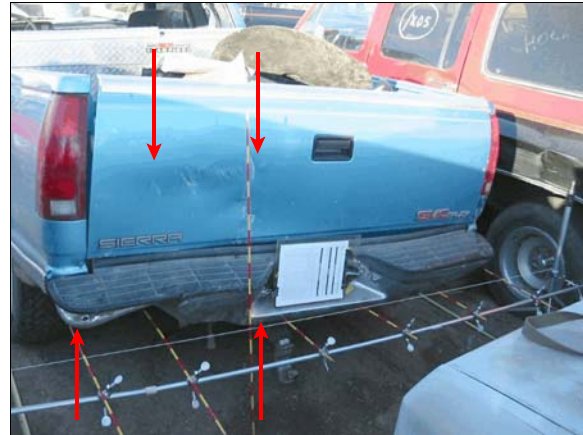
Figure 6: Direct damage to back left of GMC (arrows) due to impact with front right of case vehicle

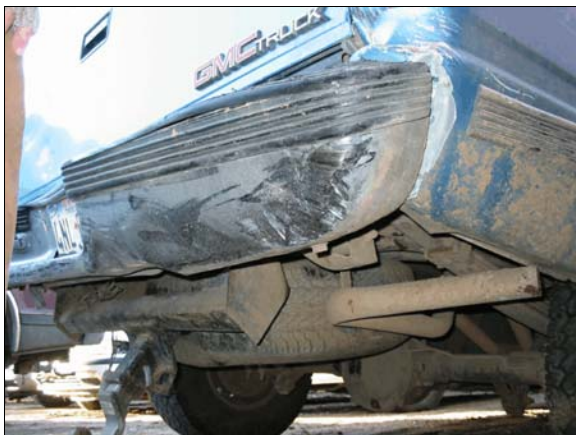
Figure 7: Damage to GMC back right corner due to impact with case vehicle's right front side

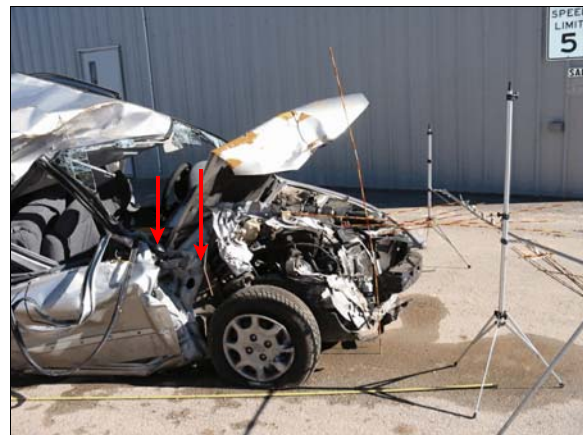
(Figure 8). The front impact to the case vehicle did not cause the driver's air bag to deploy. It is not known why the air bag did not deploy.

Figure 8: Damage to case vehicle's right front side (arrows) due to impact with back right of GMC

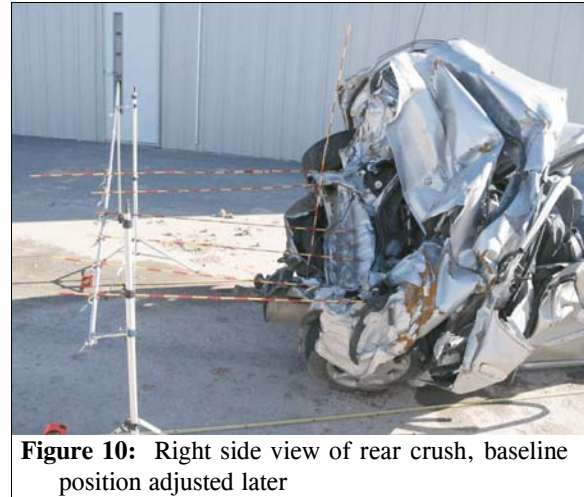
Figure 10: Right side view of rear crush, baseline position adjusted later

Exterior Damage: The case vehicle’s initial contact with the Freightliner involved the entire rear plane. Direct damage was distributed across the entire horizontal and vertical dimensions of the back of the case vehicle, and the back end was extensively crushed forward (**Figure 10**). Direct

damage began at the back left corner of the case vehicle and extended 109 centimeters (43 inches) across the damaged back plane of the vehicle. The back bumper had been knocked off the case vehicle and was not available at the inspection, so crush measurements were taken on the body panel immediately behind the back bumper mounting brackets. Adjustments were subsequently made for baseline placement, and to account for the missing bumper based on measurements of an exemplar vehicle. The residual maximum crush was determined to be approximately 120 centimeters (47 inches) occurring at C₁ (**Figure 10**). The table below shows the case vehicles back plane crush profile.

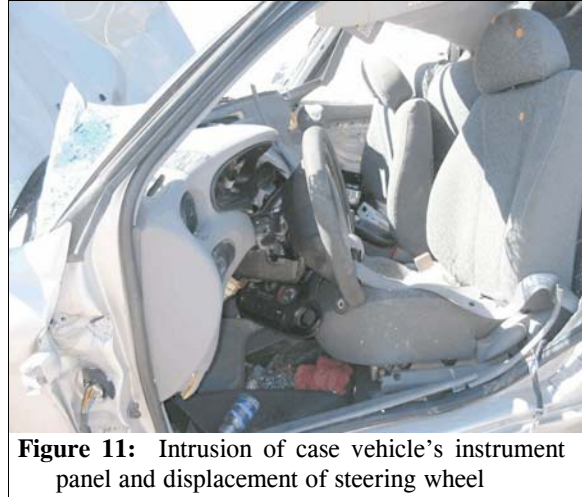
Vehicle Interior: Inspection of the case vehicle’s interior revealed probable occupant contact to the knee bolster and steering wheel. The driver’s right knee bolster had intruded and reduced nearly all the space available to the driver’s right leg. The steering column had moved downward during the crash and was resting on the driver’s seat cushion, indicating it probably contacted one

or both of the driver's thighs (**Figure 11**). The steering wheel rim had been cut by rescue personnel. Blood stains were noted on driver's seat back and head restraint. This was most likely related to the laceration the driver sustained to left side of her head. The driver's shoulder belt had been cut by rescue personnel, indicating the driver was wearing her safety belt at the time of the crash. No other occupant contacts were noted.

Figure 11: Intrusion of case vehicle's instrument panel and displacement of steering wheel

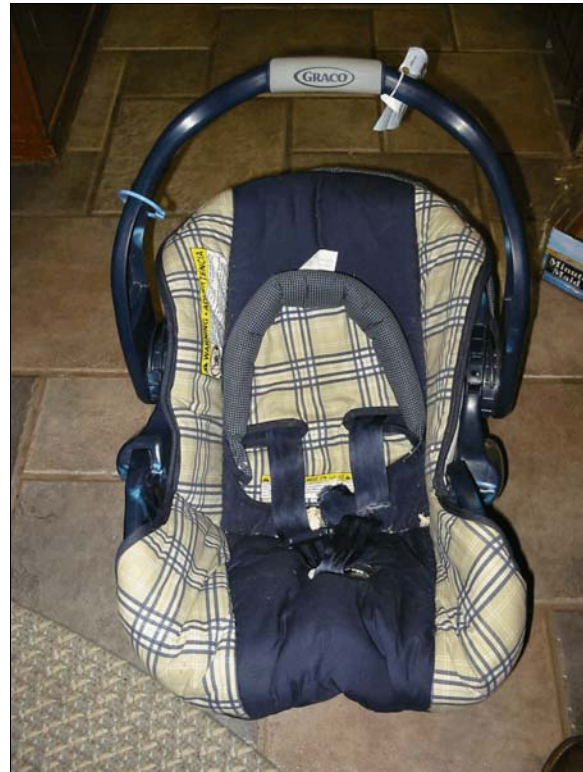
The back center passenger was seated in an infant seat (**Figure 12**) that was being used without the base in a rear-facing configuration. The infant seat was manufactured by Graco Children's Products on November 8, 2003 and was identified by model name "Snug Ride," model number 7320UVB, and serial number JJ1108030835. The infant seat was purchased new in August, 2004 and was used on a daily basis. The infant seat consisted of a one piece plastic shell with light, closed-cell foam padding at the head and shoulder area and a padded pullover cloth cover. It was designed with a three-point harness with a recessed latch plate fixed to the base of the infant seat. The harness buckle was attached to the end of the two shoulder straps, and the harness retainer clip was positioned approximately at the infant's armpit level. A carrying handle was attached to both sides of the infant seat. There were two sets of harness adjustment slots in the seat back. The harness straps were threaded through the bottom slots.

Figure 12: Overview of front of infant seat

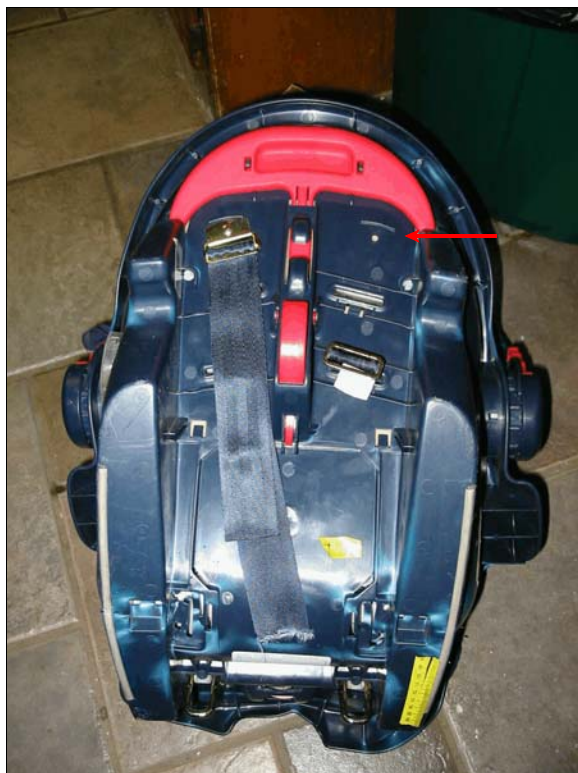
Inspection of the infant seat revealed numerous stress marks in the plastic shell indicating the infant seat had been bent during the crash as a result of the intrusion of the case vehicle's rear seat back. The plastic shell of the infant seat was dark blue. The areas of stress where the infant seat had bent and deformed exhibited a light blue color in the plastic. These stressed areas were observed on the bottom, and inside bottom portion of the infant seat running the entire width of the seat (**Figures 13** and **14** below), and radiating on to each side. Both sides of the seat exhibited stress mark discoloration and deformation with the left side of the seat being deformed the most. More vertical stress marks were observed on both edges of the infant seat back, above the head

area, and there was an abrasion on the right outer edge. In addition, the case vehicle’s lap belt had left a load abrasion on the left side of the infant seat. The stress and deformation pattern on the infant seat, as well as a photograph of the infant seat still in the case vehicle (**Figure 15**) showed that the infant seat had deformed in a “jackknife” type configuration during the crash. This was due to the intrusion of the case vehicle’s rear seat back, which bent the bottom of the infant seat upward as the infant seat was entrapped between the case vehicle’s intruding rear seat back and the front seat backs and center console. The bending produced a crack in the bottom left side of the infant seat. In addition, the right harness strap anchor was missing (**Figure 13**); however, it did not appear to have been pulled out of the back of the seat. It was not with the seat during the inspection. The left harness strap was separated (**Figure 13** and **Figure 16** below). It did not exhibit a clean cut like the driver’s safety belt. It had ragged strands of webbing fibers on each side of the webbing on one end, which is consistent with a broken belt. The other end appeared stretched; however, it also appeared to have been cut. The separation was determined not to be the result of deformation to the seat. In addition, there were no injuries to the infant indicating heavy loading of the harness strap. The separation is assumed to be the result of rescue personnel cutting and pulling on the harness strap.

Figure 13: Back of infant seat showing stress marks on bottom of seat, harness strap and missing harness anchor (arrow)

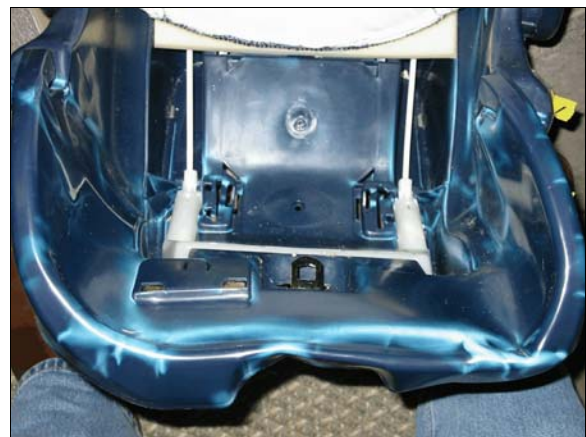
Figure 14: Deformation to bottom section of the infant seat

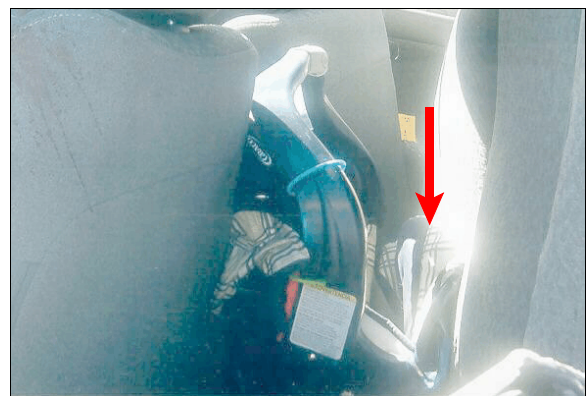
Figure 15: Family photograph of infant seat in back seat of case vehicle jammed between intruded rear seat back and front seat backs, arrow shows bent bottom portion of seat, photo from left side of car

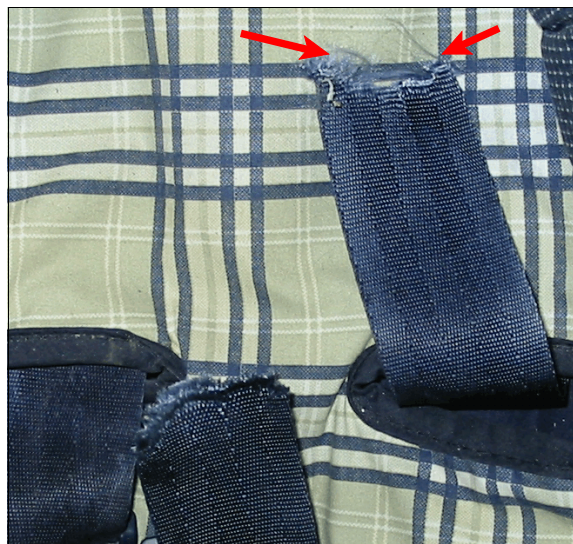
Figure 16: Separated ends of the infant seat’s left harness strap, arrow shows ragged strands of webbing fibers on edges of strap

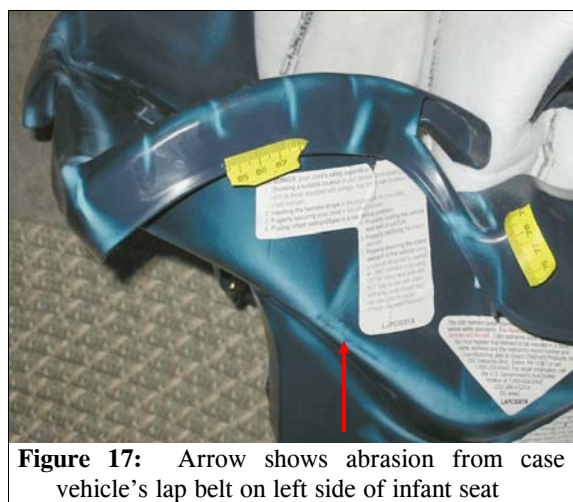
Figure 17: Arrow shows abrasion from case vehicle’s lap belt on left side of infant seat

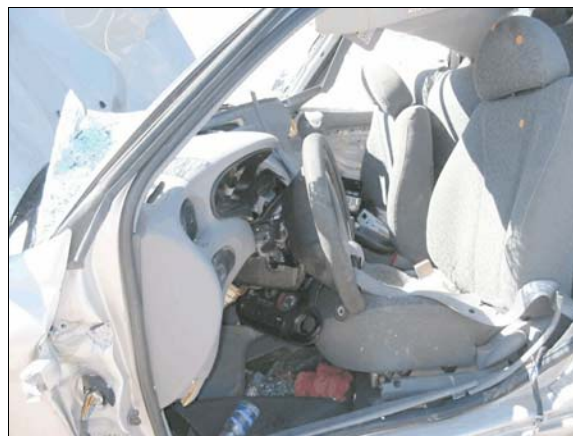
panel and the downwardly displaced steering wheel (**Figure 18**). Rescue personnel removed the driver's door, and B-pillar, and cut her safety belt and the steering wheel rim to extricate her from the vehicle.

Figure 18: Intrusion of case vehicle's instrument panel and displacement of steering wheel entrapped driver legs

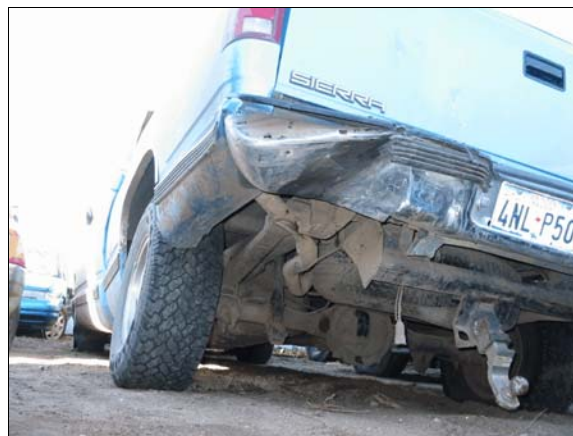
Figure 15: Underride damage due to impact by case vehicle’s front right

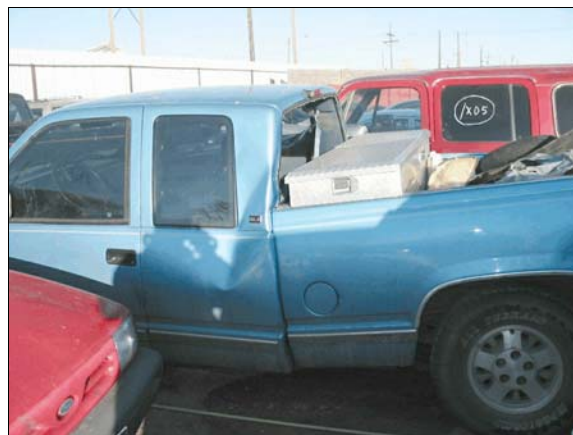
Figure 16: Induced damage to back of cab and bed

The GMC’s wheelbase was not altered due the impact. Induced damage involved the truck bed, back of the truck cab and left side of the truck cab behind the left front door (**Figure 16**).

The back left impact forced the truck bed forward, which impacted the back of the truck cab. The back end was also displaced upwards, primarily on the left side. No other induced damage or remote buckling was noted.
