Child Safety Seat Investigation/ Vehicle to Vehicle
Dynamic Science, Inc. / Case Number: DS05004
2000 Ford Expedition
California
March 2005

1. Report No. DS05004	2. Government Accession No.	3. Recipient Catalog No.	
4. Title and Subtitle Child Safety Seat Investigation		5. Report Date May 6, 2006

This on-site investigation focused on a forward facing child safety seat (CSS) that was installed in the second row left position of a 2000 Ford Expedition. The Ford Expedition was occupied by a restrained 29-year-old female driver and a 3-year-old female second row left seat passenger, who was restrained in a forward facing CSS. The CSS was anchored to the vehicle using the available lap and shoulder belt. The other vehicle was a 1984 GMC Vandura minivan driven by a 28-year-old male. The front of the Ford Expedition was struck by the GMC Vandura in a head-on configuration after the GMC crossed the center divider and traveled into the westbound

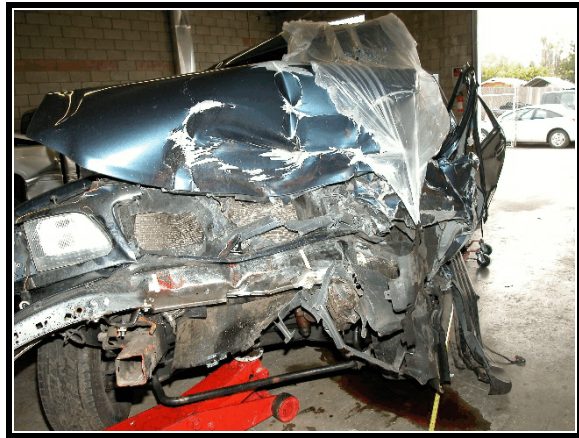
Figure 1. Front, 2000 Ford Expedition

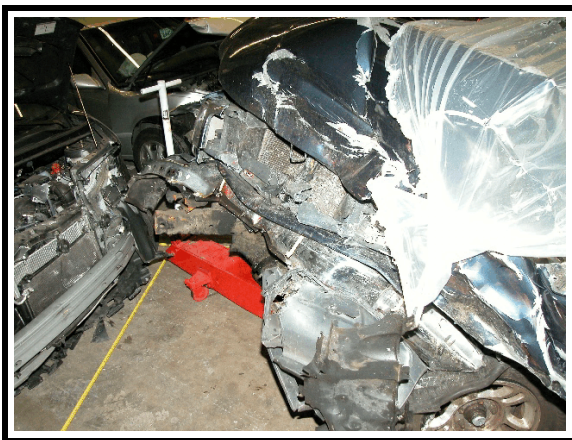
Damage Description: The 2000 Ford Expedition sustained severe front end damage as a result of the impact with the Vandura. The direct damage began at the left bumper corner and extended 112.0 cm (44.1 in) laterally. Four crush measurements were taken along the bumper plane: C1=131.0 cm (51.6 in), C2=101.0 cm (39.8 in), C3=57.0 cm (22.4 in), C4=0.0 cm (0.0 in). The right side of the bumper was pushed over the top of the frame rail. The hood was folded rearward and there was damage to the grille and radiator area. Red paint transfers were found along the bumper and grille areas. There was direct damage along the left side of the vehicle to the left rear door area caused by post impact rotation. There was remote buckling to the left side that extended into the left rear quarter panel area. The left front, right front, and left rear doors were jammed shut. The windshield was cracked from impact forces. The left rear side glass was disintegrated due to impact forces. The left wheelbase was shortened by 89.0 cm (35.0 in). The left rim was shattered and the left front tire was flat.

Figure 4. View of bumper from front left

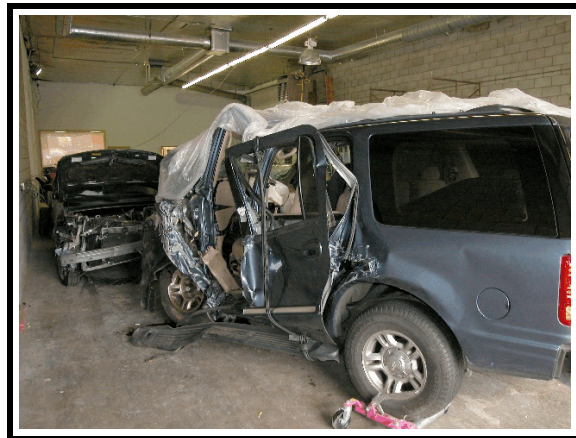
Figure 5. Left side

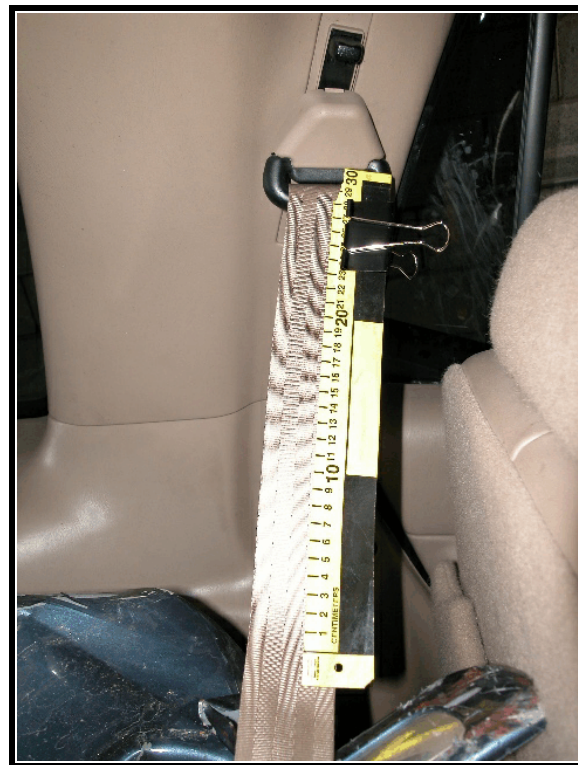
Figure 6. Loading/scuff marks to second row, left side safety belt

The second row left safety belt was used to secure an occupied forward facing child safety seat. The safety belt was found still anchoring the child seat at the time of the inspection. There was approximately 45.0 cm (17.7 in) of scuffs from loading found on the belt.

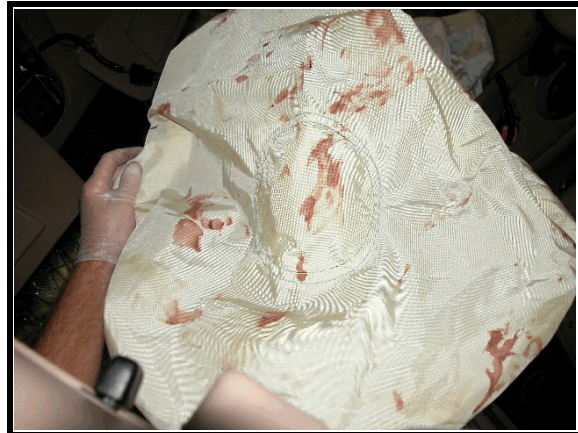
The driver's air bag deployed from the center of the steering wheel through symmetrical H - configuration module cover flaps. The top flap measured 19.0 cm (7.5 in) wide by 15.0 cm (5.9 in) high. The bottom flap measured 19.0 cm (7.5 in) wide by 6.5 cm (2.6 in) high. The bottom flap was found jammed beneath the steering wheel rim. The deployed driver's air bag measured 54.0 cm (21.3 in) in diameter in its deflated state. The air bag was equipped with a single internal tether that was attached to the circular stitching in the center of the air bag face. Two circular vent ports that measured 3.0 cm (1.2 in) in diameter were located at the 11 and 1 o'clock aspects on the back of the air bag. The air bag material was burned at the mid point between the two vent ports and 8.0 cm (3.1 in) above a line between the ports. The melted portion measured 3.0 cm (1.2 in) wide by 4.0 cm (1.6 in) high. The melted portion was surrounded by a wider area of scorching.

Figure 7. Driver's air bag

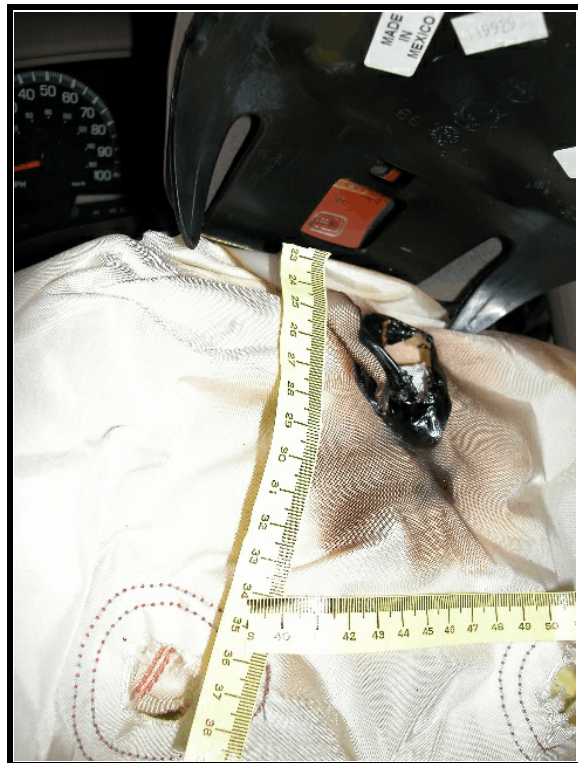
Figure 8. View of vent ports and burns to back of driver's air bag

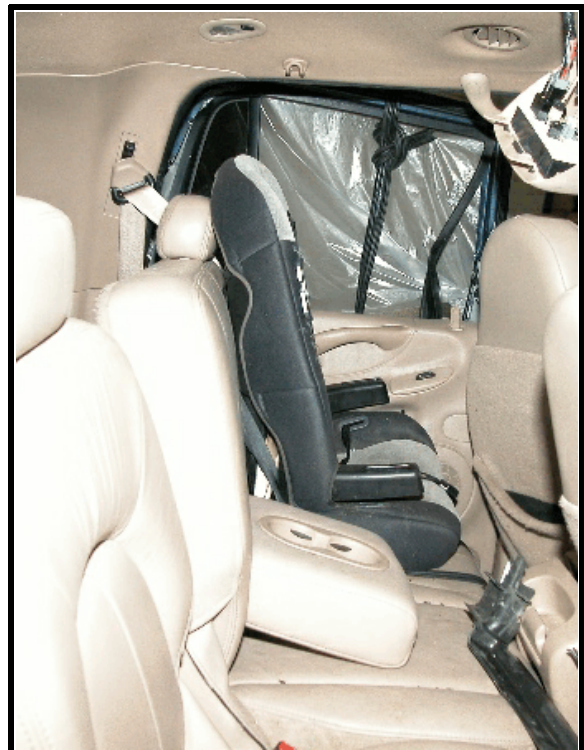
A Century Breverra Ascend SE 44892 forward facing CSS was positioned in the second row left seat of the Ford Expedition. The model number was 44892UH and the date of manufacture was August 21, 2002. The convertible CSS was configured with a five-point harness system and a two piece locking harness retainer clip. The seat was being used in the forward facing mode using the 5-point harness. The second row left safety belt was used to anchor the child safety seat. The safety belt was found still anchoring the child seat at the time of the inspection. There was approximately 45.0 cm (17.7 in) of scuffs from loading found on the belt. The manufacturer outlined recommended usage of the seat is as follows:

Figure 9. Century Ascend child seat still anchored to vehicle

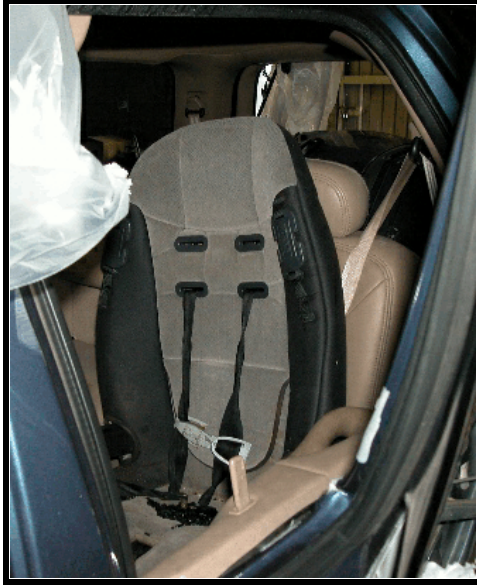
Figure 10. Century child seat. Scuff to seat back from shoulder belt.

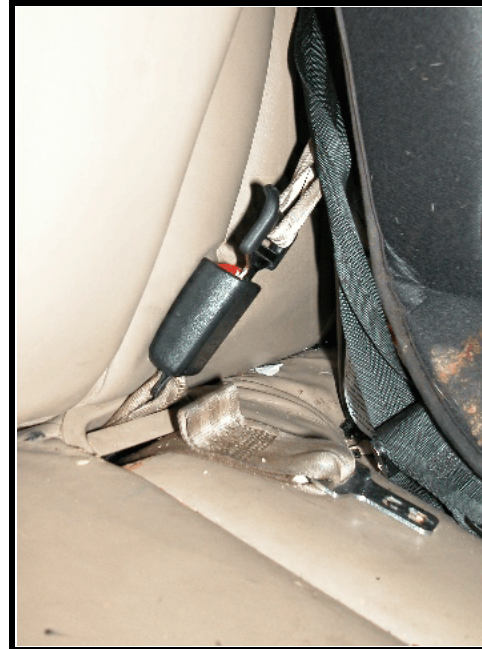
Figure 11. Child seat anchorage

The 3-year-old female child was restrained in the forward facing CSS by the 5-point harness. The CSS was installed in the second row left position by the available lap and shoulder belt. The belt had not been switched to the automatic locking retractor mode and a locking clip was not being used. The harness was routed through the lower set of harness slots.

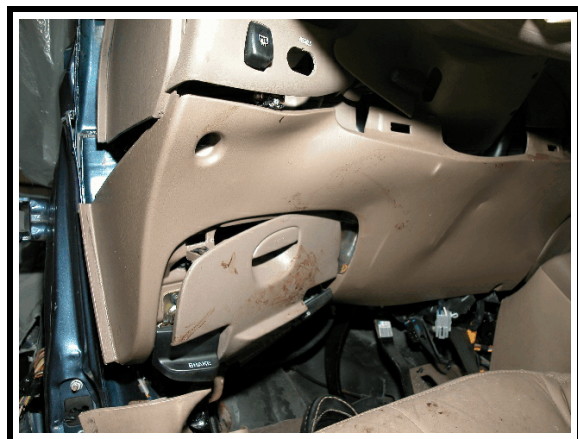
Figure 15. Left knee contact

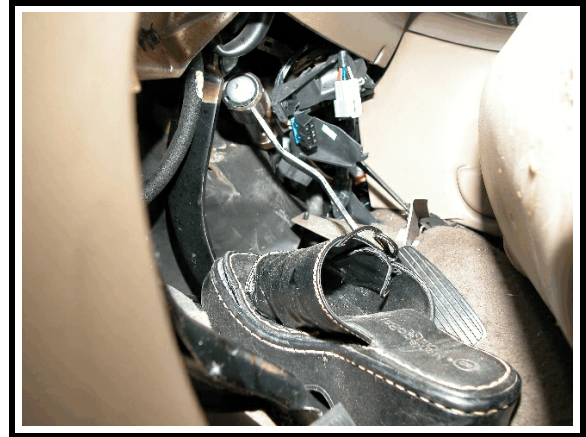
The 29-year-old driver of the Ford Expedition was seated in a forward facing fashion. The adjustable foot controls appear to have been in the fully rearward (toward driver) position. The driver was using the available lap and shoulder belt. Her right foot was on the accelerator, her left on the floor. There were no indications from any witness that the driver attempted any evasive maneuvers prior to the crash. At impact, the frontal air bags deployed and the safety belt pretensioner actuated. The female driver initiated a forward and slightly left trajectory. She loaded the safety belt. Her face and torso engaged the deployed air bag. The steering wheel rim was deformed forward. Both of her knees engaged the intruding knee bolster/instrument panel. Her left lower leg/ankle engaged the parking brake—depositing blood and tissue. Her right foot deformed the brake and accelerator pedals.

Figure 16. Floor pan and foot controls

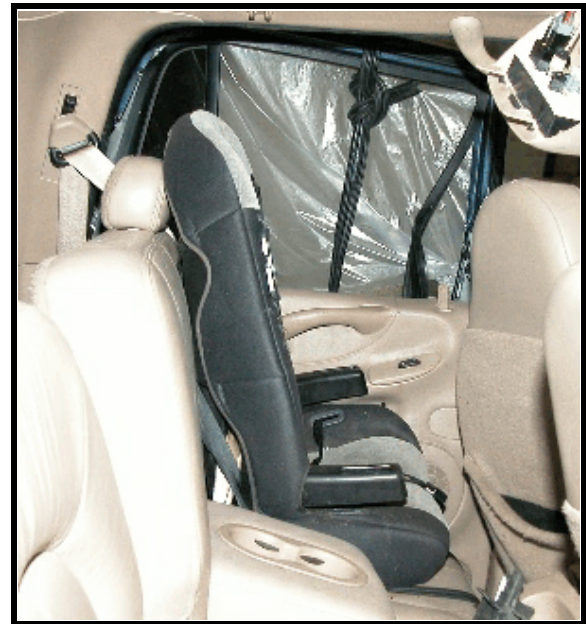
At impact, the female child occupant initiated a forward and slightly left trajectory. She loaded the child safety seat harness. The child seat, in turn, loaded the lap and shoulder belt. She pitched forward but was held in place by the child seat harness. It appears that her right arm either flew forward from impact forces or was already out in front of the child in a defensive maneuver. Her right hand likely contacted the back of the driver's seat resulting in an indirect fracture injury to the arm.

Figure 17. Child seat position relative to the back of the driver's seat
