**ON-SITE CHILD SAFETY SEAT CRASH INVESTIGATION  
COSCO VISTA HIGH BACK BELT POSITIONING BOOSTER SEAT**

**CALSPAN CASE NO: CA05-005**

**VEHICLE: 1995 OLDSMOBILE CUTLASS SUPREME**

**CRASH DATE: DECEMBER, 2004**

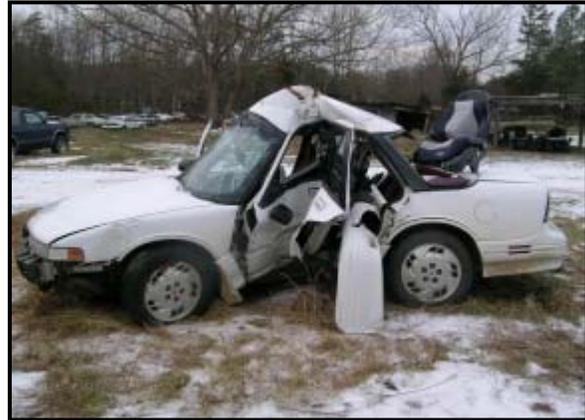
**Figure 1: Left side view of the Oldsmobile.**

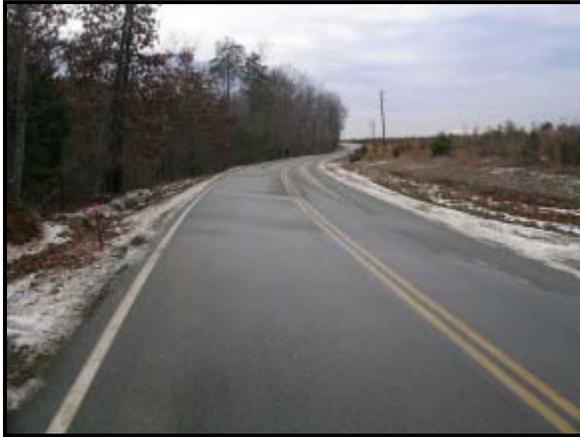
**Figure 2: Southbound lookback view**

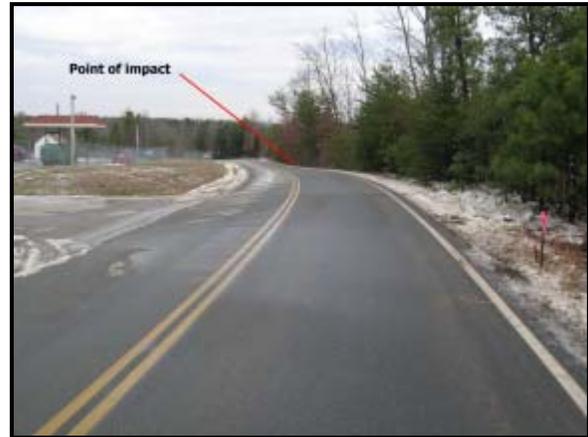
**Figure 3: Northbound trajectory view 91 m (330 ft) south of the POI.**

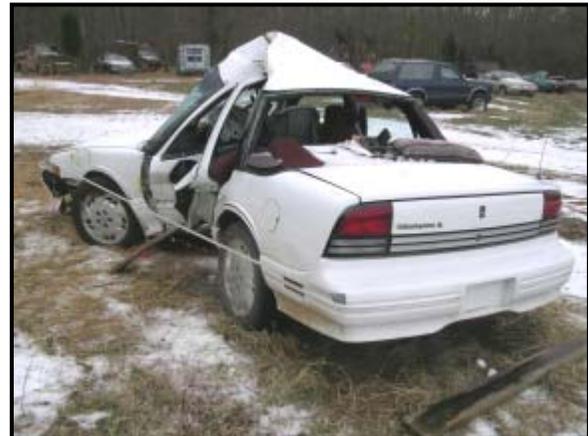
**Figure 4: left rear view of the Oldsmobile.**

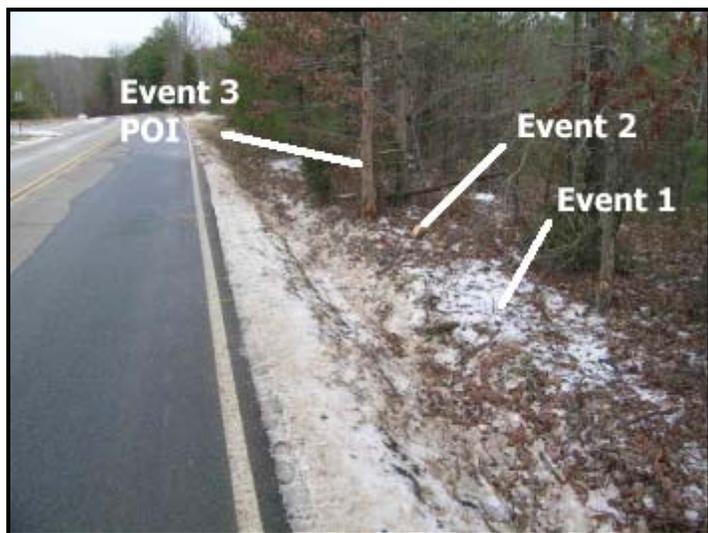
At the time of the crash, the Virginia region was experiencing unusually cold weather and the road conditions were reported as icy. The Oldsmobile traveled through the S curve, south of the point of impact, and the driver experienced a loss of directional control at the exit of the curve. The SCI scene inspection determined the Oldsmobile departed the right side of the road at a shallow angle approximately 43 m (140 ft) north of the end of the curve. **Figure 5** is a trajectory view in the area of the road side departure and the point of impact. The Oldsmobile traversed the shallow ditch, and then impacted and overrode a cluster of two 3 cm (1 in) diameter trees. The saplings were located 2.5 m (8.3 ft) from the road edge and were struck by the front right aspect of the vehicle (Event 1). This impact was recorded by the EDR as a non-deployment event. Refer to the EDR attachment at the end of this narrative report.

**Figure 5: Trajectory view at the road side departure and the POI.**

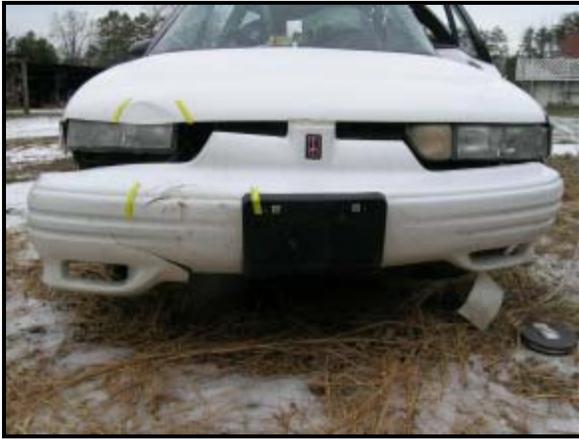
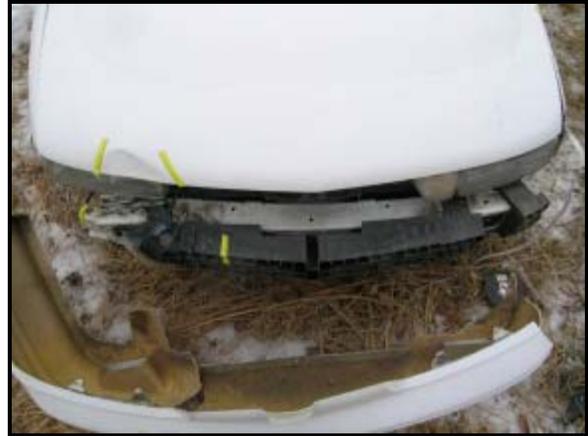
The exterior inspection of the Oldsmobile revealed three distinct areas of contact damage that related to the multiple event crash sequence. **Figures 6 and 7** are views of the Oldsmobile depicting the frontal damage. The front bumper sustained a localized impact to its right aspect consistent with small diameter trees of Event 1. The direct contact to the bumper fascia began 17 cm (6.5 in) right of center and extended right 25 cm (10.0 in). The fascia was cracked and abraded within the area of direct contact. The fascia had separated in the crash (due to forces of Event 2) allowing the bumper reinforcement bar to be examined. The reinforcement bar was deformed over a 42 cm (16.5 in) width that began 23 cm (9.0 in) right of center. The maximum deformation of the bar measured 2 cm (0.75 in) immediately inboard of its attachment to the vehicle's subframe. The hood face was damaged over a 19 cm (7.5 in) width that began 34 cm (13.5 in) right of center. The relative location of the above referenced damages was indicative of an angular contact to the trees. The Collision Deformation Classification (CDC) of the impact was 11-FZEW-1.

Figure 6: View of the fascia damage.

Figure 7: View of the reinforcement bar.

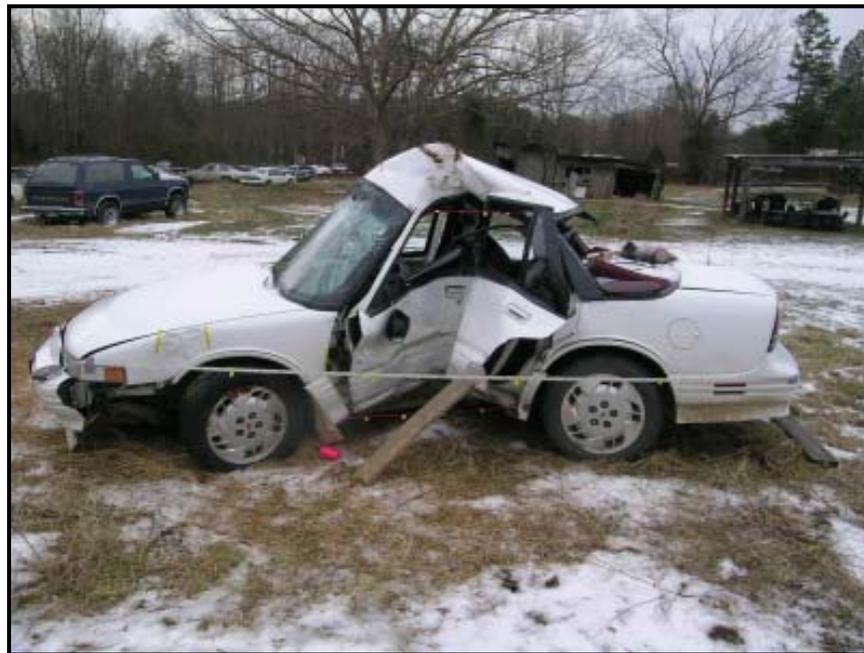
The left side of the Oldsmobile sustained two regions of the direct contact consistent with Events 2 and 3. Refer to **Figure 8**. General observations revealed a minor contact to the left front fender and a major impact to the left front door and B-pillar. The bumper fascia had separated in the impact and the left end of the fascia was missing. Reconstruction of the crash dynamics determined that the Oldsmobile struck the 10 cm (4 in) diameter tree with the left side surface (outboard end) of the fascia and then engaged the tree with the fender during its off-road trajectory. The left front fender was deformed over a 20 cm (8.0 in) wide region immediately forward of the left front wheel opening. The maximum deformation in the region measured 1 cm (0.5 in). The CDC of this impact was 11-LFEN-1. The vehicle then engaged the tree with the left front wheel redirecting its forward momentum into an induced rapid rotation. The frontal air bags deployed at this time.

Figure 8: Left side view of the Oldsmobile.

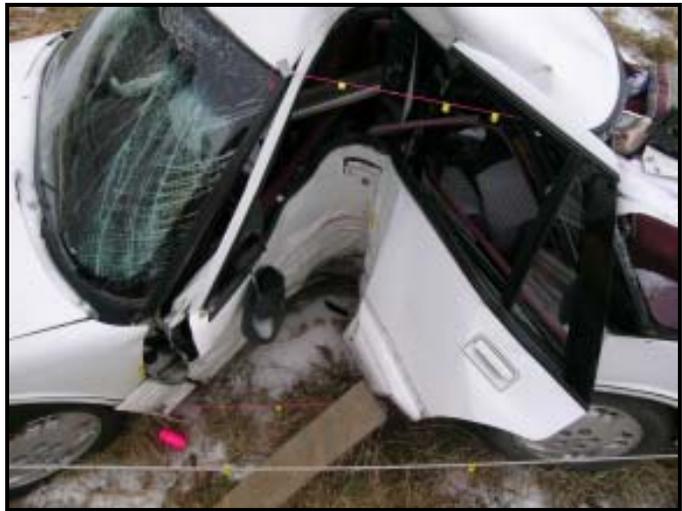
**Figure 9** is a view of the area of maximum left side deformation. The left front and rear doors were jammed shut by deformation. The right side doors remained closed during the impact and were jammed shut by body distortion.

**Figure 9: View of the maximum deformation.**

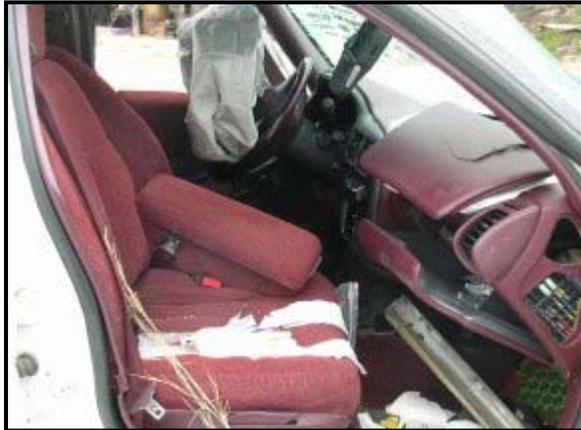
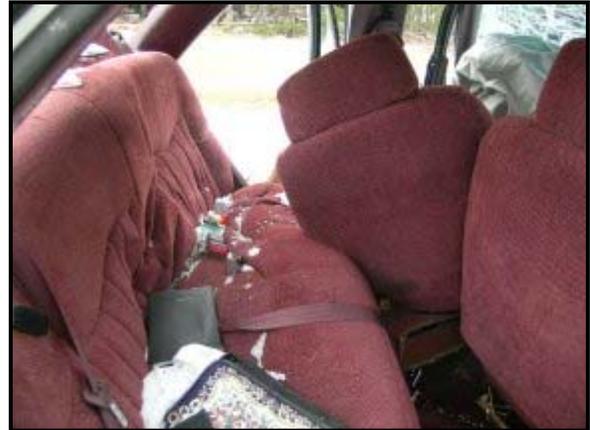
**Figures 10 and 11** are right interior views of the Oldsmobile depicting the intrusion. The driver's interior space sustained severe intrusion from the left door and B-pillar. The forward aspect of the left door panel was in contact with the 8 o'clock sector of the steering wheel rim. The intrusion at the forward aspect of the door measured 15 cm (6 in). The rear aspect of the door intrusion measured 36 cm (14 in). The lateral and longitudinal B-pillar intrusion measured

55 cm (21.5 in) and 29 cm (11.5 in), respectively. The B-pillar intrusion displaced the driver seat to the right and caused the seat back to rotate counterclockwise. The rear outboard aspect of the driver seat back was in contact with the deformed rear left seat cushion. The inboard aspect of the driver seat back was in contact with the front right seat back. The front right seat was displaced to the right approximately 6 cm (2.5 in) and was in contact with the right B-pillar.

**Figure 10:** Right interior view across the front seat.

**Figure 11:** Right interior view across the rear seat.

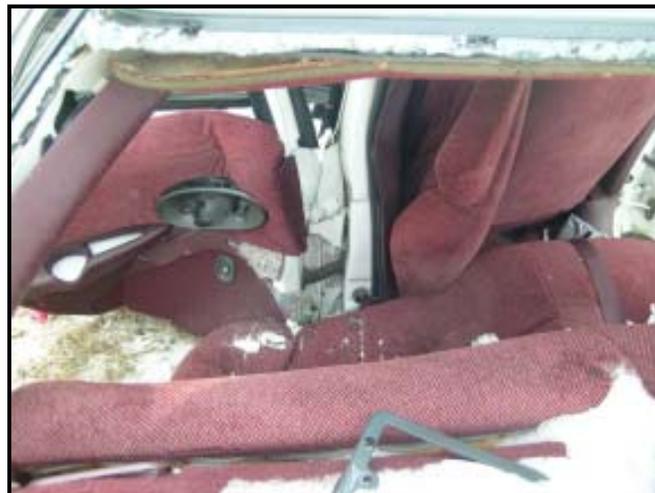
**Figure 12** is a longitudinal overhead view through the backlight depicting the intrusion at the rear seat left position. The booster seat was located in this seat position and fractured by the intrusion. It was mechanically pinned post-crash. The left rear door deformed in a semi-circular pattern about the forward aspect of the booster seat shell. The angular crash forces and crush at the left sill buckled the floor pan compressing the rear seat laterally and longitudinally. The forward aspect of the rear seat cushion was reduced in width 46 cm (18 in). The depth of the seat cushion at the left rear position was reduced 10 cm (8 in).

**Figure 12:** Overhead view through the backlight of the rear seat intrusion.

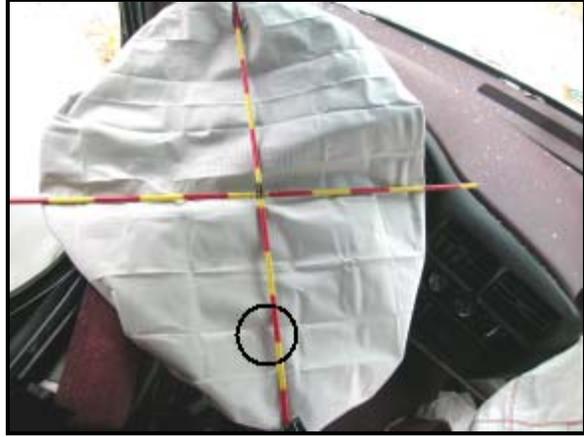
**Figure 13** is a view of the deployed driver air bag. The driver air bag was located in the center hub of the four spoke steering wheel rim. The module cover flaps were constructed of vinyl and were a symmetrical I-configuration. The width and height of the flaps measured 8 cm (3.0 in)

and 12 cm (4.9 in), respectively. The diameter of the driver air bag measured 61 cm (24 in) its deflated state. It was not tethered and was vented by two 3 cm (1.0 in) diameter ports located on the back side of the bag in the 3/9 o'clock sectors. The face of the bag exhibited vinyl transfers along its vertical mid-line axis. The transfers were intermittent and were caused by contact with the cover flaps during the deployment sequence. The driver's lips contacted the 6 o'clock sector the air bag evidenced by a pair of lipstick transfers. The contact was vertically oriented and located along the mid-line of the bag, approximately 11 cm (4.5 in) from the peripheral seam. The transfer was red in color and measured 3 cm (1.0 in) long.

**Figure 13: Deployed driver air bag.**

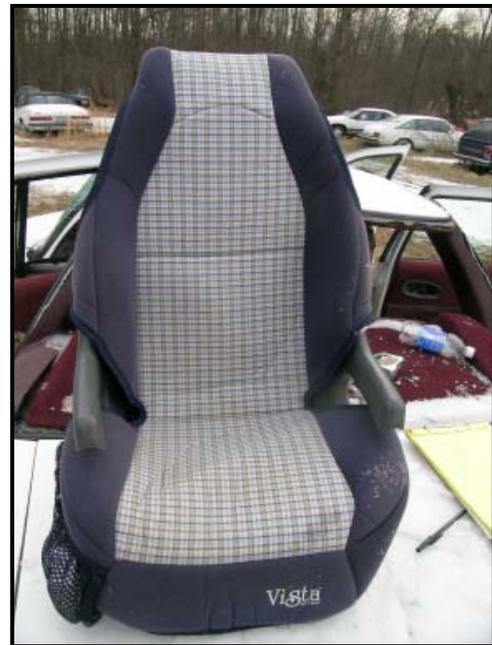
The 4 year old female was seated in a Cosco Vista high-back belt positioning booster and restrained within the rear left position of the Oldsmobile. **Figure 14** is a front view of the Cosco booster seat, Model No: 22-220-WAL. The seat was manufactured on January 28, 2003. The seat was labeled for use by child from 14 kg to 36 kg (30 lb to 80 lb) and up 132 cm (52 in), as long as the mid-point of the child's head was not above the seat back. The seat was designed to be used with the vehicle's 3-point lap and shoulder restraint. There were two warning labels on the seat that stated "Do not use with lap belt only". The seat's instruction manual was not present. Three shoulder belt positioning clips were designed into the respective outboard edges of the seat back. The purpose of the clips was to position the shoulder belt for a better fit to the seated height of the child. These clips were not in use at the time of the crash.

**Figure 14: Front view of the CSS.**

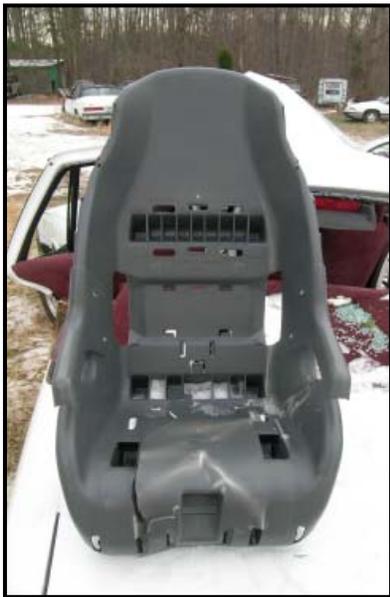
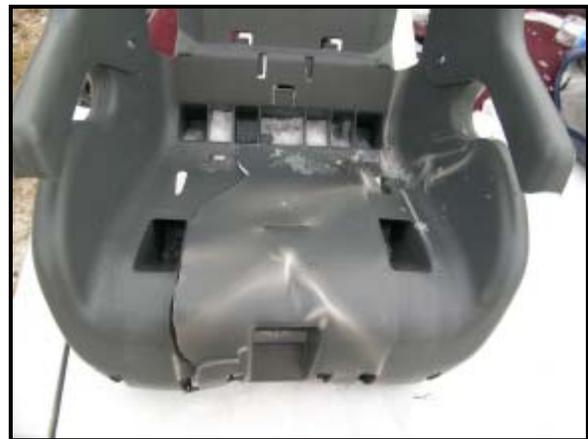
Inspection of the seat with the padding removed revealed a fracture of the base of the plastic shell. The fracture line began 9 cm (3.5 in) right of center and radiated linearly rearward to the reinforcements at the bight of the shell. Refer to **Figures 15 and 16**. The shell in the area of the left belt path was also stressed. The base fracture and related stresses were directly related to contact from the intruding left B-pillar and left rear door at impact. **Figure 17** is an overhead view of the CSS in the left rear position looking through the backlight and depicts the relationship of the seat to the intrusion.

**Figure 15: Front view of the CSS shell.**

**Figure 16: Close-up view of the fractured base.**

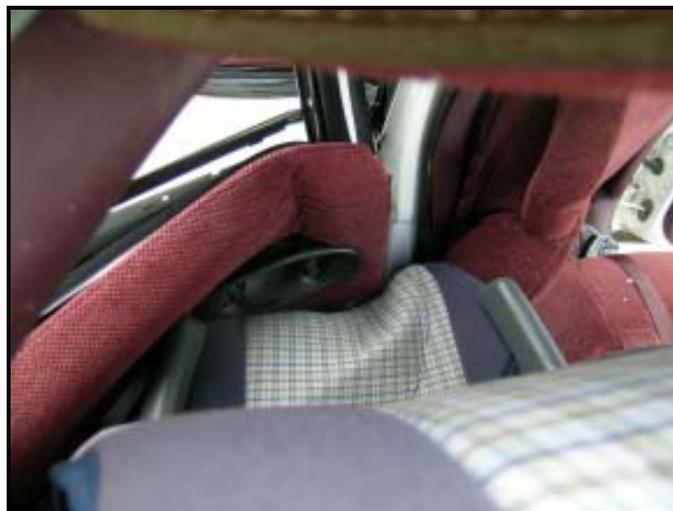
**Figure 17: Overhead view of the relationship between CSS in the rear left position and the left side intrusion.**

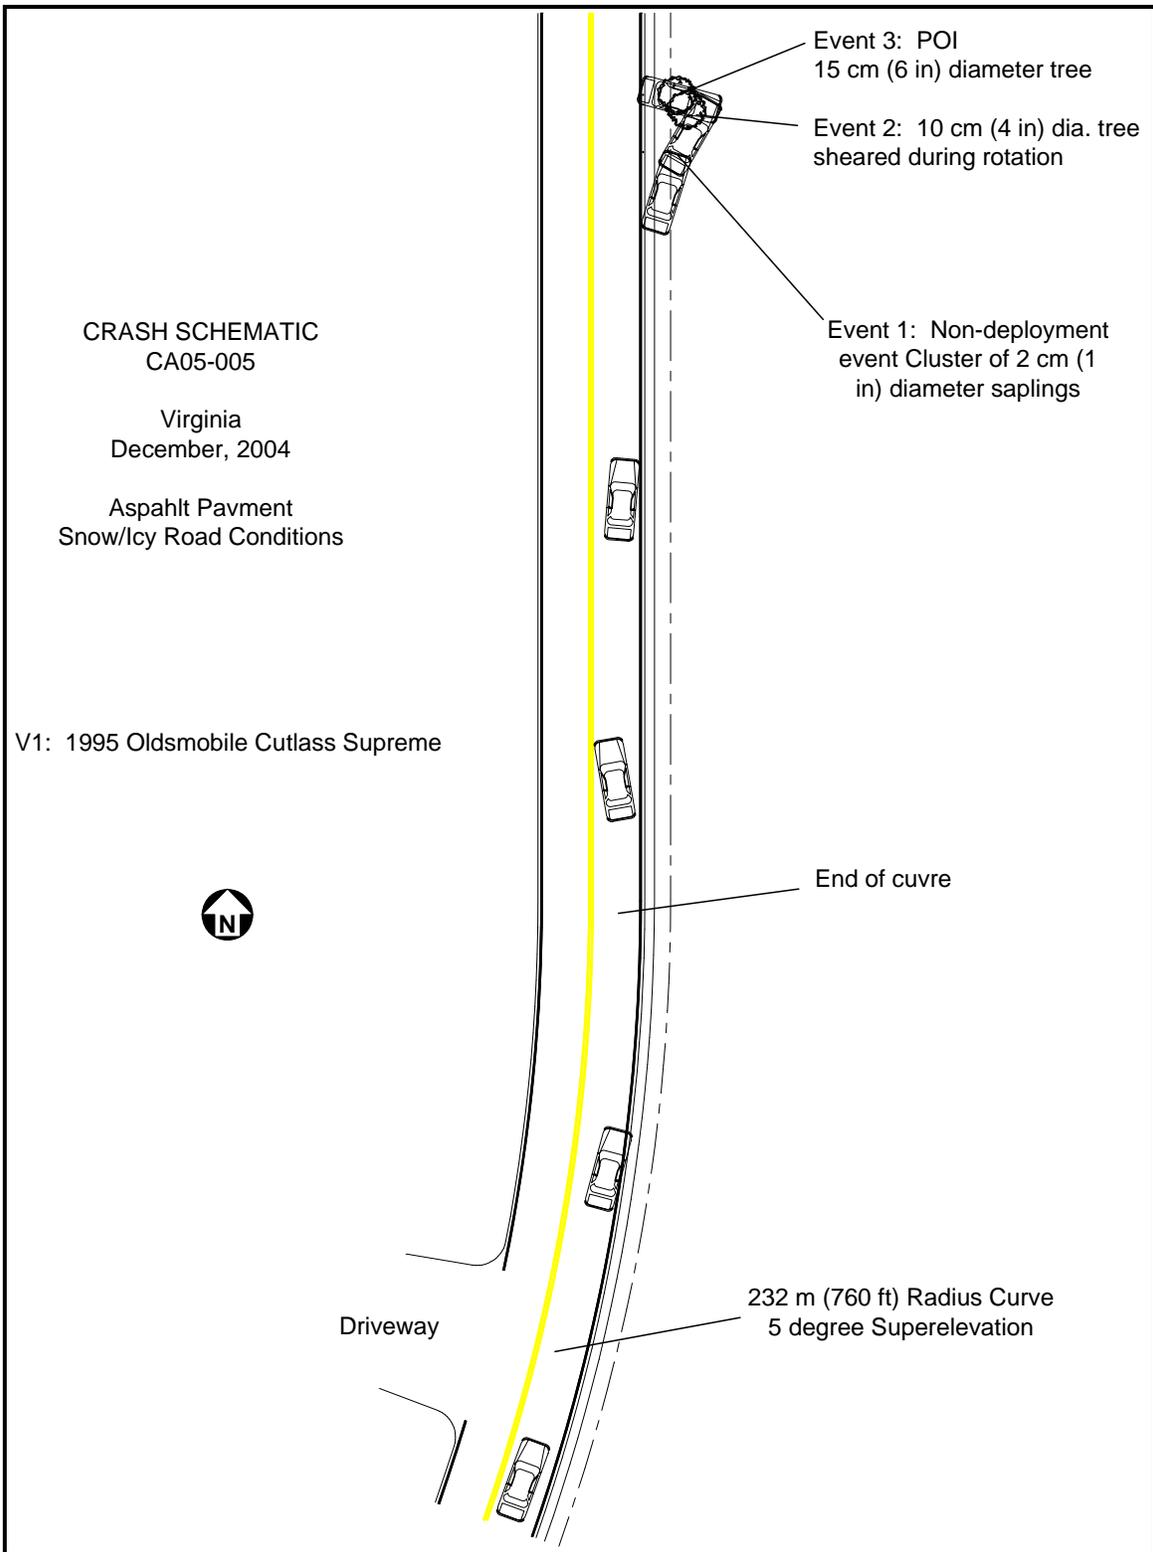
Figure 18: Crash Schematic

The Oldsmobile rotated rapidly approximately 75 degrees impacting a 15 cm (6 in) diameter tree in the process (Event 3). This tree was located 0.6 m (2.0 ft) north of the 10 cm (4 in) diameter tree. The vehicle struck the tree with the left front door and B-pillar. The 10 cm (4 in) diameter tree sheared off at ground level during the vehicle's rotation. The force of the impact resulted in severe B-pillar intrusion and bowing of the vehicle. The maximum crush was located at the left B-pillar and measured 133.1 cm (52.4 in). The Oldsmobile came to rest at the point of impact in contact with the tree. The delta V of the left side impact calculated by the Barrier Algorithm of the WINSMASH model was 77.0 km/h (47.8 mph). The longitudinal and lateral delta V components were -38.5 km/h (-23.9 mph) and 66.7 km/h (41.4 mph), respectively. A schematic of the crash is attached to the end of the report, **Figure 18**.
