TRANSPORTATION RESEARCH CENTER

ON-SITE CERTIFIED ADVANCED 208- COMPLIANT VEHICLE INVESTIGATION

CASE NUMBER - IN-05-005
LOCATION - TEXAS
VEHICLE - 2005 CADILLAC CTS
CRASH DATE - December 2004

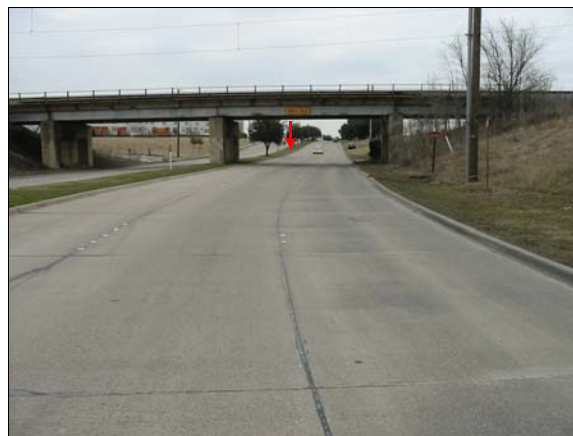
Figure 1: Overview of case vehicle’s northbound approach, arrow shows area of curb and tree impacts

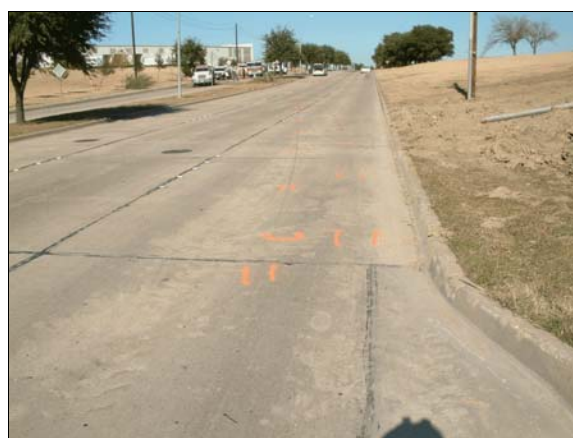
Figure 2: Police on-scene photo of case vehicle’s yaw marks, highlighted in orange

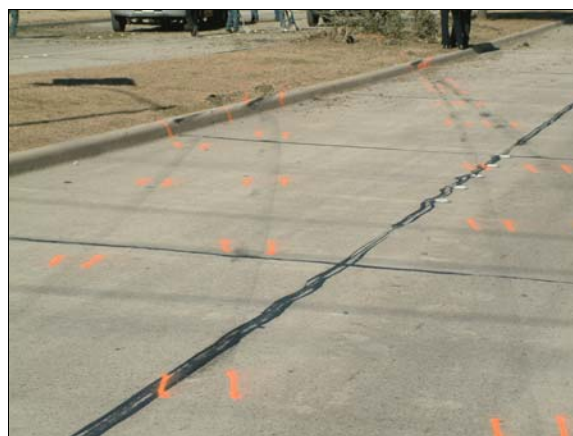
Crash: As the case vehicle rotated counterclockwise, the right front wheel impacted the median curb (**Figure 3**) breaking the wheel rim and spokes (**Figure 4** below). This impact most likely caused the case vehicle’s front right seat back-mounted side impact air bag and right side curtain air bag to deploy. The right rear wheel also impacted the curb, which dented the rim (**Figure 5** below) and the tire debanded as it

Figure 3: Police on-scene photo of case vehicle’s yaw marks and wheel impacts with curb; tire marks are, from left to right: left front, right front, left rear and right rear

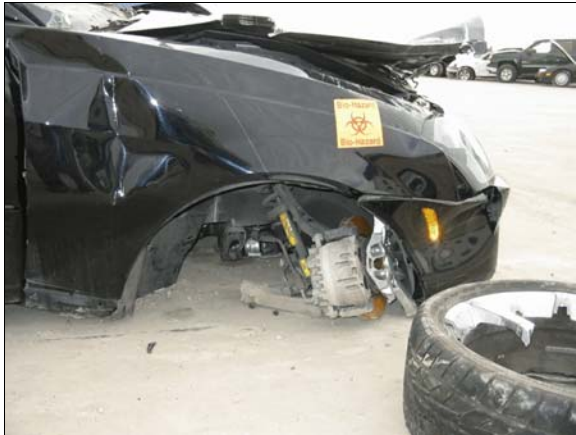
Figure 4: Damage to case vehicle's right front suspension and wheel due to curb impact

Exterior Damage: The curb impact to the case vehicle's right front wheel broke the wheel rim and spokes, and the wheel separated from the vehicle (**Figure 4** above and **Figure 10** below). The curb impact to the right rear wheel dented the rim, and the tire debedded as it furrowed into ground (**Figure 11** below). The right rear door impact with the tree involved the door sill, door and roof side rail. The resulting crush pocket (**Figure 12** below) was angled vertically outward approximately 35 degrees due to the combination of uprooting of the tree and rolling over while the vehicle was still in contact with the tree. The direct damage from the tree impact began 71

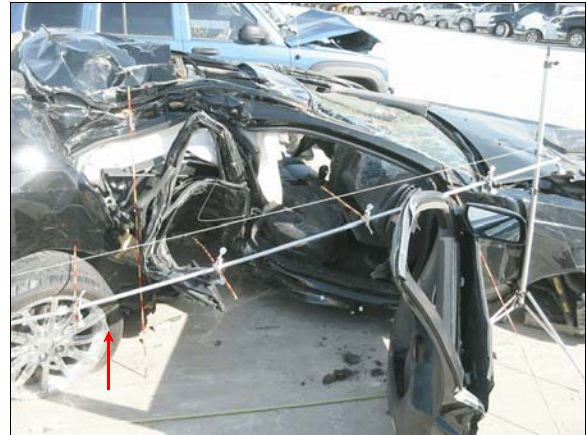
Figure 5: Damage to case vehicle's right side from tree impact [each increment on rod is 5 cm (2 in)], arrow shows dent in right rear rim from curb impact

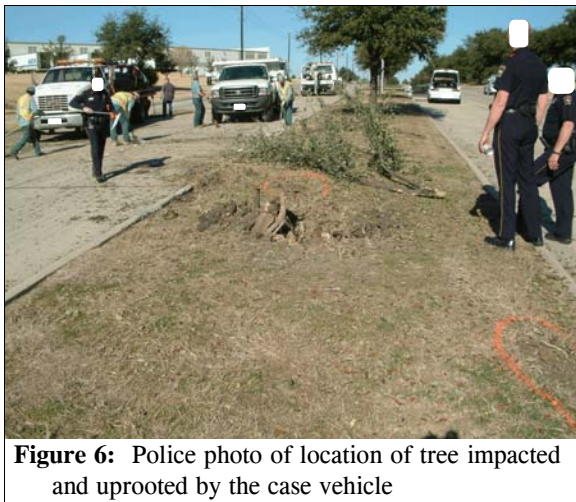
Figure 6: Police photo of location of tree impacted and uprooted by the case vehicle

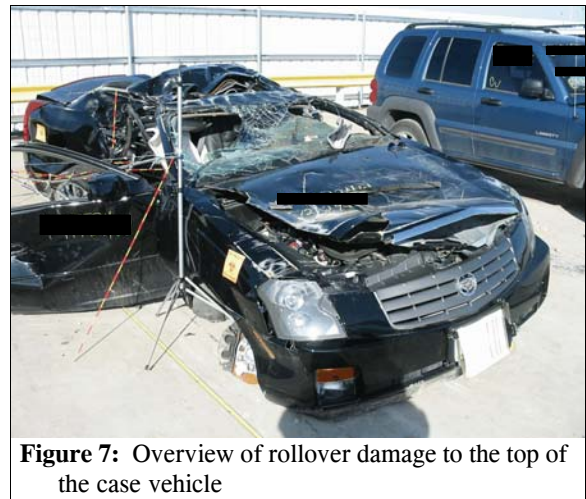
Figure 7: Overview of rollover damage to the top of the case vehicle

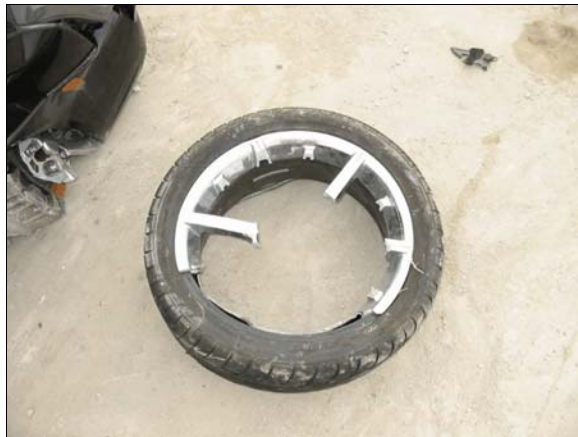
Figure 10: Damage to case vehicle's right front wheel from curb impact

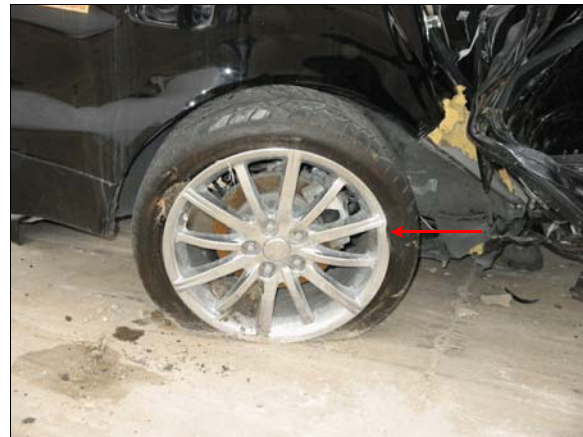
Figure 11: Dent in case vehicle's right rear rim (arrow) from curb impact, and dirt in bead and rim from furrowing into the ground adjacent to the curb

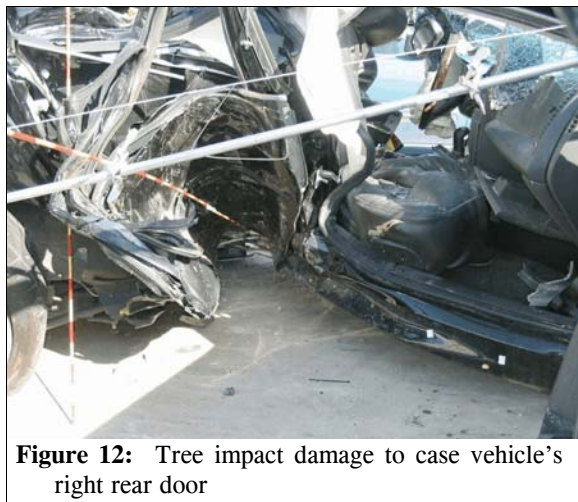
centimeters (28 inches) forward of the right rear axle and extended 100 centimeters (39.4 inches) along the door and the sill. The crush pocket in the door approximated the shape of the tree. Crush measurements were taken at the sill level. The residual maximum crush was measured as 119 centimeters (46.9 inches) occurring at C₄. The table below shows the right side crush profile.

Figure 12: Tree impact damage to case vehicle's right rear door

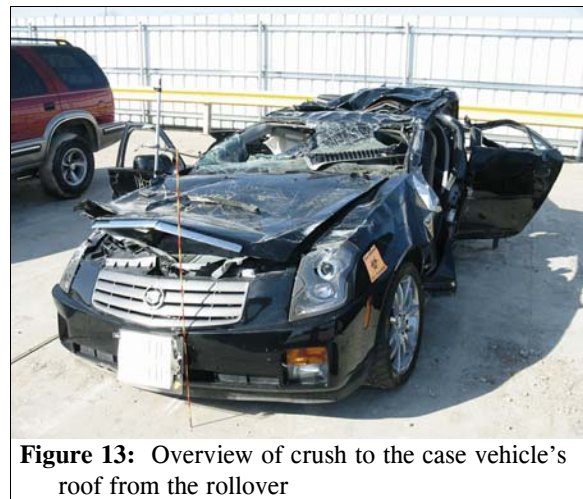
Figure 13: Overview of crush to the case vehicle's roof from the rollover

The direct damage from the rollover impact involved primarily the top of the case vehicle (Figure 13). The roof was crushed down extensively. The area of maximum residual crush

occurred at the windshield header and A-pillars and was approximately 36 centimeters (14.2 inches). There was extensive scratching to the top plane of the vehicle with the scratches angulated in multiple directions, indicating the vehicle was rotating while sliding on its top across the roadway. Some of these scratches are also related to righting the vehicle as are the scratches noted on the driver’s side. The police photos showed that the case vehicle was rolled over onto its left side and then onto its wheels by the tow truck.

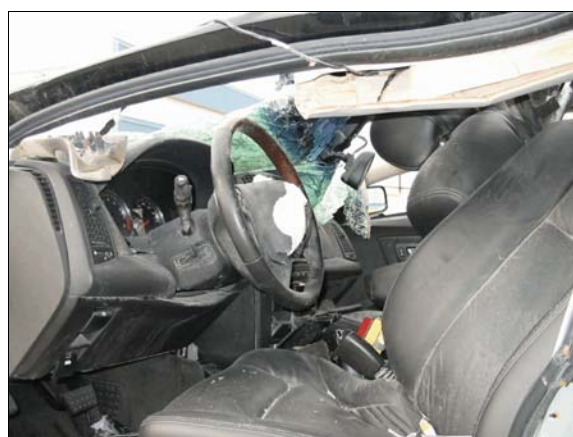
Vehicle Interior: Inspection of the case vehicle’s interior (**Figure 14** and **Figure 15** below) revealed blood stains on the roof above the driver’s seat and on the upper back portion of the driver’s air bag. No other evidence of occupant contact to any interior surfaces or components was observed. There was extensive intrusion into all passenger compartment seating positions. The roof was the primary intruding component into all the seat positions. The most severe intrusions into the driver’s space occurred along the vertical axis. There was 36 centimeters (14.2 inches) of windshield header intrusion, 27 centimeters (10.6 inches) of roof intrusion, 18 centimeters (7.1 inches) of windshield intrusion, 17 centimeters

Figure 14: Left side view of steering wheel, instrument panel and driver’s seat

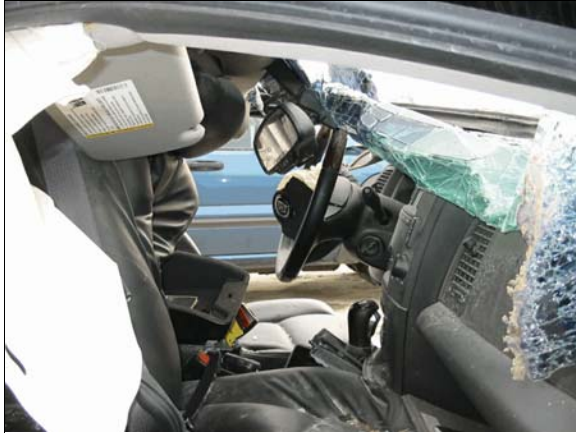
(6.7 inches) of left A-pillar intrusion and 17 centimeters (6.7 inches) of roof side rail intrusion. In addition the right rear door intruded laterally 48 centimeters (18.9 inches) into the right rear seat position. Lastly, there was no evidence of compression of the energy absorbing steering column or deformation of the steering wheel rim (**Figure 16**).

Figure 15: Right side view of front seat area and instrument panel

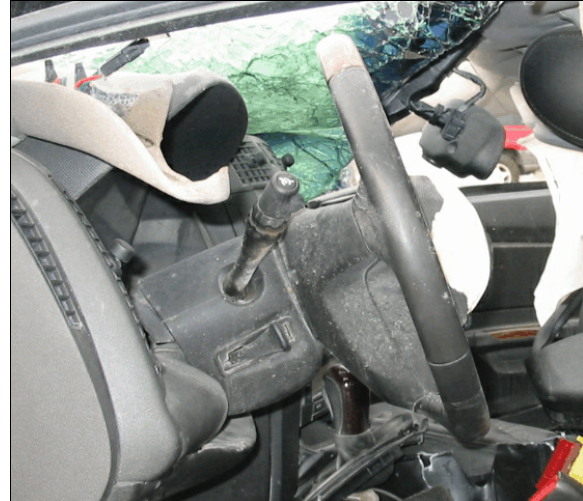
Figure 16: Left side view of steering column and steering wheel showing lack of deformation

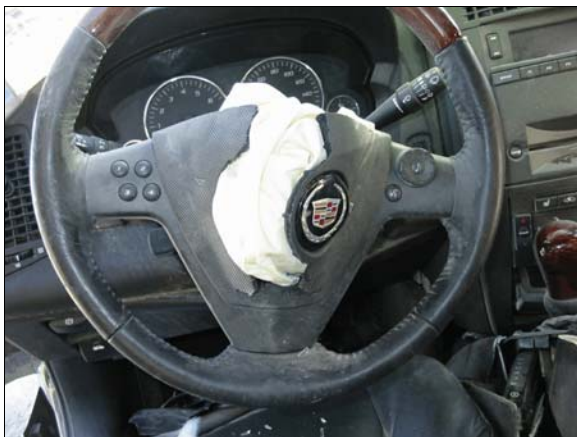
the designated tear points (**Figure 17**). There was no evidence of damage during the deployment to the air bag or the cover flaps. The module cover consisted of two approximately triangular-shaped cover flaps made of thick, pliable vinyl. The right cover flap was constructed with a circular Cadillac emblem. The left cover flap had a semi-circular cut-out that accommodated the left half of the Cadillac emblem. Each cover flap was 8.5 centimeters (3.3 inches) in width at the top, 3.5 centimeters (1.4 inches) in width at the bottom and 13 centimeters (5.1 inches) in height. The driver's air bag was designed with two tethers, each approximately 7 centimeters (2.8 inches) in width. The deployed driver's air bag (**Figure 18**) was round with a diameter of approximately 60 centimeters (23.6 inches) and had two vent ports (**Figure 19**), each approximately 3.5 centimeters (1.4 inches) in diameter, located at approximately the 11 and 1 o'clock positions. An inspection of the driver's air bag fabric revealed no evidence of occupant contact on the front of the air bag. However, a blood stain was noted on the back of the air bag in the top, right area.

Figure 17: Case vehicle's driver air bag module flaps

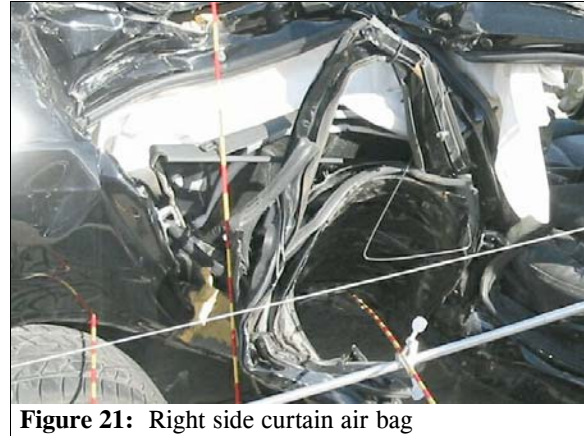
The right side curtain air bag was located along the right roof side rail (**Figure 21**) inside the headliner and extended along the front right and back right seat positions. Due to the extent of damage to the right side and the roof, a thorough documentation of the air bag was not possible. The air bag was anchored to the right C-pillar. The air bag was approximately 33 centimeters (13 inches) in height. The length of the air bag could not be accurately determined due to the level of damage and intrusion to the right side of the case vehicle. The air bag was designed without tethers or vent ports. There was an approximate 6 centimeter (2.4 inches) cut on the outside of the air bag located about 23 centimeters (9.1 inches) forward of the right C-pillar. The cut occurred in the area of the tree impact. The remainder of the air bag was unremarkable.

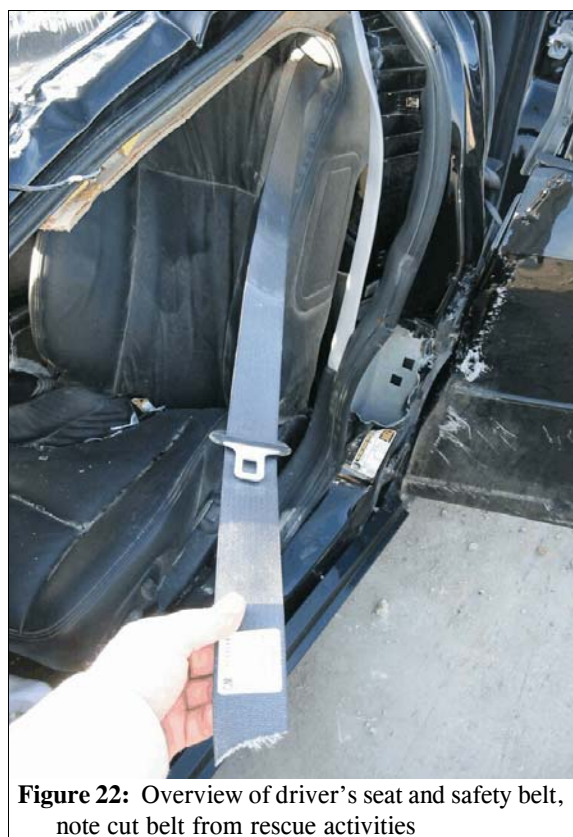
Based on this contractor's vehicle inspection and supported by the EDR data, the case vehicle's driver was restrained by his integrated, three-point, lap-and-shoulder safety belt system. The safety belt had been cut off the driver by the rescue crew (**Figure 22**).

Figure 22: Overview of driver's seat and safety belt, note cut belt from rescue activities
