ON-SITE CERTIFIED ADVANCED 208-COMPLIANT VEHICLE INVESTIGATION

CASE NUMBER - IN-05-006

VEHICLE - 2004 JEEP LIBERTY SPORT

CRASH DATE - January 2005

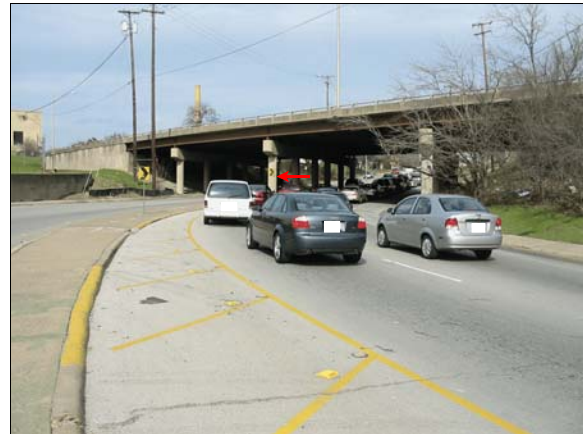
Pre-Crash: The case vehicle was traveling north in the outside lane of the right curve (**Figure 1**) approaching an overpass at a driver estimated speed of 48 km.p.h. (30 m.p.h.). The driver was intending to continue northbound. The driver attempted to change lanes to the left and lost control of the case vehicle on the wet roadway. The case vehicle began to slide toward the median. The driver locked the brakes in an attempt to avoid the crash. The crash occurred in the median on the south side of the overpass.

Figure 1: Case vehicle’s approach, northbound in outside lane, to impact with concrete bridge support (indicated by arrow)

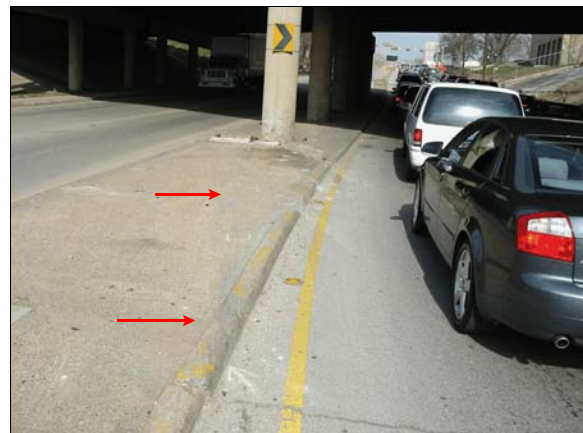
Crash: The case vehicle traveled over the concrete curbed median (**Figure 2**) and the front of the case vehicle (**Figure 3**) impacted the concrete bridge support of the overpass (**Figure 4** below) causing the case vehicle driver’s air bag to deploy. The case vehicle’s front right air bag did not deploy. The sensor in the front right seat most likely determined that the weight on the seat produced by the restrained, 28 kilogram (62 pound), 7-year-old passenger was below the front right air bag’s enable threshold and suppressed deployment of the air bag.

Figure 2: Case vehicle’s approach to impact with the concrete bridge support, arrow shows left front skid mark

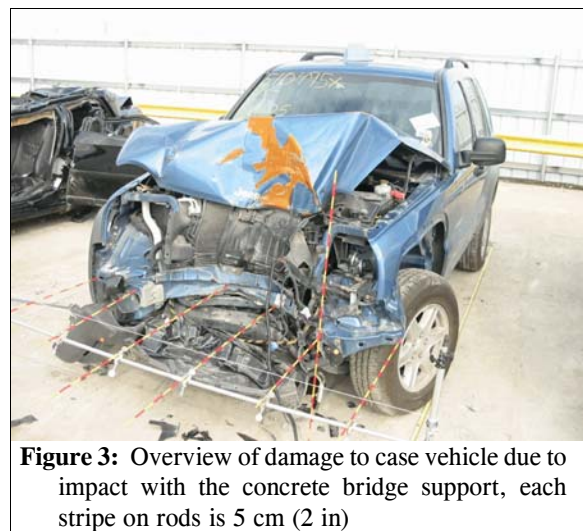
Figure 3: Overview of damage to case vehicle due to impact with the concrete bridge support, each stripe on rods is 5 cm (2 in)

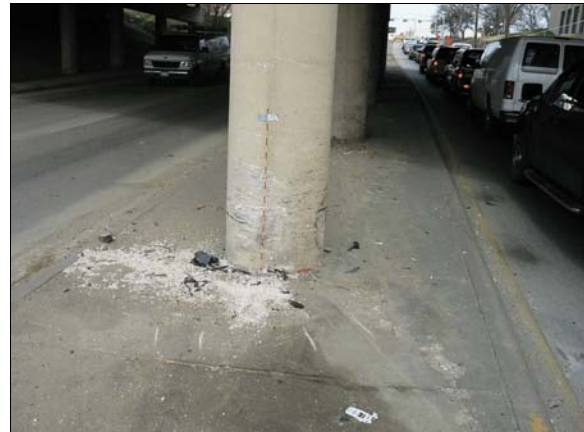
Post-Crash: The case vehicle rotated counterclockwise a few degrees and came to rest against the concrete bridge support (**Figure 4** below).

Figure 4: Case vehicle's impact and final rest location

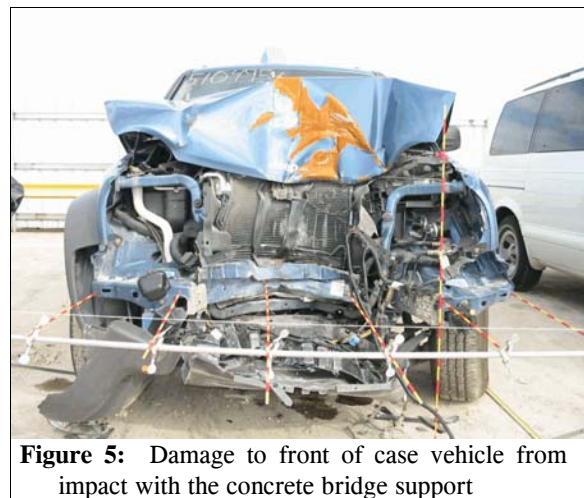
Exterior Damage: The case vehicle's impact with the concrete bridge support involved the front plane of the vehicle. The front bumper, grille and hood were directly damaged and crushed rearward (**Figure 5**). Direct damage began 28 centimeters (11 inches) left of the front right bumper corner and extended 105 centimeters (41.3 inches) along the bumper. Crush measurements were taken at the bumper. The maximum residual crush was measured as 40 centimeters (15.7 inches) occurring at C₃ and C₄ (**Figure 6** below). The table below shows the case vehicle's front crush profile.

Figure 5: Damage to front of case vehicle from impact with the concrete bridge support

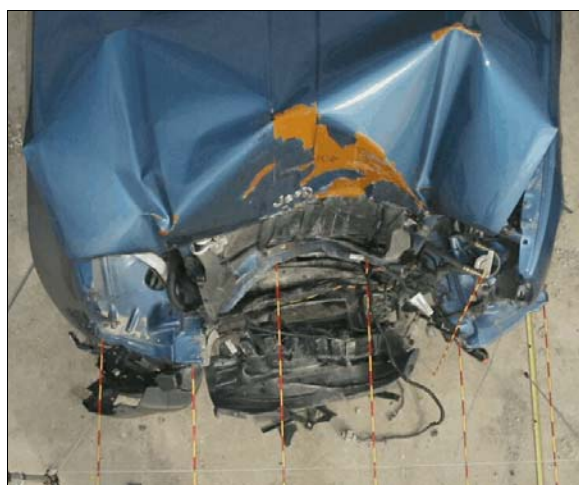
Figure 6: Top view of crush to front of case vehicle from impact with bridge support

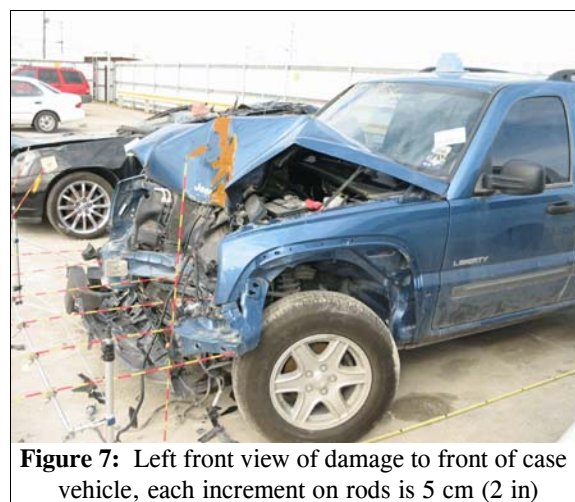
Figure 7: Left front view of damage to front of case vehicle, each increment on rods is 5 cm (2 in)

The case vehicle’s left side wheelbase was reduced 7 centimeters (2.8 inches) while the right side wheelbase was extended 1 centimeter (0.4 inch). Induced damage also involved the front bumper, grille and hood as well as both fenders and both headlamp/turn signal assemblies (**Figure 7**).

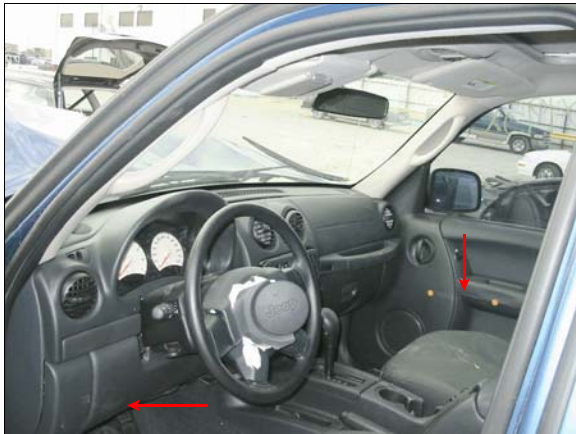
Vehicle Interior: Inspection of the case vehicle’s interior revealed an occupant contact scuff on the driver’s left knee bolster (**Figure 8** below) and a possible occupant contact scuff on the right

Figure 8: Overview of steering wheel and instrument panel, arrows show driver knee scuff on knee bolster and scuff on right front door

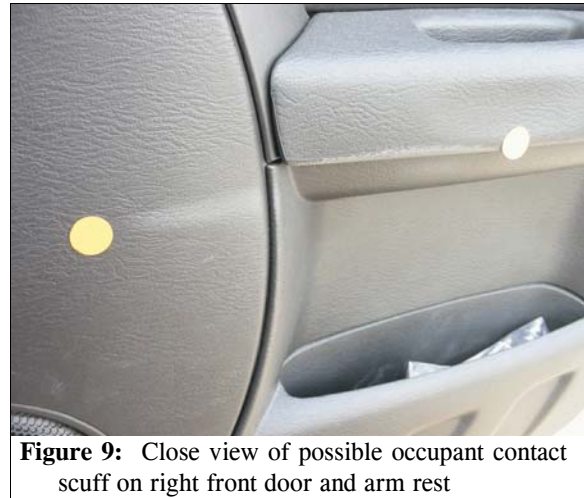
front door and arm rest (**Figures 8 and 9**). There were also several dust smears on the interior that may have been related to the air bag deployment. There were no passenger compartment intrusions. In addition, no evidence of compression of the energy absorbing steering column or deformation of the steering wheel rim was observed (**Figure 10**).

Figure 9: Close view of possible occupant contact scuff on right front door and arm rest

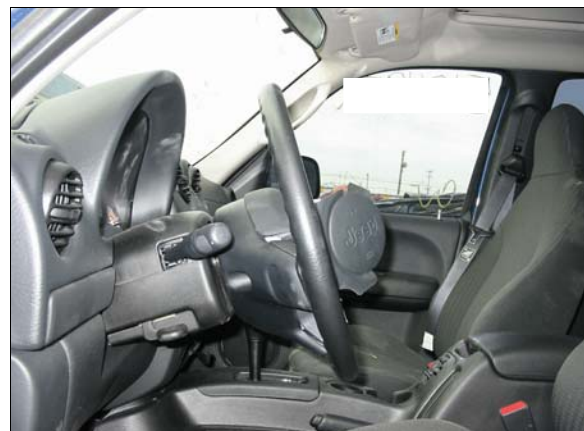
Figure 10: Case vehicle's steering column and steering wheel showing lack of deformation

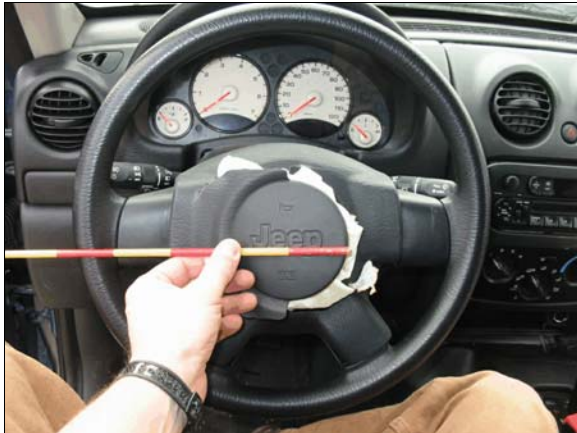
The case vehicle's driver air bag was located in the steering wheel hub. An inspection of the air bag module cover flaps and the air bag fabric revealed that the cover flaps opened at the designated tear points (**Figure 11** below). There was no evidence of damage during the deployment to the air bag or the air bag module cover flaps. The air bag module cover consisted of two cover flaps. The left module cover flap was constructed of pliable vinyl with a circular center portion that contained the Jeep emblem. The left cover flap was 14 centimeters in width

Figure 11: Case vehicle's driver air bag module flap

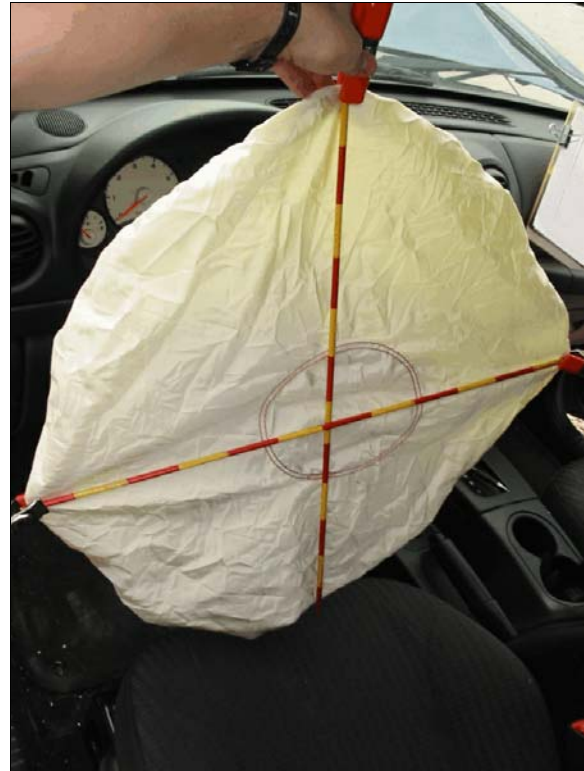
while the circular emblem within the flap was 10 centimeters (3.9 inches) in diameter. Half of the emblem mated to a semi-circular contour in the right module cover flap. The deployed driver's air bag (Figure 12 below) was round with a diameter of approximately 61 centimeters (24 inches). The air bag was designed with two tethers, each approximately 13 centimeters (5.1 inches) in width and had two vent ports (Figure 13), each approximately 3 centimeters (1.2 inches) in diameter, located at the 11 and 1 o'clock positions. No evidence of occupant contact was observed on the driver's air bag.

Figure 12: Case vehicle's driver air bag

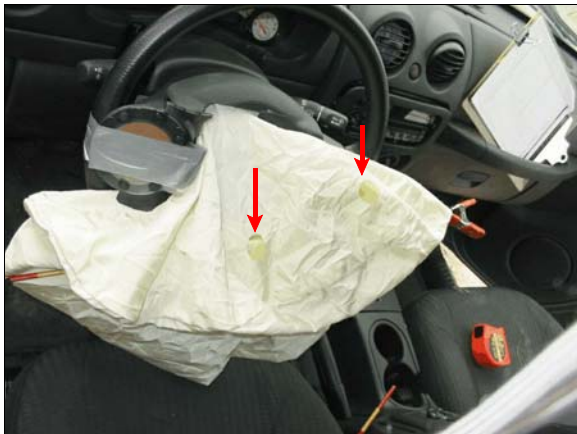
Figure 13: Top back portion of driver's air bag showing vent ports, indicated by arrows

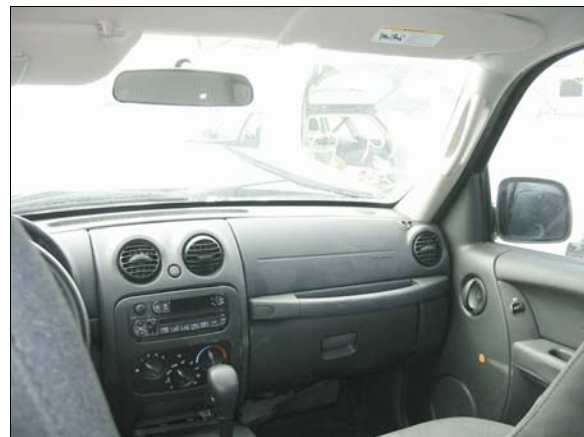
The front right passenger air bag was located in the middle of the instrument panel (Figure 14) above the grab handle. This air bag did not deploy in the crash. The air bag deployment was most likely suppressed by the case vehicle's advanced occupant protection

Figure 14: Front right passenger air bag located in middle of instrument panel above grab handle

system. The sensor in the front right seat most likely determined that the weight on the seat produced by the restrained, 28 kilogram (62 pound), 7-year-old passenger was below the air bag’s enable threshold (the specific threshold is not known) and suppressed deployment of the air bag.

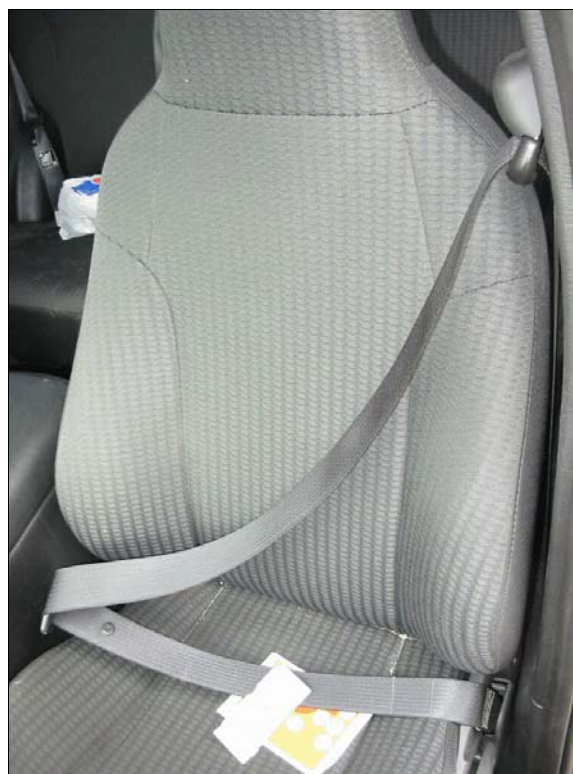
Based on the driver's interview and the vehicle inspection, the driver was restrained by her manual, three-point, lap-and-shoulder safety belt system. Inspection of the safety belt assembly revealed some light scuffs on the shoulder belt webbing. In addition, the retractor was jammed indicating the pretensioner had activated, and a length of the driver's safety belt was found spooled out of the retractor consistent with the belt being worn by the driver (**Figure 15**).

Figure 15: Case vehicle driver's safety belt in buckled position, retractor was jammed with length of belt spooled out of the retractor consistent with safety belt usage in the crash
