TRANSPORTATION RESEARCH CENTER

ON-SITE CERTIFIED ADVANCED 208- COMPLIANT VEHICLE INVESTIGATION

CASE NUMBER - IN-05-007
LOCATION - OHIO
VEHICLE - 2005 HONDA ACCORD
CRASH DATE - January 2005

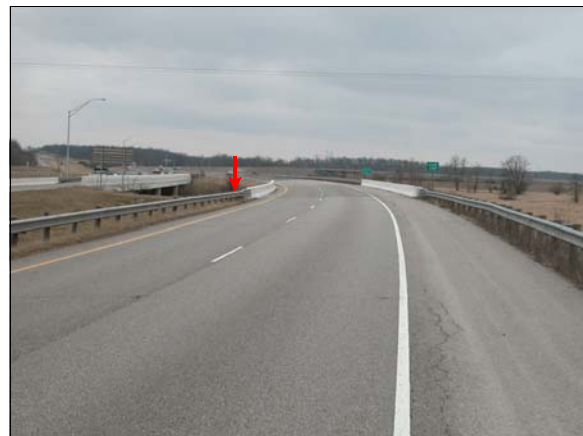
Pre-Crash: The case vehicle was traveling west in a left curve in the inside lane approaching a bridge over a secondary roadway. The case vehicle's driver was intending to change lanes to the outside lane and continue westbound (**Figure 1**). The driver lost control of the vehicle when it contacted an area of "black ice" on the partially snow covered roadway as she was changing lanes. The case vehicle initially started to rotate clockwise and then immediately began to rotate counterclockwise. The driver pumped the brakes

Figure 1: Approach of case vehicle to impacts with guardrail (arrow)

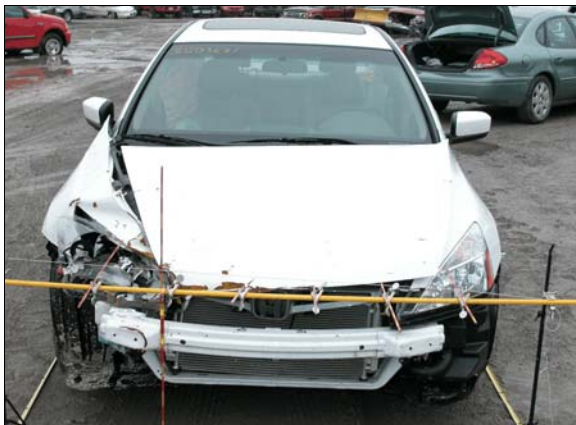
Crash: The case vehicle departed the south edge of the roadway, crossed the shoulder, and the front right of the case vehicle (**Figure 2**) impacted a median guardrail (**Figure 3**). The impact broke a reflector on the guardrail and left scrape marks on the guardrail and a guardrail post. The case vehicle continued to rotate counterclockwise and the right quarter panel (**Figure 4**) impacted the median guardrail (**Figure 5**) causing the front right passenger’s seat back-mounted, side impact air bag and the right side curtain air bag to deploy. The case vehicle’s driver air bag and the front right passenger air bag did not deploy. Following the second impact, the case vehicle continued to rotate counterclockwise and the back right bumper corner (**Figure 6** below) impacted the concrete bridge rail (**Figure 7** below).

Figure 2: Damage to front of case vehicle from first impact with the guardrail

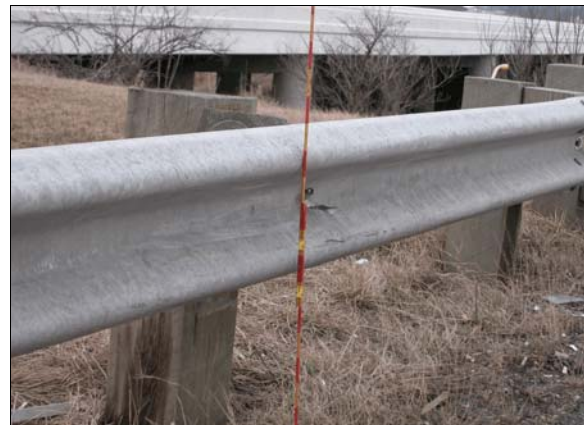
Figure 3: Location of case vehicle’s first impact with the guardrail, each stripe on rod is 5 cm (2 in)

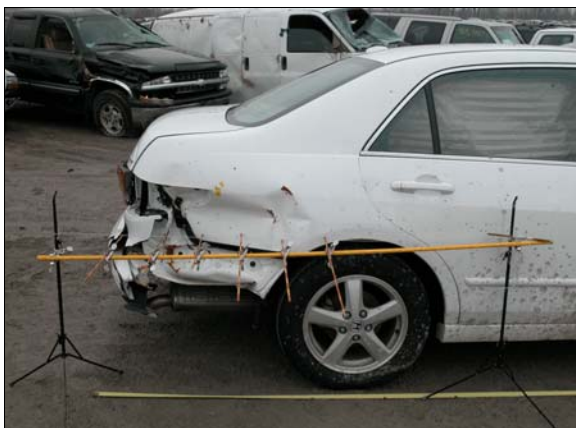
Figure 4: Damage to case vehicle’s right quarter panel from second impact with guardrail

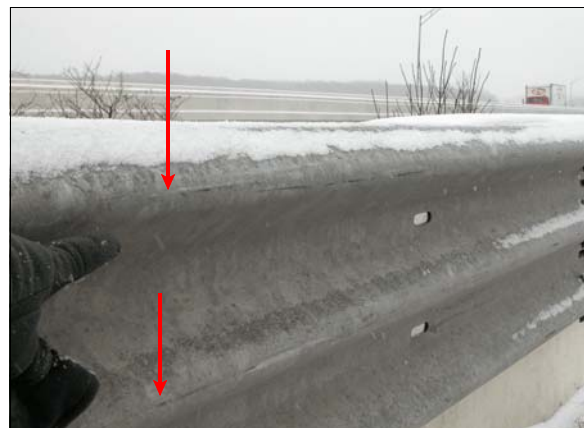
Figure 5: Location of case vehicle’s second impact to the guardrail (arrows)

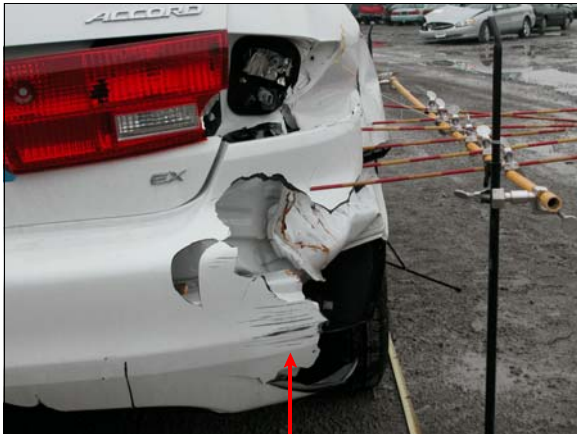
Figure 6: Damage to right corner of back bumper from impact with concrete bridge rail (arrow)

The third impact to the case vehicle involved the right corner of the back bumper. This was a minor contact with the concrete bridge rail that scratched and also likely broke some of the plastic of the back bumper cover. Direct damage began at the back right bumper corner and extended 21 centimeters (8.3 inches) along the bumper cover. There was no measurable crush to the back bumper, only broken plastic.

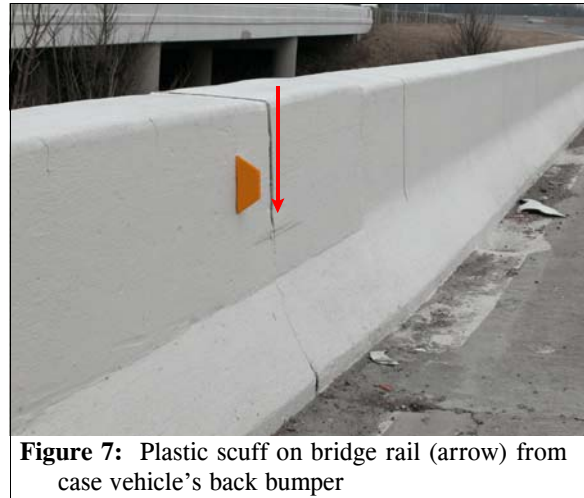
Figure 7: Plastic scuff on bridge rail (arrow) from case vehicle's back bumper

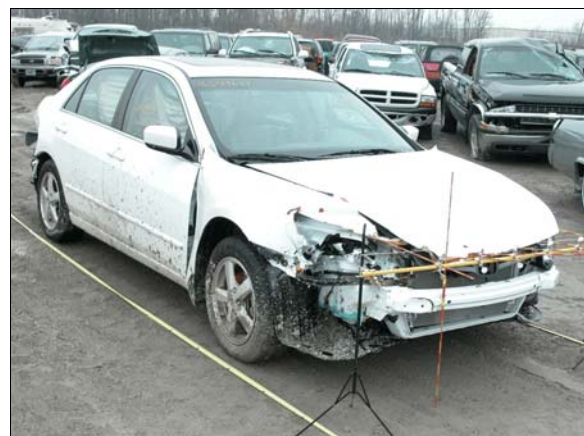
Figure 8: Overview of damage to case vehicle's front end and right quarter panel from guardrail impacts

vehicle (**Figure 8**). The grille, hood, right headlamp/ turn signal assembly and right fender were directly contacted and crushed rearward. Direct damage most likely involved the front bumper cover as well, but it was not present at the vehicle inspection. Direct damage began on the right fender above the right corner of the front bumper bar and extended 73 centimeters (28.7 inches) along the front of the fender, grille and hood. Crush measurements were taken at hood level and at the bumper bar. The maximum crush at hood level was measured as 21 centimeters (8.3 inches) occurring at C₆ (**Figure 9**). There was no measurable crush to the bumper bar. The table below shows the average of the bumper and above bumper crush.

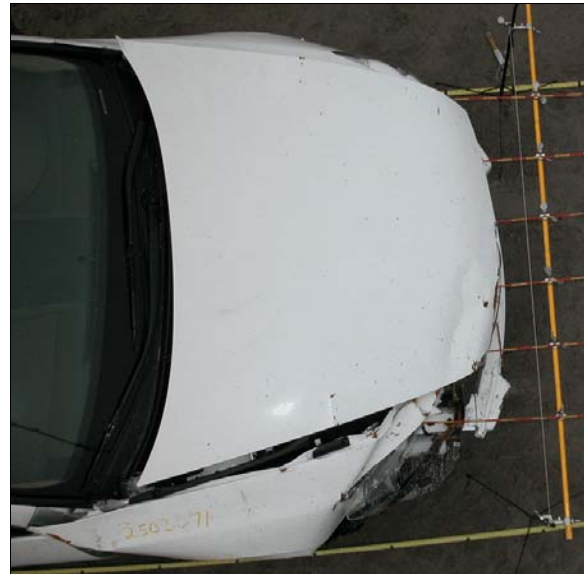
Figure 9: Top view of hood level crush from first guardrail impact

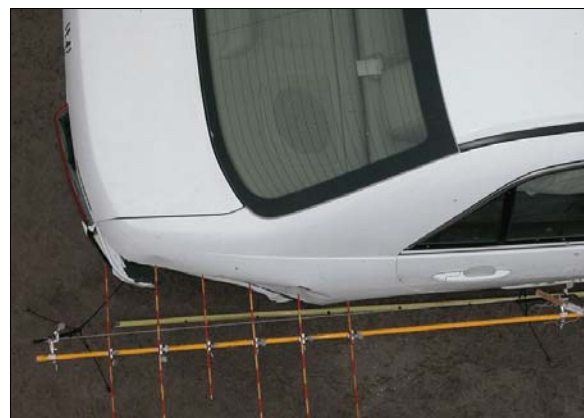
The case vehicle’s second impact with the median guardrail involved the right quarter panel. The portion of the quarter panel rear of the right rear axle was directly contacted and crushed inward and the plastic at the right corner of the back bumper cover was broken, and the corner of the back bumper bar was damaged. Direct damage began 20 centimeters (7.9 inches) rear of the right rear axle and extended 78 centimeters rearward along the quarter panel. Crush measurements were taken at the lower mid-quarter panel level. Maximum crush was measured as 19 centimeters (7.5 inches) occurring at C₂ (**Figure 10**). The table below shows the case vehicle’s crush profile for the seconds median guardrail impact.

Figure 10: Top view of crush to case vehicle’s right quarter panel from second guardrail impact

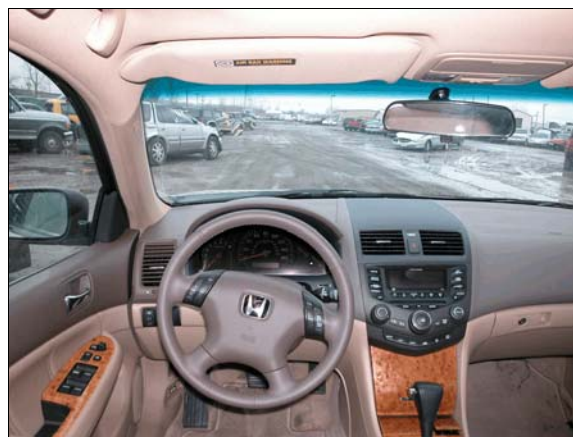
Vehicle Interior: Inspection of the case vehicle’s interior (**Figure 11** and **Figure 12** below) revealed no evidence of occupant contact to any interior surfaces or components. In addition, there was no evidence of compression of the energy absorbing steering column, and no deformation of the steering wheel rim was observed (**Figure 13** below). In addition, the case vehicle sustained no passenger compartment intrusion.

Figure 11: Overview of steering wheel, windshield and instrument panel

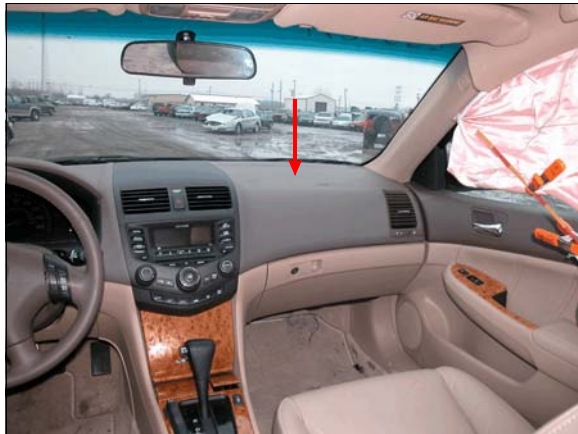
Figure 12: Overview of front right instrument panel, front right air bag located in top of instrument panel (arrow)

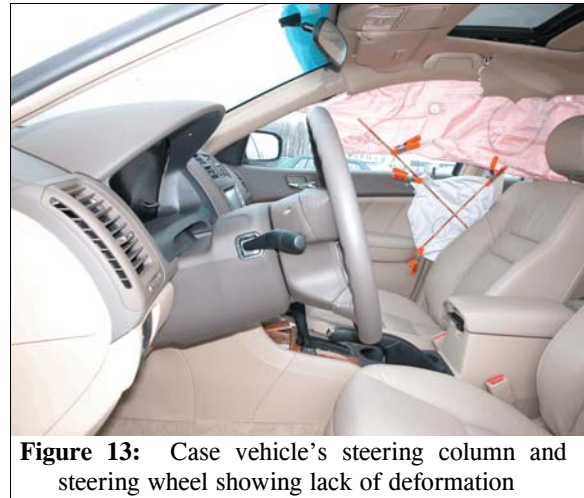
Figure 13: Case vehicle's steering column and steering wheel showing lack of deformation

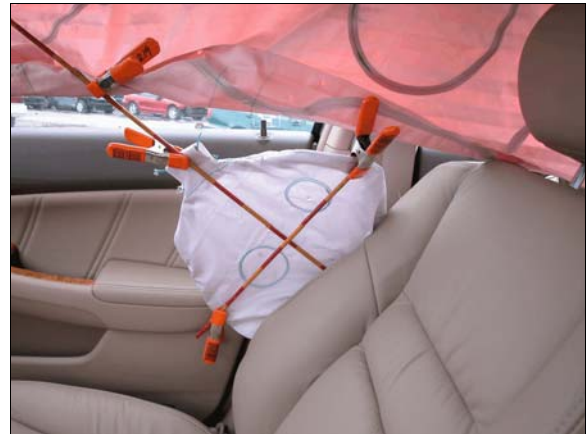
The front right passenger's side impact air bag was located in the front right seat back (**Figure 14** below). The deployed air bag was oblong in shape and had a fabric tab on its leading edge that was separated from the body of the air bag by a stitch seam. The dimensions of the air bag were approximately 35 centimeters (13.8 inches) in width and 26 centimeters (10.2 inches) in length. The air bag was designed with two circular stitch patterns (**Figure 15** below), each

Figure 14: Front right passenger's seat back-mounted side impact air bag

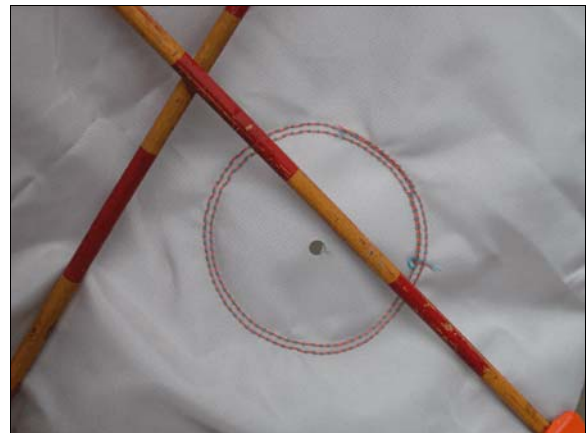
approximately 6 centimeters (2.4 inches) in diameter that stitched the inner and outer surfaces of the air bag together and shaped the air bag inflation chambers during deployment. The air bag was designed without tethers and vent ports. There was no module flap on the side of the seat back. The air bag deployed through a tear-seam in the side of the seat back. There was no evidence of damage to the air bag due to deployment, and no evidence of occupant contact was found on the air bag.

Figure 15: Circular stitch pattern in front right seat back-mounted side impact air bag

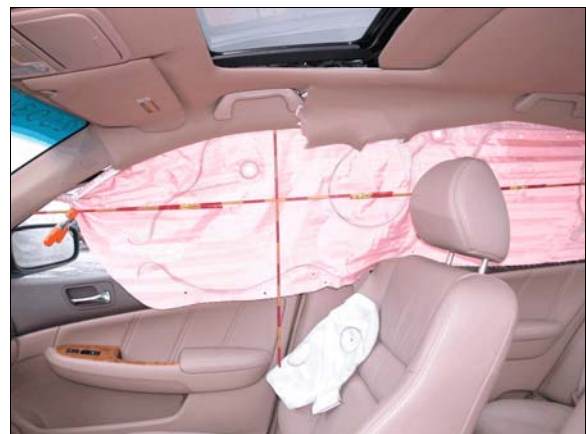
The right side curtain air bag was located along the right roof side rail (**Figure 16**) and folded accordion style inside the headliner. The air bag was designed to provide head protection for the front right passenger and back right passenger seat positions. The air bag was anchored to the upper right A-pillar by an approximate 10 centimeters (4 inches) long cloth cord. The side curtain air bag was approximately 168 centimeters (66.1 inches) in length and approximately 43 centimeters (16.9 inches) in height. It was designed without tethers and had a large inflation chamber adjacent to the front right seat, and a smaller inflation chamber adjacent to the back right seat. The inside and outside sections of the air bag material were stitched together in single stitch seams and double stitched circular areas to form the air bag inflation chambers. There was no evidence of damage due to deployment to the air bag, and no evidence of occupant contact was found on the air bag.

Figure 16: Front right side curtain air bag and front right seat

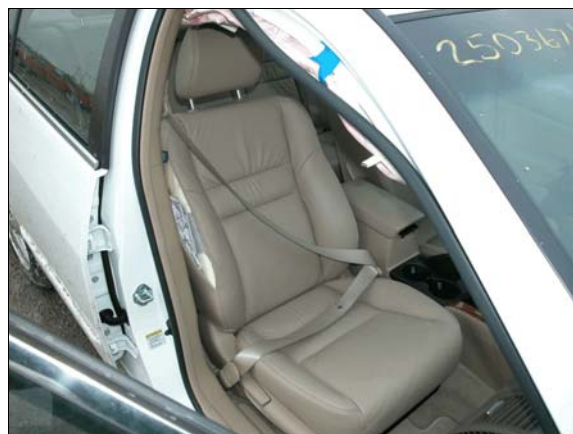
Figure 18: Front right passenger seat with safety belt buckled showing length of belt extended out of jammed retractor

pretensioner had activated, jamming the retractor and leaving about 83 centimeters (32.7 inches) of the safety belt extended out of the retractor (**Figure 18** above).
