CALSPAN ON-SITE CHILD SAFETY SEAT CRASH INVESTIGATION

CASE NO: CA05-007

VEHICLE: 1993 OLDSMOBILE CUTLASS SUPREME

CRASH DATE: JANUARY 2005

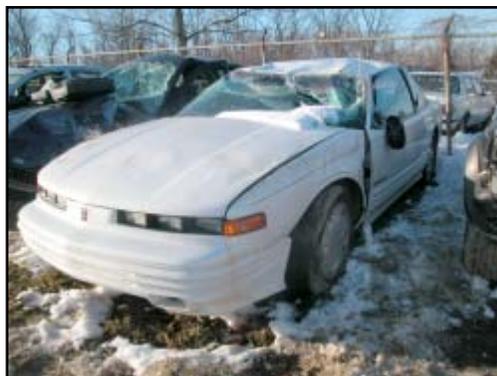
Figure 1. Damaged 1993 Cutlass Supreme

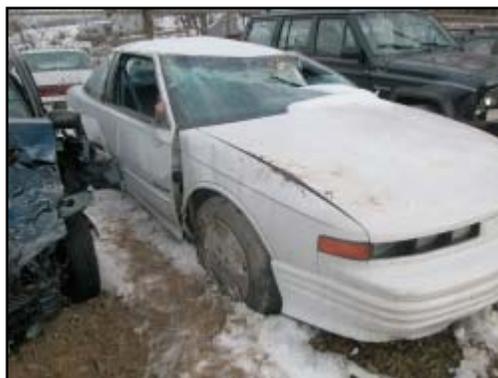
The Cutlass Supreme sustained moderate damage as a result of the rollover (**Figure 5**). The right front fender and right door sustained minor deformation as a result of the ditch bank rollover initiation. The direct contact damage began at the leading edge of the right fender and extended 167.6 cm (66.0”) rearward to 43.2 cm (17.0”) rear of the leading edge of the right front door. The deformation began at the beltline and extended 36.8 cm (14.5”) downward. The maximum lateral deformation measured 2.2 cm (0.9”) and was located 12.7 cm (5.0”) below the beltline and 36.8 cm (14.5”) rear of the leading edge of the right door. The right front wheel exhibited large amounts of dirt and grass from engagement with the ditch and ditch bank. In addition, dirt had accumulated between the top aspect of the right fender and the right side aspect of the hood from contact with the ditch bank during the first quarter turn. The right side mirror was fractured and separated. The right front door window was disintegrated. Diagonally oriented vertical abrasions were present on the face of the right fender and on the forward aspect of the right door, above the plastic body cladding. The lower cladding aft of the right side door was partially separated forward of the right rear wheel. A minor dent was present 55.0 cm (21.7”) rear of the right rear axle on the right rear quarter panel.

Figure 5. Right side damage to the Cutlass Supreme

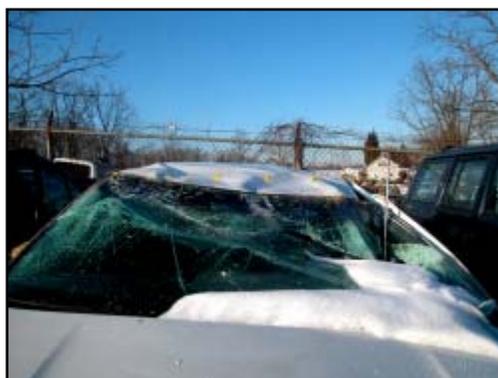
The roof sustained moderate damage as a result of the rollover. Vertical deformation was present primarily over the left front aspect and minor scuff marks were visible across the entire roof surface. The windshield header and left roof side rail were both crushed vertically due to the rollover (**Figure 6**). The maximum roof crush was located at the top of the left A-pillar and measured 12.4 cm (4.9”). Six vertical crush measurements were documented along the windshield header. The distance across the damaged windshield header measured 118.1 cm (46.5”) and the crush measurements were as follows: C1 = 12.4 cm (4.9”), C2 = 6.7 cm (2.6”), C3 = 5.7 cm (2.3”), C4 = 3.8 cm (1.5”), C5 = 2.5 cm (1.0”), C6 = 0.0 cm. Six additional crush measurements were documented along the left roof side rail. The distance across the damaged left roof side rail measured 116.9 cm (46.0”) and the vertical crush measurements were as

Figure 6. Windshield header showing vertical deformation

follows: C1 = 0.0 cm, C2 = 0.0 cm, C3 = 1.3 cm (0.5"), C4 = 5.1 cm (2.0"), C5 = 11.4 cm (4.5"), C6 = 12.4 cm (4.9"). The windshield exhibited two holed areas as a result of the crash. A large hole on the left aspect began 10.2 cm (4.0") left of the centerline and 10.2 cm (4.0") below the windshield header. The hole radiated the entire height of the windshield and laterally to the left A-pillar. The maximum width of the hole measured 55.9 cm (22.0") over the steering wheel. A second hole was located on the right side of the windshield that began 45.1 cm (17.8") right of center and extended 38.1 cm (15.0") diagonally downward to the right A-pillar.

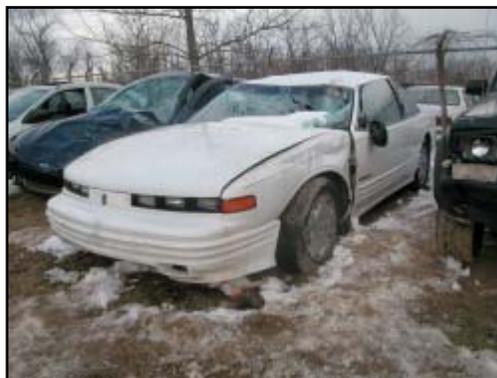
The left side plane sustained minor damage (**Figure 7**). The left front fender was deformed along its entire length. The maximum lateral deformation was located 34.9 cm (13.8") forward of the left front axle and measured 5.1 cm (2.0"). The left side door was slightly displaced, and the left front window was displaced in the window frame, although it remained intact. The top forward aspect of the left front door sustained minor outward displacement, possibly from rescue personnel forcing the door open.

Figure 7. Left side damage

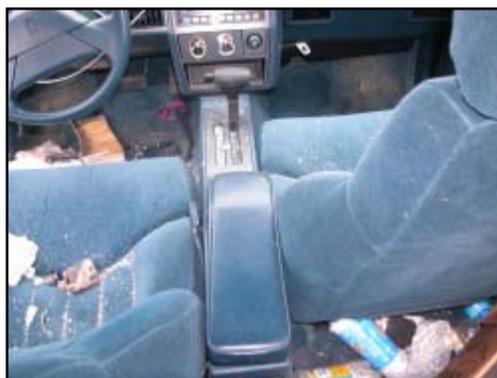
The Oldsmobile Cutlass Supreme sustained moderate interior damage as a result of passenger compartment intrusion and occupant contact. There was no evidence of occupant contact on the instrument panel or steering wheel rim. The top aspect of the center console was displaced 1.3 cm (0.5") to the right as a result of loading from the driver as she initiated her lateral trajectory to the right (**Figure 8**). Both sun visors were displaced from the plastic clasps and the rear view mirror was displaced as a result of the windshield fracture.

Figure 8. Displaced center console

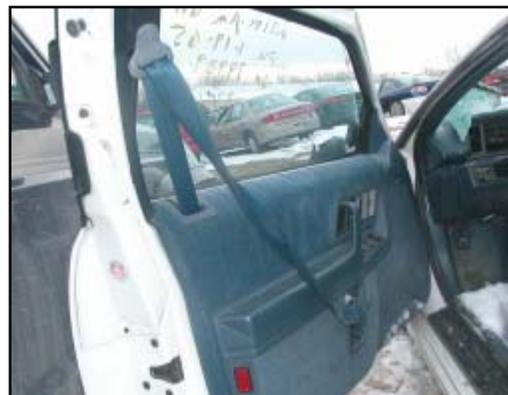
The Cutlass Supreme was equipped with door-mounted 3-point automatic safety belts for the driver and front right passenger positions. Each safety belt was configured with Emergency Locking Retractors (ELR) and a sewn-on latch plate. The driver's safety belt (**Figure 9**) exhibited 1.5 twists in the webbing between the sewn-on latch plate and the door-mounted D-ring. The driver's safety belt was not used in this crash. Due to the "used" nature of the vehicle, faint historical use abrasions on the latch plate could not be attributed to the driver in the crash. A crease in the webbing was present at the D-ring in the stowed position, which suggested lack of historical use.

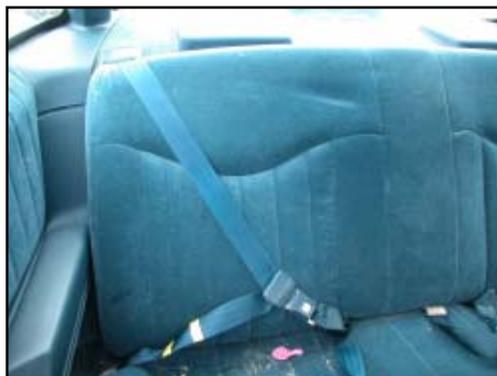
The rear right safety belt (**Figure 10**) was used to install the forward-facing convertible CSS in the vehicle. A lateral crease was present on the safety belt webbing from the latch plate loading, and was located 51.4 cm (20.3”) above the lower anchor. Faint plastic transfers were present on the bottom aspect of the webbing and were located 17.1 cm (6.8”) above the lower anchor and extended 4.8 cm (1.9”) along the webbing. Based on the post-crash installation of the CSS, the plastic transfers appeared to have been a result of engagement of the safety belt webbing with the outboard aspect of the CSS belt path.

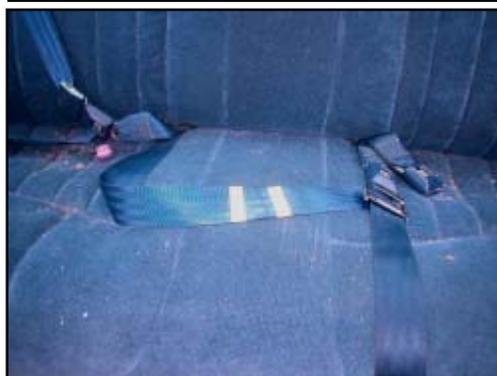
The rear center lap belt (**Figure 11**) was configured with a fixed-length section of webbing and a locking latch plate. At the time of the inspection, the plastic latch plate cover was separated from the latch plate. It was unknown if the latch plate cover was present at the time of the crash, and it should be noted that the missing cover did not compromise the integrity of the locking latch plate. At the time of the vehicle inspection, the lap belt webbing exhibited a lateral crease from latch plate loading located 44.5 cm (17.5”) above the anchor. The total fixed-length lap belt measured 100.3 cm (39.5”).

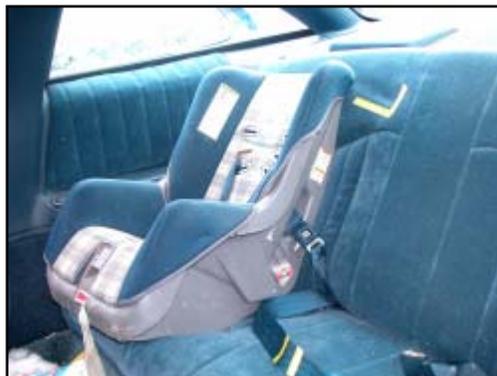
A convertible Century CSS was positioned in the rear right seat and secured by the manual 3-point lap and shoulder belt with the locking latch plate (**Figure 12**). The CSS appeared to be consistent with a Century STE model, but it could not be confirmed. The CSS was configured with a five-point harness system. Most of the labeling on the CSS had been removed, and the model number was unknown. The date of manufacture was August 2001. A warning on the plastic shell stated: “Do not use this car seat after December 2007.” A family member stated that the CSS was purchased new approximately three years ago and was used habitually to restrain the 3-year-old female.

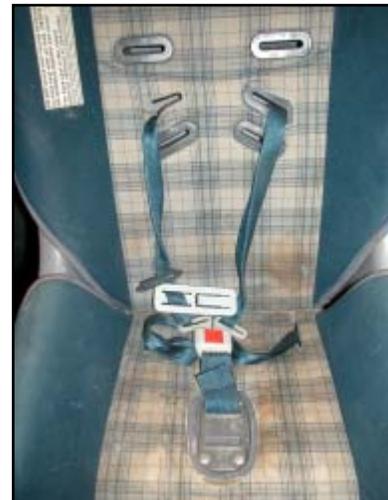
At the time of the CSS inspection, the kickstand was engaged for forward facing use. The family indicated that the kickstand was down at the time of the crash. The shoulder harnesses were routed through the second set of rear-facing harness slots, versus the top set of forward-facing slots. All of the harnesses were folded in half. The length of the left and right harness straps between the slots and the buckle measured 30.5 cm (12.0”) and 27.9 cm (11.0”), respectively. The adjustment tab on the front of the CSS was extended 22.9 cm (9.0”). The harness retainer clip was present on the right harness straps 2.5 cm (1.0”) above the buckle, however, it was unknown if it the left harness strap was engaged with the locking tab on the retainer clip at the time of the crash. At the time of the CSS inspection, the left harness was not engaged with the retainer clip and there was no deformation or historical use marks consistent with regular use. The harness system is shown in **Figure 13**. The CSS was equipped with a tether strap. The tether strap was found in a stowed position on the rear aspect of the CSS, and was not used to install the CSS in the vehicle.

The Century convertible CSS sustained minor damage as a result of the crash. The right second harness slot plastic cover disengaged from the front aspect of the CSS fabric as a result of loading to the harness system by the 3-year-old. The right harness was gathered and jammed in the right latch plate slot as a probable result of occupant loading, as well. The left outboard aspect of the forward-facing belt path sustained abrasions and minor gouges from the engagement against the locking latch plate and buckle, due to the height of the buckle webbing. The right outboard aspect of the forward-facing belt path sustained minor abrasions from loading against the lap belt.

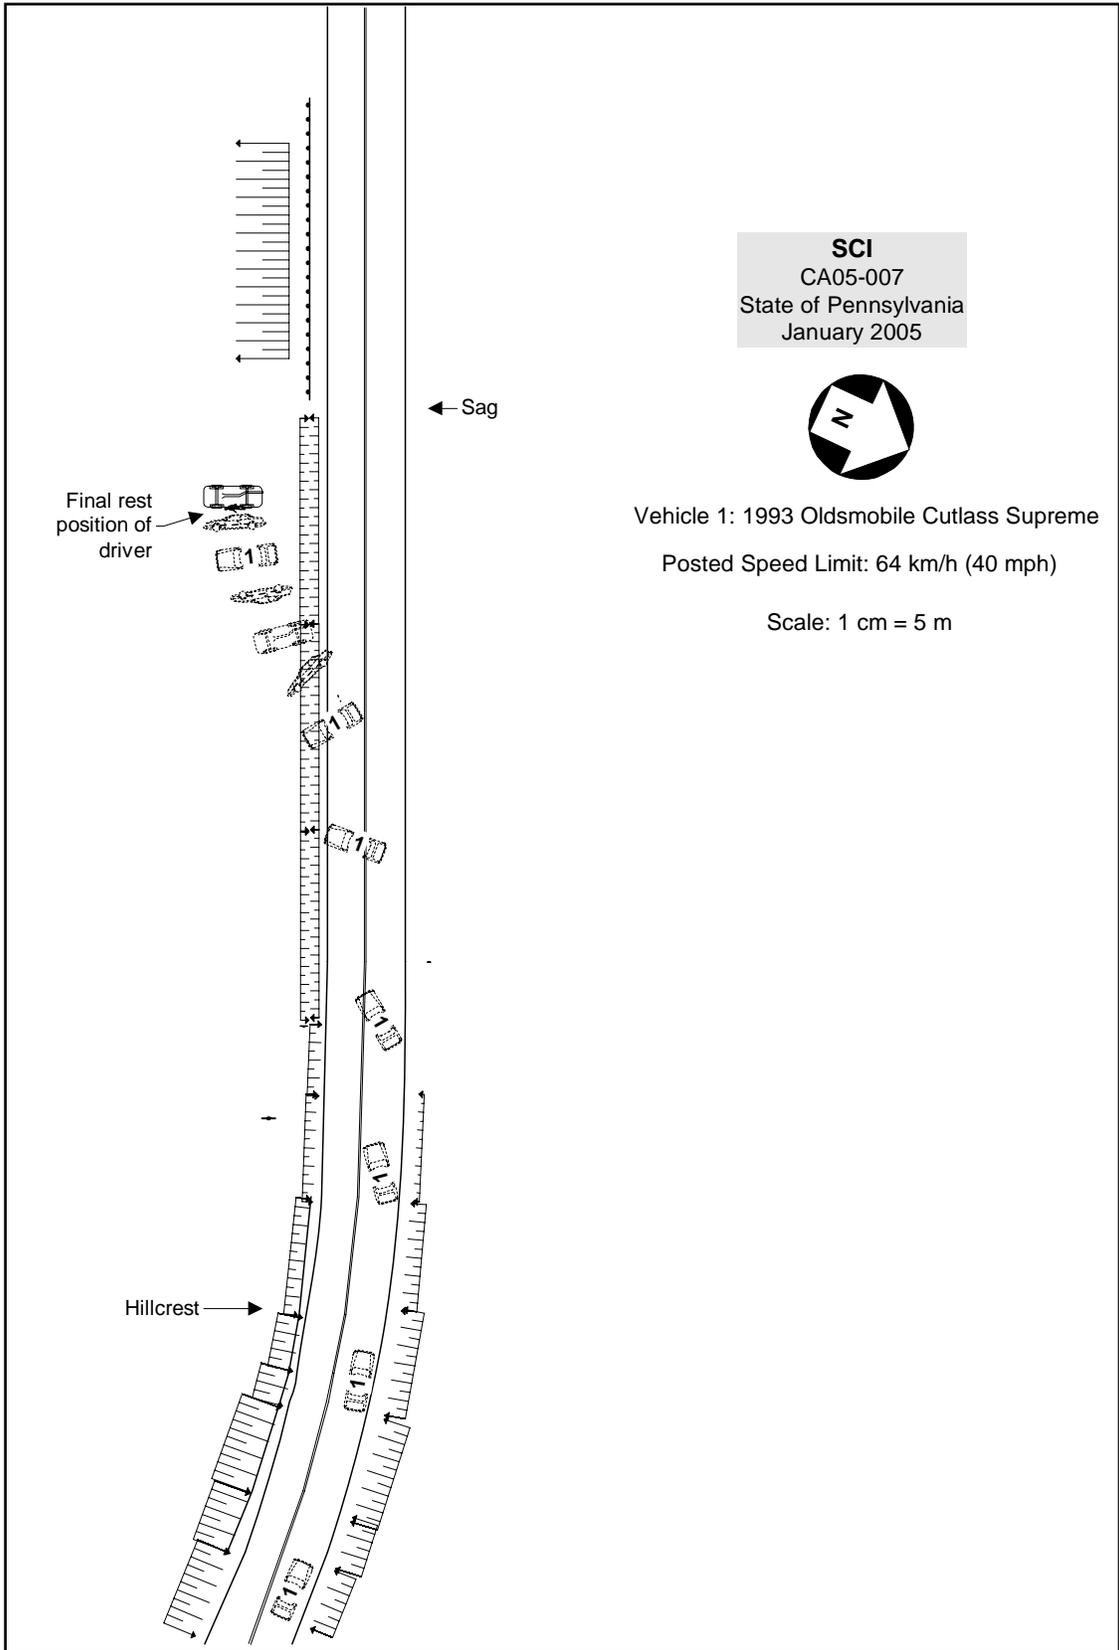
Figure 14. Scene schematic

This single-vehicle crash occurred during nighttime hours in the state of Pennsylvania in January 2005. At the time of the crash, police reported that no adverse weather conditions were present and that the asphalt roadway surface was dry. The crash occurred on a rural two-lane roadway where the roadway exited a southbound left curve with a negative grade from a hillcrest. The north/south roadway was configured with one travel lane in each direction, separated by a double-yellow centerline. The roadway at the crash site, was bordered by grassy fields and a shallow drainage ditch on the east roadside that measured 2.4 m (7.9') in width and 1.0 m (3.3") in depth. The roadway exhibited an approximate 3 percent positive and negative southbound grade on both sides of the hillcrest, respectively. The hillcrest was located at the apex of the left southbound curve 63.7 m (209.0'), north of the roadside departure. The curve passed through a cutout in a hill, which restricted southbound visibility. The earth walls on either side of the cutout measured 3.5 m (11.5') in height at the hillcrest and were located 1.0 m (3.2') from either road edge. At the crash site, the negative southbound grade approached a sag in the roadway, located 24.1 m (79.1') south of the point of roadside departure. A cable guardrail was present on the east roadside at the roadway sag. The guardrail exhibited damage from a previous unrelated crash. The posted speed limit for the north/south roadway was 64 km/h (40 mph). The scene schematic is included as **Figure 14** of this narrative report.
