**CALSPAN ON-SITE CERTIFIED ADVANCED 208-COMPLIANT
VEHICLE CRASH INVESTIGATION**

CASE NO: CA05-008

VEHICLE: 2004 CHEVROLET AVALANCHE

CRASH DATE: DECEMBER 2003

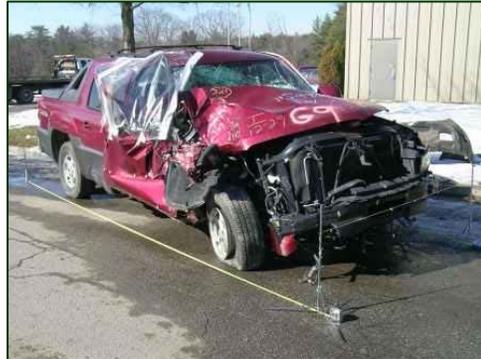
Figure 1. Front right corner damage to the 2004 Chevrolet Avalanche.

The front right corner area of the Avalanche impacted the tree resulting in moderate damage to the frontal and right side planes. The bumper fascia, grille, and right headlamp assembly were removed from the vehicle prior to the SCI inspection. Maximum crush was located at the leading edge of the right front fender and measured 101 cm (39.9"). The direct contact damage along the frontal plane could not be determined from the remaining bumper fascia; therefore, the damage width was measured at the hood face. The contact began 62 cm (24.25") right of the vehicle's centerline and extended 33 cm (13") to the right corner. The direct and induced damage width extended across the full frontal width of the bumper beam and measured 168 cm (66"). The bumper beam and upper radiator support were deformed by the front right corner impact and required independent crush profiles (**Figure 4**). The bumper beam crush was as follows: C1 = 0 cm, C2 = 0 cm, C3 = 0 cm, C4 = 3 cm (1.1"), C4 = 11 cm (4.5"), C5 = 31 cm (12.1"). The profile at the level of the upper radiator was as follows: C1 = 0 cm, C2 = 1 cm (0.3"), C3 = 5 cm (2"), C4 = 10 cm (4.1"), C5 = 19 cm (7.6"), C6 = 39 cm (15.4").

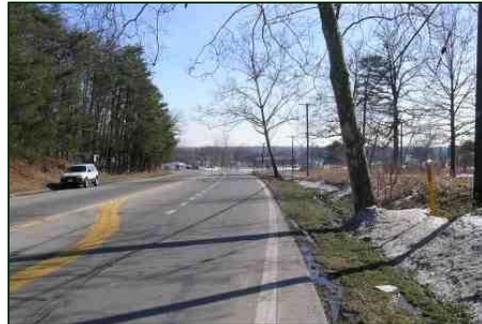
The crash occurred on a three-lane road during nighttime hours under overcast skies with a light rainfall. The asphalt road surface was wet. There were no streetlights in the area of the crash. The driver noted that due to the rain and the lack of overhead lighting, the roadway and surrounding area was extremely dark. The roadway curved to the left for southbound traffic. Prior to the impact site, the grade transitioned from a hillcrest to a two percent negative grade. The roadway also widened from two lanes to three which

Figure 2. Southbound approach to the crash site.

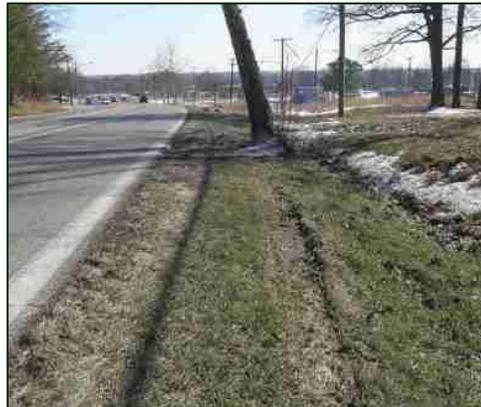
The 42-year old male driver of the 2004 Chevrolet Avalanche pickup truck was traveling in a southerly direction on the two lane roadway at an EDR recorded speed of 51 km/h (32 mph) at -5 seconds prior to Algorithm Enable (AE). He ascended a positive grade and a hillcrest and attempted to negotiate a left curve as the roadway transitioned to a negative grade. The driver allowed the vehicle to drift wide right as it departed the southbound travel lane onto the grassy roadside. A tire mark, probably the right front tire of the Avalanche, was present on the roadside. This mark, which gouged the soft soil, began 21.7 m (71.2') north of the struck tree and faded at 10 m (32.9') north of the tree (**Figure 3**).

Figure 3. Right front tire mark and the struck tree.

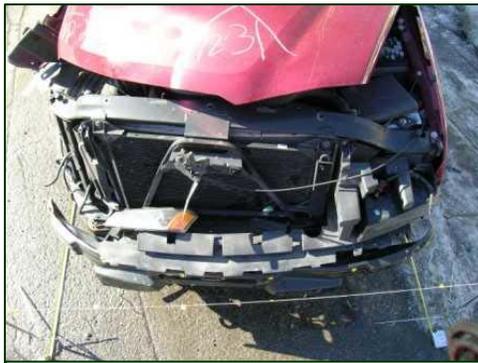
Figure 4. Overhead view of the frontal crush profiles.

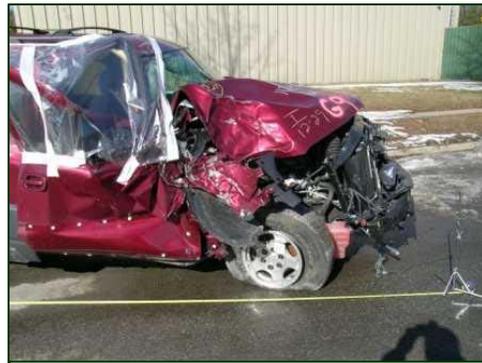
Figure 5. Lateral view of the extent of crush to the right A-pillar.

The direct contact damage continued past the corner area of the frontal plane. The tree engaged the right front tire and wheel and extended into the right A-pillar (**Figure 5**).

The right side wheelbase was reduced in length by 17 cm (6.7"). Additionally, the inner bead of the right front alloy wheel was fractured and the inner sidewall of the tire was cut from tree engagement. The Collision Deformation Classification (CDC) for this impact event was 12-FREE-6.

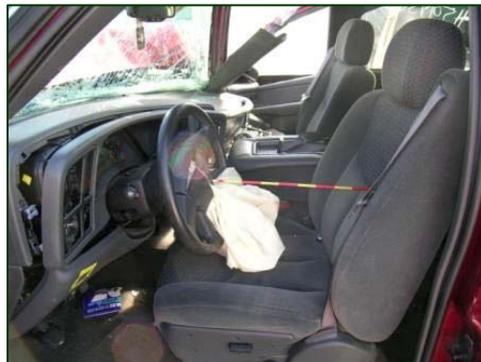
The interior of the Chevrolet Avalanche sustained moderate damage as a result of the frontal impact with the tree and driver contact with interior components. The interior space was reduced in size by intrusion of numerous components. Maximum intrusion involved 33 cm (13") of rearward displacement of the right instrument panel and the lower right A-pillar. The intruding components (**Figure 6**) are identified in the following table:

Figure 6. Passenger compartment intrusion.

Position	Component	Direction	Magnitude
Front left	Face of instrument cluster	Rearward	3 cm (1")
Front left	Knee bolster	Rearward	2 cm (0.75")
Front center	Mid instrument panel	Rearward	14 cm (5.5")
Front right	Mid instrument panel	Rearward	25 cm (10")
Front right	Right A-pillar/IP	Rearward	33 cm (13")
Front right	Windshield header	Rearward	10 cm (4")
Front right	Toe pan	Rearward	Unknown

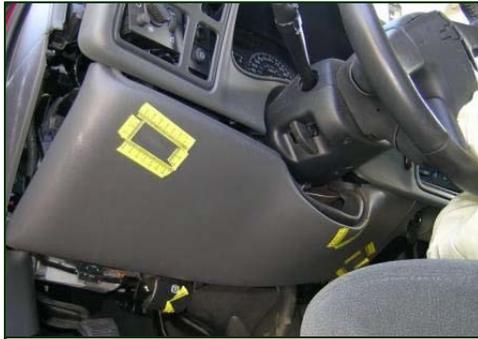
The driver's knees and lower legs contacted and scuffed the knee bolster (**Figure 7**) and the parking brake release lever. These contacts did not produce residual damage. He loaded the manual safety belt system and loaded through the deployed air bag. This loading force was absorbed by the steering wheel flange which deformed, identified by a change in the gap between the steering wheel and the column (**Figure 8**). The left side

Figure 7. Driver knee scuffs to bolster.

Due to his mid track seat position, the driver's knees contacted the knee bolster. His left knee scuffed the bolster as his lower leg scuffed the parking brake release lever. The driver's right knee scuffed the bolster at the base of the steering column. An additional leg scuff was noted to the lower right aspect of the bolster panel. Although the driver denied injury during the SCI interview, the Police Accident Report (PAR) noted that the driver complained of a sore knee. This was probably related to the bolster contact.

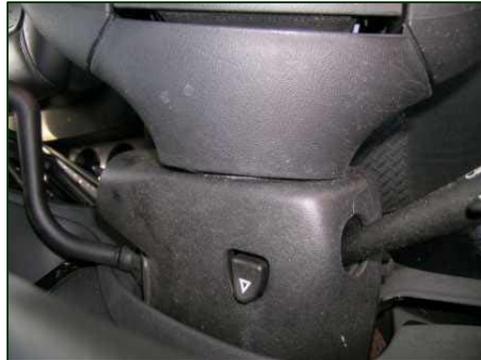
was closed while the right side of this gap was opened to 5 mm (0.4"). There was no compression of the energy absorbing steering column.

Figure 8. Bending of steering wheel flange.

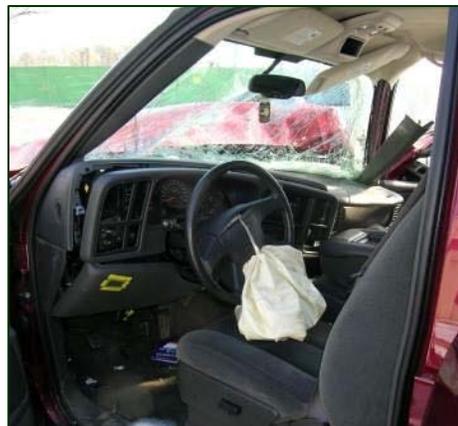
The 2004 Avalanche was equipped with a Certified Advanced 208-Compliant (CAC) frontal air bag system for the driver and front right passenger positions. The system consisted of dual-stage air bags, seat track positioning sensors, safety belt buckle switches, and a front right occupant presence sensor. The front right seat was not occupied; therefore the front right air bag was suppressed. The status of the front right air bag was displayed in the rear view mirror. The manufacturer of this vehicle has certified that the Avalanche meets the advanced air bag requirements for FMVSS No. 208. The driver's air bag deployed from an I-configuration module cover that was incorporated within the 4-spoke steering wheel rim (**Figure 9**). The flaps measured 11 cm (4.5") in height, 7 cm (2.75") in width at the top and 5 cm (2") in width at the bottom aspect. The air bag membrane was 62 cm (24.5") in diameter and was tethered by two wide band straps at the 3 and 9 o'clock positions. The bag was vented by two 3 cm (1.25") diameter

Figure 9. Deployed Stage 1 driver's air bag.

ports located at the 12 o'clock sector of the air bag, 10 cm (4") forward of the peripheral seam. There was no driver contact evidence or damage to the deployed air bag membrane.

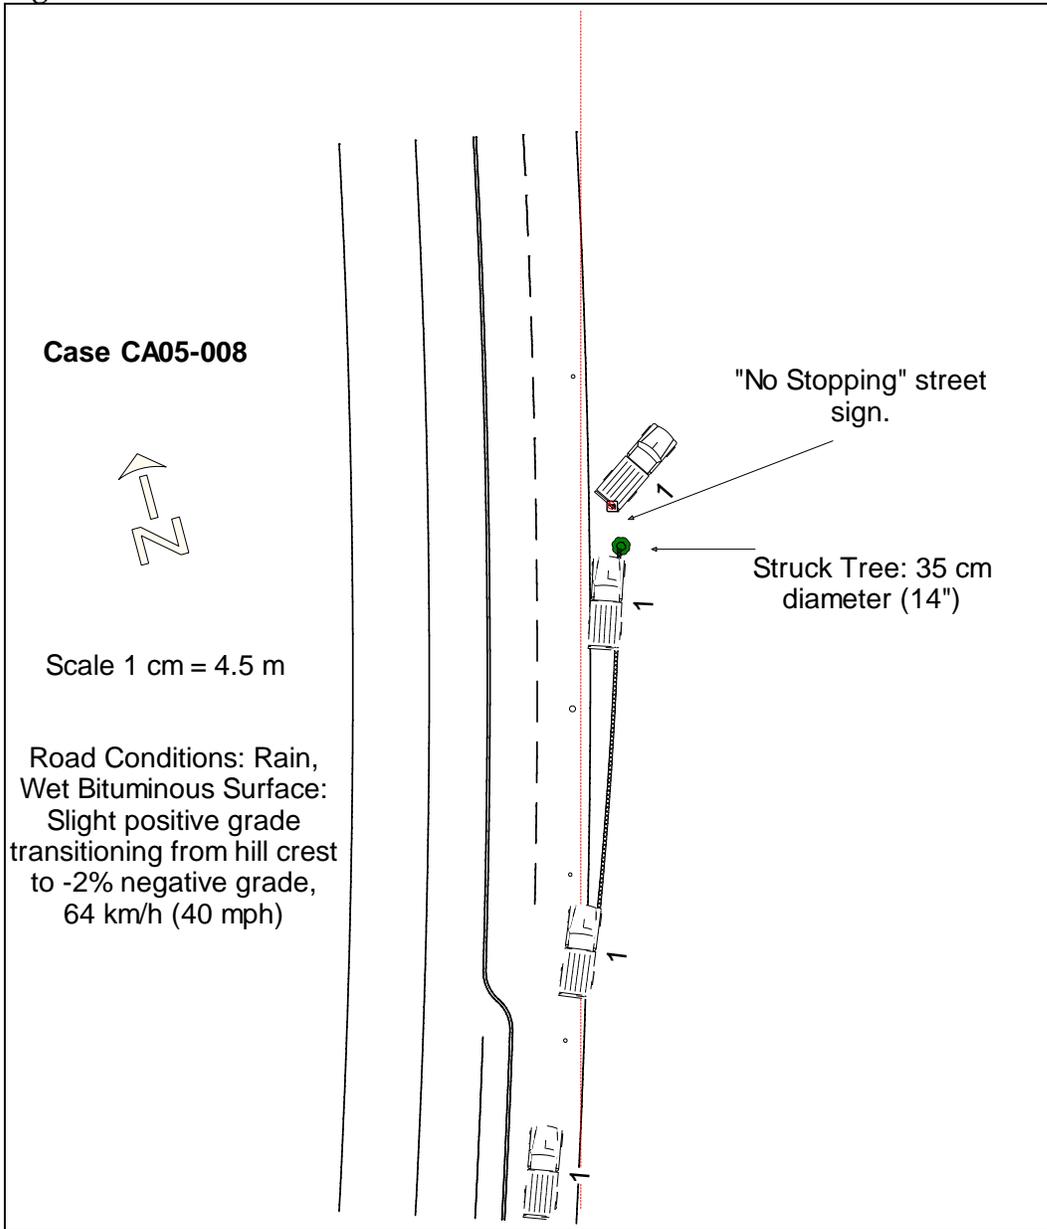
Figure 11 – Scene Schematic

included a designated left turn lane for southbound traffic. There was no stabilized shoulder supporting the southbound travel lane. The northbound lane was bordered by a 4.6 m (5.1') wide asphalt shoulder. The total width of the roadway at the impact site was 9.7 m (31.8'). **Figure 2** is an overall view of the crash site. The Scene Schematic is included as **Figure 11** of this narrative report.
