**CALSPAN ON-SITE CERTIFIED ADVANCED 208-COMPLIANT  
VEHICLE CRASH INVESTIGATION**

**CASE NO: CA05-011**

**VEHICLE: 2004 CHEVROLET SUBURBAN**

**CRASH DATE: DECEMBER 2004**

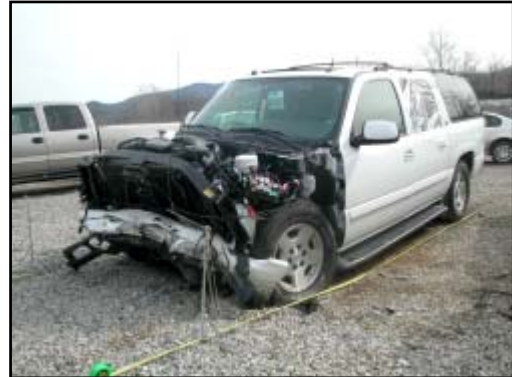
**Figure 1. Damaged 2004 Chevrolet Suburban**

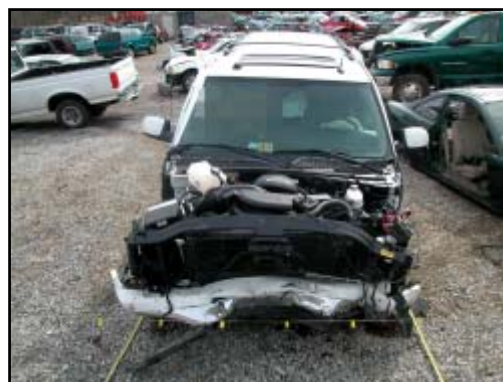
The 2004 Chevrolet Suburban sustained moderate frontal damage as a result of the impact with the Buick Century (**Figure 4**). The direct contact damage began on the front left bumper corner and extended 177 cm (69.5”) across the bumper to the front right corner. The maximum crush was located at C3, 14 cm (5.5”) left of the bumper centerline, and measured 43 cm (17”). Paint transfers and longitudinal abrasions were present on the entire width of the bumper. The entire bumper was crushed rearward and deflected 8 cm (3”) to the right. The forward aspect of the left frame rail penetrated the bumper and was deflected to the right. The front left aspect of the bumper was deflected downward. The combined direct and induced damage measured 172 cm (67.5”) across the entire front bumper. The frontal trim, grille, and headlamps above the bumper were separated from the vehicle. The hood and front fenders were also removed prior to the SCI inspection. The upper and lower radiator supports sustained induced damage and were deflected rearward and to the right. The frontal crush deflected the front axle rearward, which resulted

**Figure 4. Frontal damage to the 2004 Chevrolet Suburban**

in a 10 cm (4") reduction in the left wheelbase and a 7 cm (3") reduction in the right wheelbase. The left front wheel was restricted against the damaged front bumper and the forward aspect of the left sill (**Figure 5**). Minor buckling was present on the roof 15 cm (6") forward of the left B-pillar centerline. The induced roof damage caused slight displacement of the sunroof. The right front door was displaced slightly from the frontal impact. The Collision Deformation Classification (CDC) for the frontal impact with the Buick Century was 12-FDEW-2. Six crush measurements were documented across the front bumper and were as follows: C1 = 35 cm (13.8"), C2 = 34 cm (13.4"), C3 = 43 cm (16.9"), C4 = 34 cm (13.4"), C5 = 18 cm (7.1"), C6 = 18 cm (7.1").

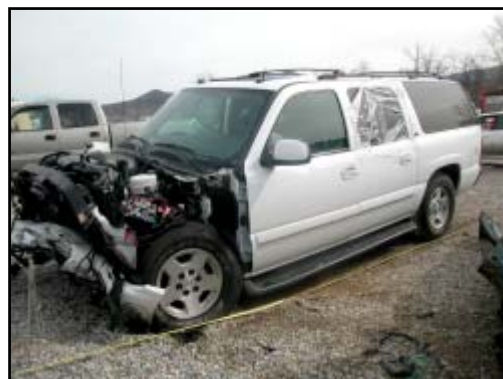
**Figure 5. Left side view**

The left rear window was disintegrated at the time of the SCI inspection, however, there was no additional vehicle damage that was consistent to support a secondary left side impact.

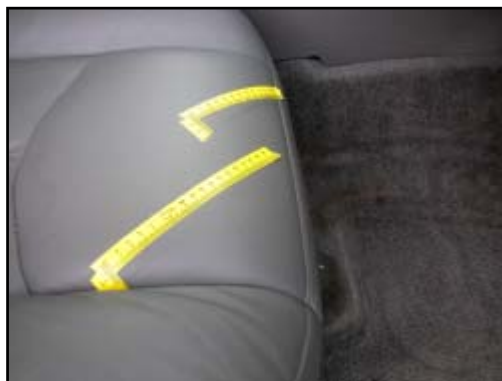
The 2004 Chevrolet Suburban sustained moderate interior damage as a result of occupant contact. Both toe pans sustained minor longitudinal intrusion. The knee bolster was slightly displaced and the upper left instrument panel was partially separated on the outboard aspect. The steering column was compressed forward which resulted in a left shear capsule displacement of 4 cm (1.5"), and a right shear capsule displacement of 3 cm (1.3"). The front right seat cushion exhibited two linear scuffmarks (**Figure 6**). The outboard scuffmark measured 19 cm (7.5") in length and the inboard scuffmark measured 13 cm (5.1") in length. Both scuff marks were oriented at an approximate 45-degree angle from longitudinal. The rear view mirror was displaced slightly CCW, and the inboard front right passenger's visor anchor was partially separated. The vertical separation of the aft edge of the visor anchor measured 1 cm (0.4"). The laterally oriented handle above the front right passenger's air bag module was bowed 3 cm (1.2") upward at the center aspect, and rotated slightly forward from possible contact with the front right passenger's arms (**Figure 7**). The front right passenger's air bag cover flap (immediately below the handle) sustained comparable bowing in the opposite direction at the same location. The HVAC air director located immediately to the left of the front right passenger's air bag cover flap was deflected forward 3 cm (1.2") within its frame.

**Figure 6. Scuff marks on front right seat**

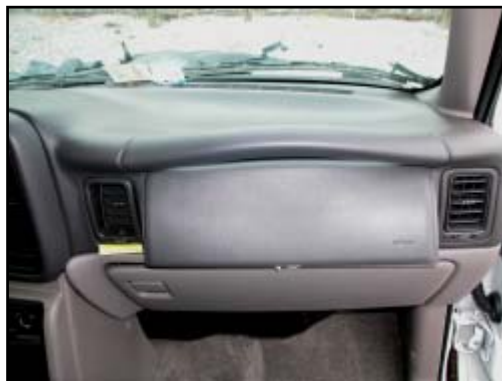
**Figure 7. Close-up of right instrument panel damage from probable occupant contact**

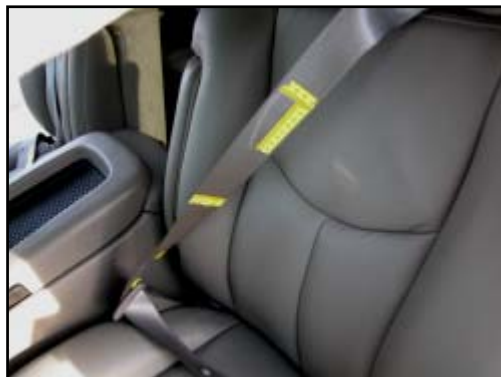
The 2004 Chevrolet Suburban was configured with manual integrated 3-point lap and shoulder belts for the front seats. The driver's safety belt was configured with a sliding latch plate and an Emergency Locking Retractor (ELR). The driver's safety belt webbing sustained minor deformation as a result of occupant loading and the plastic-covered latch plate was abraded from engagement against the webbing. **Figure 8** shows a curvilinear fabric transfer that was present on the bottom plane of the shoulder belt, located 26 cm (10.3") above the latch plate position (located 65 cm (25.5") above the lower anchor). The transfer extended 7 cm (2.9") up the webbing. The front right passenger's safety belt (**Figure 9**) was configured with a sliding latch plate and a switchable Automatic Locking Retractor (ALR)/ELR. The safety belt webbing had been cut 74 cm (29.0") above the lower anchor. The remaining shoulder belt webbing measured 90 cm (38.5") from the integrated shoulder belt plastic trim. The shoulder belt had been used to secure the front right door post-crash. At the time of the SCI inspection, the retractor was restricted and the top aspect of the extended shoulder belt webbing was found gathered in the plastic trim. Due to the post-crash deformation of the safety belt webbing caused by securing the door, loading evidence could not be identified. The sliding latch plate cover sustained faint abrasions from loading.

**Figure 8. Transfer on driver's safety belt**

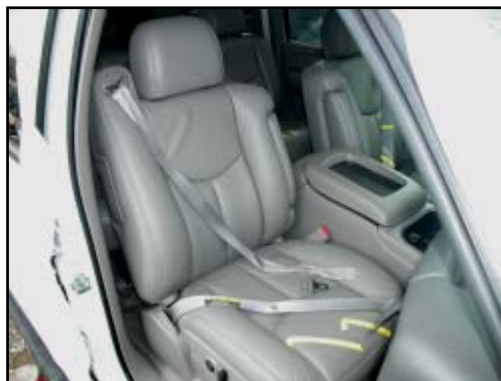
**Figure 9. View of front right passenger's safety belt**

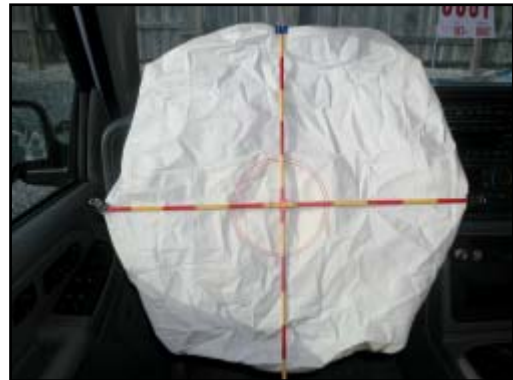
The 2004 Chevrolet Suburban was equipped with a Certified Advanced 208-Compliant safety system that included dual stage frontal air bags for the driver and front right passenger with a Passenger Sensing System. The driver's air bag deployed from the steering wheel hub through symmetrical I-configuration module cover flaps. Each cover flap measured 6 cm (2.5") in width and 12 cm (4.6") in height. The deployed driver's air bag measured 66 cm (26") in diameter in its deflated state (**Figure 10**). There was no contact evidence present on the driver's air bag. The air bag was tethered by two internal straps that measured 13 cm (5.1") in width, and were located at the 3 and 9 o'clock positions. The driver's air bag was vented by two 3 cm (1.2") diameter circular ports that were located at the 11 and 1 o'clock positions, on the rear of the air bag.

**Figure 10. Deployed driver's air bag**

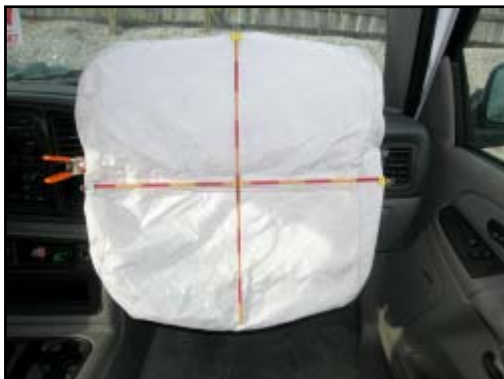
The front right passenger's air bag (**Figure 11**) deployed from a mid-mount module configured with a single rectangular vinyl cover flap hinged at the top aspect. The cover flap measured 39 cm (15.4") in width and 14 cm (5.5") in height. The cover flap was bowed from possible compression of the front right passenger's arm(s) between the opening cover flap and the lateral handle above the air bag module (**Figure 12**). The deployed front right passenger's air bag measured 50 cm (19.7") in width and 56 cm (22.0") in height in its deflated state. The air bag was tethered by a full-width tether strap at the horizontal centerline. It was vented by two circular ports that measured 3 cm (1.2") in diameter, which were located at the 3 and 9 o'clock aspects of the side panels. There was no contact evidence present on the front right passenger's air bag.

**Figure 11. Deployed front right passenger's air bag**

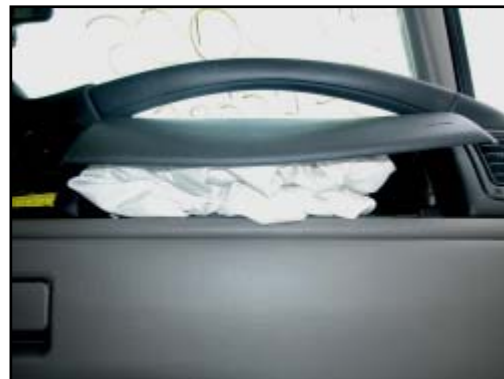
**Figure 12. View from lower instrument panel showing damaged cover flap and lateral handle**
