Child Safety Seat Fatality/ Vehicle to Object
Dynamic Science, Inc. / Case Number: DS05011
2000 Toyota Celica
California
June 2005

1. Report No. DS05011	2. Government Accession No.		3. Recipient Catalog No.	
4. Title and Subtitle Child Safety Seat Fatality Investigation		5. Report Date May 15, 2006

Dynamic Science, Inc.
Crash Investigation
Case Number: DS05011

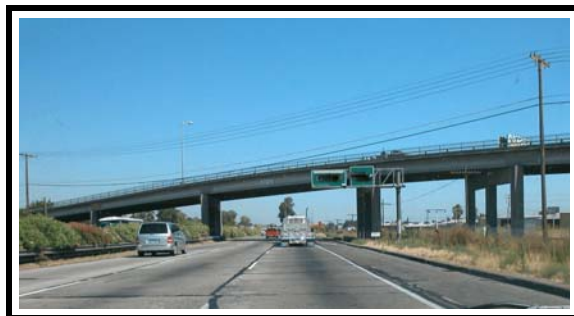
Figure 2. Area of impacts, rollover, and final rest (looking south)—lane 1 to left of image

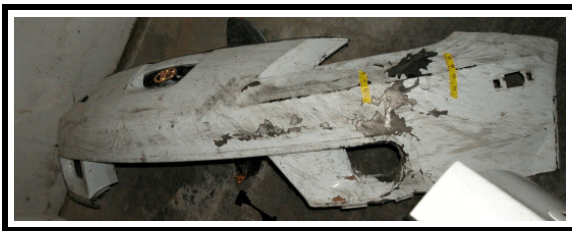
The 2000 Toyota Celica sustained moderate front/left side damage from the impacts with the guardrail and moderate roof damage from the rollover. The direct frontal damage began at the left bumper corner and extended laterally 21.0 cm (8.3 in). Direct damage extended down the left side for 85.0 cm (33.5 in). The left front tire was knocked off and the left wheelbase was shortened by 8.0 cm (3.1 in). The front left rim was abraded and the wheel was flat. There was direct contact damage along the left side of the hood that extended rearward and included the A pillar and the left roof rail and roof area. The mirrors on both sides were broken off. There was direct road surface contact along the right front fender. The front right tire rim was abraded and the tire was flat. Both front doors and the hatch remained closed and operational. The windshield was fractured during the rollover. The right rear window and the backlight glazing disintegrated. The roof glass was cracked and out of place.

Figure 3. Initial contact area to front left bumper corner

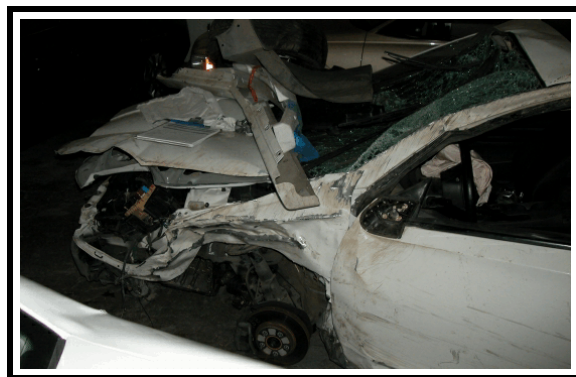
Figure 4. Guardrail damage down left side

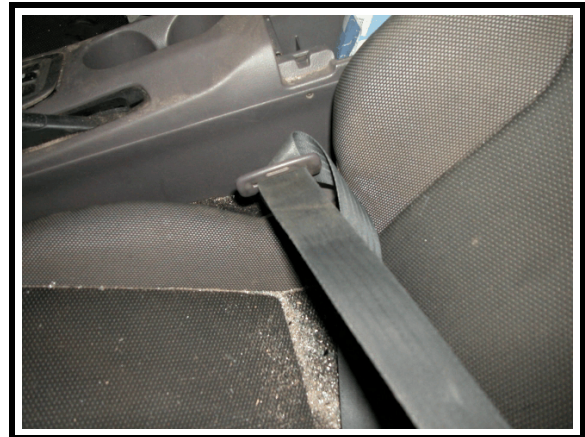
The driver's belt showed signs of past usage and there were also indications of webbing loading at the latch plate area from this crash. The remaining safety belts also showed signs of historical usage.

Figure 5. Loading to webbing of driver's seat belt

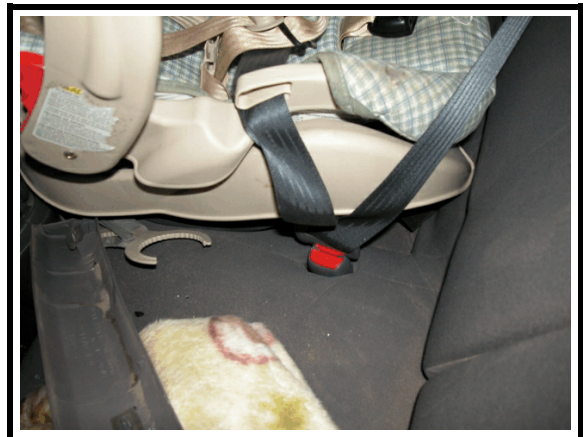
The rear right seat safety belt was used to anchor a Graco Snug Ride infant safety seat. There were no indications that the seat belt had been switched to the ALR mode.

Figure 7. Rear right seat belt—used with infant seat

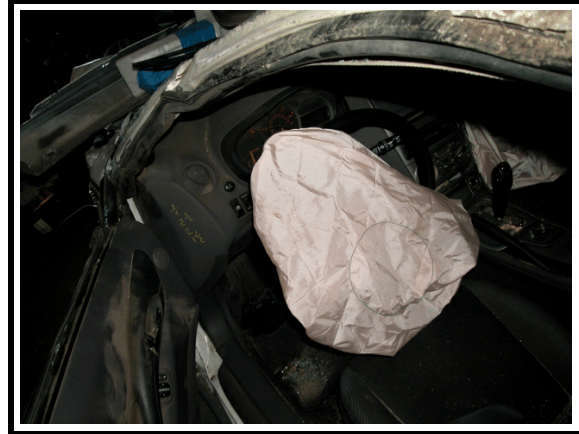
The driver's air bag deployed from the center of the steering wheel hub through Y configuration module cover flaps. The top flap measured 15.0 cm (5.9 in) wide by 8.0 cm (3.1 in) high. The bottom flap measured 15.0 cm (5.9 in) wide by 6.0 cm (2.4 in) high. The deployed driver's air bag 60.0 cm (23.6 in) wide in its deflated state. The air bag was tethered by a single internal tether that was stitched in the center of the air bag face. Two circular vents were located at the 11 and 1 o'clock aspects on the back of the air bag. There was no damage or indication of occupant contact to the air bag.

Figure 8. Driver's air bag

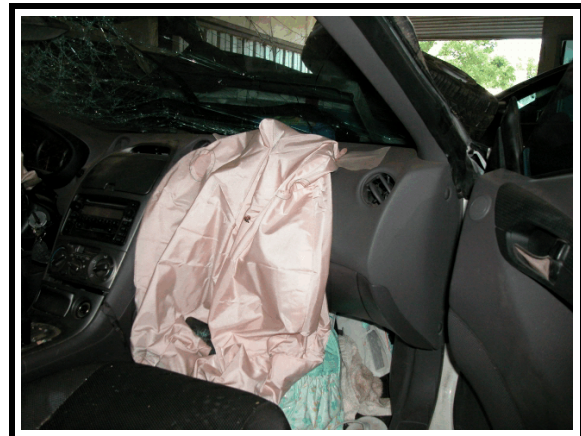
The front right passenger's air bag deployed from a top mount module with rectangular H configuration cover flaps. The top module cover flap measured 21.0 cm (8.3 in) wide by 6.0 cm (2.4 in) high. The bottom module cover flap measured 21.0 cm (8.3 in) wide by 8.0 cm (3.1 in) high. The deployed front right passenger air bag measured 41.0 cm (16.1 in) in width and 38.0 cm (15.0 in) in height. Two circular vent ports were located at the 3 and 9 o'clock aspects of each side panel of the air bag. There was no damage or indication of occupant contact to the air bag.

Figure 9. Deployed front right passenger's air bag

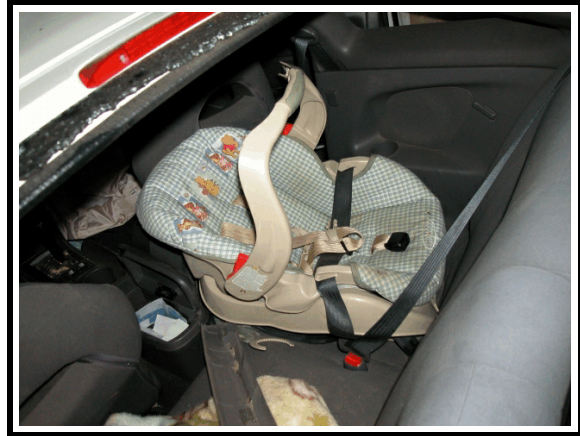
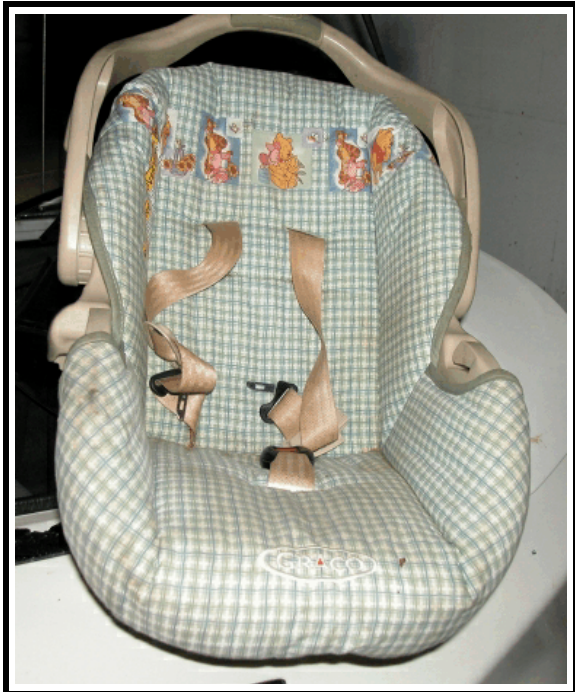
The infant seat was installed in a rear facing configuration using the stay-in-vehicle base. The seat was improperly installed. The Toyota's manual 3-point lap and shoulder belt was routed through the infant seat's vehicle belt hooks that are intended to be used when the seat is installed without the base. When using the stay-in-vehicle base, it is the base that is anchored to the vehicle using the vehicle belt system. The vehicle was equipped with a lap and shoulder belt that was switchable ELR to ALR and had a sliding latch plate. The investigating officer indicated that the belt had not been switched to ALR and a locking clip was not being used.

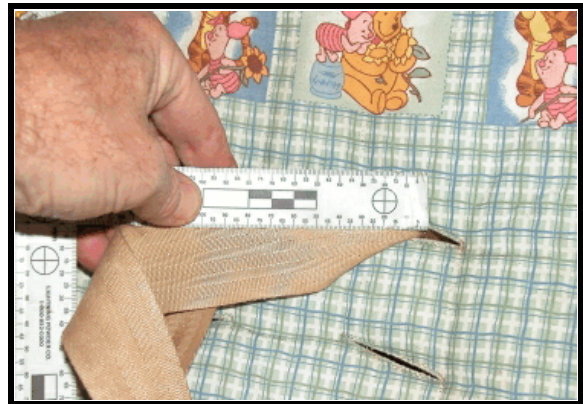
There was no damage to the seat. There were no indications of stress or loading to the vehicle's seat belt. There were faint scuff marks found on the left portion of the harness webbing near the upper left slot.

Figure 13. Scuff located on bottom of left side webbing

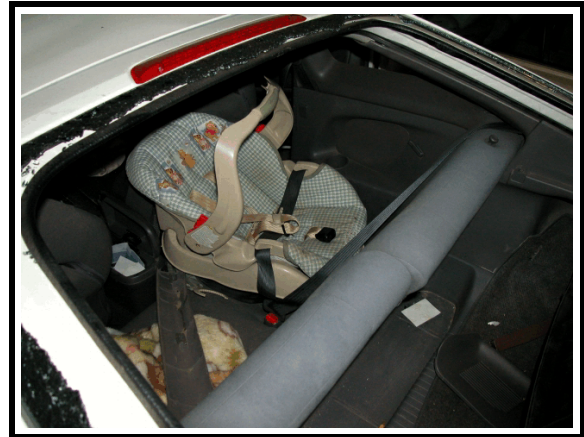
The 4-month-old second row right occupant was reclined in a rear facing Graco Snug Ride infant seat. The infant seat was installed in a rear facing configuration using the stay-in-vehicle base. The Toyota's manual 3-point lap and shoulder belt was routed through the infant seat's vehicle belt hooks that are intended to be used when the seat is installed without the base. When using the stay-in-vehicle base, it is the base that is anchored to the vehicle using the vehicle belt system. The vehicle was equipped with a lap and shoulder belt with switchable retractor and a sliding latch plate. The investigating officer indicated that the belt had not been switched to the ALR mode and a locking clip was not being used. It appears that the child may

Figure 14. Overview showing child seat in relation to rear window

not have been wearing the infant seat's internal 5-point harness or the harness unbuckled at some point. There were no harness loading type injuries. While the parents indicated that the harness was buckled, first responders to the scene found that it was not buckled. As the driver lost control of the vehicle, it entered the left shoulder and struck the guardrail. This rear seat occupant translated forward in response to the 12 o'clock direction of force and began loading the child seat back. The vehicle was redirected to the right. The damage to the left front tire caused drag and the vehicle was pulled back into the guardrail a second time. This was likely a light swiping type impact. The vehicle continued its rotation until had rotated approximately 90 degrees before it tripped and began overturning with its right side leading. As the vehicle completed the first two quarter turns, this occupant was ejected through the backlight. The slope of the rear window and its positioning above the rear seat offers a fairly straight path of egress from the vehicle as the vehicle went over on its roof. The infant seat remained anchored to the vehicle. There were no indications that the child might have slipped out of the harness straps. The child occupant was transported from the scene to a local emergency room where he was declared dead at 2228 hours, less than one hour post-crash. According to the autopsy report he sustained multiple skull fractures, scalp hemorrhages, subdural and subarachnoid hemorrhages, multiple brain lacerations, and multiple abrasions to the head, torso and extremities. The infant seat remained anchored to the vehicle.
