CALSPAN ON-SITE SCHOOL BUS CRASH INVESTIGATION

CASE NO: CA05-012

VEHICLE: 1996 INTERNATIONAL CHASSIS BLUE BIRD SCHOOL BUS

CRASH DATE: FEBRUARY 2005

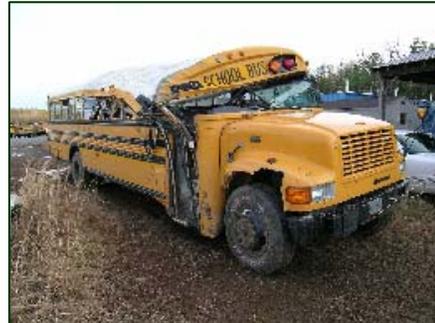
This on-site investigation focused on the severity of the crash and the injury sources that contributed to the death of a 16-year old male school bus passenger. The school bus was a 1996 International Model 3800 conventional chassis with a 64-passenger Blue Bird body. The driver of the bus relinquished control as she attempted to negotiate a right curve of a two-lane roadway in a 56 km/h (35 mph) speed zone. The bus departed the right road edge and entered a drainage ditch that paralleled the roadway. The depth of the ditch caused the bus to cant to its right as it impacted a large diameter tree with the upper right A-pillar, windshield header, and roof area (**Figure 1**).

Figure 1. Exterior damage to the school bus.

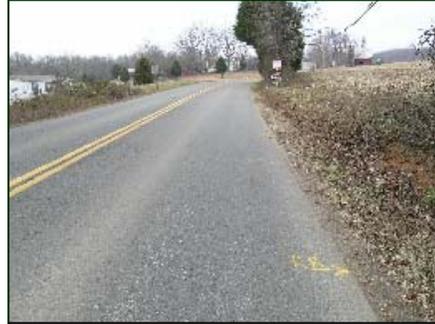
The crash occurred on a rural two-lane east/westbound state route during daylight hours. At the time of the crash, the weather conditions were reported as clear and dry. The asphalt travel lanes were 3 m (10.5') in width and were delineated by double yellow centerlines with no edge lines. Both road edges consisted of earth shoulders that transitioned to shallow drainage ditches. The drainage ditch adjacent to the north road edge averaged 0.6 m (2') in width and varied from 30-76 cm (12-30") in depth and was located 0.5-0.7 m (20-28") outboard of the north pavement edge. A culvert pipe crossed under the road and intersected the north ditch 13 m (42') east of the primary tree impact location. At the location of the culvert, the ditch was approximately 76 cm (30") in depth. **Figure 2** is an overall view of the crash site in the westbound direction.

Figure 2. Overall view of the crash site.

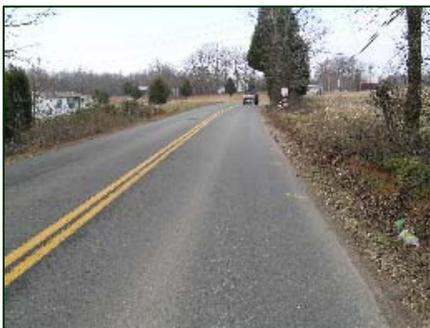
Figure 6. Point of initial road departure of the school bus.

The right roadside departure of the bus was evidenced by subtle rotating tire marks on the earth surface between the pavement edge and the ditch. The right side tires entered the ditch and scrubbed the backside of the ditch as the bus continued in a westerly direction.

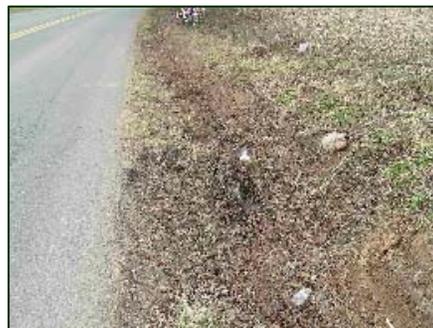
Figure 7. Culvert pipe and deepest point of the ditch.

As the ditch transitioned to a depth of 76 cm (30”) for a culvert that crossed the road (**Figure 7**), the bus rolled laterally to the right as it continued forward. The estimated lateral right roll was approximately 45 degrees. The outboard aspect of the right front tire and wheel, along with the lower right side of the bus were spattered with mud as the bus traveled in the ditch.

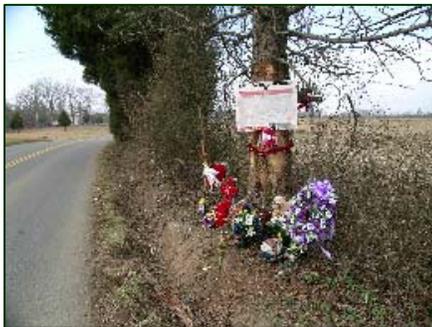
As the bus remained in a semi-rolled attitude of approximately 45 degrees, it continued forward in a westerly direction and struck a 51 cm (20”) diameter deciduous (sweet gum) tree (**Figure 8**). The initial impact involved the upper right corner of the right A-pillar and the windshield header/bulkhead area (**Figure 9**). The impact deflected this corner area rearward 105 cm (41.25”). The upper right A-pillar was crushed rearward to the position of the right B-pillar. The diagonal attitude of the bus resulted in engagement of the roof against the tree. The tree contact extended 109 cm (43”) laterally from the right corner of the A-pillar/header juncture to the centerline of the vehicle. The damage continued rearward along the roof, terminating at the right H-pillar location. The tree was debarked over an area that extended 213 cm (84”) above the ground.

Figure 8. Struck tree.

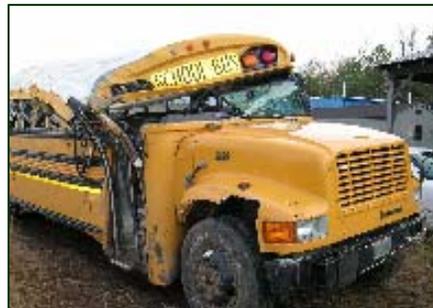
Figure 9. Impact area to the windshield header/A-pillar/bulkhead juncture.

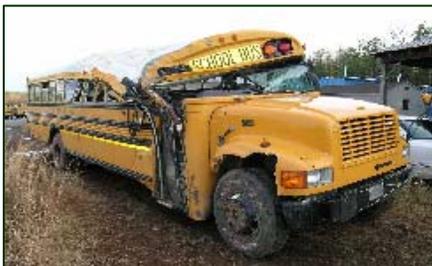
The juncture of the right upper A-pillar, windshield header, and overhead bulkhead area (**Figure 10**) impacted the large diameter tree as the bus rolled to a near 45-degree attitude to the right. As this structural area of the bus was crushed rearward, the roof engaged the tree as the bus continued in a westerly direction. The lateral extent of direct contact damage began at the right corner of the roof/A-pillar juncture and extended 109 cm (43") to the midline of the bus body along the top surface of the bulkhead (vertical face between the windshield header and the roof line). The maximum crush at the leading edge of the bulkhead was measured at 104 cm (41.25") at the right corner (**Figure 11**). The impact displaced the full width of the bulkhead/header area resulting in a combined induced and direct damage length of 203 cm (80"). A reference line was established to the original position of the bulkhead and a crush profile was documented at six equidistant points. The crush values were as follows: C1 = 11 cm (4.5"), C2 = 26 cm (10.125"), C3 = 41 cm (16.125"), C4 = 62 cm (24.25"), C5 = 79 cm (31.0"), C6 = 105 cm (41.25").

Figure 10. Primary impact damage to the header/A-pillar area.

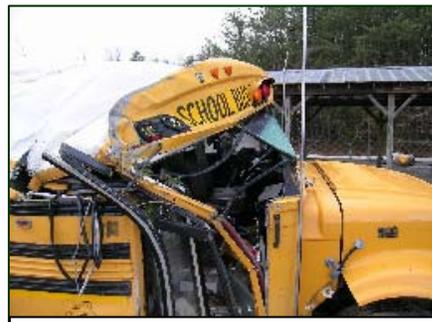
Figure 11. Extent of crush at the header area.

The direct contact damage extended longitudinally along the right roof side rail/upper pillar, and roof areas. The direct contact damage consisted of tree bark transfers and extended 428 cm (168.4") from the deformed location of the right upper A-pillar to the location of the right H-pillar. A vertical crush profile was documented along the right roof side rail at each pillar location. The vertical crush values at the right pillar locations were as follows: A=- 15 cm (15.25"), B=- 56 cm (22.0"), C=- 24 cm (9.5"), D=- 16 cm (6.5"), E=- 13 cm (5"), F=- 5 cm (2"), G=- 1 cm (0.5"), H=- 0 cm.

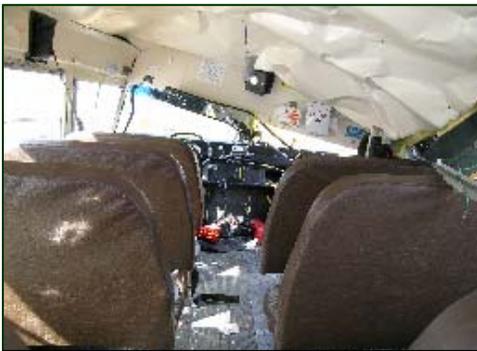
The interior of the school bus sustained severe damage that was attributed to the primary impact with the large diameter tree (**Figure 12**). There was minor interior damage attributed to occupant contact. The driver was reportedly restrained and did not contact interior components forward of her seated position. The driver's belt system did not yield evidence of crash related loading. A fluid spatter was noted to the center and right instrument panel and below that was attributed to a spilled soft drink can that was found on the floor of the bus during the on-site SCI investigation.

Figure 12. Intrusion/interior damage to the school bus.

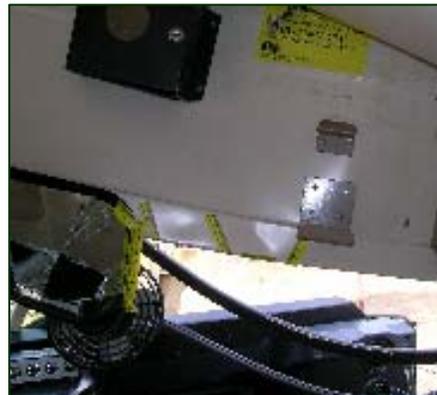
Figure 13. Student passenger head contact points to the mirror and header/bulkhead area.

The student passenger who was seated on the left side of the bus in row one initiated a forward trajectory from his initial right side facing position. His head impacted the large interior rear view mirror (**Figure 13**) that was fastened to the overhead bulkhead above the driver's position. The head contact was located at the right edge of the mirror glass. A skin/hair-like oil transfer was noted to the right aspect of the mirror. This contact fractured the mirror glass and deflected the right aspect of the mirror housing 11 cm (4.5") forward. The lateral deflection of the mirror unit extended 20 cm (8") inboard of the right corner.

Adjacent to the right edge of the fractured and deformed mirror were two areas of deformation (dents) at the lower edge of the overhead bulkhead/windshield header (**Figure 13**). The first dent was circular in nature and was located 9-13 cm (3.5-5.5") right of the centerline and 1-5 cm (0.5-2") above the bottom edge of the header/bulkhead. The dent was approximately 3 mm (1/8") in depth. There was no visible body evidence (hair, tissue, fluid) associated with this dent. The second dent was located 20-28 cm (8-11") right of the vehicle's centerline and 1-6 cm (0.25-2.5") above the bottom edge. This dent was approximately 3 mm (1/8") in depth and appeared to have a vertical crease at the midline that may have resulted from induced buckling as the bulkhead was crushed rearward. The location of these dents was 117 cm (46") forward of the left first row seat back (inclusive of intrusion).

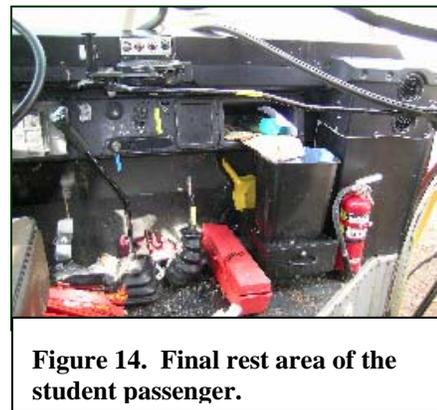
The deceased passenger came to rest on the floor in a slumped position, predominately on his back with his head in the vicinity of the emergency brake lever and the cassette tape box. He bled profusely from the ears and nose onto the cassette tape box and the floor. The investigating officer noted a single hair on the stalk of the emergency brake lever. The brake lever was hinged at the mid point and a rubber boot concealed the lower aspect of the lever/bracket. The mounting bracket for the lever within the boot appeared to be deformed to the right; however, the upper end of the lever remained in a near vertical position. There was no contact evidence on the boot or brake lever. Inspection of an exemplar bus revealed that the bottom brake lever bracket was vertical. This component was initially suspected as an injury source of the deceased passenger and remains as the investigating officer's primary injury source. A plastic release lever was incorporated into the aft portion of the upper brake lever. This protruding component was not damaged. **Figure 14** is a view of the final rest position of the deceased student passenger.

Figure 14. Final rest area of the student passenger.

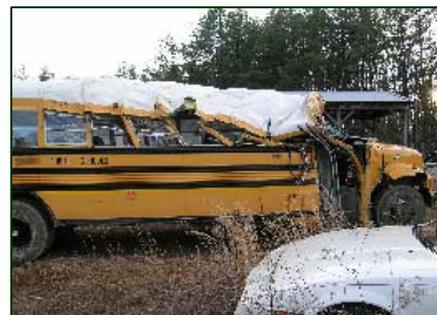
The right side pillars sustained severe damage from the tree engagement (**Figure 15**). The right upper A-pillar at the windshield header was crushed rearward approximately 91 cm (36") beyond the original location of the B-pillar. The pillar deflection fractured two welds and four sheet metal screws below the beltline which resulted in a separation of the mid A-pillar from the front wall of the bus body. The impact also crushed the upper aspect of the right

Figure 15. Right side pillar collapse.

The right B-pillar was crushed rearward to a near horizontal position. The measured angle of the pillar was 85 degrees aft of vertical. The upper aspect of the pillar remained secure to the roof side rail. The top of the right C-pillar was deflected rearward and was completely torn from the side rail. The measured angle of this pillar was 75 degrees aft of its original vertical position. The right D-pillar was crushed rearward and was partially separated at the level of the beltline. The measured angle of this pillar was 55 degrees aft of vertical. The right E- and F-pillars were deflected to angles of 30 degrees with the damage ending at the longitudinal position of the right H-pillar. The G-pillar was displaced to an angle of 18 degrees with 2 degrees of displacement of the upper aspect of the H-pillar.

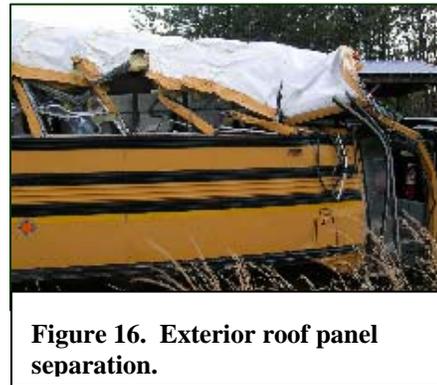
The exterior roof system was comprised of eight aluminum panels that extended laterally from side rail-to-side rail and were fastened to the body with a series of rivets to the side rails and roof bows. Three areas of panel separation resulted from the tree engagement (**Figure 16**). The first panel was 91 cm (36") in width and extended from the windshield header to the B-pillars. This panel overlapped the leading edge of the second panel that was 142 cm (55.75") in width and extended from the B- to the D-pillars. At the location of the right C-pillar, the roof panel was torn in a triangular pattern that measured 10 cm (4") longitudinally and 53 cm (21") laterally, originating at the right side rail. This tear resulted in the separation of seven rivets.

The third roof panel was 142 cm (56") in width and extended from the D-pillars to the F-pillars. At the location of the right D-pillar, there was extensive roof panel separation of the second and third panels at the overlap seam. A triangular separation measured 46 cm (18") longitudinally at the side rail and approximately 46 cm (18") laterally at the aft edge of the second panel and 61 cm (24") laterally at the leading edge of the third panel, both originating at the side rail, extending inboard toward the midline of the roof.

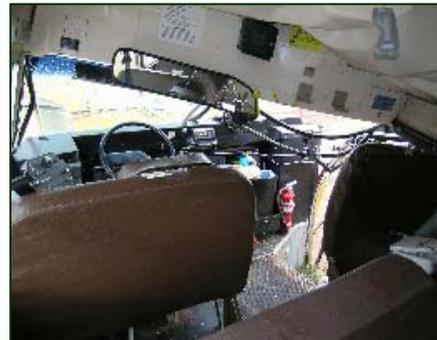
Figure 17. Trajectory and contact points of the student passenger.

forward motion and slightly left due to the rolled attitude of the bus (**Figure 17**). The tree impact crushed the overhead header/bulkhead rearward and downward intruding this component into the passenger's trajectory. He impacted the right aspect of the large interior mounted rear view mirror. An oily skin or hair transfer was noted to the right edge of the mirror glass. This contact deformed the right edge of the mirror 11 cm (4.5") forward and fractured the mirror glass (**Figure 18**). The left side of the passenger's head probably impacted the intruding header/bulkhead adjacent to the mirror contact. Two shallow dents were noted to the vertical face directly above the bottom edge (**Figure 19**). This contact probably resulted in the head injuries the passenger sustained. In addition to the basilar skull fracture, the 16-year old male passenger sustained a herniation of the brainstem, a subarachnoid hemorrhage, a diffuse brain edema, an intra cerebral hemorrhage, and a head laceration.

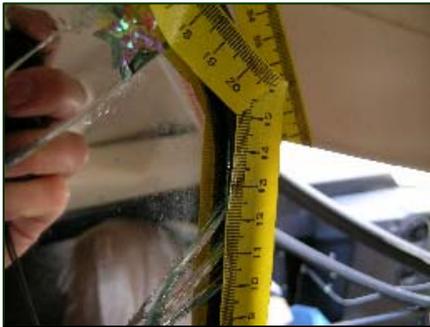
Figure 18. Head contact to the mirror .

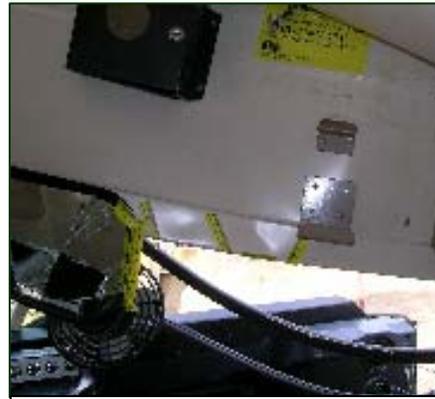
Figure 19. Head contact to the header/bulkhead .
