# INDIANA UNIVERSITY

## TRANSPORTATION RESEARCH CENTER

## REMOTE CHILD AIR BAG-RELATED FATALITY INVESTIGATION

CASE NUMBER - IN-05-012  
LOCATION - Minnesota  
VEHICLE - 1997 Ford Escort  
CRASH DATE - October 2002

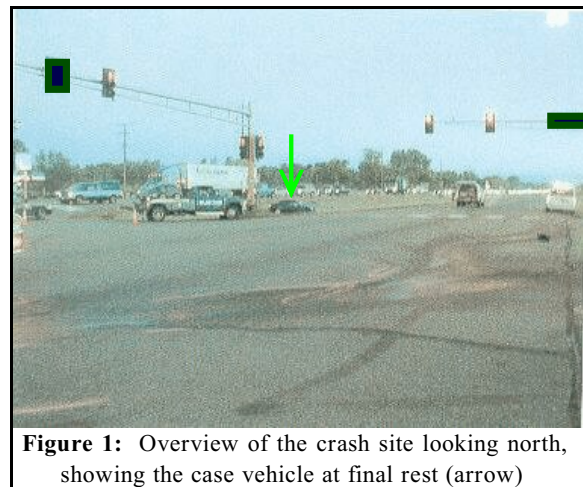
**Figure 1:** Overview of the crash site looking north, showing the case vehicle at final rest (arrow)

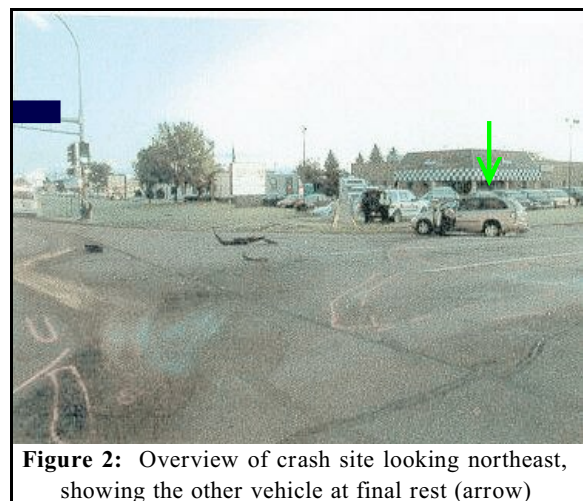
**Figure 2:** Overview of crash site looking northeast, showing the other vehicle at final rest (arrow)

The crash occurred within the intersection. The front of the case vehicle impacted the other vehicle's right side, causing the case vehicle's driver and front right passenger air bags to deploy. The other vehicle's driver and front right passenger air bags also deployed. The case vehicle's driver apparently provided post-impact steering input, leading to the case vehicle coming to rest in the state highway's grass median just north of the intersection, heading eastward (**Figure 1**). The other vehicle rotated clockwise approximately 260 degrees as it slid northeastward. The other vehicle came to rest slightly east of the intersection, with its front wheels off the north road edge and its rear wheels in the roadway, heading a few degrees west of north (**Figure 2**).

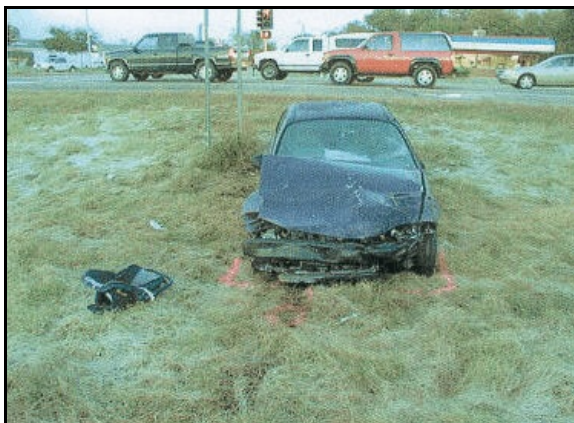
The case vehicle sustained direct contact damage across its entire front (**Figure 3**). The left and right bumper struts were bent and the entire bumper structure was shifted to the right, with the bumper crushed rearward against the radiator. The leading edge of the hood showed direct contact damage and the hood was crushed rearward and folded upward at the center. The leading edges of both fenders sustained direct contact and both headlamp/turn signal assemblies were shattered and broken away. The front portion of the left fender was crushed rearward with induced damage extending back to the left A-pillar (**Figure 4**). There is no visible damage on the left side rearward of the A-pillar. The right side is not visible in the available photographs. It appears that the wheelbase was unchanged and there is no visible damage to any of the wheels/tires or glazing.

**Figure 3:** Front of case vehicle at final rest; note, the child safety seat that was in use at the time of the crash was removed from the vehicle by first responders and is laying on the grass

The CDC for the case vehicle's single impact was estimated from the available photographs as **10-FDEW-2 (310 degrees)**. The WinSMASH reconstruction program, CDC-only algorithm based on the photo-estimated CDCs for the two vehicles, was used. The total, longitudinal and lateral delta-Vs for the case vehicle are, respectively: 30 km.p.h. [18.6 m.p.h.], -19.3 km.p.h. [-12.0 m.p.h.] and + 23.0 km.p.h. [+ 14.3 m.p.h.]. This is a borderline reconstruction but the results appear reasonable. This was a crash of moderate severity (24-40 km.p.h. [15-25 m.p.h.]) for the case vehicle.

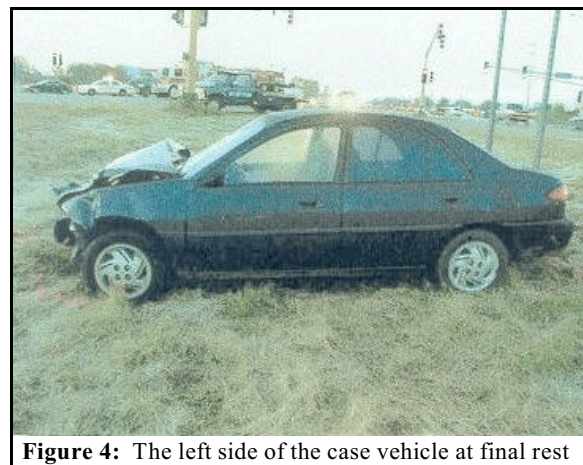
**Figure 4:** The left side of the case vehicle at final rest

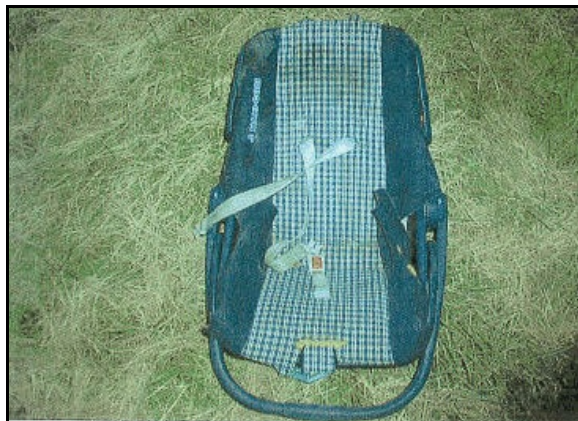
The front right passenger was placed in a Maxi-Cosi "Cabrio" infant carrier/safety seat (ISS) that was intended for rear-facing use in a vehicle, but this make/model is not manufactured or sold for use in the United States. The label indicates that it is suitable for children up to weight 16 kilograms [35 pounds]. The ISS was fitted with a three-point harness system that buckled between the child's legs, with the shoulder straps threaded through the middle slots. It had a folding carrying handle but no shield (**Figure 5**). The ISS consisted of a rigid, one-piece plastic shell lined with padded fabric. The fabric was soiled, heavily worn and frayed in some places. The plastic shell was fractured and a seam was partially separated along the area where the seat cushion joins the seat back (**Figure 6**). The case vehicle driver could not recall whether the child was buckled in the harness or whether the ISS was secured by the case vehicle's safety belt system, and did not know if the seat was forward or rearward facing at the time of the crash.

**Figure 5:** Front of infant seat, photographed where it was found (see Figure 3)

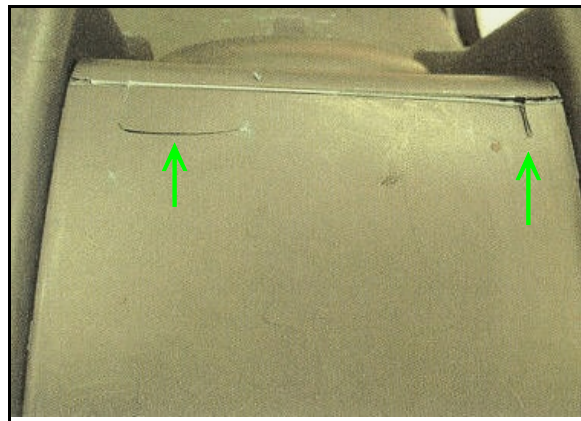
**Figure 6:** Bottom of infant seat, showing fracture of plastic body (left) and separation of seam (right)

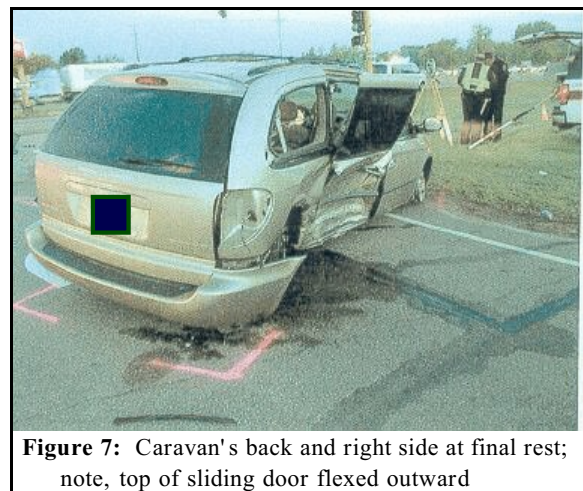
The Caravan sustained direct contact damage along its right side, extending from the B-pillar rearward to the trailing edge of the rear wheel well. The lower half of the sliding door was crushed inward, and this caused the upper half of the door to flex outward (**Figure 7**). The body panel around the right rear wheel well was crushed inward and the right rear wheel/tire assembly was broken off (**Figure 8**). The left rear and right front tires were separated from their rims and deflated, with the left front tire showing no visible damage. The plastic rear bumper cover was displaced and the both tail lamp/turn signal assemblies were entirely absent. The right rearmost window's glazing was disintegrated and all other glazing was undamaged.

**Figure 7:** Caravan's back and right side at final rest; note, top of sliding door flexed outward

The CDC for the Caravan's single impact was estimated from the available photographs as **01-RZEW-3 (40 degrees)**. The WinSMASH reconstruction program, CDC-only algorithm based on the photo-estimated CDCs for the two vehicles, was used. The total, longitudinal and lateral delta-Vs for the Caravan are, respectively: 18.0 km.p.h. [11.2 m.p.h.], -13.8 km.p.h. [-8.6 m.p.h.] and -11.6 km.p.h. [-7.2 m.p.h.]. This is a borderline reconstruction and these results appear somewhat low. This was a crash of low severity (14-23 km.p.h. [9-14 m.p.h.]) for the Caravan.

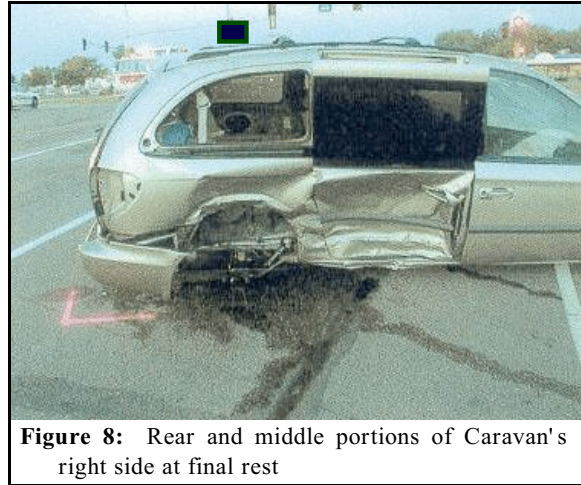
**Figure 8:** Rear and middle portions of Caravan's right side at final rest

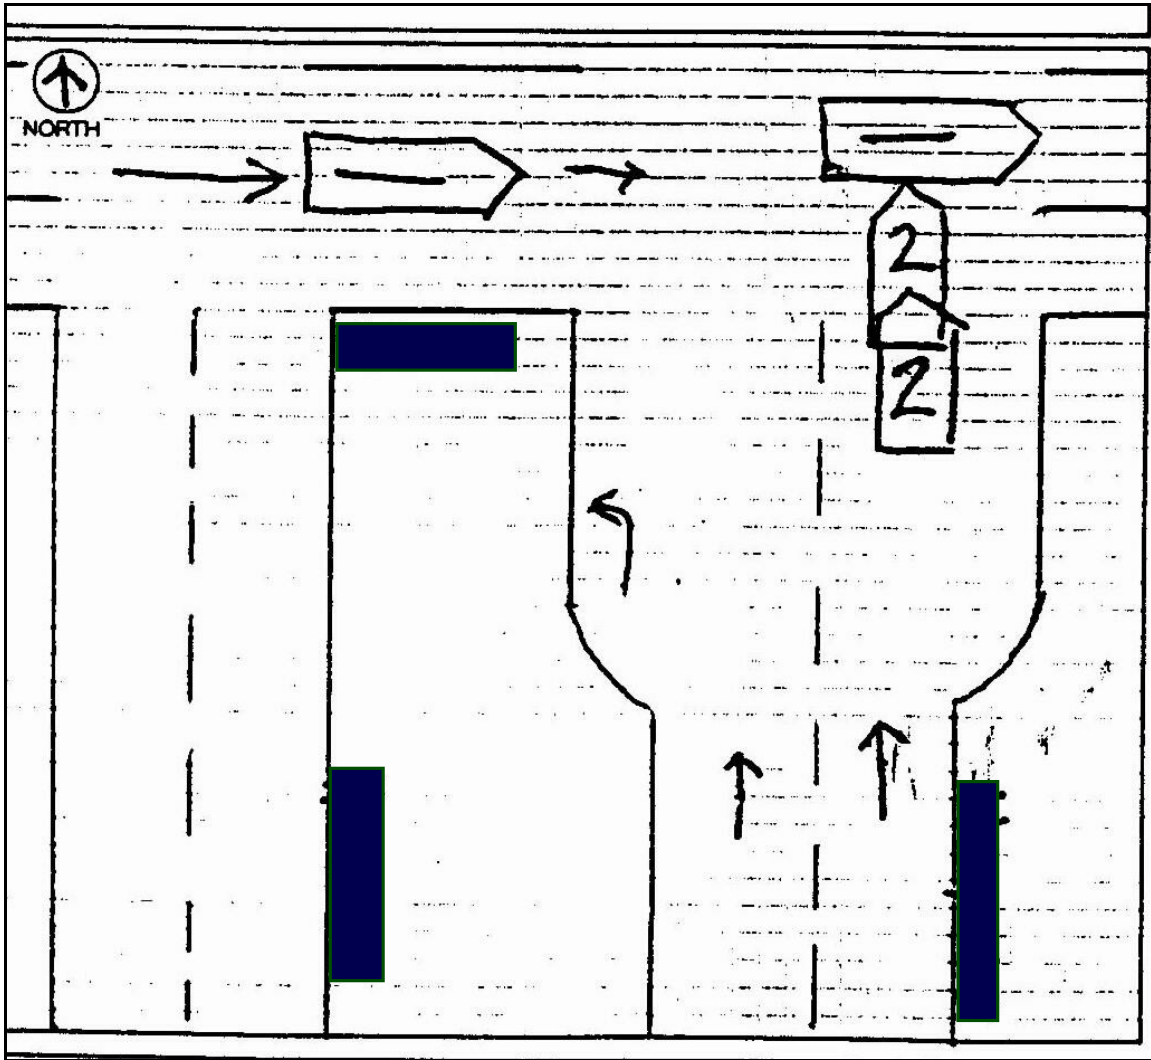
Scene diagram copied from police crash report. The case vehicle is V2 in this diagram.
