CRASH DATA RESEARCH CENTER
Calspan Corporation
Buffalo, NY 14225

ON-SITE CHILD SAFETY SEAT INVESTIGATION
CALSPAN CASE NO: CA05-013

VEHICLE – 2000 FORD EXPEDITION
COSCO EDDIE BAUER CONVERTIBLE SEAT

LOCATION – MARYLAND
CRASH DATE – JANUARY 2005

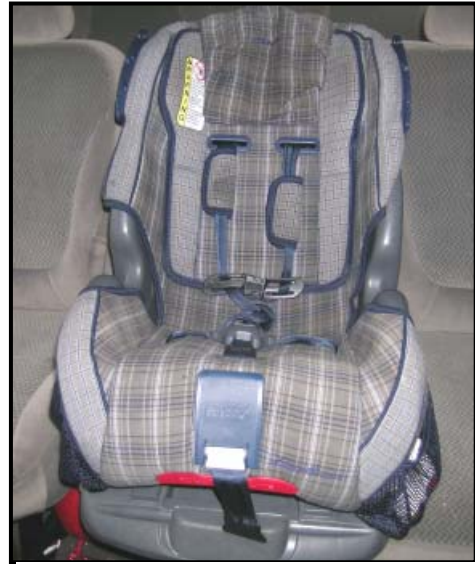
This on-site investigation focused on the performance of a Cosco Eddie Bauer Child Safety Seat (CSS) installed in a forward facing mode in the center rear position of a 2000 Ford Expedition, **Figure 1**. The Ford Expedition was involved in an intersection crash with a 1990 Chrysler New Yorker. The Cosco CSS was occupied by a 4 year old male at the time of the crash. The 36 year old female driver of the Ford failed to yield the right-of-way at the intersection resulting in the impact. The restrained driver of the Ford sustained police reported possible injuries and the child passenger sustained reported non-incapacitating injuries. Both occupants were transported to a local hospital. The 23 year old unrestrained male driver of the Chrysler sustained a police reported disabling injury and was transported to a local hospital.

Figure 1: Front view of the Cosco child safety seat.

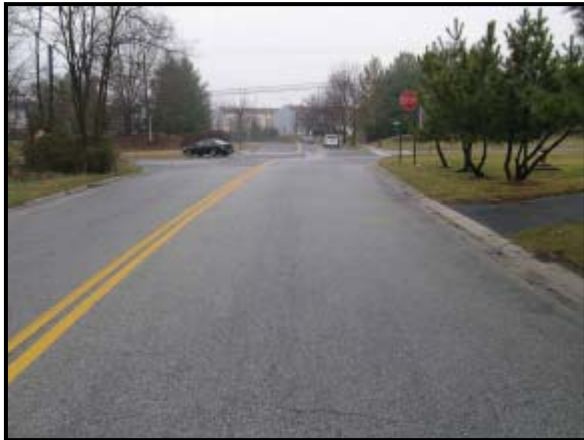
drivers. The speed limit in the area of the crash was 48 km/h (30 mph). **Figures 2 and 3** are northbound and eastbound trajectory views approaching the intersection, respectively.

Figure 2: Northbound trajectory view.

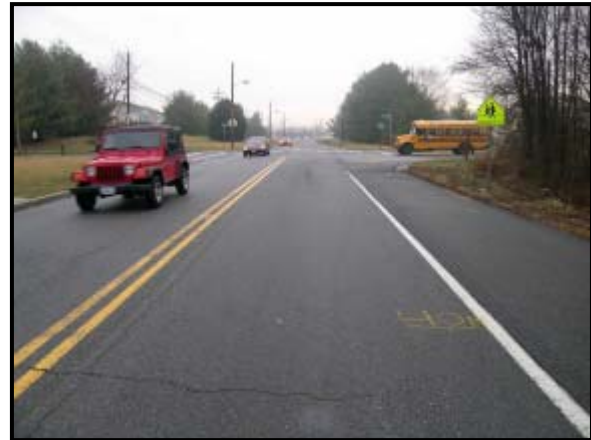
Figure 3: Eastbound trajectory view.

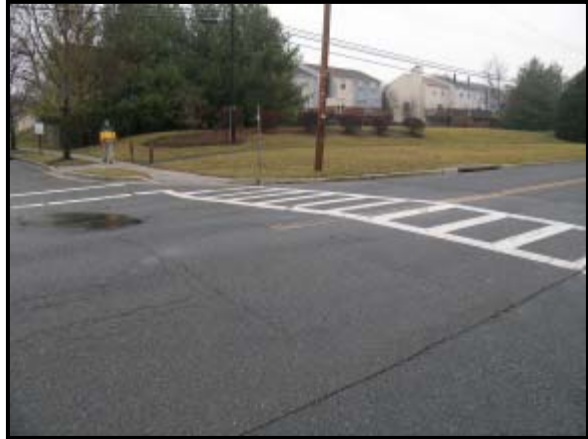
were deflated. **Figure 4** is a view of the northeast quadrant of the intersection. The vehicle mounted the curb and the left rear tire/axle and quarterpanel area of the Chrysler impacted a 23 cm (9 in) diameter utility pole located 1.4 m (4.6 ft) north of the curb edge. This impact, rearward of the vehicle center of gravity, redirected the vehicle's momentum into a clockwise rotation. The contact to the utility pole was evidenced by an 18 cm (7 in) scuff from the Chrysler's Landau roof (upper C-pillar area) that was located 110.5 cm (43.5 in) above the ground. The Chrysler then came to rest facing northeast in-close proximity to the pole (approximately 18.6 m (61.0 ft) from the initial impact). A schematic of the crash sequence is attached to the end of this report as **Figure 15**.

Figure 4: View of the northeast intersection quadrant.

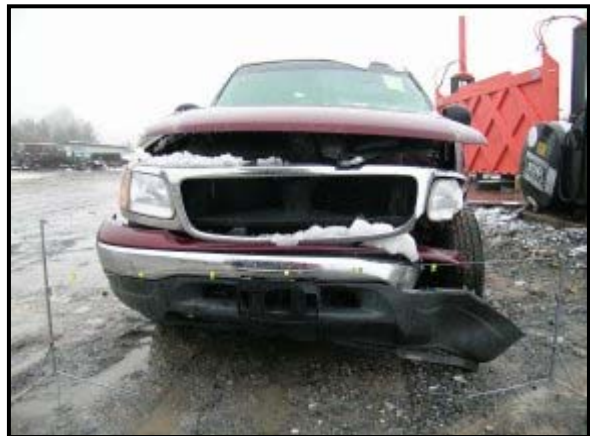
The front and left side planes of the Ford Expedition sustained contact damages consistent with the initial frontal impact and secondary side slap crash sequence. The left aspect of the Ford's front plane sustained 29.2 cm (11.5 in) of direct contact damage that began 56.9 cm (22.0 in) left of center and extended to the left corner, **Figure 5**. The combined width of the direct and induced damage extended across the 142 cm (56 in) end width of the vehicle. The left end of the front bumper deformed rearward and inboard as a result of the 2 o'clock direction of the impact force. The measured residual crush profile at the bumper level was as follows: C1 = 18.0 cm (7.1 in), C2 = 2.0 cm (0.8 in), C3 = 0, C4 = 2.0 cm (0.8 in), C5 = 3.0 cm (1.2 in), C6 = 0. The direct contact from the frontal engagement wrapped around the left corner due to the induced clockwise rotation of the Ford. The direct contact on the left front fender ended 6.4 cm (2.5 in) rearward of the left front axle. The fender was displaced rearward and buckled due to the contact. The left

Figure 5: Front view of the Ford.

wheelbase was reduced 2.8 cm (1.1 in). The right wheelbase was unchanged. The right front door was jammed shut due to the body deformation. Both left doors and right rear door were operational. The Collision Deformation Classification (CDC) was 10-FLEE-3. The delta V calculated by the damage algorithm of the WINSMASH program was 8.7 km/h (5.4 mph). The longitudinal and lateral components were -4.4 km/h (-2.7 mph) and 7.6 km/h (4.7 mph), respectively.

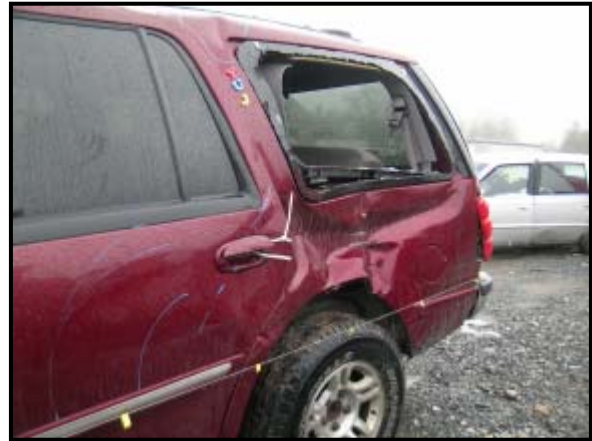
The left quarterpanel of the Ford sustained moderate damage as a result of the sideslap, **Figure 6**. The direct damage measured 71.1 cm (28.0 in), began 37.5 cm (14.75 in) forward of the left rear axle and extended rearward. The maximum crush measured 21.0 cm (8.3 in) and was attributed to contact from the right end of the Chrysler's rear bumper corner. The maximum crush was located 25.4 cm (10.0 in) aft of the left rear axle and 19.1 cm (7.5 in) above the wheel opening. Within the region of maximum crush, two 8.9 cm (3.5 in) long horizontal abrasions were observed. The abrasions were separated 6.4 cm (2.5 in) vertically. This contact pattern was directly attributed to contact with the right corner of the Chrysler's rear bumper. The combined width of the direct and induced damage measured 218.4 cm (86.0 in), began at the left B-pillar and extended to the left rear corner. The measured residual crush profile was as follows: C1 = 0, C2 = 6.0 cm (2.4 in), C3 = 24.0 cm (9.4 in), C4 = 4.0 cm (1.6 in), C5 = 1.0 cm (0.4 in), C6 = 0. The impact caused the left rear window glazing to disintegrate. The CDC of this impact was 09-LZAW-3.

Figure 6: View of the left rear quarterpanel.

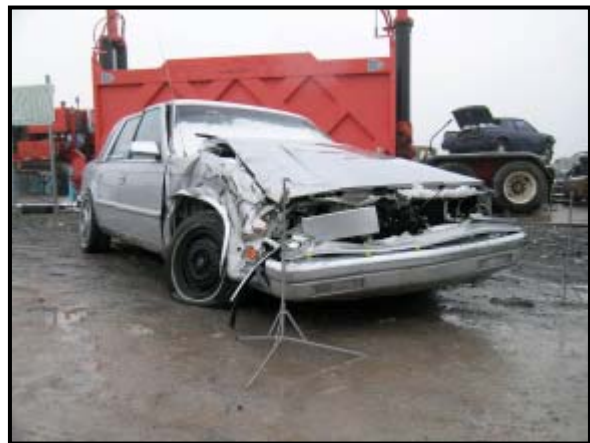
The front, right, and left side planes of the Chrysler sustained three distinct regions of damage directly related to the vehicle's multiple crash sequence. The right aspect of the Chrysler's frontal plane sustained 30 cm (12 in) of direct contact damage that began 45.0 cm (17.75 in) right of center and extended to the right corner. Refer to **Figure 7**. The direct contact then wrapped around the right front corner due to the vehicles' rotation and ended 5.1 cm (2.0 in) rearward of the right front axle. The residual crush profile measured along the bumper was as follows: C1 = 0, C2 = 0, C3 = 2.0 cm (0.8 in), C4 = 5.0 cm (2.0 in), C5 = 8.0 cm (3.1 in), C6 = 12.0 cm (4.7 in). The right wheelbase was reduced 12.4 cm (4.9 in). The windshield and side

Figure 7: Front right oblique view of the Chrysler.

window glazings remained intact and all the doors were operational post-crash. The CDC of the frontal impact was 01-FREE-3. The delta V calculated by the damage algorithm of the WINSMASH program was 12.4 km/h (7.7 mph). The longitudinal and lateral components were -10.8 km/h (-6.7 mph) and -6.2 km/h (-3.9 mph), respectively.

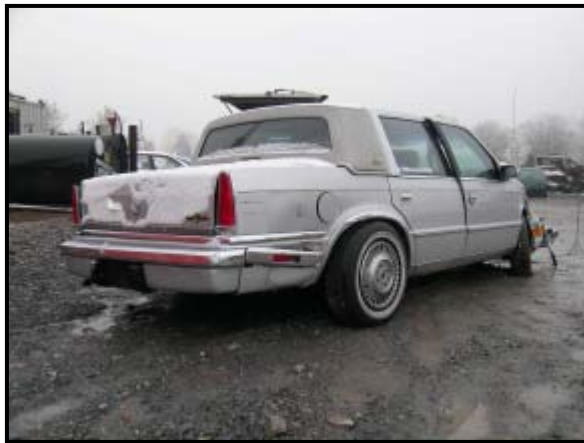
The right corner of the Chrysler's rear bumper impacted the left quarterpanel of the Ford during the sideslap. Inspection of the rear structures of the Chrysler revealed that the entire aft aspect, rearward of the C-pillars deformed to the left as a unit. Note, the exposure of the right rear tire from the wheel opening due to the left deformation in **Figure 8**, as compared to the enclosure of the left rear tire within the wheel opening of **Figure 9**. The left shift of the rear structures was an estimated 15 cm (6 in), measured at the rear bumper corner. The CDC of the contact was 83-RBEW-2. Note the 3 o'clock principle direction of the impact force was incremented by 80 to denote the left end shift.

Figure 8: Right rear view of the Chrysler.

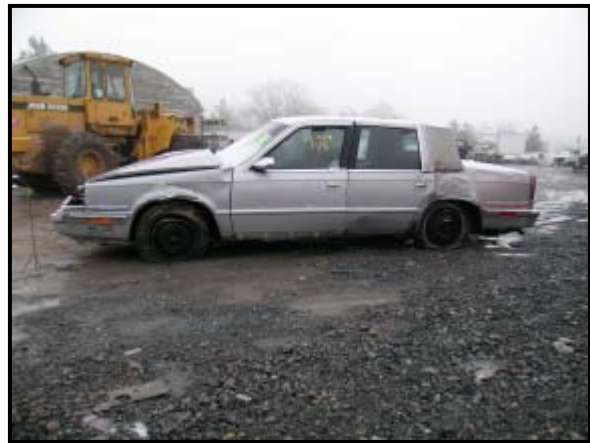
As the Chrysler slid to final rest, the left tires struck and mounted the curb at the northeast intersection quadrant. These impacts caused deformation to both wheel rims and both tires to debeat. The CDC's were 09-LFWN-1 and 09-LBWN-1. The left quarterpanel of the Chrysler then struck the utility pole. The direct contact measured 66.0 cm (26.0 in) and was centered on the left rear axle. The maximum residual crush measured 8.4 cm (3.3 in). The Landau roof at the left C-pillar was abraded and torn. This damage was consistent with the scuff observed on the pole during the scene inspection. The CDC of this contact was 09-LZAW-2. Refer to **Figure 9**.

Figure 9: Left side view of the Chrysler.

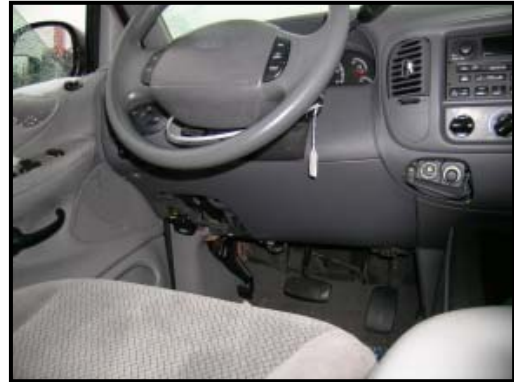
The only identified interior contact was a probable left lower extremity contact to the knee bolster. The contact was identified by the displacement of the trim panel concealing the fuse panel at the outboard aspect of the bolster, **Figure 10**. The trim panel was not in the vehicle.

Figure 10: Ford interior view.

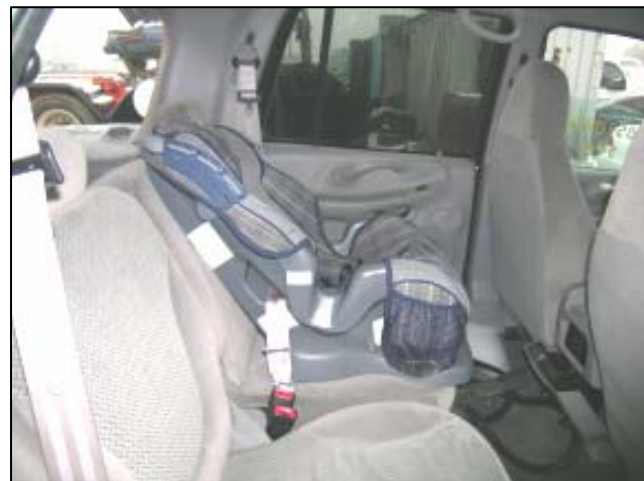
Figure 11: Right view of the CSS in Row 2.

The CSS was restrained in a forward facing mode by the lap belt in the center position of Row 2 at the time of the crash. The CSS was still buckled in that position at the time of the SCI vehicle inspection, **Figure 11**. The latch plate was inserted in the buckle and the ALR retractor was locked. Inspection revealed the restraint webbing

was routed through the proper belt path. In its restrained condition, the CSS had approximately 5 cm (2 in) of lateral movement and 3.8 cm (1.5 in) of fore/aft movement when grasped at the belt path. During the inspection, the restraint was unlatched and examined. The webbing spooled in and out of the retractor properly and the retractor locked as designed. Examination of the webbing was unremarkable. There was no crash related evidence identified.

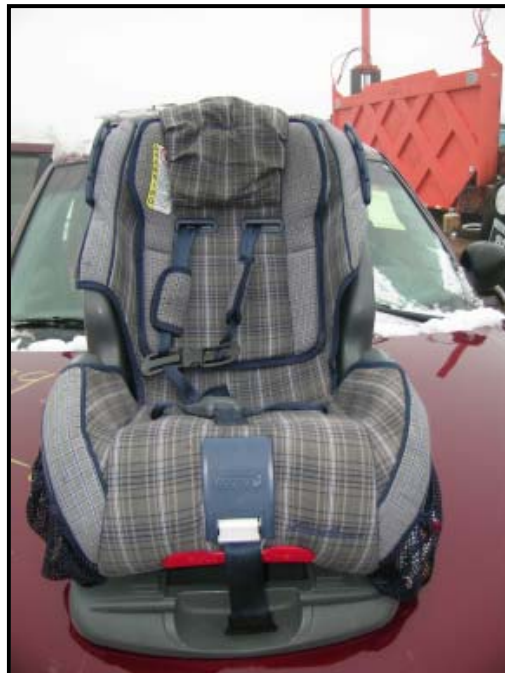
The 4 year old male was restrained in a Cosco Eddie Bauer CSS in the center position of the Ford's second row. **Figure 12** is a front view of the Cosco CSS, Model No: 02-537-MET. The seat was manufactured on January 19, 2002. The seat's labeling was intact. The labels indicated the seat was for use by children with a weight and height of 2.3 kg to 36.3 kg (5.0 lb to 80.0 lb) and 48.3 cm to 129.5 cm (19 in to 51 in). The CSS was to be used in a rear-facing mode for infants up to 10 kg (22 lb), forward facing for toddlers 10 kg to 18 kg (22 lb to 40 lb), and as a belt positioning booster seat for a child 13.6 kg to 36.3 kg (30 to 80 lb). The seat's instruction manual was not present.

Figure 12: Front view of the CSS.

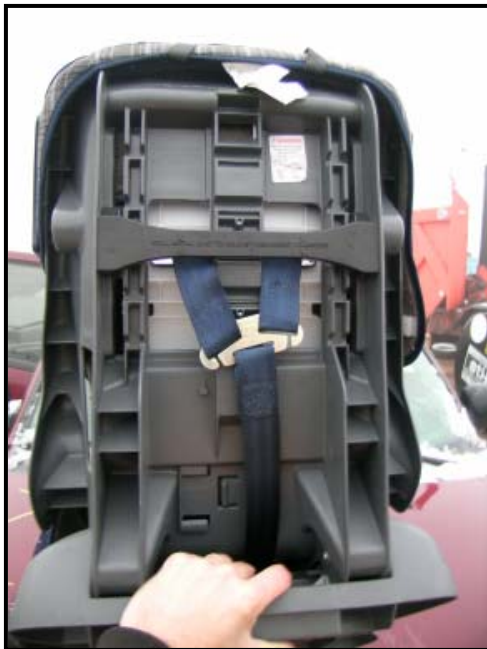
The CSS was designed with a three position adjustable base and a 5-point harness. The seat was adjusted to the middle position at the time of inspection. The angle of the seat measured 30 degrees. The shell would not lock into the most upright adjustment position. The 5-point harness consisted of two shoulder straps, a two piece chest clip, two upper thigh straps, and a crotch buckle. The height of the shoulder straps had a five position adjustment located on the back of the shell, **Figure 13**. The shoulder straps were adjusted to the mid-position. This adjustment also controlled the height of the head restraint. The seat was not equipped with a tether strap. The harness straps were roped throughout its path and were roped through the chest clips, **Figure 14**. There was no loading evidence identified on the harness straps. The location of the chest clips measured 25 cm (10 in) below the harness slots. Referring to **Figure 16**, the right (male) chest clip appeared to be have been reversed from its designed orientation at a time when the harness straps were rethreaded. When clipped together, the chest clip formed an “S” shape. By reversing the orientation of the right clip, the buckled clip would form a symmetrical arc, the more typical design.

Figure 13: Back view of the CSS.

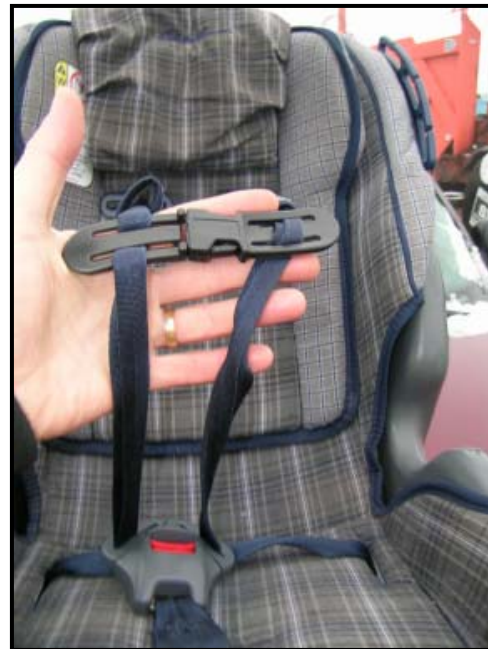
Figure 14: Close-up view the roped harness straps and chest clip.

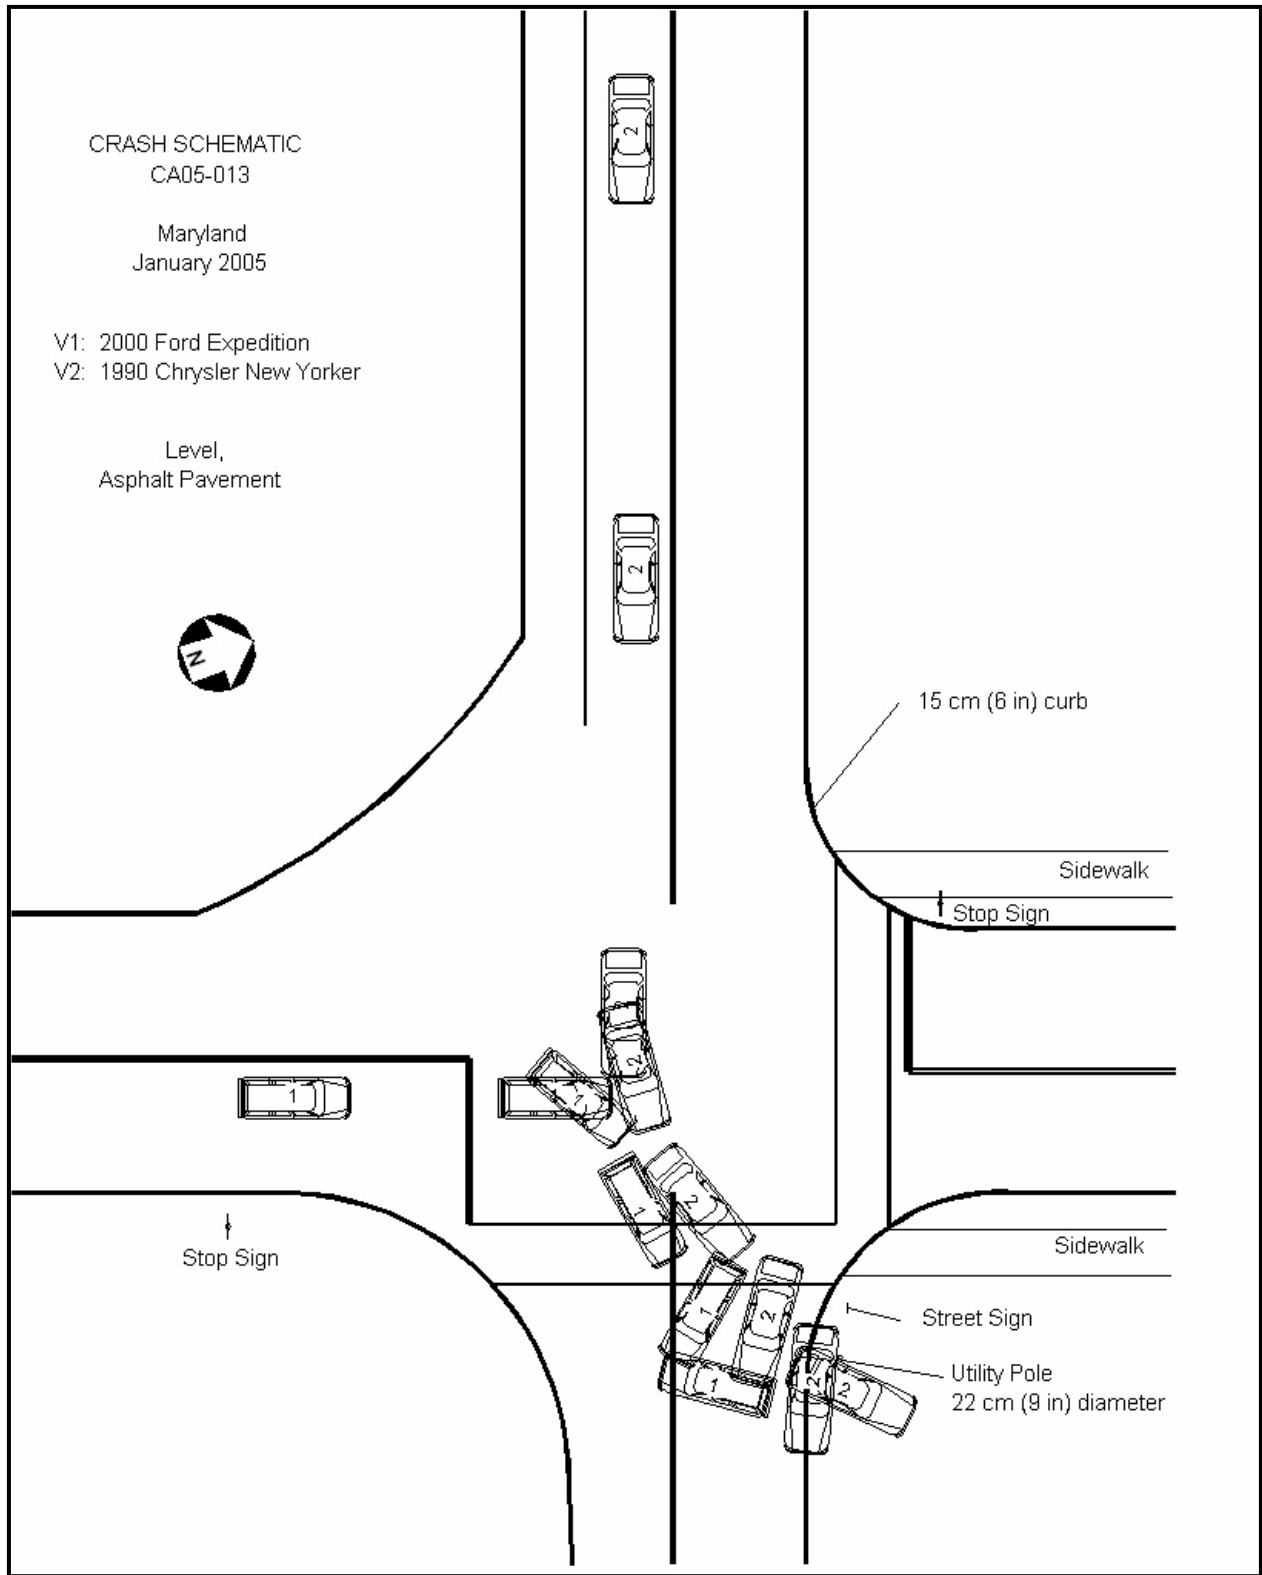
Figure 15: Crash schematic.
