**CALSPAN ON-SITE CERTIFIED ADVANCED 208-COMPLIANT
VEHICLE CRASH INVESTIGATION**

CASE NO: CA05-014

VEHICLE: 2005 DODGE GRAND CARAVAN

LOCATION: VIRGINIA

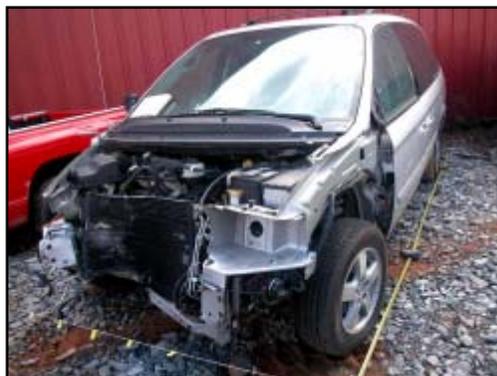
Figure 1. Damaged 2005 Dodge Grand Caravan

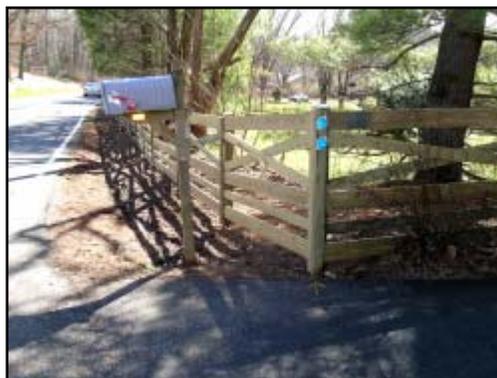
Figure 2. View of replaced fence, mailbox, and struck tree

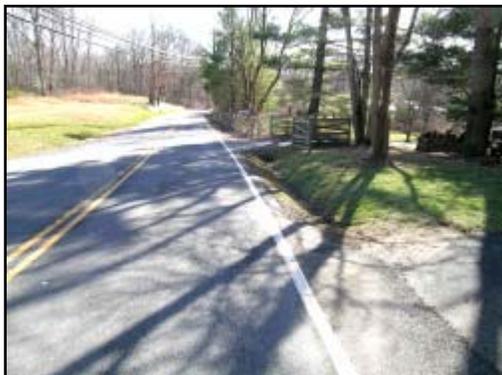
The 66-year-old male driver was operating the Grand Caravan in a southbound direction on the two-lane roadway. He became distracted while looking at an object on the right roadside, and the Grand Caravan drifted off the right roadside in a tracking mode (**Figure 3**). The right aspect of the undercarriage gouged the roadside in a longitudinal orientation, outboard of the west fog line as the right front wheel of the Grand Caravan entered the ditch (**Figure 4**). The driver of the vehicle applied his brakes, but continued in a tracking mode across the private driveway.

Figure 3. Southbound approach

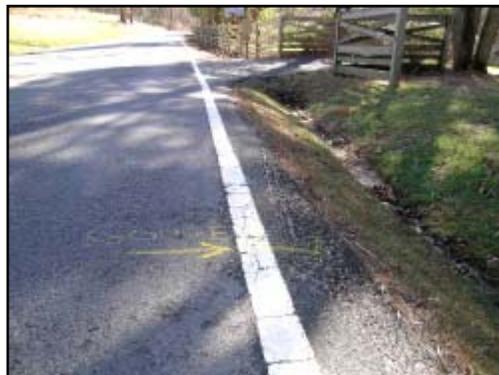
Figure 4. Roadside departure showing gouges

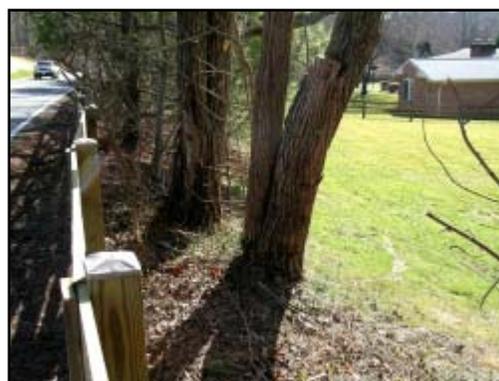
The front right aspect of the Grand Caravan struck the corner post of the wood fence. The impact resulted in minor damage due to the yielding nature of the post and rail fence. Immediately after the fence contact, the front left aspect struck the mailbox post to the left of the fence, which also resulted in minor damage. Neither impact was sufficient to deploy the frontal air bags in the Grand Caravan. The vehicle continued in a tracking mode through the fence, striking four additional posts with the front aspect. The Grand Caravan subsequently struck the 49.5 cm (19.5") diameter tree located inboard of the fence with the front right aspect (**Figure 5**). The impact resulted in moderate damage to the Grand Caravan and was sufficient to deploy the driver's air bag, fire the driver's safety belt buckle pretensioner, and deploy the driver's knee air bag. The damage algorithm of the WinSMASH program computed a total delta-V of 26.0 km/h (16.2 mph) for the tree impact, based on the Grand Caravan's frontal crush profile. The Grand Caravan came to rest adjacent to the tree. The tree sustained scarring that began 15.2 cm (6.0") above the ground and extended 76.2 cm (30.0") upward.

Figure 5. Struck tree

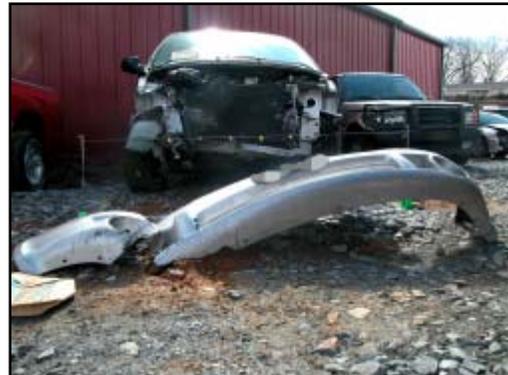
The 2005 Dodge Grand Caravan sustained minor undercarriage damage as a result of the contact with the asphalt road surface as it departed the roadway and traveled into the ditch. The bottom aspect of the fascia sustained longitudinal abrasions that began 19.7 cm (7.8”) right of the centerline and continued to the front right corner (**Figure 6**). The Collision Deformation Classification (CDC) for the impact with the ground was 00-UFZW-1.

Figure 6. Bottom aspect of bumper fascia

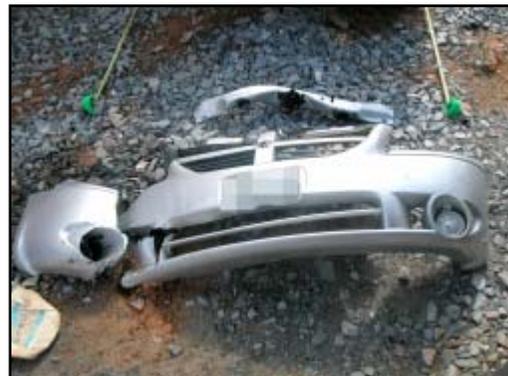
The Grand Caravan sustained minor damage due to the multiple frontal impacts with the fence posts, fence rails, and mailbox post. The bumper fascia (**Figure 7**) sustained fractures from the multiple frontal impacts, and was separated from the vehicle at the time of the SCI inspection. The fascia exhibited small fractures that were located 50.1 cm (20.0”) and 68.6 cm (27.0”) left of the centerline. A third fracture was located 36.8 cm (14.5”) left of the centerline at the top aspect of the fascia. Due to the multiple impacts with the fence posts, fence rails, and mailbox post, it was not possible to attribute the frontal damage with specific impacts prior to the tree. The CDC for the combined impacts was 12-FREN-1.

Figure 7. Front aspect of fascia, grille, and separated upper radiator support

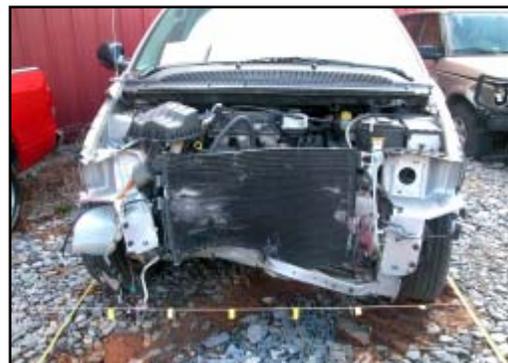
The tree impact caused moderate frontal damage to the Grand Caravan. The right corner of the bumper fascia sustained a complete vertical fracture as a result of the tree impact, which was located 41.9 cm (16.5”) right of the centerline, and radiated around the inboard aspect of the right fog lamp frame. The frontal structure was crushed rearward because of the tree impact (**Figure 8**). The bumper beam and upper radiator support were both

Figure 8. Frontal crush profile

separated at the time of the SCI inspection. The direct damage on the lower radiator support began 8.9 cm (3.5") right of the centerline and extended 50.2 cm (19.8") to the front right corner. The maximum crush measured 29.8 cm (11.8") and was located 19.1 cm (7.5") right of the centerline. The combined direct and induced damage involved the entire frontal width of the Grand Caravan. The CDC for the impact with the tree was 12-FZEW-2. Six crush measurements were documented along the lower radiator support and were as follows: C1 = 0.0 cm, C2 = 6.4 cm (2.5"), C3 = 12.7 cm (5.0"), C4 = 24.8 cm (9.8"), C5 = 26.0 cm (10.3"), C6 = 13.0 cm (5.1").

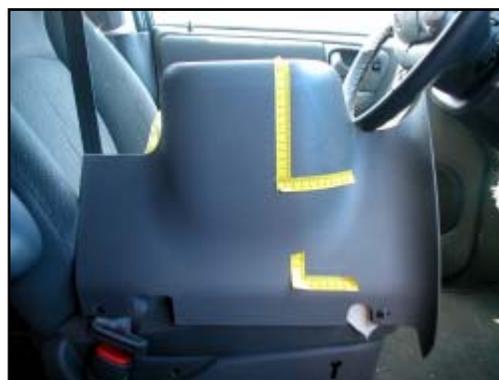
The 2005 Dodge Grand Caravan sustained minor interior damage related to driver contact and air bag deployment. The knee bolster (**Figure 9**) was separated as a result of the knee air bag deployment. Two scuff marks were present on the face of the knee bolster from contact with the driver's knees. The first scuff mark began 12.7 cm (5.0") right of the bolster centerline, 14.0 cm (5.5") below the top aspect, and extended diagonally upward and to the left 12.1 cm (4.8"). The second scuffmark began 5.1 cm (2.0") right of the bolster centerline, 6.4 cm (2.5") above the bottom aspect, and extended linearly 3.8 cm (1.5") to the right. There was no intrusion of the passenger compartment.

Figure 9. Close-up of damaged knee bolster

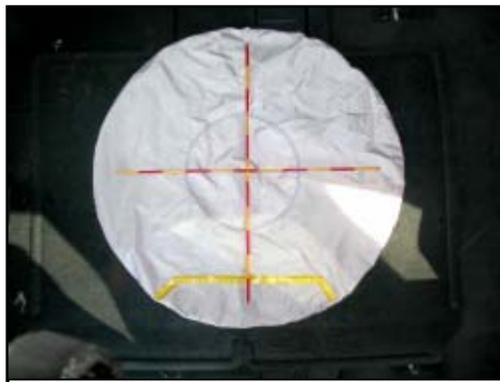
The 2005 Dodge Caravan was equipped with a Certified Advanced 208-Compliant safety system that included dual-stage frontal air bags, safety belt buckle pretensioners, and a driver's knee air bag. The driver's air bag and knee bolster air bag were cut from their respective modules prior to the SCI inspection, and were found in the vehicle. The driver's air bag (**Figure 10**) deployed from the steering wheel hub through a single cover flap hinged at the top aspect. The cover flap measured 20.6 cm (8.1") in width and 11.4 cm (4.5") in height. The deployed driver's air bag measured 66.0 cm (26.0") in diameter. The air bag was tethered by two internal straps that measured 12.7 cm (5.0") in width and were located at the 3 and 9 o'clock positions.

Figure 10. Driver's air bag (cut from module)

The air bag was vented by two circular ports located at the 12 o'clock position on the rear of the air bag. The vent ports measured 1.9 cm (0.8") in diameter and were located 3.8 cm (1.5") inboard from the circumferential seam. A red neoprene liner was present in the steering wheel hub around the inflator. The driver's air bag exhibited a blue transfer on the bottom aspect consistent with fabric. The transfer began 18.4 cm (7.3") left of the centerline, extended 34.9 cm (13.8") to the right along the bottom aspect of the air bag, and was located 23.5 cm (9.3") below the horizontal centerline.

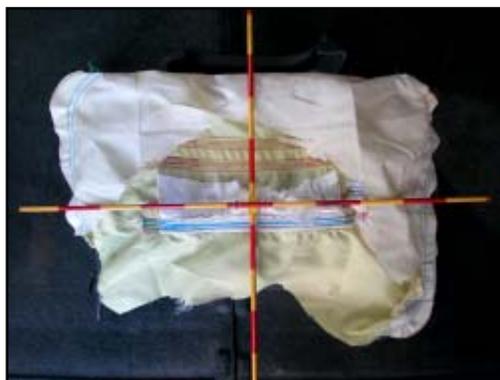
The driver's knee air bag (**Figure 11**) deployed from behind the knee bolster as a result of the crash. Dodge's website identified the knee air bag as a "Driver's Side Inflatable Knee Blocker." It further described the knee air bag's purpose was to protect the driver's knees and keep the driver in position in the event of a crash. The deployment of the knee air bag displaced the knee bolster rearward, and the air bag inflated between the lower instrument panel and the knee bolster. The knee air bag was rectangular in shape and measured 48.3 cm (19.0") in width and 35.6 cm (14.0") in height. A lateral tether that measured 22.2 cm (8.8") in width and 10.1 cm (4.0") in depth was located in the center of the air bag.

Figure 11. Driver's knee air bag (cut from module). Rear aspect of knee bolster is below air bag.

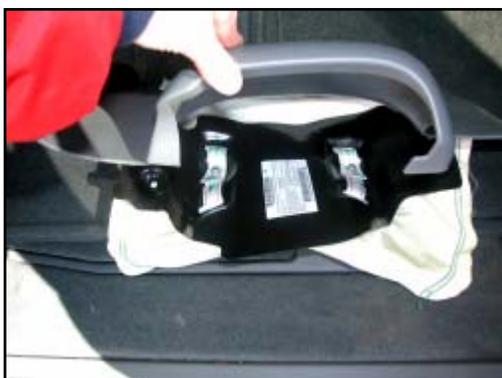
The air bag was attached to a metal backing plate on the rear aspect of the knee bolster by two 2.5 cm (1.0”) wide straps that were spaced 15.2 cm (6.0”) apart (**Figure 12**). The knee air bag was also secured to the lower instrument panel by two 2.5 cm (1.0”) wide straps that were located 7.6 cm (3.0”) apart. Each strap was secured by a metal bolt/nut. The air bag was inflated by a tubular inflator mounted horizontally on the lower instrument panel (**Figure 13**). The inflator measured 22.9 cm (9.0”) in length and 3.8 cm (1.5”) in diameter, and exhausted on the inboard aspect. The air bag fabric on the outboard aspect was looped around the inflator and slid laterally around the inflator canister, which possibly acted as a venting mechanism for the knee air bag.

Figure 12. Top of knee bolster/air bag looking down, showing metal plate and attachment straps

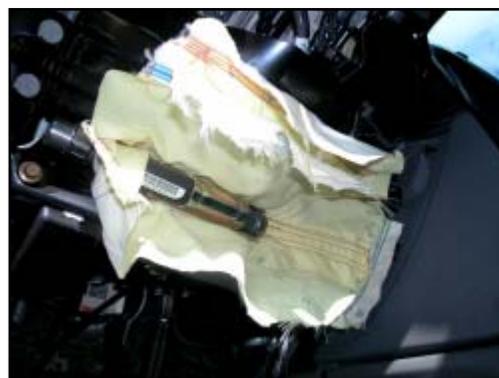
Figure 13. View of forward aspect of knee air bag and inflator from left
