**CALSPAN ON-SITE CHILD SAFETY SEAT CRASH INVESTIGATION**

**CASE NO: CA05-015**

**VEHICLE: 1997 HONDA CIVIC**

**CRASH DATE: JANUARY 2005**

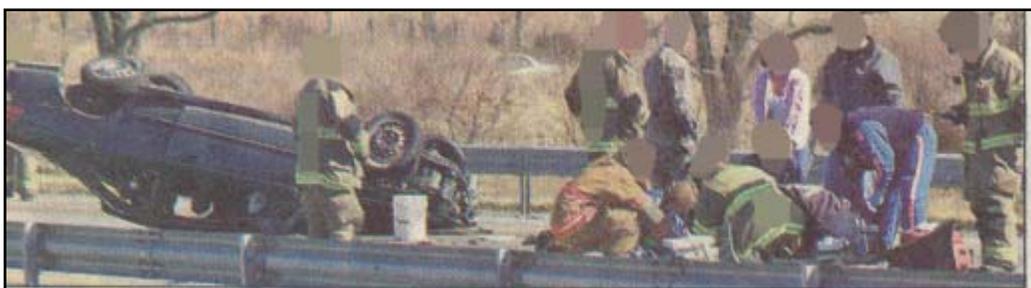
**Figure 1. On-scene news photograph showing final rest of the Honda Civic**

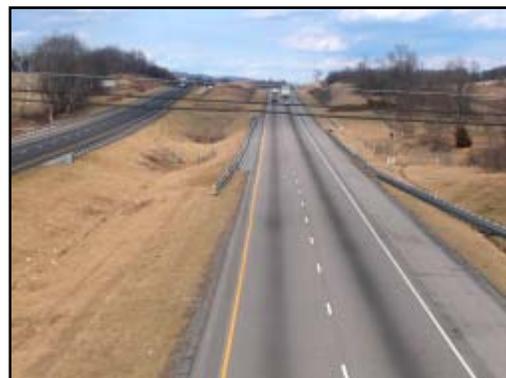
**Figure 2. Overhead view of northbound lanes and crash site**

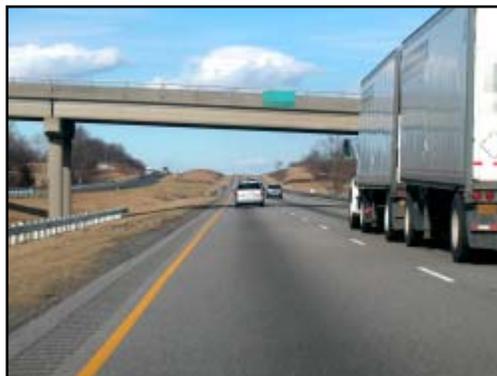
The 22-year-old female driver was operating the Honda Civic on the inboard northbound lane (**Figure 3**). The investigating agency reported that she was attempting to pass a tractor semi-trailer that was traveling on the outboard northbound lane. As she attempted to overtake the truck, she lost directional control of the vehicle. Police reported that the Civic traveled to the left onto the shoulder and grassy median. The driver steered right in an attempt to regain control and re-enter the roadway. The driver over-corrected to the right as the Civic re-entered the inboard travel lane, adjacent to the passing truck.

**Figure 3. Northbound approach for the Honda Civic**

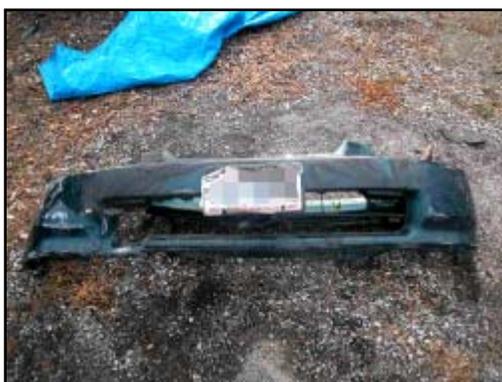
The 1997 Honda Civic sustained moderate frontal damage as a result of the frontal impact with the left rear aspect of the tractor semi-trailer. The rubber tire marks on the front bumper fascia began 62 cm (24.5”) right of center and extended 117 cm (46.1”) to the left across the fascia (**Figure 4**). The maximum crush was located 41 cm (16.3”) right of the vehicle’s centerline and measured 41 cm (16.3”) in depth. The combined direct and induced damage involved the entire frontal width of the vehicle and measured 104 cm (41.0”). The front bumper fascia and bumper beam were separated at the time of the SCI inspection. The upper and lower radiator supports were crushed rearward (**Figure 5**). Six crush measurements were documented along the lower

**Figure 4. Separated front bumper fascia**

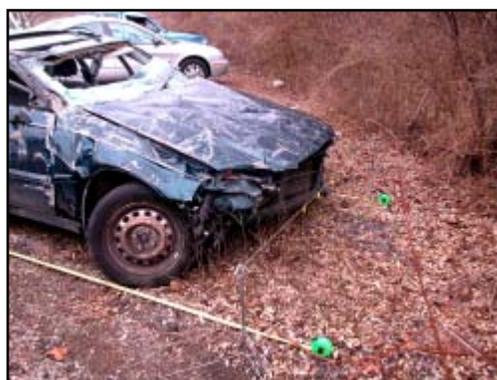
**Figure 5. Frontal damage to the 1997 Honda Civic**

radiator support and were as follows: C1 = 0 cm, C2 = 0 cm, C3 = 4 cm (1.5”), C4 = 9 cm (3.5”), C5 = 13 cm (5.1”), C6 = 10 cm (3.9”). The Collision Deformation Classification (CDC) for the frontal impact was 01-FDEW-1.

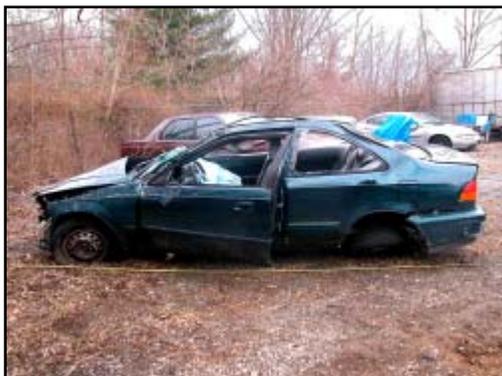
The Civic sustained severe damage as a result of the rollover event. The left front tire was debanded and the left front wheel was deformed and abraded. Heavy abrasions were present on the left upper fender, left roof side rail, left C-pillar, roof, hood, and entire right side plane. Both side mirrors were separated. The left and right rear axles were deformed causing the rear wheels to be out of camber. The right front wheel was abraded. The right and left side planes sustained minor lateral deformation and both side doors were slightly displaced (**Figures 6 and 7**). The

**Figure 6. Left side rollover damage**

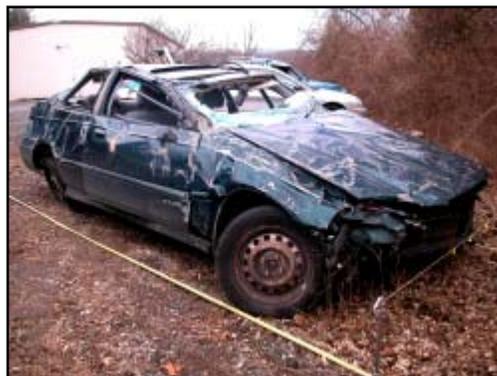
**Figure 7. Right side rollover damage**

roof, right roof side rail, and windshield header were crushed as a result of contact with the ground. The maximum crush was located at the top aspect of the right A-pillar and measured 15 cm (5.9"). Six vertical crush measurements were documented along the right roof side rail as follows: C1 = 0 cm, C2 = 1 cm (0.4"), C3 = 3 cm (1.2"), C4 = 8 cm (3.1"), C5 = 13 cm (5.1"), C6 = 15 cm (5.9"). Six vertical crush measurements were also documented along the windshield header as follows: C1 = 1 cm (0.4"), C2 = 3 cm (1.2"), C3 = 6 cm (2.5"), C4 = 10 cm (3.9"), C5 = 11 cm (4.3"), C6 = 15 cm (5.9"). The CDC for the rollover event was 00-TDDO-3.

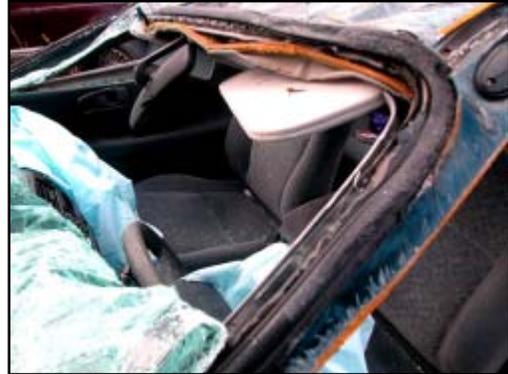
During the rollover, the windshield sustained severe damage (**Figure 8**). The windshield was fractured, holed, and sustained bond separation. The bond separated along the entire length of the left A-pillar and the separation extended along the windshield header 86 cm (33.9"). Bond separation was also present on the right A-pillar, which began at the top aspect and extended vertically 48 cm (18.9"). The outer gasket on the perimeter of the windshield sustained heavy abrasions from the rollover.

**Figure 8. Windshield damage from left side**

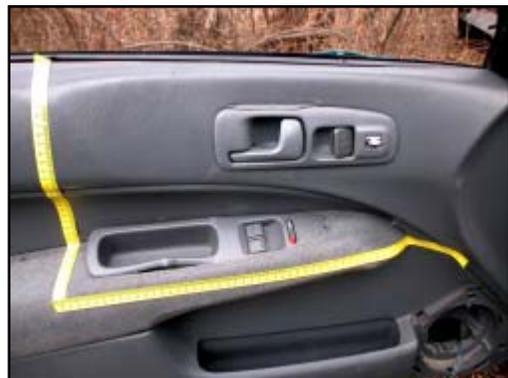
The 1997 Honda Civic sustained moderate interior damage as a result of occupant contact and passenger compartment intrusion during the crash. A 24 cm (9.5") wide fracture was present on the left aspect of the knee bolster from probable contact with the driver's left knee. The entire knee bolster was displaced. The driver's interior door was slightly deformed, and the plastic trim on the top aspect of the armrest was deformed and displaced as a result of occupant loading (**Figure 9**). The door panel above the door handle was also damaged. The outboard aspect of the driver's seat back exhibited tears and scuff marks from contact with the driver's safety belt latch plate during the rollover. The latch plate, in the stowed position, engaged the seat back in a longitudinal orientation. The roof crush resulted in moderate passenger compartment intrusion.

**Figure 9. Damaged driver's interior door panel**

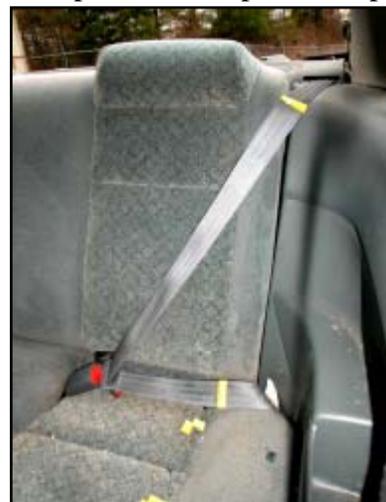
The left rear safety belt (**Figure 10**) was used to secure the detachable base of the rear-facing CSS. Minor deformation was present on the webbing that began 13 cm (5.1") above the anchor and extended 84 cm (33.1") up the webbing. A minor puncture

**Figure 10. Rear left safety belt**

was located 67 cm (26.4”) above the anchor on the outboard aspect of the shoulder belt webbing.

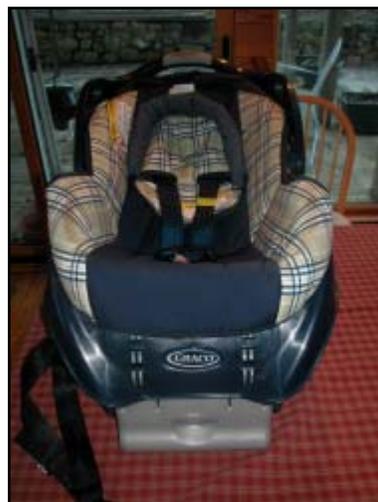
The Graco Snug Ride was a rear-facing CSS with a detachable base (**Figure 11**). The Model Number was 7320UVB and the Date of Manufacture was 08/09/04 on the CSS and on the base. The CSS was designed for rear-facing use only, and for children weighing 9 kg (20 lb) or less and whose height was 66 cm (26”) or less. The 3-month-old male child was within the manufacturer’s height and weight range for this CSS.

**Figure 11. Graco Snug Ride rear-facing CSS**

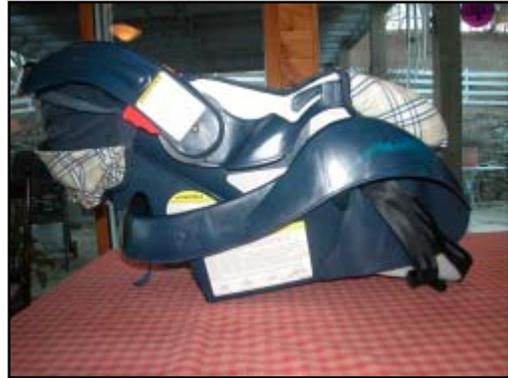
The Graco Snug Ride CSS sustained minor damage as a result of the crash. The CSS remained secured in the detachable base. The detachable base exhibited abrasions on the right aspect of the rear-facing belt path from engagement with the vehicle’s safety belt. Stress marks in the plastic were present above the left aspect of the belt path (**Figure 12**). There was no damage to the bottom aspect of the base. Minor damage was noted on the CSS. Minor abrasions and scuff marks were present on both outboard side aspects of the CSS. A minor lateral crease was present on the left harness strap as a result of loading. The crease was located 13 cm (5.1”) below the left harness slot. The harness retainer clip did not exhibit any abrasions, and there was no damage present on the harness slots.

**Figure 12. Left side (with respect to installation in vehicle) showing stress mark in base**

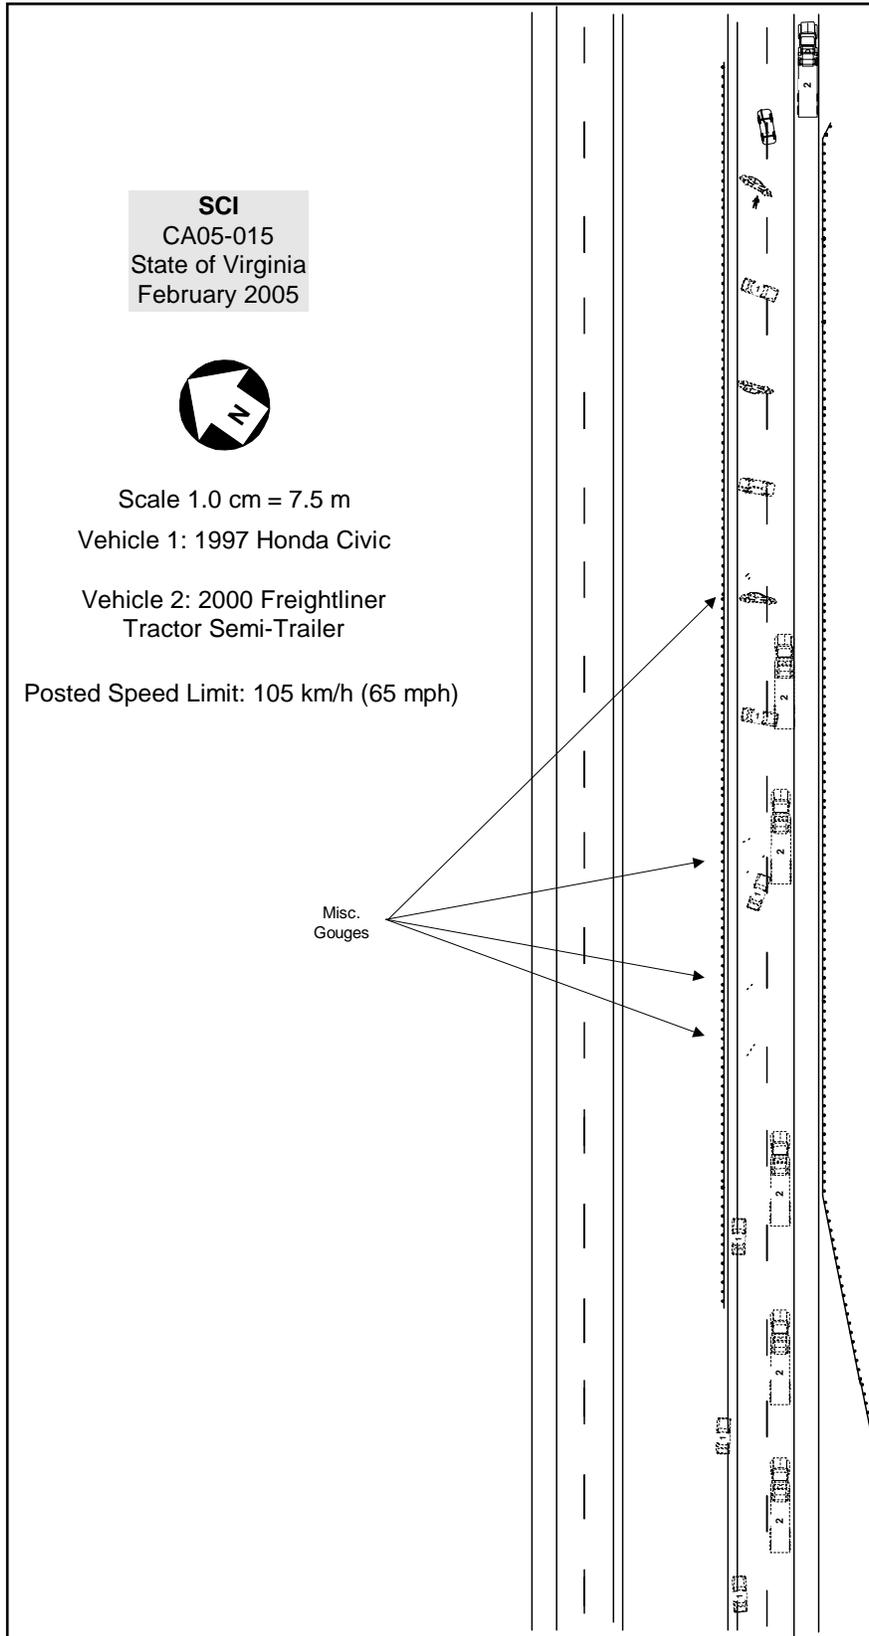
*Figure 13. Scene Schematic*

the travel lanes. The posted speed limit for the divided highway was 105 km/h (65 mph). The scene schematic is included as **Figure 13** at the end of this report.
