**CALSPAN ON-SITE CERTIFIED ADVANCED 208-COMPLIANT
VEHICLE CRASH INVESTIGATION**

CASE NO: CA05-016

VEHICLE: 2004 MAZDA 3

CRASH DATE: DECEMBER 2004

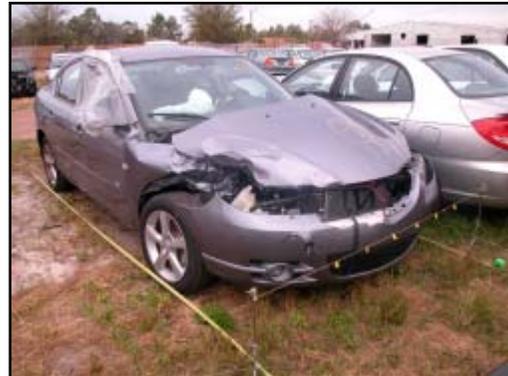
Figure 1. Damaged 2004 Mazda 3

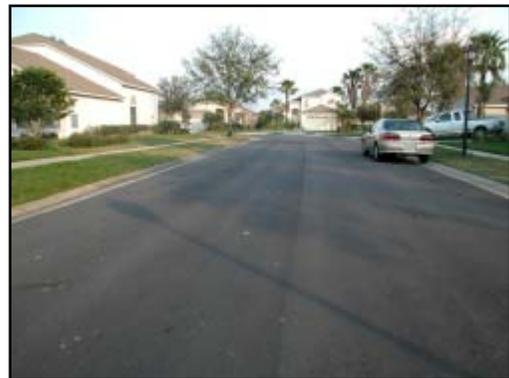
The male driver of the Mazda 3 was operating the vehicle in a westbound direction on the two-lane roadway. A 2000 Ford Explorer was legally parked on the north roadside, straddling the concrete drainage channel. As the Mazda 3 exited the right curve (**Figure 2**), the driver lost control of the vehicle. He steered left in an attempt to regain control, and the vehicle initiated a counterclockwise (CCW) yaw. The wet roadway surface and the low tire inflation in all four tires likely contributed to the vehicle's pre-crash yaw due to the reduced coefficient of friction. The Mazda crossed the center of the roadway and into the opposite travel lane in the CCW yaw. As it approached the parked Explorer, the Mazda was oriented approximately 45 degrees CCW from its original travel direction.

Figure 2. Westbound approach for the Mazda 3

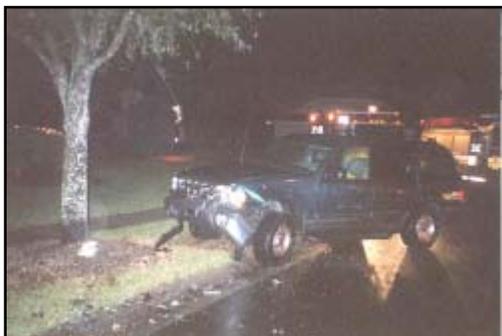
Figure 3. On-scene photograph showing final rest of the Explorer

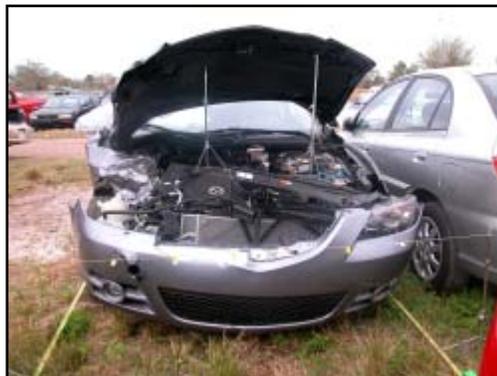
The 2004 Mazda 3 sustained moderate frontal damage as a result of the initial impact with the Ford Explorer. Minor scuff marks were present on the right corner of the top aspect of the bumper fascia, although there was no structural deformation or crush of the front bumper beam. Minor direct contact deformation on the front aspect of the hood began 36 cm (14.0") right of center and extended to the front right corner. The composite upper radiator support was fractured 19 cm (7.3") right of center, and the fractured portion was separated from the vehicle (**Figure 5**). The entire upper radiator support was displaced rearward on the right side, pivoted around the left corner. The maximum crush was projected to the probable location of the right corner of the crushed upper radiator support, which measured 13 cm (5").

Six crush measurements were documented along the upper radiator support. The crush measurements were projected across the missing right section of the upper radiator support. The crush measurements were as follows: C1 = 0 cm, C2 = 0 cm, C3 = 6 cm (2.5"), C4 = 10 cm (4.0"), C5 = 11 cm (4.5"), C6 = 13 cm (5.0"). The Collision Deformation Classification for the impact with the Explorer was 01-FREN-1.

Figure 5. Frontal view of damaged Mazda 3

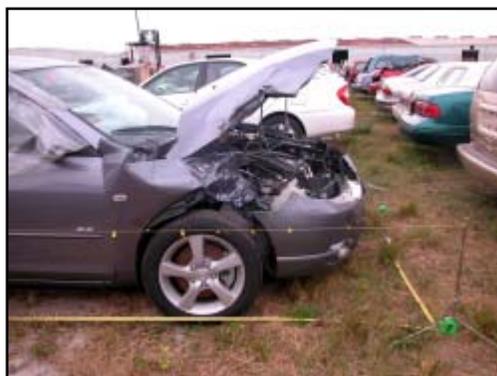
The direct contact damage began on the front corner of the right fender and extended 67 cm (26.3") rearward. The fender was crushed laterally and longitudinally from direct contact with the Explorer while rotating around the vehicle (**Figure 6**). The maximum lateral crush was located at the leading edge of the right fender and measured 36 cm (14.0"). The deformation involved the entire height of the right front fender and extended onto the right aspect of the hood. The combined direct and induced damage began at the leading edge of the right front fender, extended 88 cm (34.5") rearward, and terminated at the aft edge of the fender. The fender was buckled outward at the rear aspect due to the longitudinal crush. The aspect of the hood separated at the hinge during the crash, and the entire hood was displaced CCW about the left hinge. The right front window glazing disintegrated as a result of the impact. Six crush measurements were documented along the right front fender as follows: C1 = 0 cm, C2 = 0 cm, C3 = 13 cm (5.0"), C4 = 22 cm (8.5"), C5 = 36 cm (14.0"), C6 = 32 cm (12.5").

The crush measurements are for anecdotal purposes alone due to front end being the initial point of contact.

Figure 6. View of right front damage

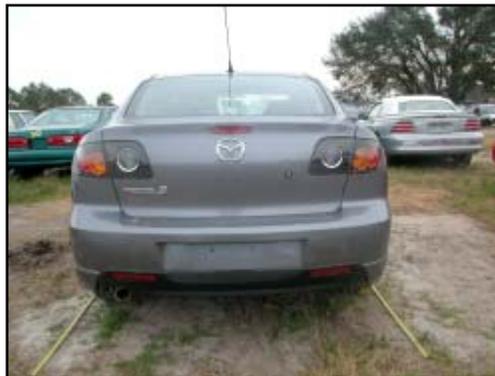
The Mazda 3 sustained minor rear damage as a result of the secondary endswipe with the Explorer (**Figure 7**). The direct contact damage began 44 cm (17.5”) left of the centerline on the rear bumper fascia, and extended 119 cm (47.0”) to the right rear corner. Paint transfers and scuff marks from the Explorer were present on the rear bumper fascia. Additional paint transfers and scuff marks were present on the trunk face, from contact with the Explorer’s left rear mid-door area. The direct contact on the trunk face began 11 cm (4.5”) right of the centerline and extended 52 cm (20.5”) onto the right rear tail light. There was no residual crush or structural damage to the bumper fascia or trunk face. The CDC for the endswipe with the Explorer was 03-BDES-1.

Figure 7. Damaged rear trunk face and bumper fascia

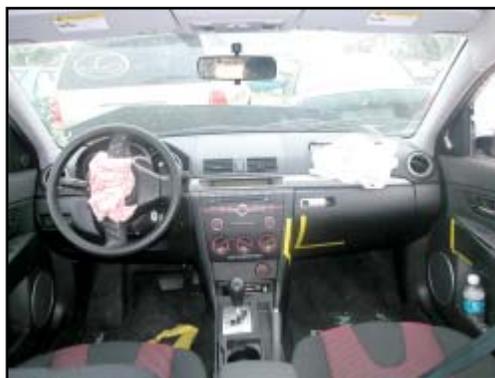
The 2004 Mazda 3 sustained minor interior damage as a result of occupant contact (**Figure 8**). The center console was slightly displaced to the right, and sustained a fracture on the left side panel aft of the leading edge of the driver’s seat. Contact evidence supporting the presence of a front right passenger was present on the glove box door, the right front panel of the center console to the right of the HVAC controls, and on the interior right front door. Contacts to the right center console panel and the glove box door were consistent with a left knee strike by the front right passenger and the door. A faint transfer consistent with tissue was present on the upper aspect of the right panel, adjacent to the inboard aspect of the glove box. The transfer measured 6 cm (2.5”) in height and 4 cm (1.5”) in width. A curvilinear scuffmark was present below the probable tissue transfer and measured 10 cm (4.0”) in length. A second probable tissue transfer was present on the glove box door. The transfer was located 5 cm (2.0”) to the right of the inboard edge and 8 cm (3.0”) below the top edge. The transfer measured 5 cm (2.0”) in width and 4 cm (1.5”) in height. A linear scuff was present below the probable tissue transfer on the glove box door, began 4 cm (1.5”) to the right of the inboard edge, and 20 cm (8.0”) above the bottom edge. The transfer measured 13 cm (5.0”) in length. Pocketing on the right door interior began 18 cm (7.0”) rear of the leading edge of the door from the front right occupant’s right knee. The pocketing measured 11 cm (4.5”) in length and involved the entire height of the armrest. The top aspect of the armrest was displaced as a result of the contact.

Figure 8. View of front seat positions and occupant contact

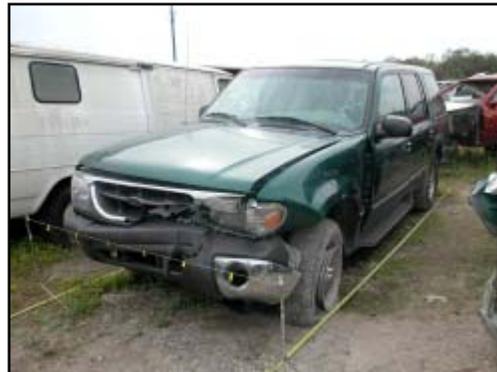
The Explorer sustained moderate frontal damage as a result of the initial impact with the Mazda 3. The direct damage began 27 cm (10.5”) left of the centerline on the front bumper, and extended 53 cm (21.0”) to the left front bumper corner. The bumper was crushed rearward, and scuff marks were present on the left aspect of the bumper, and the reinforced plastic bumper was fractured inboard of the left corner. The left fog lamp was separated from the front bumper housing. The direct contact extended vertically to 14 cm (5.5”) below the leading edge of the hood. The grille was fractured on the left aspect, the left headlamp was displaced, and the trim surrounding the headlamp and grille was fractured. The combined direct and induced damage involved the entire frontal width of the Explorer and measured 151 cm (59.5”) across the front bumper. The entire bumper was displaced rearward and slightly to the right, as a result of the frontal impact. The forward aspect of the left fender was deflected inboard 6 cm (2.5”). The maximum crush to the front of the Explorer was located 45 cm (17.7”) left of the vehicle’s centerline and measured 11 cm (4.4”). The left front tire was debaded, but there was no wheelbase reduction as a result of the crash. The CDC for the impact with the Mazda was 11-FYEW-1. Six crush measurements were documented along the front bumper and were as follows: C1 = 10 cm (4.0”), C2 = 11 cm (4.4”), C3 = 8 cm (3.4”), C4 = 2 cm (1.0”), C5 = 0 cm, C6 = 0 cm.

Figure 9. View of damaged Ford Explorer

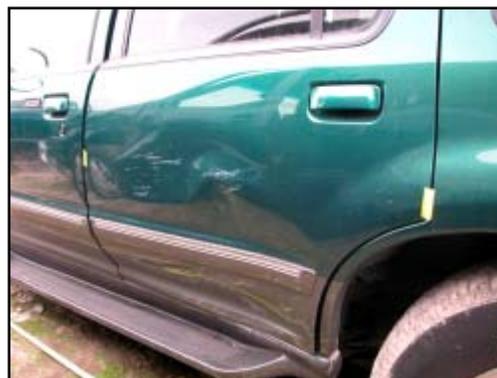
The Explorer sustained minor left side damage as a result of the Mazda 3’s endswipe (**Figure 10**). The direct contact began 12 cm (4.8”) aft of the leading edge of the left rear door. The direct contact abrasions were located below the side trim and extended 68 cm (26.7”) rearward. There was no lateral crush or deformation on the lower aspect of the door. Additional abrasions and paint transfers were located above the side trim on the rear door from contact with the Mazda’s trunk face. The direct contact damage began 20 cm (7.8”) aft of the leading edge of the left rear door and extended 43 cm (17.0”) rearward. The direct contact was vertically located 20 cm (8.0”) below the beltline and measured 15 cm (6.0”) in height. The maximum lateral deformation measured 1 cm (0.3”) on the aft aspect of the door above the trim. The combined direct and induced damage measured 97 cm (38.3”) along the entire length of the left rear door. The CDC for the endswipe was 12-LPES-1.

Figure 10. View of left side damage

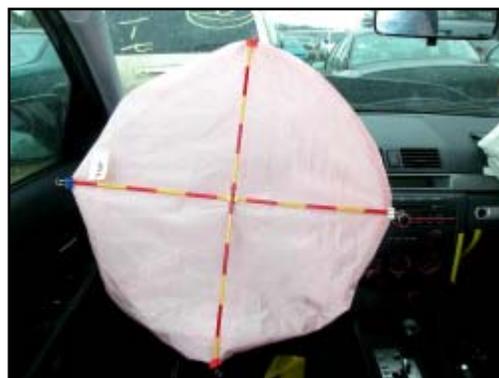
The 2004 Mazda 3 was equipped with a Certified Advanced 208-Compliant safety system that included dual-stage frontal air bags, safety belt buckle pretensioners, and seat track position sensors. The driver's air bag deployed from the steering wheel hub through a tri-flap cover design. The top flap measured 11 cm (4.4") in width and 5 cm (2.0") in height, with a circular logo centered on the upper flap that extended an additional 4 cm (1.5") below the outboard aspects of the top flap. The bottom flaps were symmetrical, contoured around the circular logo cutout, and measured 6 cm (2.3") in height and 6 cm (2.3") in width. The driver's air bag (**Figure 11**) measured 61 cm (24.0") in diameter in its deflated state. There was no contact evidence present on the air bag fabric. The air bag was vented by two circular 3 cm (1.0") diameter ports that were located at the 11 and 1 o'clock sectors on the rear of the air bag, positioned 8 cm (3.0") from the circumferential seam. The driver's air bag was not tethered.

Figure 11. Deployed driver's air bag

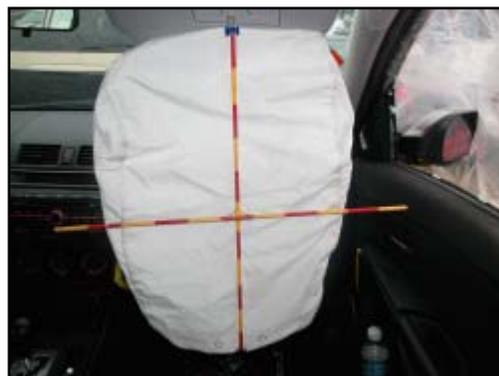
Figure 12. Deployed front right passenger's air bag

The front right passenger air bag (**Figure 12**) deployed from a top-mount module configured with a rectangular cover flap hinged at the forward aspect. The cover flap measured 24 cm (9.5") in width and 14 cm (5.5"), in height. The front right passenger's air bag was slightly oblong in shape. The air bag measured 33 cm (13.0") in width (seam-to-seam) at the top and bottom aspects and measured 36 cm (14.0") in width at the

horizontal centerline. The air bag measured 60 cm (22.0”) in height. There was no contact evidence present on the air bag. A lateral external tether was present on the rear aspect of the air bag, 17 cm (6.5”) above the bottom seam. The tether measured 2 cm (1.8”) in height and 27 cm (10.5”) in width (seam-to-seam). A separate heavy fabric strap was attached to the outboard aspects of the air bag module housing. The strap was 2 cm (0.6”) in height and measured 48 cm (19.0”) in length.

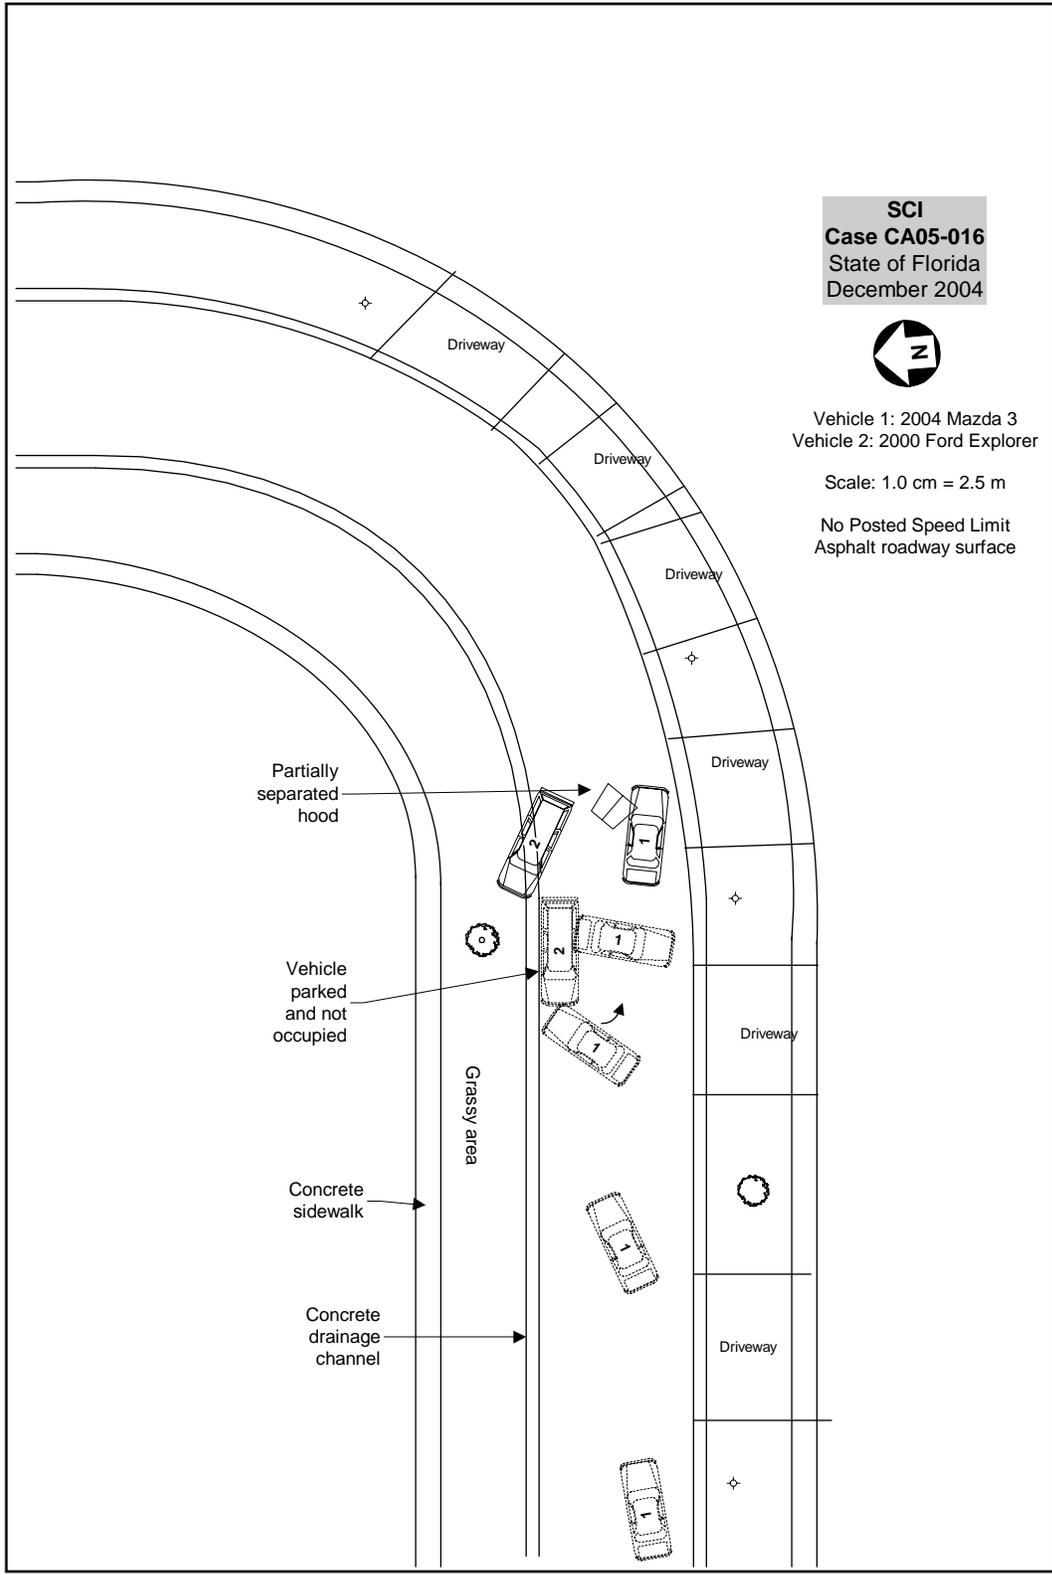
Figure 13. Scene schematic

This two-vehicle crash occurred during nighttime hours in the state of Florida in December 2004. The crash occurred on a two-lane, undivided, residential roadway in a private development. At the time of the crash, it was raining and the asphalt roadway surface was wet. The roadway was illuminated by roadside light poles. The east/west roadway consisted of one lane in each direction, bordered by concrete drainage channels. The roadway was straight and level at the crash site; however, an eastbound right curve exited west of the crash site, and a 90-degree left curve was present immediately east of the crash site. The roadside environment consisted of grassy yards, concrete sidewalks, concrete driveways, and private residences. The speed limit was not posted. The scene schematic is included as **Figure 13** at the end of this narrative report.
