Certified Advanced 208 Compliant Vehicle Investigation / Vehicle to Vehicle
Dynamic Science, Inc. / Case Number: DS05016
2005 Buick Rendezvous
Oregon
August 2005

1. Report No. DS05016	2. Government Accession No.	3. Recipient Catalog No.	
4. Title and Subtitle Certified Advanced 208 Compliant Vehicle Investigation		5. Report Date May 3, 2006

This on-site investigation focused on the performance of the side and front air bag systems in a Certified Advanced 208-Compliant (CAC) vehicle (2005 Buick Rendezvous CXL). The multi-stage air bags were certified by the manufacturer to meet the advanced air bag requirements of Federal Motor Vehicle Safety Standard No. 208. This two vehicle crash occurred in August 2005 at 2002 hours in an urban area of Oregon. The crash occurred within the confines of a four-leg intersection. The case vehicle was a 2005 Buick Rendezvous being driven by a restrained 36-year-old female. There were two additional passengers in the vehicle. The other vehicle was a 1997 Ford Econoline van being driven by a 29-year-old male. The Buick Rendezvous was traveling west on a two lane, two-way roadway with no traffic controls. The Ford van was traveling north on a two lane

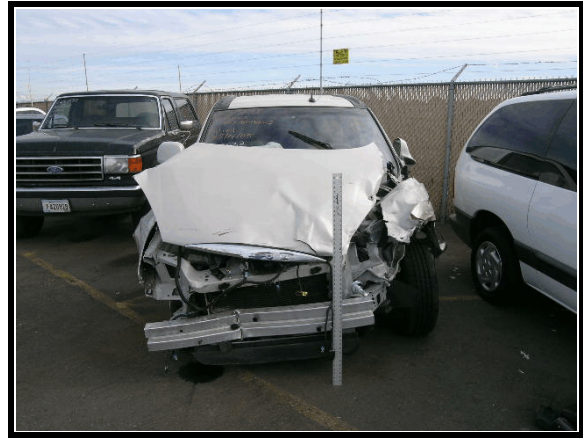
Figure 1. Front of 2005 Buick Rendezvous

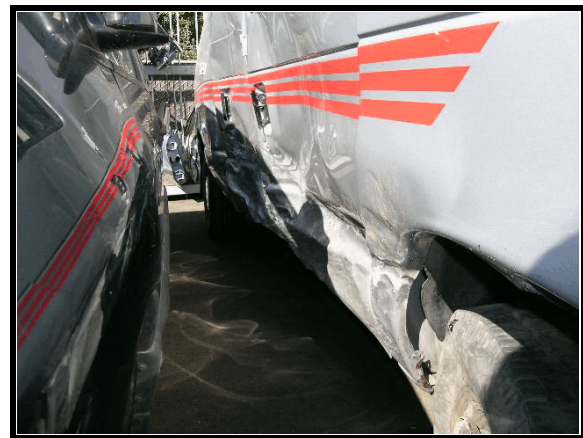
Figure 2. Right side damage - 1997 Ford Econoline E250 Cargo van

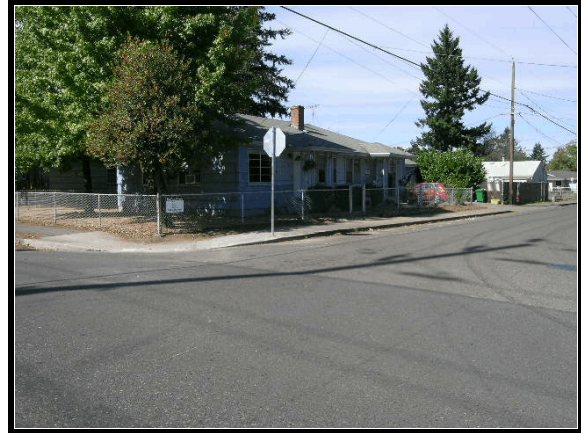
After the initial impact, the Buick was redirected, traveled over the northwest curb of the intersection and the front of the case vehicle impacted a stop sign, shearing the metal sign post from its base. The Buick came to final rest on the west sidewalk, facing northwest. The Ford continued traveling in a northwesterly direction, traveled over the west curb, over a short concrete landscaping edger, through a chain link fence and came to final rest facing northwest, partially in the yard of a private residence.

Figure 5. Case vehicle's post-impact trajectory towards the impacted stop sign pole (pole replaced)

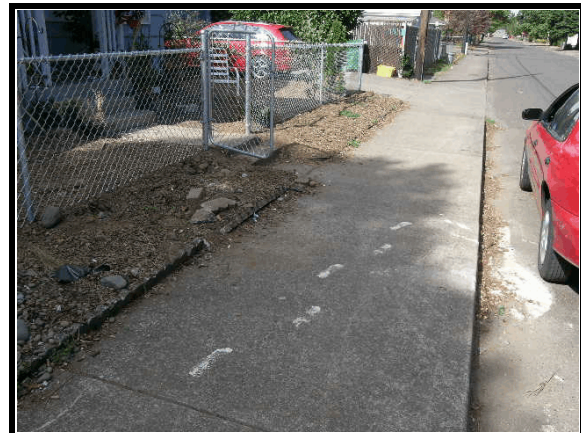
Figure 6. 1997 Ford Econoline's post-impact trajectory. Sidewalk, edger and fence damaged (fence replaced).

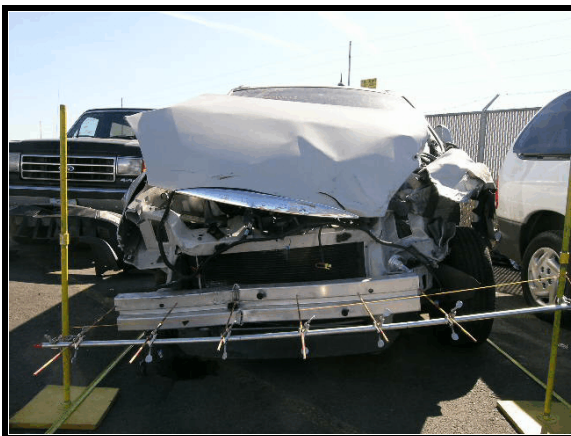
Damage Description: This vehicle sustained moderate front end damage as a result of the impact with the Ford Econoline van. The Rendezvous sustained 156.0 cm (61.4 in) of direct damage along the front bumper, beginning at the left bumper corner and extending to the right. The hood, front bumper and left/right fenders were damaged. Both frame rails shifted to the right more than 10.2 cm (4.0 in). The right front and left rear tires were debanded and the left rear tire rim was scuffed. There was no integrity loss and the doors and rear liftgate remained closed and operational. Six crush measurements were documented along the front bumper as follows: C1=3.0 cm (1.2 in), C2=14.0 cm (5.5 in), C3=20.0 cm (7.9 in), C4=28.0 cm (11.0 in), C5=20.0 cm (7.9 in), C6=8.0 cm (3.1 in). The case vehicle sustained moderate front end damage as a result of the impact with the metal stop sign post. The location and width of the direct damage from this impact could not be determined due to overlapping damage from the first crash event, but the impact left a distinct 'V' shaped indentation in the bumper bar. The top of the stop sign fell on the vehicle and left red paint transfers on the left fender and left outside mirror cover.

Figure 7. Front, 2005 Buick Rendezvous

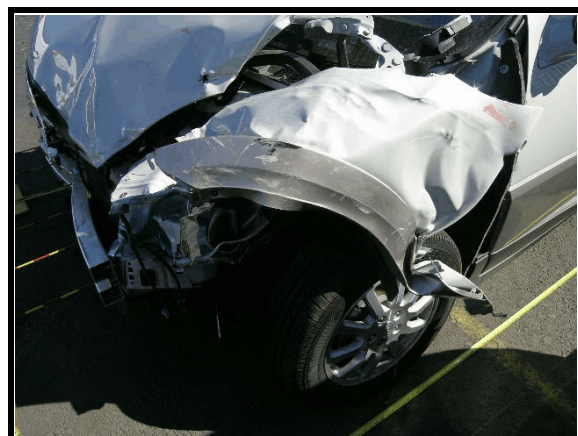
Figure 8. Front/Left damage and red paint transfer (upper fender) from stop sign

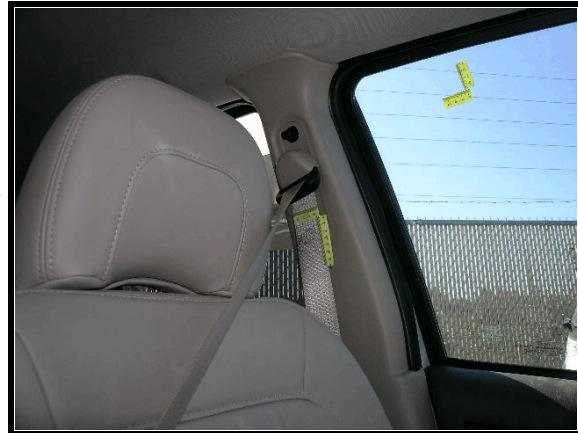
There was an oil transfer on the upper left quadrant of the driver's side window. There was a scuff on the right A-pillar, likely due to occupant contact. There were friction marks on the shoulder portions of both front seat belts. The webbing of the second row right shoulder belt was stretched slightly. There was no intrusion and no integrity loss. The side doors and hatch all remained closed and operational. There was no glazing damage except for minor scuffs to the lower right windshield caused by the passenger front air bag cover flap during the air bag deployment.

Figure 9. Driver shoulder belt scuff and oily transfer to left front glazing

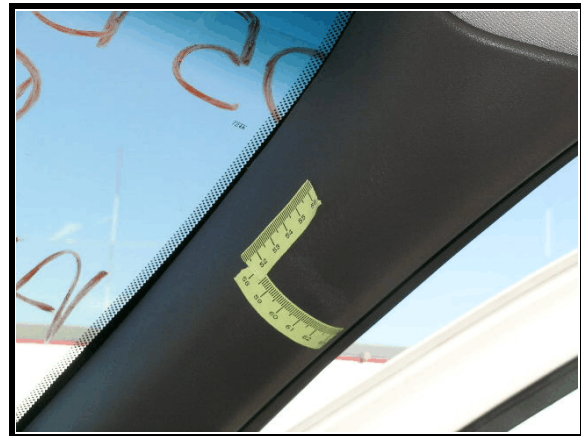
Figure 10. Scuff to the right A-pillar.

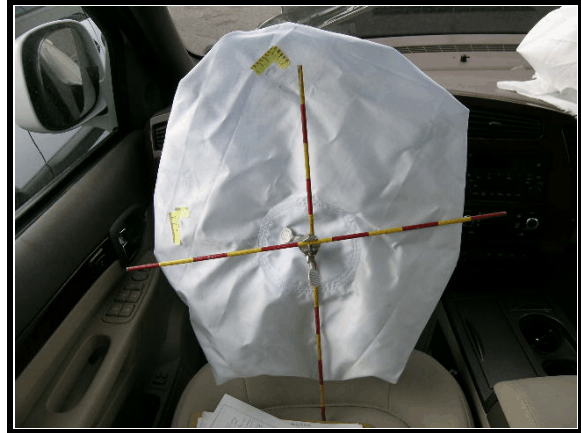
Figure 11. Driver's front air bag.

The driver's air bag was mounted in the center of the steering wheel hub. The air bag module had an I configuration. The left flap measured 6.0 cm (2.4 in) wide by 10 cm (3.9 in) high. The right flap measured 11.0 cm (4.3 in) wide by 10.0 cm (3.9 in) high. The air bag was circular in shape and in its deflated state, measured 55.0 cm (21.7 in) in diameter. There were no signs of occupant contact but there were black cover flap deployment streaks located in the center left section and the upper left quadrant. Between the 11 and 12 o'clock positions there was a 2.0 cm (0.8 in) by 1.0 cm (0.4 in) piece of material that was slightly melted, which likely occurred during the deployment. On the back of the air bag, there were black cover flap deployment streaks in several locations. The air bag had three internal tethers. There were two circular vent ports on the back of the bag at the 11 and 1 o'clock positions. The distance between the maximum deployment area of the air bag and the front left seat back was 38.0 cm (15.0 in).

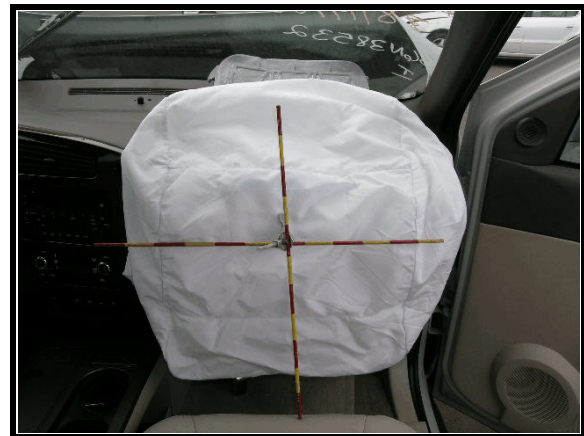
Figure 12. Right front passenger's front air bag

The front right passenger air bag was a top instrument panel mount. The module had a single forward opening cover flap that was rectangular in shape and measured 37.0 cm (14.6 in) wide

by 20.0 cm (7.9 in) high. The air bag measured 47.0 cm (18.5 in) seam to seam laterally and was 70.0 cm (27.6 in) high. The distance between the maximum deployment area of the air bag and the front right seat back was 60.0 cm (23.6 in). There were two circular vent ports on the sides of the air bag at the 3 and 9 o'clock positions. There was no damage to the air bag or cover flap but the cover flap scuffed the windshield during deployment.

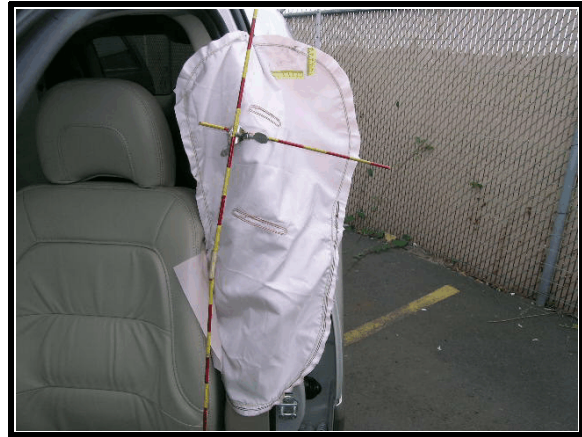
The driver's seat back mounted side air bag module was located between the middle and upper portion of the seat back cushion. The module had a single cover flap that was rectangular in shape and measured 8.0 cm (3.1 in) wide by 22.0 cm (8.7 in) high. The deployed side air bag was semi-rectangular in shape and had rounded edges. In its deflated state, the bag had a height of 80.0 cm (31.5 in) and an excursion of 45.0 cm (17.7 in) at the top edge and 25.0 cm (9.8 in) along the bottom edge. There were black transfers found on the inside top center section of the bag, which likely occurred during the deployment. On the outer portion of the bag there were black cover flap deployment streaks in the upper left and center section of the bag. The air bag was not equipped with tethers or vent ports and there was no damage to the module cover flap.

Figure 13. Driver's side air bag

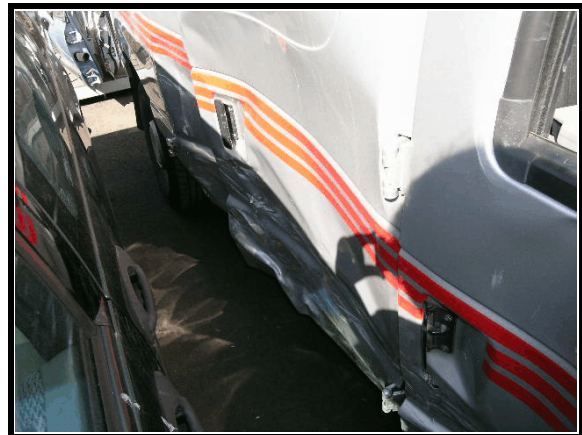
The 1997 Ford Econoline E250 sustained moderate right side damage as a result of the impact with the front of the Buick Rendezvous. The CDC for this event was 01LYEW2. There was 254.0 cm (100.0 in) of direct contact along the Econoline's right side that began 65.0 cm (25.6 in) forward of the right rear axle and extended forward. The location of maximum crush was 158.0 cm (62.2 in) forward of the right rear axle and consisted of 12.0 cm (4.7 in) of crush. The right front tire was torn, deboned and flat and the right front glazing disintegrated during the impact. The two double doors located just behind the right front door were damaged in the crash. The right rear door was found ajar. It was tied to the second right rear door which was jammed shut. The Econoline sustained light front end damage as a result of the impact with the chain link fence. There was 94.0 cm (37.0 in) of direct contact to the front bumper beginning 2.0 cm (0.8 in) to the right of the post-crash centerpoint, extending left along the front plane. This damage was attributed to the impact between the front of the Econoline and the chain link fence. There were scrapes extending

Figure 14. Right side damage - 1997 Ford Econoline E250 Cargo van

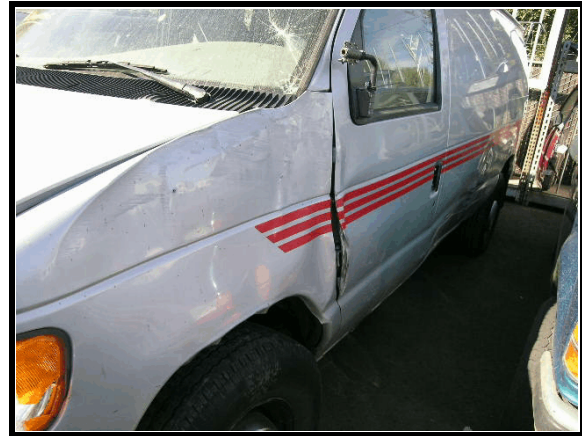
Figure 16. Left side damage - 1997 Ford Econoline 250 Cargo van

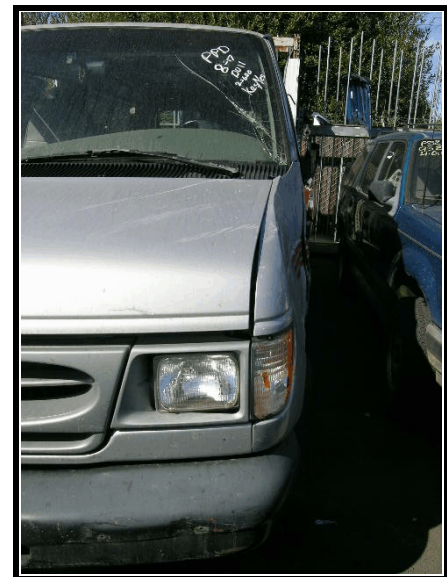
diagonally across the mid to left side of the hood and damage to the left side of the windshield, which likely occurred when the Econoline drove through the fence. There was crimping to the left front lower door which was attributed to a continuation of the impact damage that occurred when the Econoline drove through the chain link fence. The metallic fuel tank, mounted forward of the rear axle on the left side, was deformed and abraded, but there was no apparent leakage. This damage may have occurred when the Econoline traveled over the curb. There was additional direct contact on the right front bumper corner and forward aspect of the right fender that is believed to be unrelated to this crash. There was additional unrelated direct damage to the lower left side of the van. The unrelated damage may be attributed to the two hit and run crashes this vehicle was involved in just prior to the crash with the Buick Rendezvous. The available driver and right front passenger air bags did not deploy during the crash.

Figure 15. Front bumper, hood, and windshield damage from fence impact

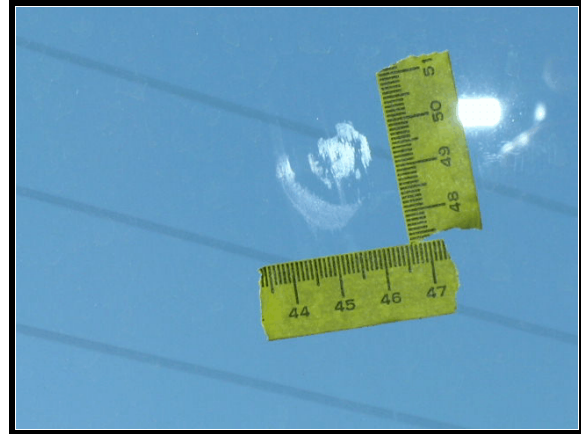
Figure 17. Oily transfer to left front side glazing

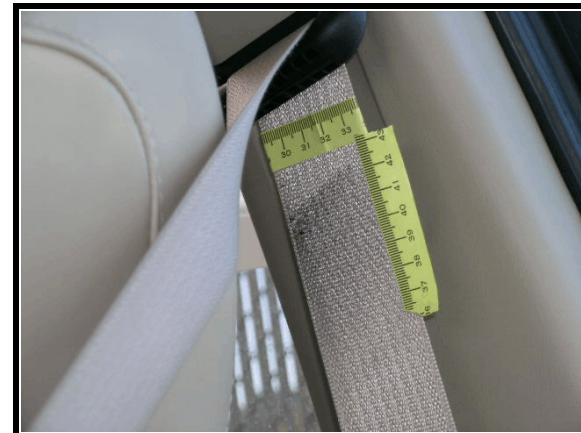
Figure 18. Evidence of loading to driver's seat belt

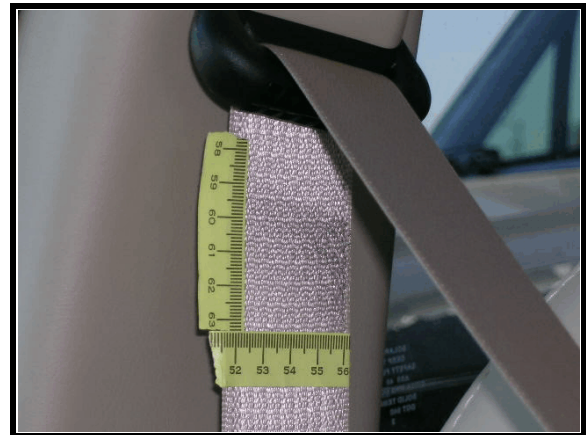
Figure 19. Evidence of loading to front right passenger's seat belt

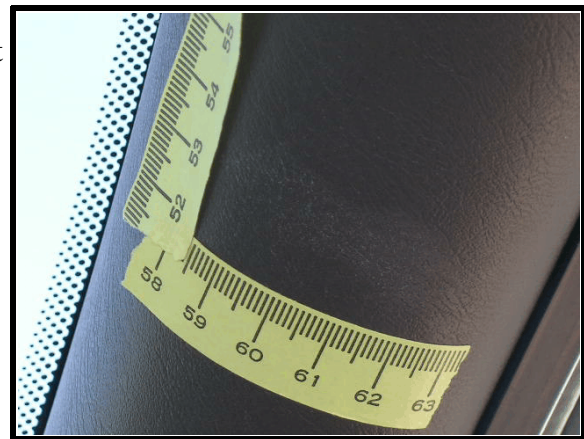
Figure 20. Close-up of occupant contact to right A pillar

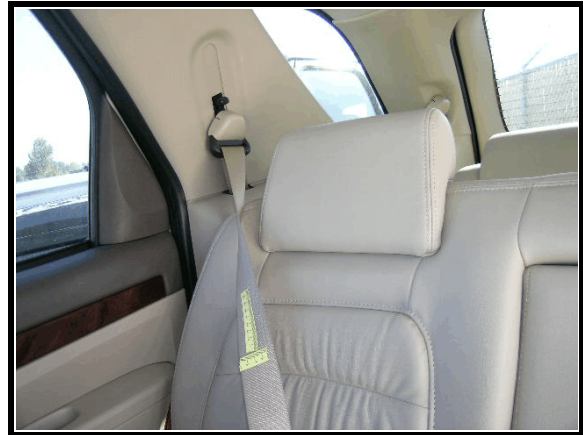
Figure 21. Location of faint stretch mark to second row right seat belt
