Gas/Electric Hybrid Vehicle Investigation/Vehicle to Vehicle
Dynamic Science, Inc./Case Number: DS05017
2005 Toyota Prius
California
July 2005

1. Report No. DS05017	2. Government Accession No.		3. Recipient Catalog No.	
4. Title and Subtitle Gas/Electric Hybrid Vehicle Investigation			5. Report Date June 8, 2006

This on-site investigation focused on the gas/electric hybrid system in a 2005 Toyota Prius, as well as conformance to Federal Motor Vehicle Safety Standard, Section 571.305, Standard No.305 (Electric-powered vehicles: electrolyte spillage and electrical shock protection).

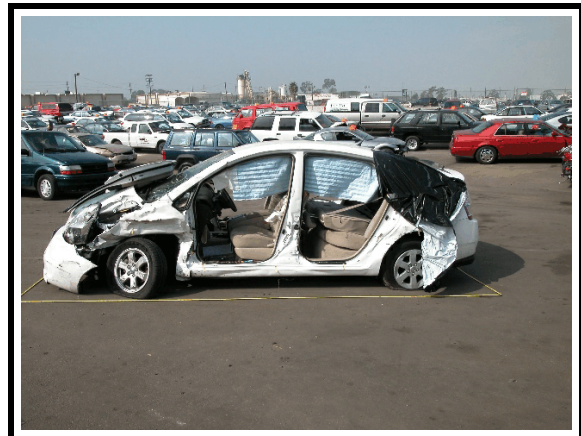
Figure 1. Left side damage - 2005 Toyota Prius

The 2005 Toyota Prius sustained moderate left side damage as a result of the impact with the Sequoia. The Prius sustained 364.0 cm (143.3 in) of direct damage along the left side beginning at the left front bumper corner, extending rearward (Figure 7). There was also direct damage to the right front of the case vehicle, beginning at the right front bumper corner and extending 95.0 cm (37.4 in) rearward down the right side, and 22.0 cm (8.7 in) laterally across the bumper (Figure 8).

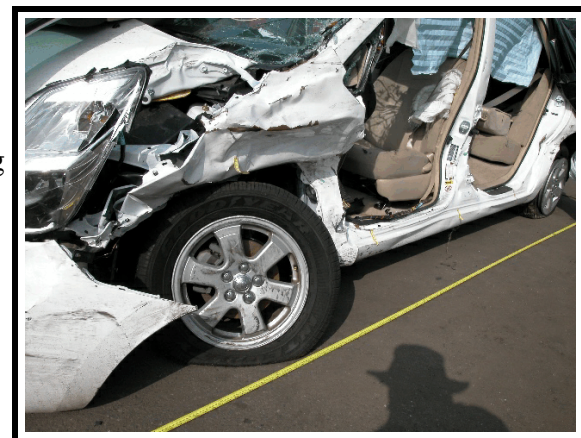
Figure 2. Left side damage - 2005 Toyota Prius

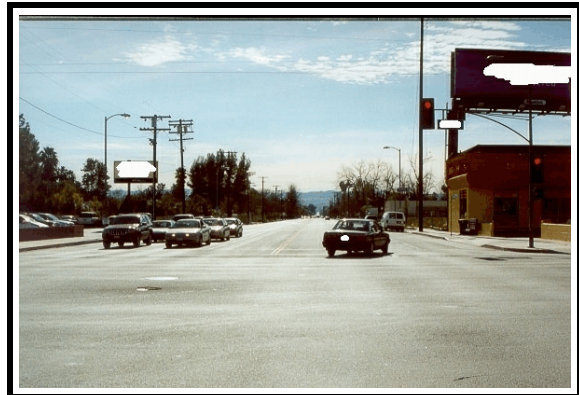
The Toyota Sequoia turned left as the Prius was crossing through the intersection and the front of the Sequoia struck the left side of the Prius (11LDEW3). The impact severity was moderate and resulted in the deployment of the case vehicle's driver's seat back mounted side air bag and left side curtain. The missing vehicle routine of the Winsmash program, computed a total delta V of 40.0 km/h (24.9 mph). The longitudinal and lateral components were -34.6 km/h (-21.5 mph) and 20.0 km/h (12.4 mph), respectively. The Prius continued south, traveled over the southwest corner of the intersection and struck a wall (01FREE6) that was adjacent to the sidewalk (Figure 6). Per the police report, both vehicles came to final rest near the southwest corner of the intersection.

Figure 5. Case vehicle's initial point of impact - south

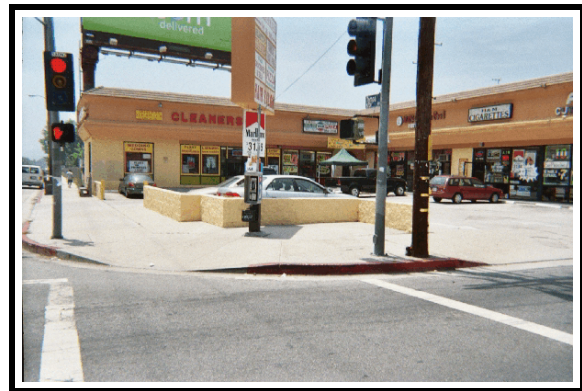
Figure 6. Case vehicle's post-impact trajectory

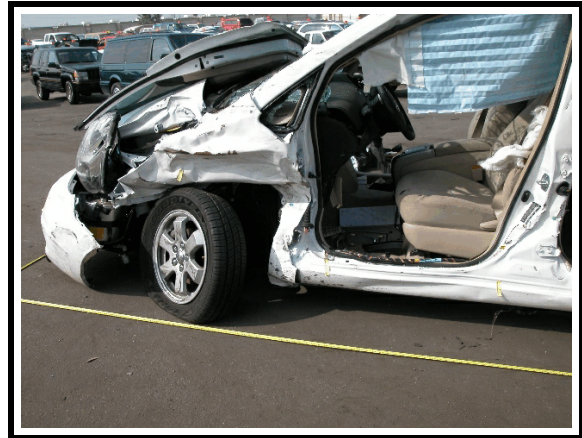
Six crush measurements were documented along the damaged left side as follows: C1=16.0 cm (6.3 in), C2=19.0 cm (7.5 in), C3=19.0 cm (7.5 in), C4=17.0 cm (6.7 in), C5=26.0 cm (10.2 in), C6=27.0 cm (10.6 in).

Figure 7. Damage to left front of case vehicle

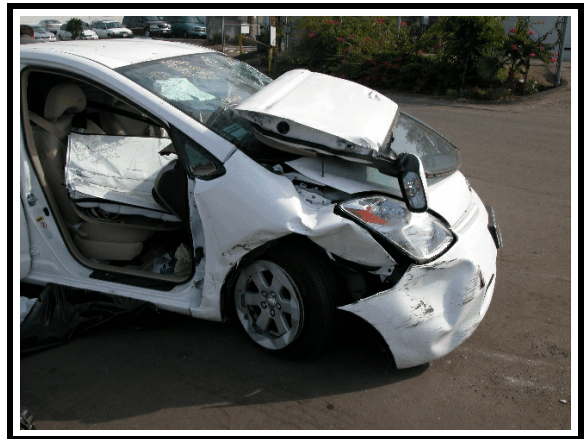
Figure 8. Damage to the right front of case vehicle

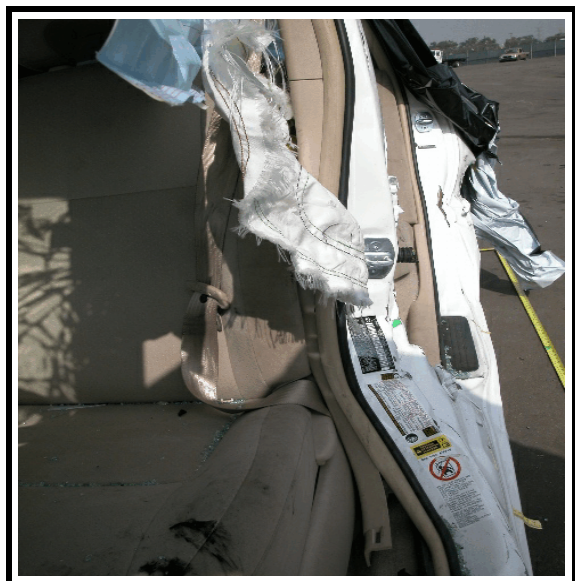
Figure 9. B pillar intrusion and trapped driver's seat belt

The left front door panel, B pillar and lower A pillar all intruded laterally into the driver's area (Figure 10). The B pillar intrusion likely damaged the driver's seat belt retractor, causing her seat belt to lock in place post-crash, after it had been removed by the driver. There was slight longitudinal left front instrument panel intrusion.

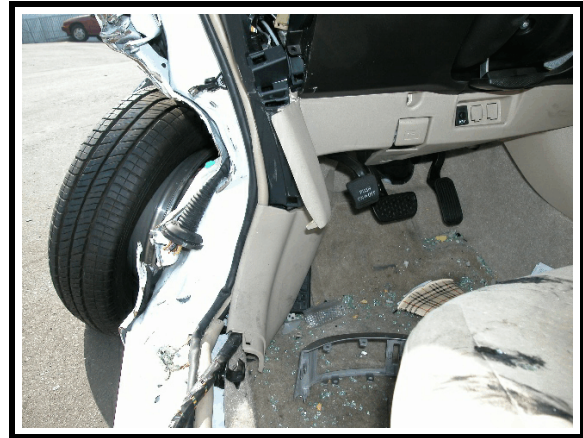
Figure 10. Intrusion into driver area

Position	Intruded Component	Magnitude of Intrusion	Direction
LF	Door panel	Greater than 10.0 cm (3.9 in)	Lateral
LF	A pillar	10.0 cm (3.9 in)	Lateral
LF	B pillar	9.0 cm (3.5 in)	Lateral
LF	Left instrument panel	2.0 cm (0.8 in)	Longitudinal

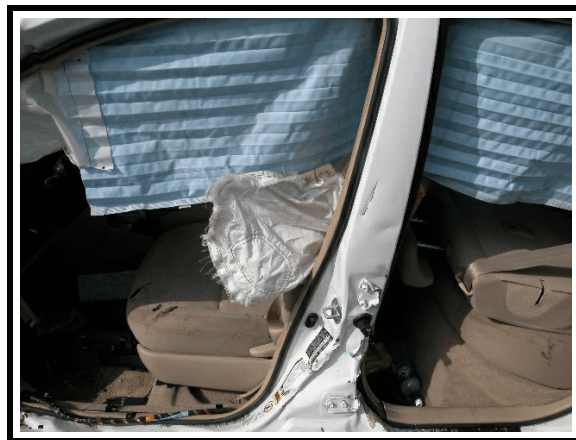
Figure 11. Deployed left side curtain and driver's seat back mounted air bag

The left side air bag and side air curtain both deployed as a result of the impact with the Toyota Sequoia (Figures 11 and 12).

The left side air curtain deployed from the roof cladding. The side air curtain was 158.0 cm (62.2 in) long and 38.0 cm (15.0 in) high. It essentially ran from the A pillar to the C pillar. There were 17 horizontal folds in the curtain. There were no indications of occupant contact and the curtain was not damaged.

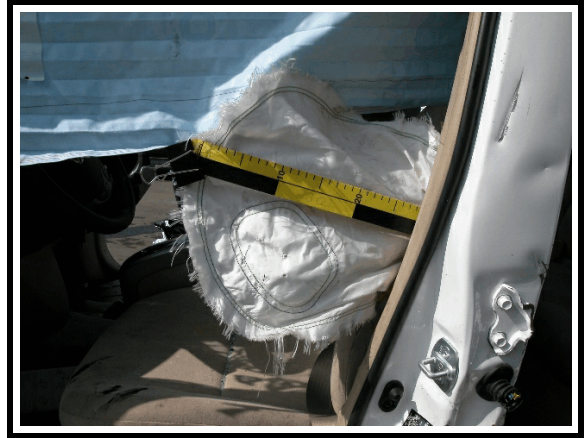
The driver's side air bag deployed from the driver's seat back. The air bag was basically circular in shape and measured 36.0 cm (14.2 in) high by 33.0 cm (13.0 in) wide. There was a 14.0 x 11.0 cm (5.5 x 4.3 in) tether at the forward edge. Within the area bordered by the tether there were three small vent ports. There was no indication of occupant contact and the air bag was not damaged.

Figure 12. Driver's deployed side air bag

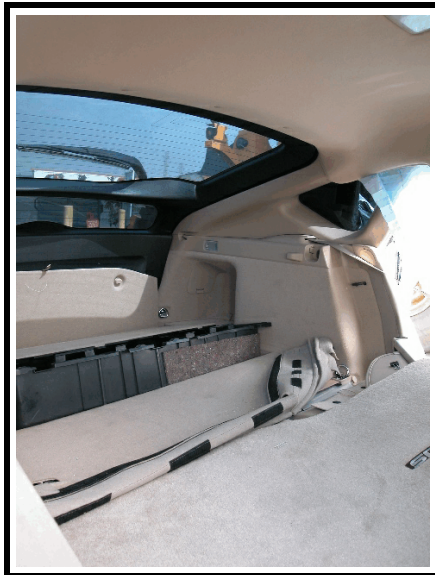
- There were no indications of electrolyte spillage from the propulsion battery.
- There was no movement of the battery module.
- The electrical isolation test was not conducted. There was no power available.
- There were no indications of any arcing, fire or component meltdown.

Figure 14. Traction battery located behind the second row seat back
