**CALSPAN ON-SITE CERTIFIED ADVANCED 208-COMPLIANT VEHICLE  
CRASH INVESTIGATION**

**CALSPAN CASE NO: CA05-021**

**VEHICLE: 2005 JEEP LIBERTY**

**CRASH DATE: JANUARY 2005**

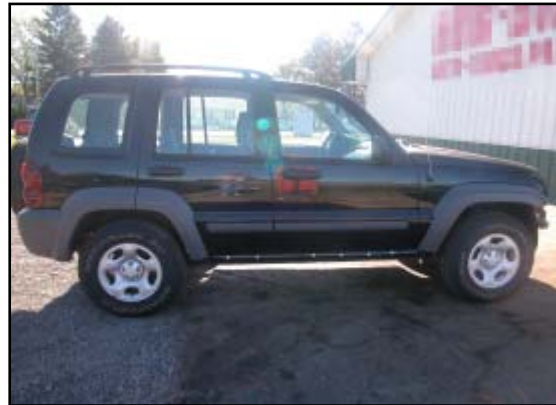
**Figure 1. Subject vehicle 2005 Jeep Liberty.**

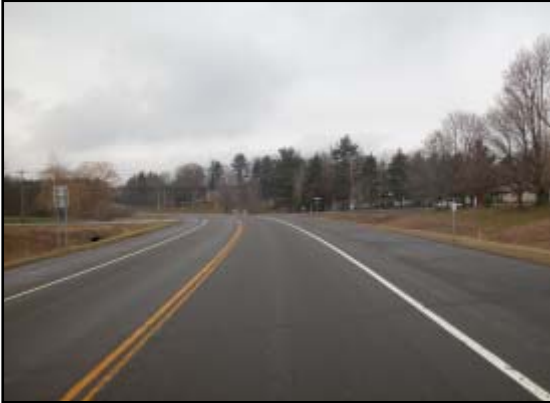
The restrained 28-year-old female driver of the 2005 Jeep Liberty was operating the vehicle westbound (**Figure 2**) approaching the four-leg intersection. The 17-year-old male was operating the 1994 Ford northbound approaching the intersection where he came to a stop (**Figure 3**). The driver of the Ford failed to observe the Jeep and entered the intersection to continue his northbound travel.

**Figure 2. Jeep's westbound approach to the four-leg intersection.**

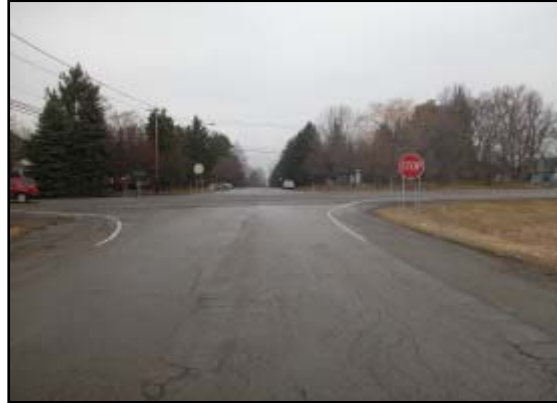
**Figure 3. 1994 Ford northbound approach.**

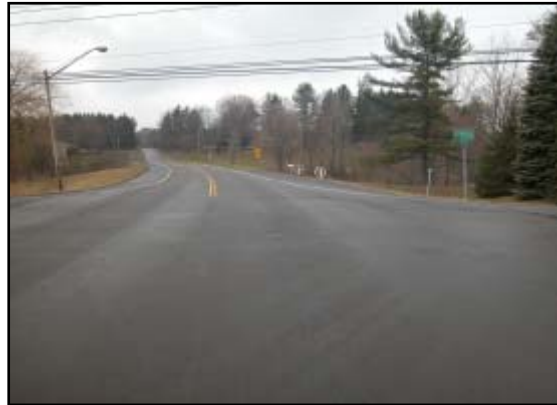
The front aspect of the Jeep impacted the right side of the Ford within the northeast quadrant of the intersection (**Figure 4**). The resultant directions of force were with the 11 o'clock sector for the Jeep and 2 o'clock sector for the Ford. The exact model of the 1994 Ford was unknown; therefore, the barrier equivalent algorithm of the WINSMASH program was used to calculate a delta-V for the Jeep. The total delta-V for the Jeep was 13 km/h (8.1 mph) with longitudinal and lateral components of -12 km/h (-7.6 mph) and 4 km/h (2.8 mph).

**Figure 4. Area of impact from the Jeep's westbound approach.**

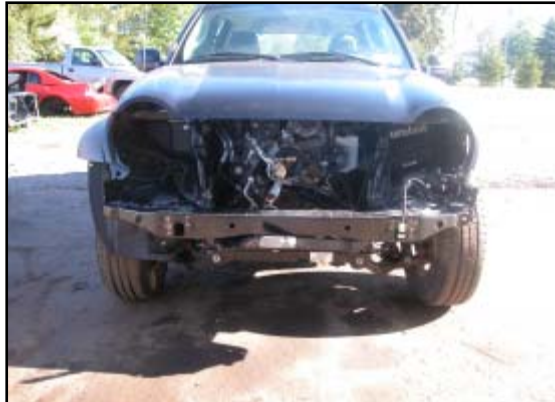
The 2005 Jeep Liberty sustained moderate severity frontal damage as result of the crash. It should be noted that the images included in this report are replacement images (**Figure 5**) that were taken of the Jeep during the repair process. The original images that depict the damage were lost due to a corrupt image card.

**Figure 5. Front of the 2005 Jeep under repair. (Replacement Image)**

The maximum crush measured 16 cm (6.3”) and was located 11 cm (4.3”) right of the centerline. The direct contact damage measured 91 cm (35.8”) and began 25 cm (9.5”) right of the centerline and extended to the front left corner. Six equidistant crush measurements were used to document the residual damage to the bumper beam and were as follows: C1 = 0 cm, C2 = 2 cm (0.8”), C3 = 0 cm, C4 = 13 cm (5.2”), C5 = 0 cm, C6 = 0 cm. The Collision Deformation Classification for this impact was 11-FDEW-1.

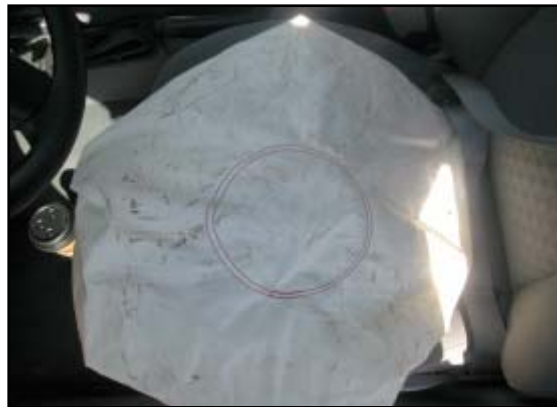
**Figure 6. Deployed driver's frontal air bag.**

In the subject crash, both frontal air bags deployed (**Figure 6**). The driver's air bag was conventionally located in the center of the steering wheel hub. A single cover flap concealed the air bag. There were no damage or occupant contact points present on the air bag membrane; however, dirt was present on the membrane from post-crash handling.

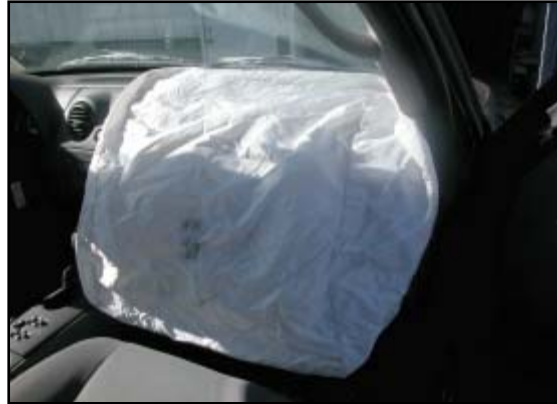
The front right passenger air bag was a mid-mount design in the right instrument panel (**Figure 7**). Two cover flaps concealed the air bag with the instrument panel. The air bag membrane was not damaged and was free of occupant contact. The CAC system appeared to have performed as designed in the subject crash.

**Figure 7. Deployed front right air bag.**

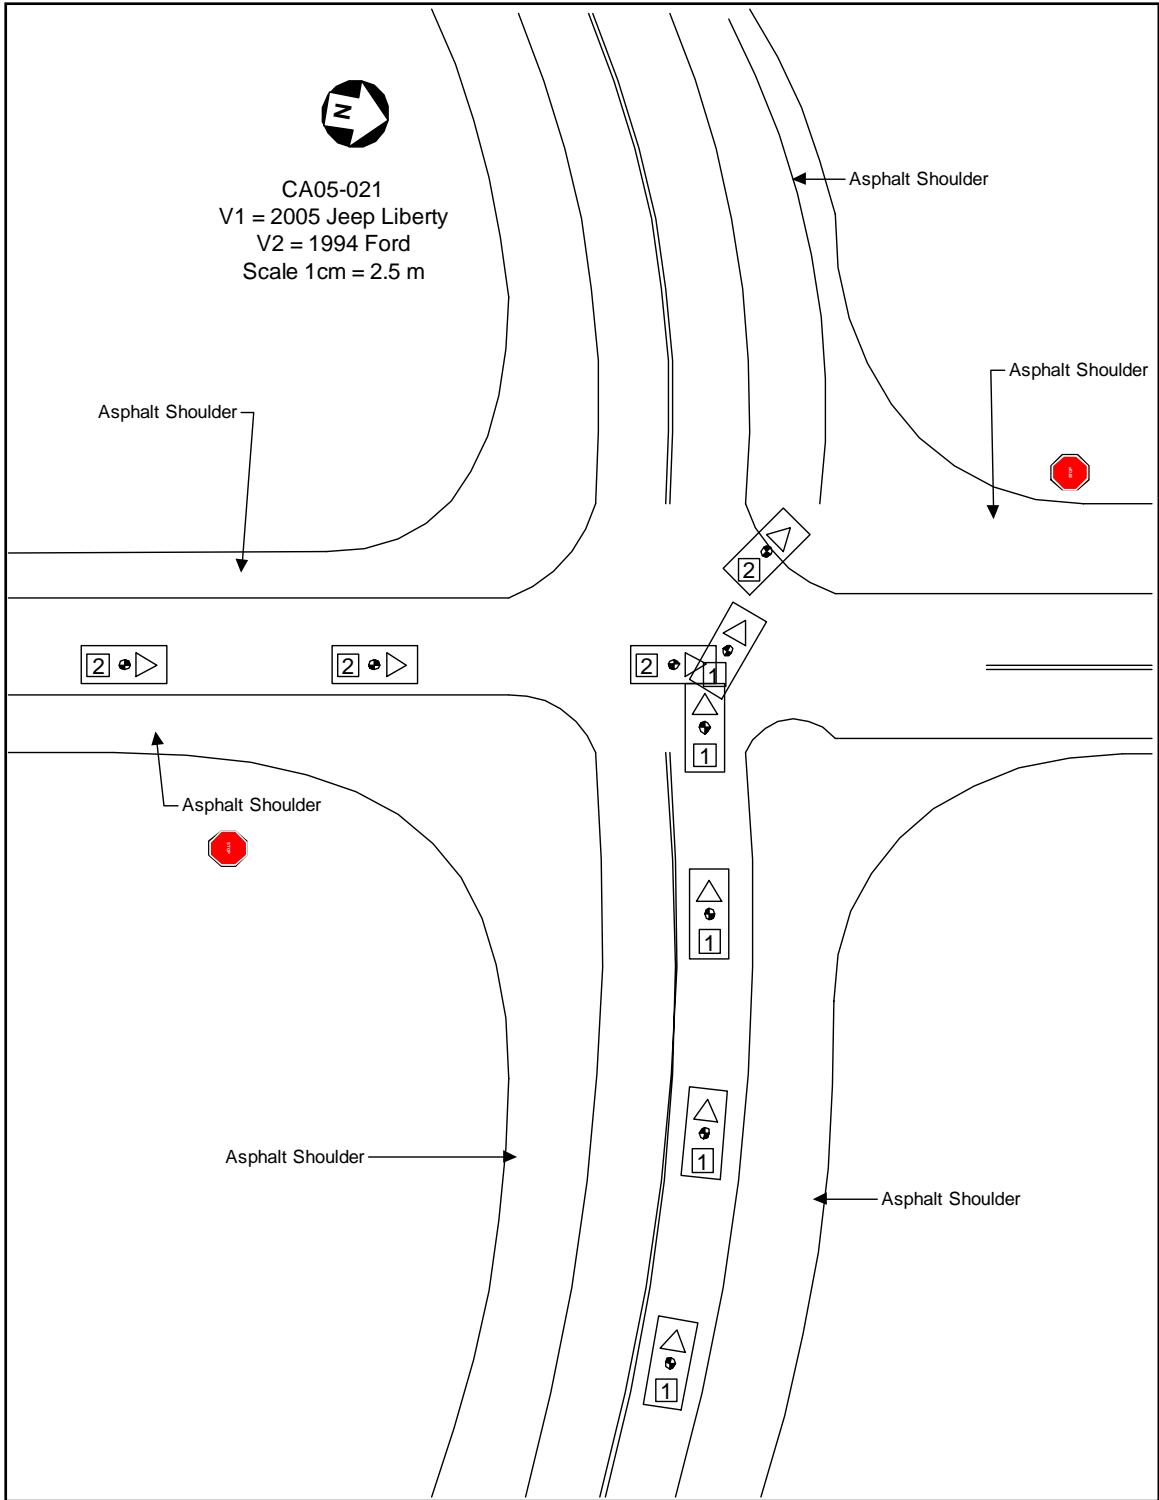
**Figure 8. Scene Schematic**

This intersection crash occurred during the daylight hours of January 2005. At the time of the crash, it was snowing and the roadway was snow and ice covered. The crash occurred within a four-leg intersection. The north and south legs of the intersection were configured with one travel lane in each direction. Double yellow centerlines delineated the travel lanes for the north leg. The east and westbound legs were configured with one travel lane in each direction that was delineated by double yellow centerlines. The roadway curved left for the westbound travel direction. The posted speed limit for the roadways was 64 km/h (40 mph). The scene schematic is included as **Figure 8** of this report.
