CALSPAN ON-SITE CHILD SAFETY SEAT INVESTIGATION

SCI CASE NO. – CA05-023

SUBJECT VEHICLE – 2001 MITSUBISHI MONTERO

CRASH DATE – APRIL 2005

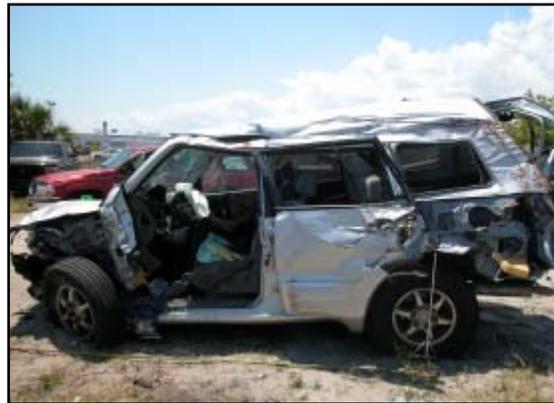
The 2001 Mitsubishi Montero sustained severe left side damage as a result of the initial impact with the Lufkin trailer (**Figure 5**). The direct contact damage began on the left door window frame and extended 274 cm (108.0”) rearward, which included a 107 cm (42.0”) section of the quarter panel that was torn from the vehicle. Additionally, the direct contact damage on the left side rail measured 236 cm (93.0”) and extended from the A-pillar to the D-pillar. Due to the torn sheet metal, a crush profile could not be obtained along the left side plane of the vehicle. Therefore, the lateral crush was documented at the side rail for this impact at each pillar location. The crush at the A-pillar measured 3 cm (1.2”), B-pillar 10 cm (4.0”), C-pillar 25 cm (10.0”), and D-pillar 25 cm (10.0”). The Collision Deformation Classification (CDC) for this impact was 11-LDAW-3.

Figure 5. Left side damage to the Mitsubishi from the impact with the Lufkin trailer.

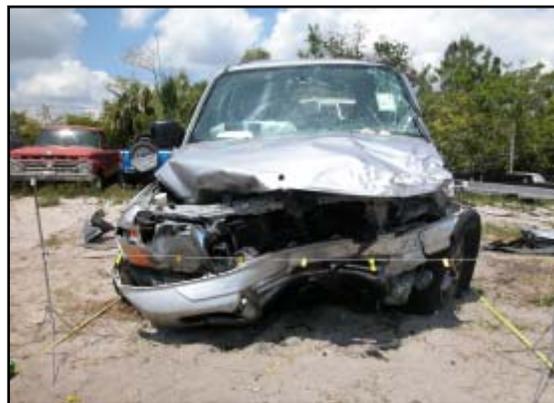
The Mitsubishi sustained moderate frontal damage as a result of the impact with the front of the Ford (**Figure 6**). The direct contact damage measured 130 cm (51.2”), and extended to the front left bumper. The maximum crush measured 45 cm (17.7”) and was located at the left corner of the bumper support. A crush profile was documented across the full width of the bumper support of 130 cm (51.2”) and was as

Figure 6. Frontal damage to the Mitsubishi from the impact with the Ford.

follows: C1 = 45 cm (17.7”), C2 = 22 cm (8.6”), C3 = 11 cm (4.3”), C4 = 4 cm (1.6”), C5 = 0.0, C6 = 0.0. The CDC assigned to this impact was 12-FDEW-2.

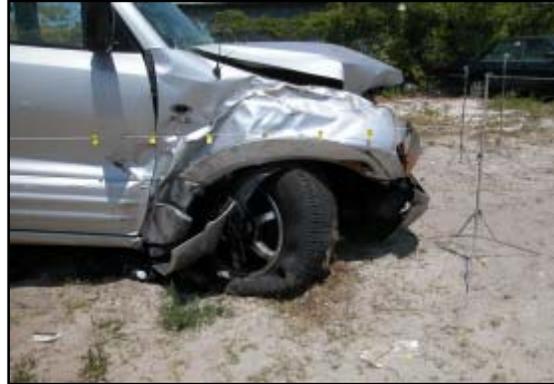
The Mitsubishi sustained minor right side damage as a result of the secondary impact with the Ford (**Figure 7**). The direct contact damage began aft of the forward edge of the right front door and extended forward and measured 117 cm (46.0”). The maximum crush measured 6 cm (2.4”) and was located on the front right fender. The crush profile was documented at the mid-door level for this impact was as follows: C1 = 3 cm (1.2”), C2 = 3 cm (1.2”), C3 = 6 cm (2.4”), C4 = 5 cm (2.0”), C5 = 6 cm (2.4”), C6 = 3 cm (1.2”). The assigned CDC for this event was 03-RFEW-1.

Figure 7. Right side damage to the Montero from the secondary impact with the Ford

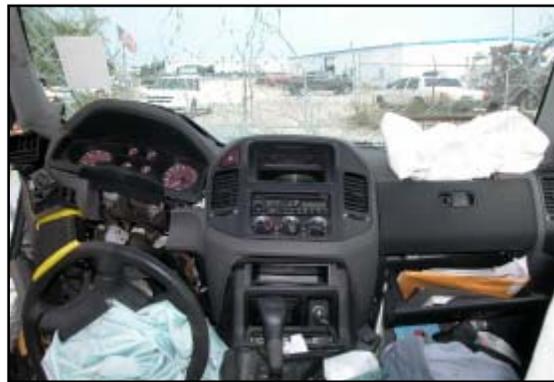
The 2001 Mitsubishi Montero sustained severe interior damage as a result of occupant contacts, air bag deployment, and passenger compartment intrusion. The driver loaded the seat cushion as she responded to the crash forces. The loading deformed the seat track mounting brackets inward, which allowed the cushion to travel downward and forward. Also noted on the seat cushion was a red cloth transfer and frictional abrasions. Deformation and body fluid were noted to the left knee bolster. The lower aspect of the steering wheel rim was deflected 6 cm (2.4”) forward. There was complete separation of the shear capsules. **Figures 8 and 9** are an overall view of the damage to the left instrument panel and driver’s seat cushion.

Figure 8. Interior damage to the first row of the Montero.

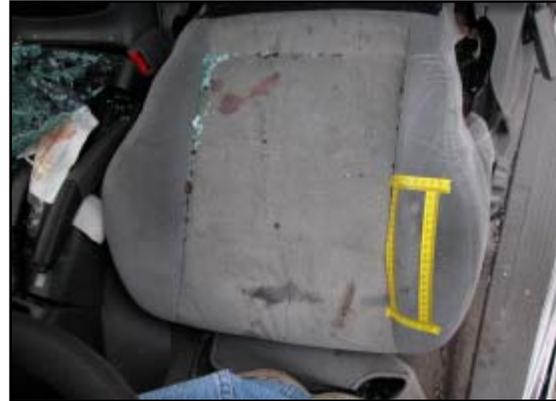
Figure 9. Overhead view of the Mitsubishi's driver's seat cushion and frictional

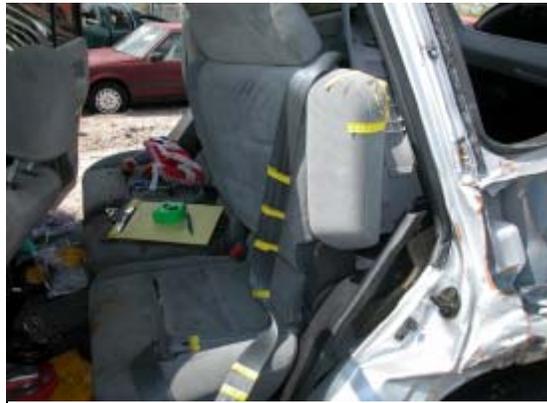
The Lufkin trailer penetrated the passenger compartment during the initial impact. The penetration occurred at the second row where the rear left corner of the trailer contacted the outboard aspect of the rear left seatback resulting in a vertical tear approximately 8 cm (3.1”) in height. A double stroller that weighed approximately 14 kgs (30 lbs) was located in the rear cargo area of the vehicle. At impact, the stroller loaded the rear of the second row seatback, which resulted in four tears to the cloth, and forward displacement of the seatback (**Figures 10 and 11**). The longitudinal distance between the front left seat back and the left rear CSS seatback was 27 cm (10.6”) and the front seatback to the CSS cushion was 9 cm (3.5”). The second row center and right seatbacks were also displaced forward. The infant CSS was not with the vehicle at the time of the SCI inspection, therefore the longitudinal distance between the CSS and front right seatback was unknown. The passenger compartment intrusions are listed in the table below:

Figure 11. Forward deformation of the second row seatbacks of the Mitsubishi and left seatback contact from the Lufkin trailer.

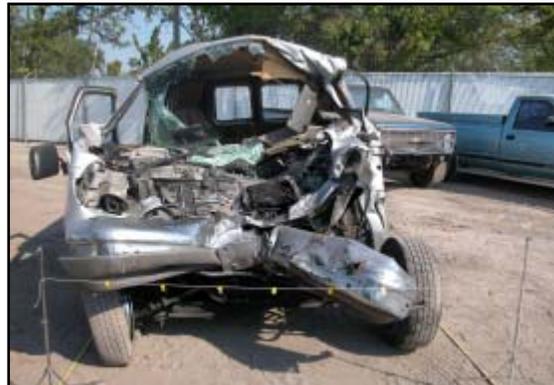
The 1995 Ford Econoline sustained severe frontal damage as a result of the frontal impact with the Mitsubishi (**Figure 12**). The direct contact damage measured 122 cm (48.0”) and extended from the front left bumper corner to the front right bumper corner. The maximum crush at the bumper measured 61 cm (24.0”) and was located 48 cm (18.9”) inboard of the left corner. The maximum crush at the upper radiator support measured 105 cm (41.3”) and was located 48 cm (18.9”) inboard of the left corner. Due to the Mitsubishi overriding the frontal plane of the Ford, the crush was documented at the bumper, upper radiator support, and windshield header. The crush measurements were documented using a combined direct and induced damage width of 122 cm (48.0”). The crush at the bumper was as follows: C1 = 0.0 cm, C2 = 27 cm (10.6”), C3 = 61 cm (24.0”), C4 = 55 cm (21.6”), C5 = 28 cm (11.0”), C6 = 2.0 cm (0.8”). The crush at the upper radiator support was as follows: C1 = 77 cm (30.3”), C2 = 85 cm (33.5”), C3 = 105 cm (41.3”), C4 = 101 cm (39.7”), C5 = 94 cm (37.0”), C6 = 72 cm (28.3”). The CDC for this impact was 12-FDAW-6.

Figure 12. Frontal damage to the Ford from the impact with the Mitsubishi.

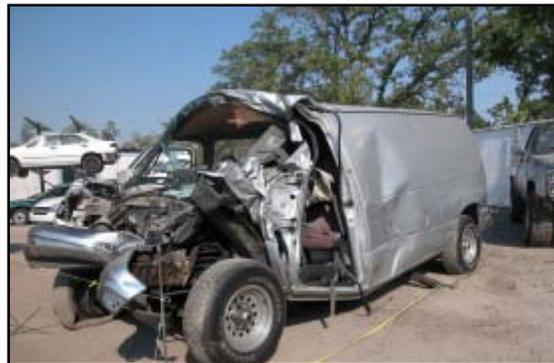
Figure 13. Ford’s windshield header damage and crush profile.

As a result of the override impact, the front of the Mitsubishi contacted the windshield header of the Ford (**Figure 13**). A damage profile was measured to represent the deformation to this area and was as follows: C1 = 22 cm (8.6"), C2 = 20 cm (7.8"), C3 = 5 cm (2.0"), C4 = 0 cm, C5 = 0 cm, C6 = 8 cm (3.1").

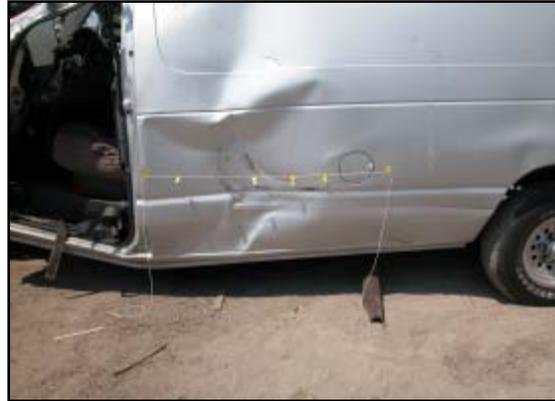
Figure 14. Left side damage to the Ford from the impact with the Mitsubishi's right rear tire.

As the Ford and the Mitsubishi disengaged, the vehicles rotated which resulted in a secondary impact. The impact involved the right rear tire of the Mitsubishi contacting the left side of the Ford (**Figure 14**). The direct contact damage consisted of a rotating tire scuffmark on the quarter panel rear of the B-pillar. The crush on the left side of the Ford was as follows: C1 = 1 cm (0.4"), C2 = 4 cm (1.6"), C3 = 8 cm (3.1"), C4 = 6 cm (2.4"), C5 = 4 cm (1.6"), C6 = 0 cm. The CDC for this impact was 09-LPEW-1.

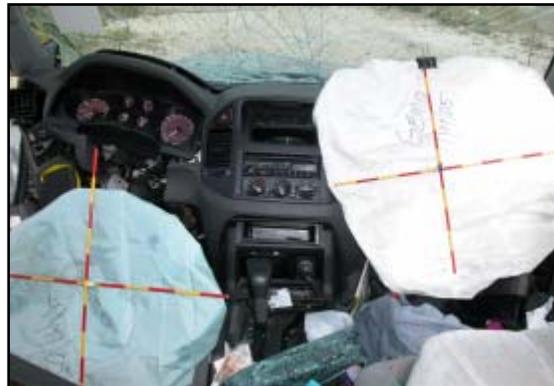
The 2001 Mitsubishi Montero was equipped with a redesigned frontal air bag system that deployed as result of the frontal impact with the Ford (**Figure 15**). The driver's air bag was conventionally located in the center of the steering wheel hub. Two A-symmetrical cover flaps concealed the air bag. The top cover flap measured 14 cm (5.5") in height and 14 cm (5.5") in width at the center tear seam. The lower cover flap measured 3 cm (1.2") in height and 14 cm (5.5") in width. The air bag membrane was 60 cm (23.6") in diameter in its deflated state and was vented by two ports that were located on the rear aspect of the air bag at the 11 and 1 o'clock positions. Two wide band tethers at the 9 and 3 o'clock positions tethered the driver's air bag. There were no occupant contact points present on the air bag membrane; however, dirt and body fluid were present on the air bag face.

Figure 15. Mitsubishi's deployed frontal air bag system.

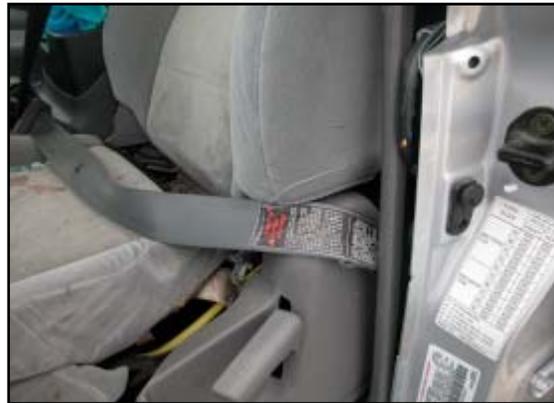
The 2001 Mitsubishi Montero was equipped with manual 3-point lap and shoulder safety belts for the outboard seating positions. The rear center was configured with a 2-point manual lap belt. The driver's safety belt was configured with a sliding latch plate, an Emergency Locking Retractor (ELR), and an energy management loop. The driver utilized her safety belt in the crash, which was evidenced by the abrasions on the latch plate and deployed energy management loop (**Figure 16**).

Figure 16. Mitsubishi's driver's lap belt with deployed energy management loop.

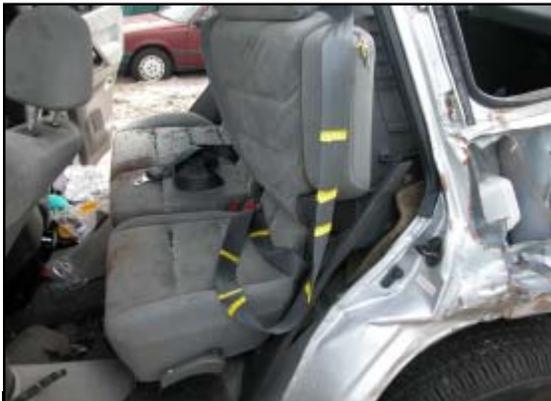
Figure 17. Loading evidence on left rear safety belt of the Montero.

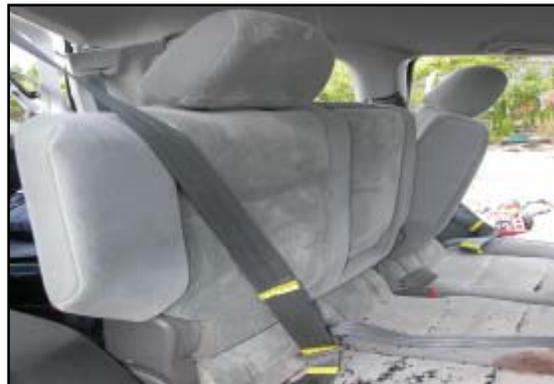
The front right safety belt was configured with a sliding latch plate, a switchable ELR/Automatic Locking Retractor (ALR), and an energy management loop. The front right position was not occupied therefore; the safety belt was not used during the crash. The rear outboard safety belts were configured with sliding latch plates and switchable ELR/ALR. The left rear safety belt was used to restrain a child safety seat (CSS) that was occupied by the 2-year-old male occupant. Usage was supported by the loading marks and black plastic transfers on the webbing from the CSS (**Figure 17**). The rear center lap belt was not used in this crash. The rear right safety belt was used to restrain an infant CSS that was occupied by the 7-month-old male occupant. The safety belt exhibited usage evidence that consisted of gray plastic transfers from the CSS (**Figure 18**).

Figure 18. Loading evidence on right rear safety belt of the Montero.

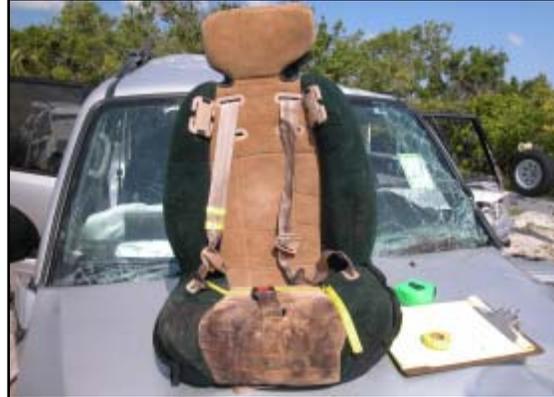
Two CSS's were used in the rear of the Mitsubishi during the crash. The rear left CSS was a Century Select Breverra Classic Model No. 4865MAL01 and was manufactured on 8/2/2000 (**Figure 19**). The seat was designed to be used as a forward facing CSS with the 5-point harness for children weighing between 13.6-18.1 kg (30-40 lbs), or as a belt-positioning booster for children weighing between 13.6-36.3 kg (30-80 lbs). The seat was used as a forward facing CSS with the 5-point harness system by the 2-year-old male. The vehicle's lap and shoulder belt was routed through the rear belt path to restrain the CSS. This was supported by the loading abrasions that were noted on the belt path and plastic transfers on the safety belt. The harness system was routed through the top slots at the time of the SCI inspection. Additionally, the harness system displayed minor usage evidence that consisted of curling to the harness straps from the child occupant. A 1.0 cm (0.4") tear was noted to the right harness strap and several areas on both straps contained body fluid. Located on cloth seat cushion were body fluid, brain matter, and hair. No damage was noted to the CSS structure.

Figure 19. Rear left forward facing Century CSS.

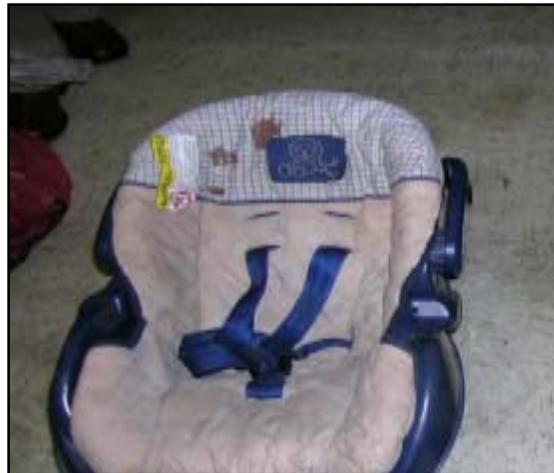
The rear right CSS was a Graco Lite Rider Model No. 7426CUB that was manufactured on 6/29/2002 (**Figure 20**). The CSS consisted of a child safety seat with an integral five-point harness system, a pivoting carrying handle, and a detachable base. Additionally, the base was equipped with an adjustable foot that was extended to the lowest of three positions. The CSS was designed as an infant restraint for children that weigh 9.1 kg (20 lbs) or less and height of 66.0 cm (26.0") or less. The 7-month-old male that occupied the CSS was 69 cm (27") in length and weighed 8 kgs (18 lbs). His height was beyond the manufacturer's recommended height of limits (26.0") 66 cm; consequently the CSS was misused according to the manufacturer specifications. Minor stress marks were noted to the front and rear of the top aspect of the shell and to the cushion area of the shell. Stress marks were noted at the base of the shell where the integral harness system was routed through from left to right side indicative of loading to the harness system. Additionally, stress marks were noted to the reinforcements that were located on the outboards aspects of the shell adjacent to the carrying handle. The

Figure 20. Right rear Graco infant CSS.

Minor stress marks were noted to the front and rear of the top aspect of the shell and to the cushion area of the shell. Stress marks were noted at the base of the shell where the integral harness system was routed through from left to right side indicative of loading to the harness system. Additionally, stress marks were noted to the reinforcements that were located on the outboards aspects of the shell adjacent to the carrying handle. The

base exhibited stress marks on the left side due to contact from the shell reinforcements. The harness system was located in the lower slots at the time of the SCI inspection. In the fastened position, the retainer clip was approximately 2.5 cm (1.0”) lower on the left harness strap. There was no damage to the harness system; however, the left harness strap was folded longitudinally at the left hip area.
