**CALSPAN ON-SITE CHILD SAFETY SEAT CRASH INVESTIGATION**  
**GRACO SNUG RIDE REAR-FACING CHILD SAFETY SEAT**  
**SCI CASE NO: CA05-024**

**VEHICLE: 2004 NISSAN QUEST**  
**LOCATION: CONNECTICUT**  
**CRASH DATE: MARCH, 2005**

Contract No. DTNH22-01-C-17002

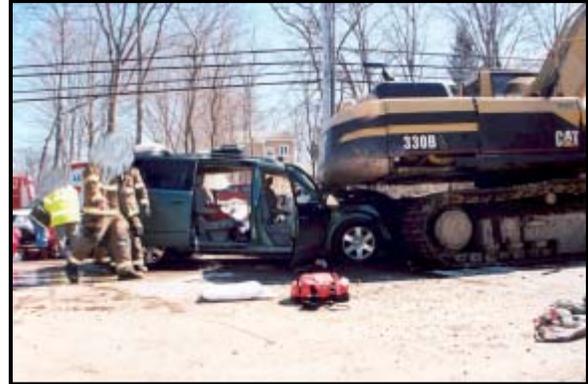
**Figure 1: On-scene view of the crash site and the final rest position of the Nissan**

on-scene view of the crash site. The front plane of the Nissan impacted the back plane of the excavator and came to rest. The force of the crash resulted in the deployment of the Nissan's frontal air bags and the left side inflatable impact protection system. Both infants remained secured in the child safety seats during the crash. However, the infant secured in the CSS on the left side of the second row sustained an AIS-6 cervical spine injury and brain hemorrhages due to the acceleration/deceleration of the crash. He was pronounced deceased 185 minutes post-crash. The infant secured in the second row right CSS was transported to a local hospital, evaluated and released without injury. The restrained driver of the Nissan was not injured. The unrestrained 59 year old female front right passenger sustained blunt force head and chest trauma which required hospitalization.

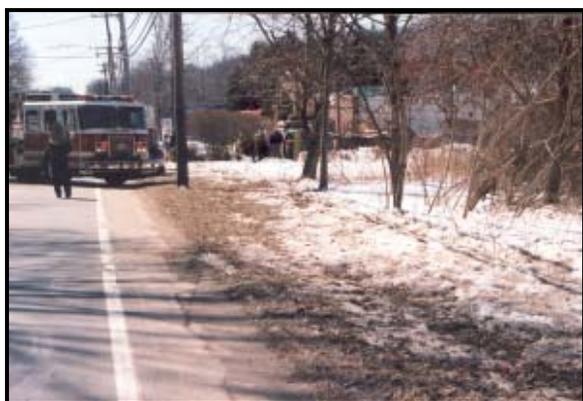
**Figure 3: Trajectory view at the roadside departure.**

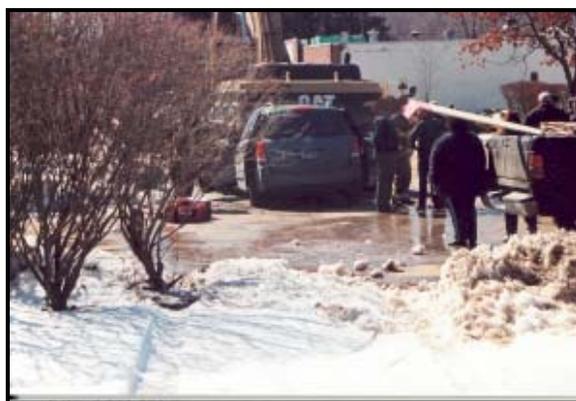
**Figure 2: Trajectory view 24 m (80 ft) from the point of impact.**

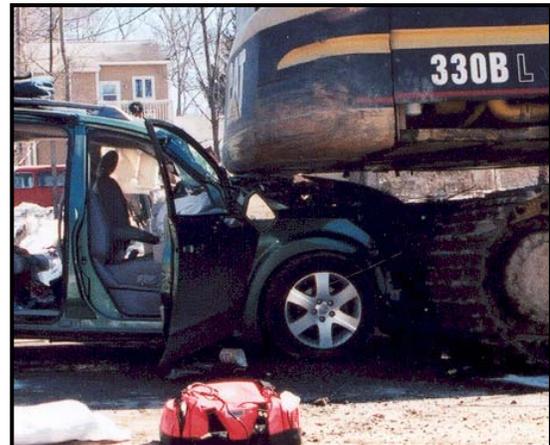
**Figure 15** at the end of this report is a schematic of the crash. The front plane of the Nissan struck the back plane of the parked excavator. The directions of the impact force were in the 12/6 o'clock sectors for the Nissan and Caterpillar, respectively. Due to the overhanging design of the excavator, the front bumper of the Nissan passed under the excavator's counterweight and impacted the left drive track. Nearly simultaneously with the bumper impact, the upper aspect of the right A-pillar, the windshield, and the windshield header impacted the counterweight. The force of the frontal impact caused the front safety belt pretensioners to fire and the deployment of the frontal air bags and the left side inflatable impact protection. The total delta V of the Nissan calculated by the Damage Algorithm of the WINSMASH model was 40.6 km/h (24.9 mph). This value appeared to underestimate the severity of the impact based on SCI field experience.

**Figure 5: Close-up view of the impact configuration and final rest position of the Nissan.**

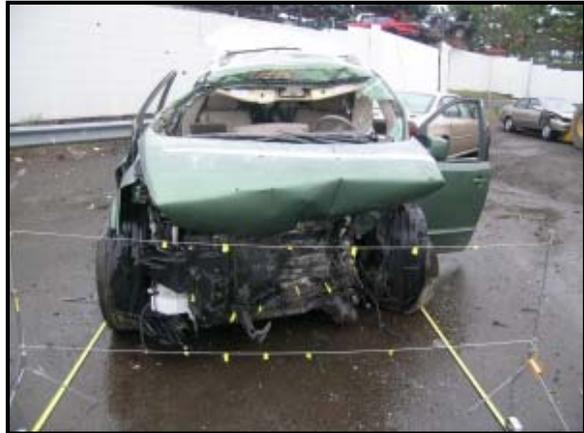
**Figure 7** is a front view of the damaged Nissan taken during the SCI inspection. The direct contact damage was comprised of two distinct regions of contact directly associated to the overhanging structure of the excavator. The combined width of direct contact damage associated to the two regions extended across the entire 160 cm (63 in) frontal end width. The regions of contact could be separated at the base of the A-pillars. The direct and induced damage at the bumper elevation was associated to contact with the left track of the excavator. The direct contact at the bumper elevation began 22 cm (8.6 in) right of center and extended 102 cm (40.1 in) to the left corner of the front bumper. The residual crush profile at the bumper elevation was as follows: C1 = 78 cm (30.7 in), C2 = 49 cm (19.3 in), C3 = 39 cm (15.4 in), C4 = 17 cm (6.7 in), C5 = 5 cm (2.0 in), C6 = 17 cm (6.7 in). The direct damage at the windshield header resulted from a nearly simultaneous impact with the excavator's counterweight. The direct damage at this elevation began 43 cm (17.0 in) left of center and extended 107 cm (42.0 in) to the right corner of the header. The residual crush profile across the windshield header was: C1 = 0 cm (0.0 in), C2 = 18 cm (7.1 in), C3 = 18 cm (7.1 in), C4 = 20 cm (7.9 in), C5 = 16 cm (6.3 in), C6 = 8 cm (3.2 in). **Figures 8 and 9** are left and right lateral views of the Nissan's impact, respectively. All the doors remained closed during the impact. The front left door and the front right door were open at the time of the inspection but could not be related due to deformation of the vehicle's structure. Both sliding second doors were operational. The windshield fractured and the glazing of the front row windows disintegrated during the impact. The left wheelbase was reduced 33 cm (13.1 in). The left front wheel rim was fractured during the impact. The right wheelbase was unchanged. The Collision Deformation Classification was 12-FDAA6.

**Figure 7: Nissan frontal damage.**

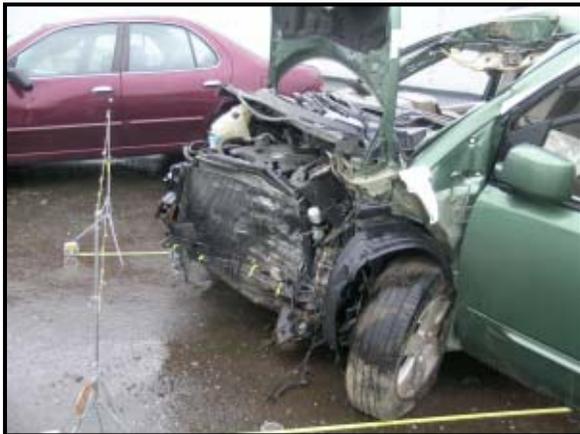
**Figure 9: Left lateral view.**

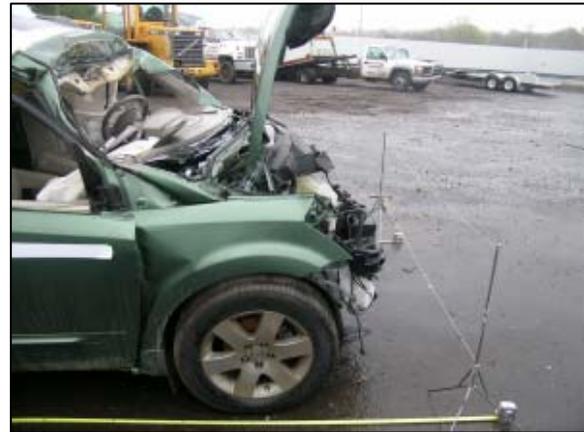
**Figure 8: Right lateral view**

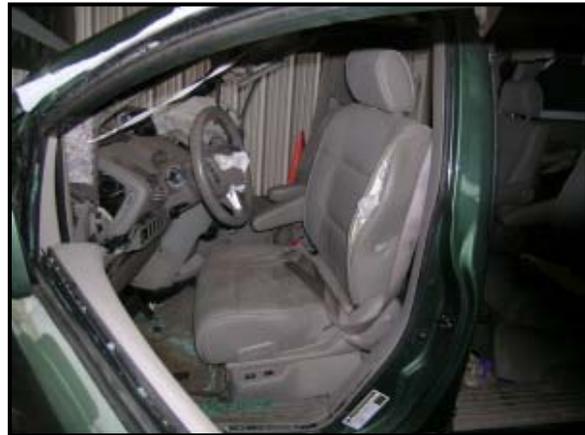
The leather upholstered, 8-way powered, driver seat was adjusted to a rear-third track position that measured 7 cm (2.9 in) forward of full rear, **Figure 10**. The total seat track travel measured 24 cm (9.5 in). The seat back recline angle measured 10 degrees. The anti-submarine angle of the seat cushion measured 3 degrees. The upper outboard aspect of the driver seat back appeared to be deformed rearward by a counterclockwise rotation. The estimated deformation of the upper left aspect of the seat back was 9 cm (3.5 in). The horizontal distance from the seat back to the center hub of the steering wheel measured 41 cm (16 in). This distance was measured 46 cm (18 in) above the seat bight. The Nissan Quest was equipped with adjustable pedals. The pedals were adjusted to the rear most position (closest to the driver). The total pedal adjustment measured 8 cm (3 in).

**Figure 10: Left interior view of the driver seat.**

driver's belt webbing was locked in an extended position and lying on the seat, refer to **Figure 10** above. The exposed length of the webbing measured 212 cm (83.5 in). The D-ring was adjusted to the full-up position. The webbing was jammed in the D-ring from loading by the driver during the ride-down of the crash. Additionally, the webbing exiting the D-ring was abraded over an 11 cm (4.5 in) length and the frictional surface of the D-ring was also heavily abraded. The evidence identified during the SCI inspection indicated the driver was restrained at the time of the crash.

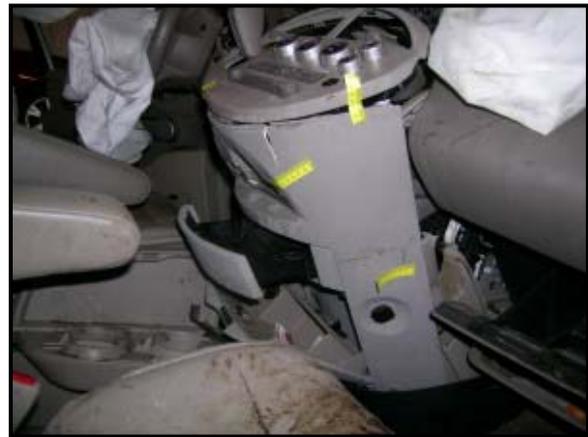
The unrestrained front right passenger contacted the center and right aspect of the cylindrical center instrument panel with her torso and lower extremities, **Figure 11**. The circular panel comprising the top of the center instrument panel was displayed to the left and forward by front right occupant contact. An 8 cm (3 in) vertical fracture at the 5 o'clock sector of the cylindrical panel was also noted. Body fluid transfers were noted adjacent to the fracture site and to the lower right aspect of the side panel. A lower extremity contact was noted to the central aspect of the glove box door. This contact was identified by a 9 cm (3.5 in) long scuff mark located 10 cm (4 in) right of the glove box latch. The latching mechanism of the glove box was also fractured by this contact.

**Figure 11: View of the occupant contacts to the center instrument panel.**

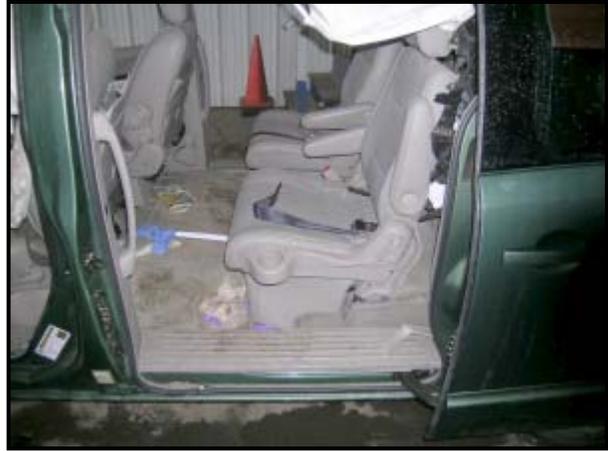
driver's seat back measured 91 cm (36 in). This measurement was taken at the elevation of the seat bight. The horizontal distance from the seat back to the driver's seat back 58 cm (23 in) above the seat bight measured 95 cm (37.5 in). The horizontal distance from the Row 2 right seat back to the front right passenger seat back measured 86 cm (34 in) at the seat bight. The horizontal distance from the seat back to the front passenger seat back 58 cm (23 in) above the seat bight measured 85 cm (33.5 in). **Figure 13** is a left interior view depicting the interior volume between the first and second row of seats.

**Figure 13: Left interior view of the second row.**

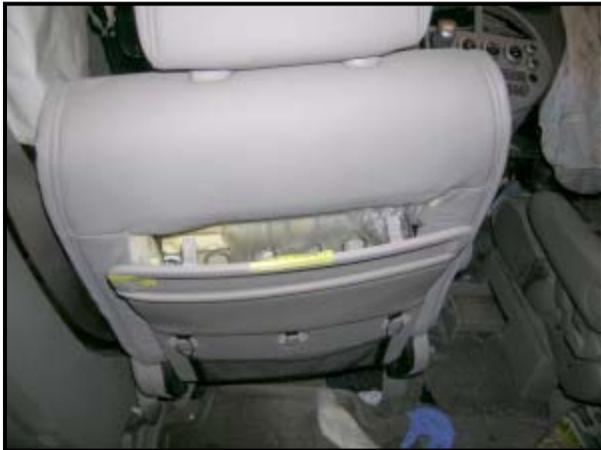
During the ride down of the crash, the backs of the front seats were contacted by the shells of the respective CSS's. **Figures 14 and 15** are views of the left front and right front seat back respectively. The seat backs consisted of a map pocket sewn onto a vinyl insert that covered the seat's internal structure. The driver's seat back exhibited a 1 cm (0.4 in) abrasion to the upper outboard aspect. Additionally, the vinyl insert was displaced rearward. As reported earlier in this report, the upper outboard aspect of the seatback appeared deformed rearward approximately 9 cm (3.5 in). Refer to **Figure 14** The front right seat back exhibited an 8 cm (3 in) long vertical linear abrasion located 8 cm (3 in) left of center. The inboard aspect of the map pocket stitching was torn over a 13 cm (5.3 in) length.

**Figure 14: Driver's seat back.**

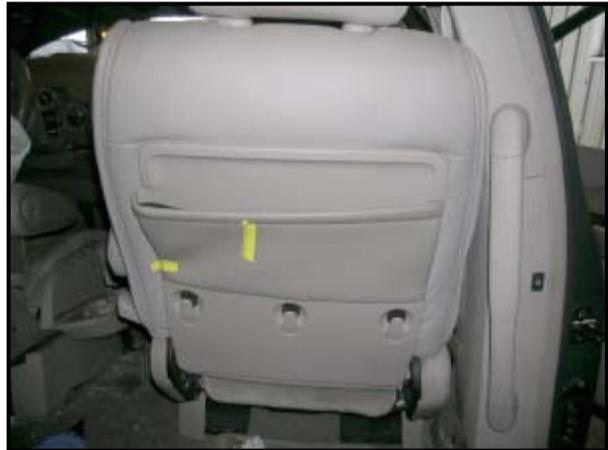
**Figure 15: Front right passenger seat back.**

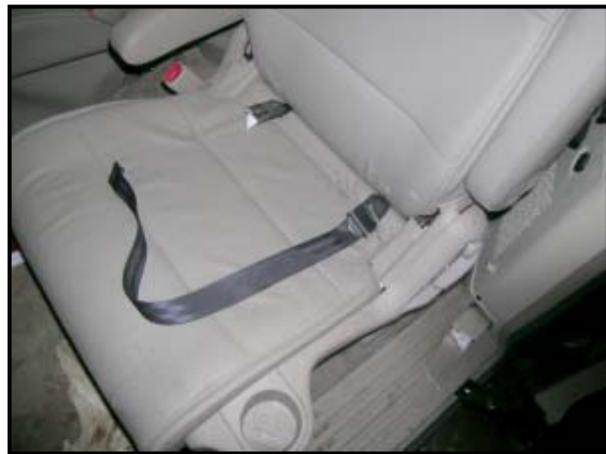
The second row left safety belt was cut 20 cm (8 in) above the floor anchor and 73 cm (28.8 in) from the latch plate. Refer to **Figure 16**. The total length of the cut section measured 146 cm (57.6 in). This section of webbing was removed from the Nissan and transported with the CSS. It was located in the police property room and inspected at that location. There was no evidence of loading noted on the webbing. The balance of the webbing above the cut section spooled back into the retractor and was not available for inspection. The Row 2 left seat LATCH webbing was cut at the locking slide adjuster attached to the seat's outboard LATCH anchor and 8 cm (3 in) above the inboard LATCH anchor. This cut section measured 39 cm (15.2 in) in length and was still threaded through the CSS base. The outboard ends of this webbing were creased due to loading from the CSS base. This webbing section was also inspected in the police property room.

**Figure 16: Cut seat belt of the Row 2 left seat.**

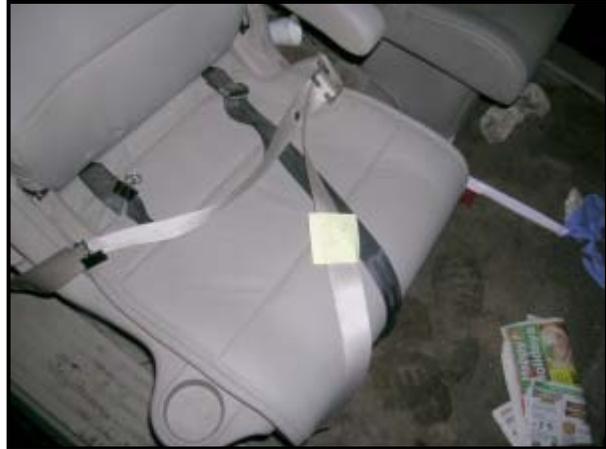
**Figure 17** is a view of the second row right seat and its restraints. The second row right safety belt was cut 44 cm (17.2 in) above the floor anchor and 53 cm (21 in) from the latch plate. The cut webbing section was still buckled into the latch plate receiver. A locking clip was installed on the webbing adjacent to the latch plate. The total length of the cut section measured 118 cm (46.5 in). The webbing section appeared loaded over a 20 cm (7.8 in) length that began 24 cm (9.5 in) from the latch plate due to loading from the CSS base. The

**Figure 17: Second row right seat cut vehicle seat belt and cut LATCH webbing.**

balance of the webbing had spooled back into the retractor and was not available for inspection. The LATCH webbing was cut in a single place and was still attached to the seat. The cut was located 9 cm (3.5 in) above the outboard anchor and 45 cm (17.8 in) from the locking slide adjuster adjacent to the inboard LATCH anchor. No residual evidence of loading was found during examination of the LATCH webbing. The reader is encouraged to refer to the *Child Safety Seat Data* section of this report for further information regarding the CSS installation and for additional photographs.

The cut was located 9 cm (3.5 in) above the outboard anchor and 45 cm (17.8 in) from the locking slide adjuster adjacent to the inboard LATCH anchor. No residual evidence of loading was found during examination of the LATCH webbing. The reader is encouraged to refer to the *Child Safety Seat Data* section of this report for further information regarding the CSS installation and for additional photographs.

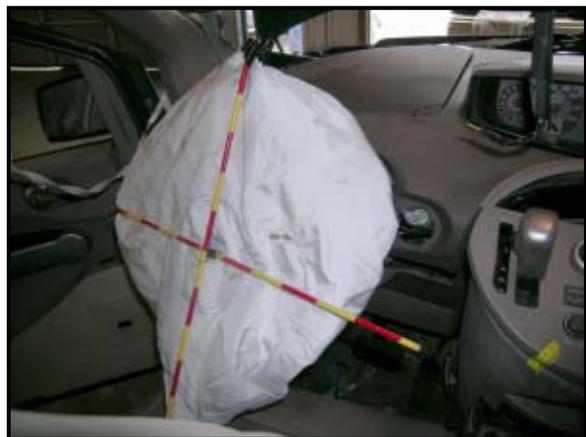
The driver air bag, **Figure 18**, was housed within an H-configuration module designed into the center hub of the steering wheel. The diameter of the deployed air bag measured 53 cm (21 in). It was tethered by two 10 cm (4 in) wide straps and vented by two 4 cm (1.5 in) diameter ports on the back side of the bag in the 11/1 o'clock sector. There was a 3 cm (1.2 in) cut of the bag's fabric in the 12 o'clock on the back side membrane due to contact with the fractured windshield during the impact. The cut did not affect the performance of the air bag. A 4 cm (1.5 in) long lip stick transfer was noted on the face of the air bag. It was located within the 3 o'clock sector of

**Figure 18: View of the deployed air bags.**

the tether circle 6 cm (2.5 in) right of the center line. The transfer resulted from contact between the driver's face and the deployed air bag. Post-crash blood spatters were noted in the 2 and 11 o'clock sectors of the bag.

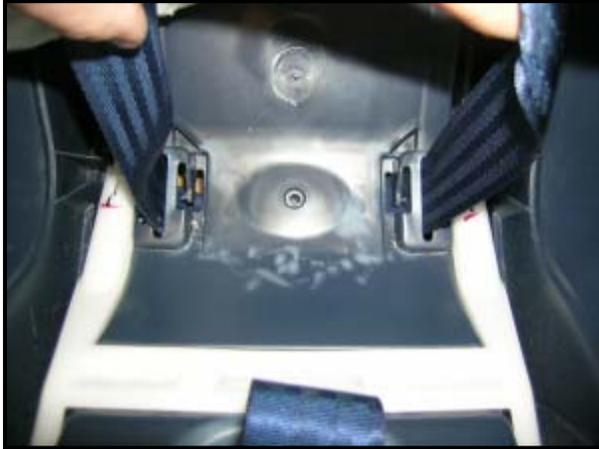
Examination of the bucket of the CSS shells revealed a significant difference in the post-crash condition of the respective seats. Major stress marks were identified in the bucket of the left shell and in the belt guides where the 5-point restraint webbing passes under the bucket, **Figure 21**. These stress indicators were absent in the bucket and on the belt guides of the right shell, **Figure 22**. The presence of the stress marks in the left seat indicated the left CSS was subjected

to larger deceleration forces. In-turn, the occupant of the left seat was subjected to these larger deceleration forces. The stressed condition of the left seat was consistent with the greater trauma suffered by the left occupant as compared to the right.

Figure 21: Stress marks in the bucket of the left CSS shell.

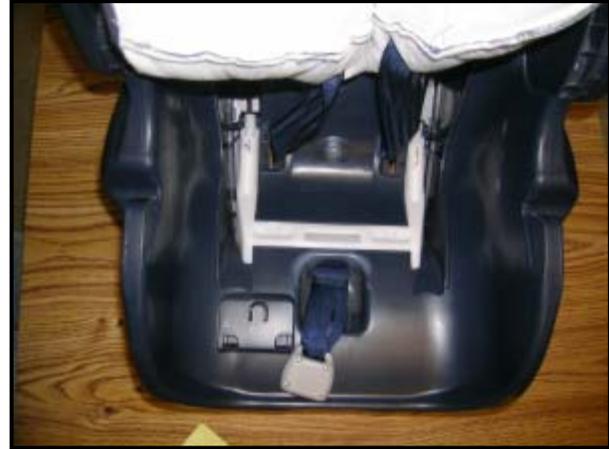
Figure 22: Bucket of the right shell.

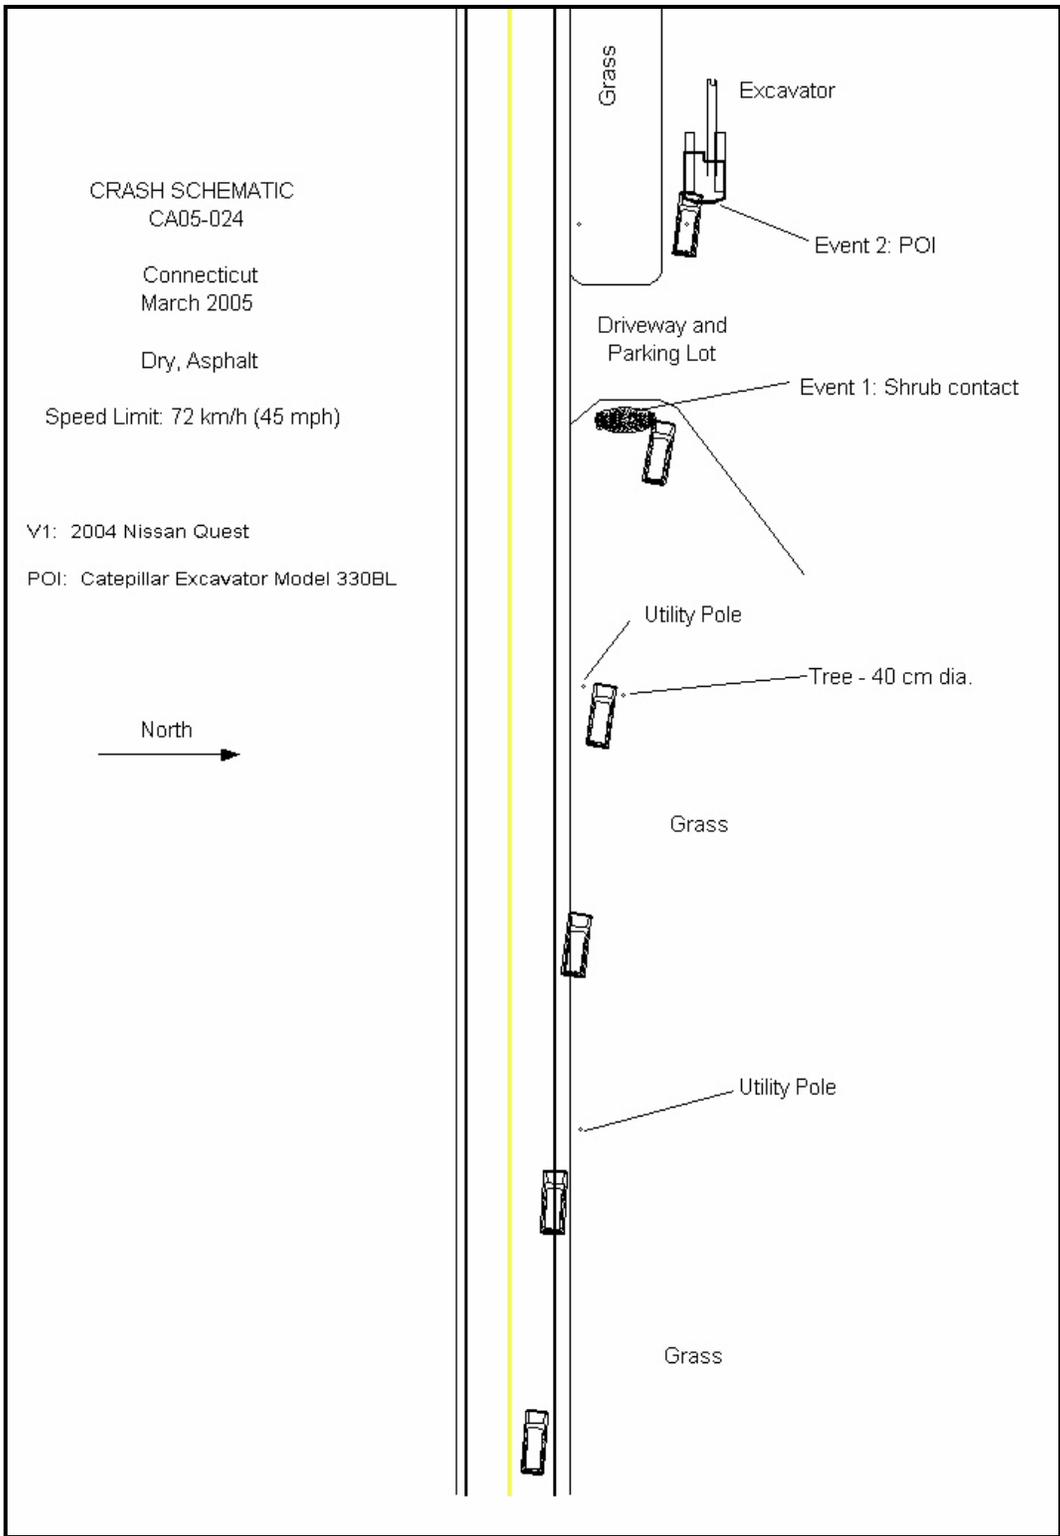
Figure 23: Crash Schematic.
