# INDIANA UNIVERSITY

## ON-SITE SIDE IMPACT INFLATABLE OCCUPANT PROTECTION INVESTIGATION

CASE NUMBER - IN-05-024  
LOCATION - TEXAS  
VEHICLE - 2005 NISSAN ALTIMA  
CRASH DATE - July 2005

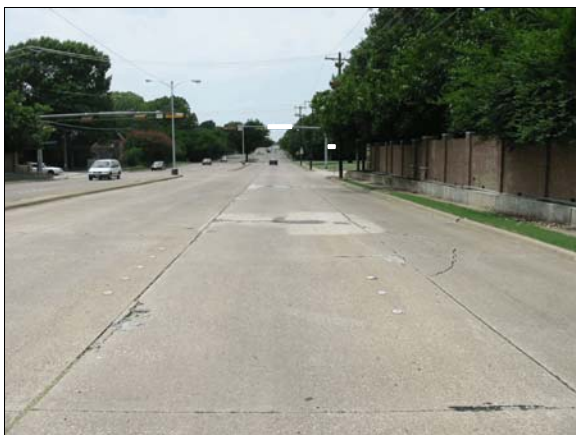
**Pre-Crash:** The case vehicle was traveling west in the center through lane approaching the Honda, which was also westbound and slowing for the red light at the intersection (**Figure 1**). The case vehicle’s driver stated to police that he took his eyes off the road to answer his cellular telephone. There was no indication on the police crash report that the driver made any pre-crash avoidance maneuver. However, the damage to the front of the case vehicle was offset to the right indicating the driver likely steered left just prior to the impact. The underride damage to the case vehicle indicated the driver was most likely applying the brakes at impact. The crash occurred in the center through lane just prior to the four-leg intersection (**Figure 2**).

**Figure 1:** Approach of case vehicle and Honda westbound in center through lane

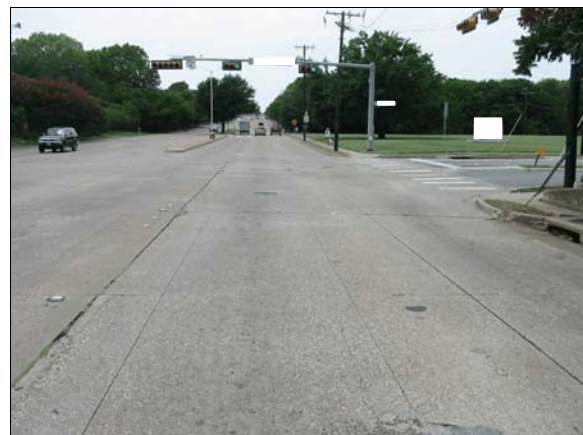
**Figure 2:** Area of impact and final rest in center westbound through lane just prior to the intersection

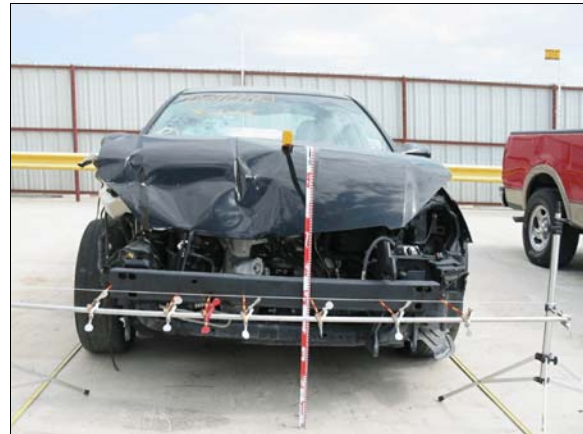
**Crash:** The front of the case vehicle (**Figure 3** below) impacted the back of the Honda causing the case vehicle’s driver and front right passenger air bags to deploy. The impact was low severity, so it is likely that only the first stage of the case vehicle’s dual stage air bags deployed. The damage to the case vehicle’s hood indicates the case vehicle underrode the back bumper of the Honda.

**Figure 3:** Overview of front damage to case vehicle due to impact with the back of the Honda, numbers on vertical scale are tenths of meter

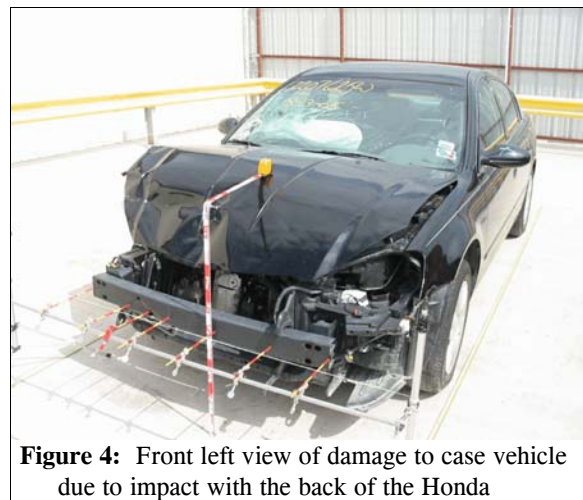
**Figure 4:** Front left view of damage to case vehicle due to impact with the back of the Honda

**Exterior Damage:** The case vehicle’s impact with the Honda involved the front bumper, grille hood and right headlamp/turn signal assembly (**Figures 4 and 5** above). The bumper, hood, grille and right headlamp/turn signal assembly were directly damaged and crushed rearward. The direct damage began at the front right bumper corner and extended 74 centimeters (49.1 inches) across the front end. The residual maximum crush to the bumper bar was measured as 5 centimeters (2 inches) occurring at C<sub>6</sub>. The following table shows the case vehicle’s crush profile.

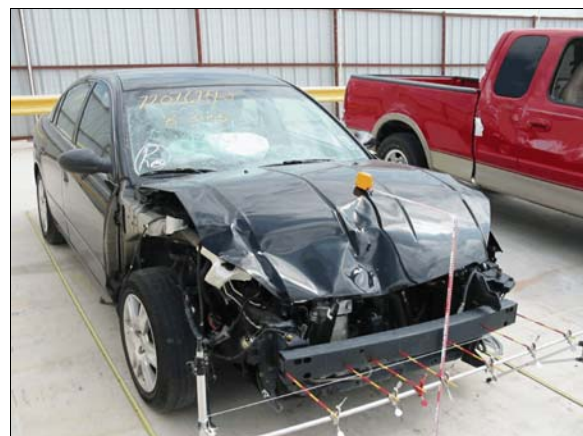
**Figure 5:** Front right view of damage to case vehicle

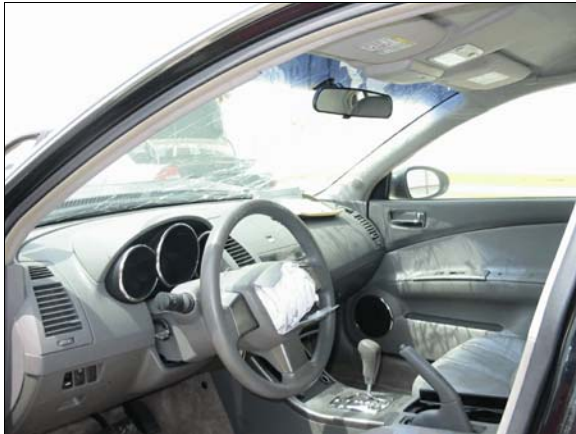
**Vehicle Interior:** Inspection of the case vehicle’s interior (**Figure 6** below) revealed a possible makeup transfer on the top central portion of the front right air bag. In addition, the front right air bag contacted and fractured the windshield during its deployment (**Figure 7** below). No other occupant contact evidence was found, and no intrusion of the passenger compartment was observed. . Finally, there was no evidence of compression of the energy absorbing steering column (**Figure 8** below).

**Figure 6:** Overview of instrument panel, windshield and steering wheel

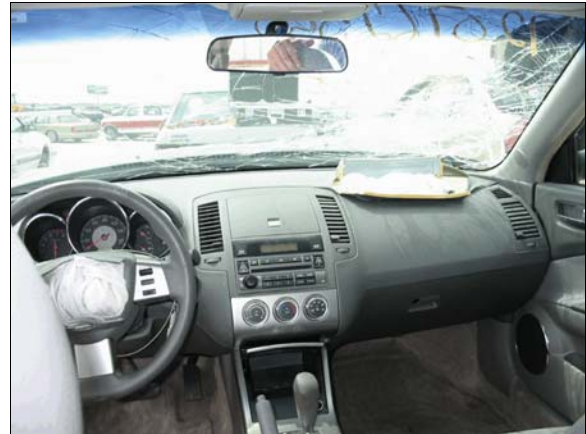
**Figure 7:** Overview of case vehicle's instrument panel and windshield

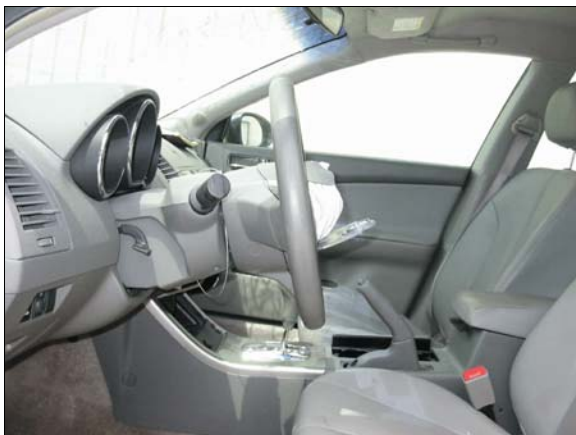
**Figure 8:** Left side view of case vehicle's steering wheel and column showing no deformation

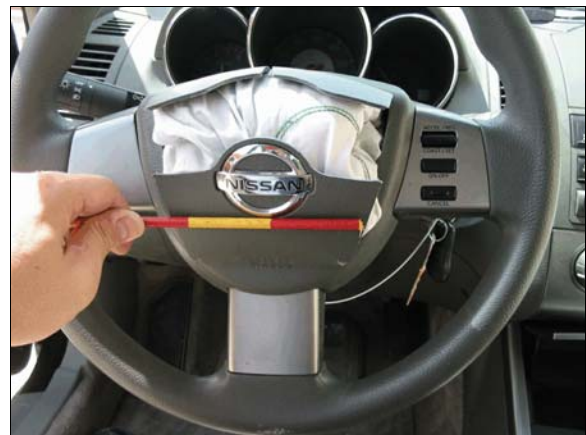
**Figure 9:** Case vehicle driver's air bag module cover flaps, each increment on rod is 5 cm (2 in)

The case vehicle's driver air bag was located in the steering wheel hub. An inspection of the air bag module cover flaps and the air bag fabric revealed that the cover flaps opened at the designated tear points (**Figure 9**). There was no evidence of damage during the deployment to the air bag or the air bag module cover flaps. The air bag module cover consisted of three cover flaps, two at the top and one at the bottom. The cover flaps were constructed of pliable vinyl approximately 3 millimeters (0.1 inch) thick. The top flaps were 7.5 centimeters in length and 4

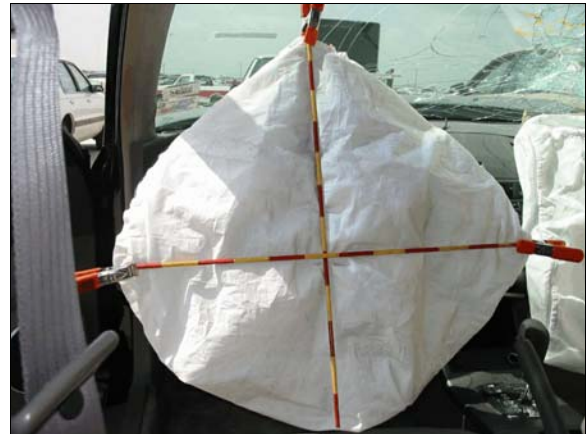
**Figure 10:** Case vehicle driver's air bag

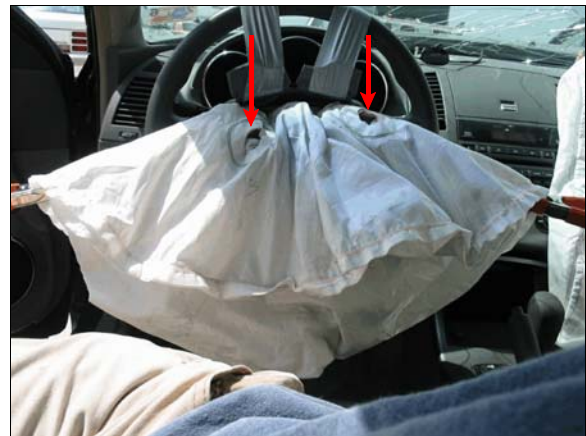
**Figure 11:** Arrows show case vehicle driver's air bag vent ports

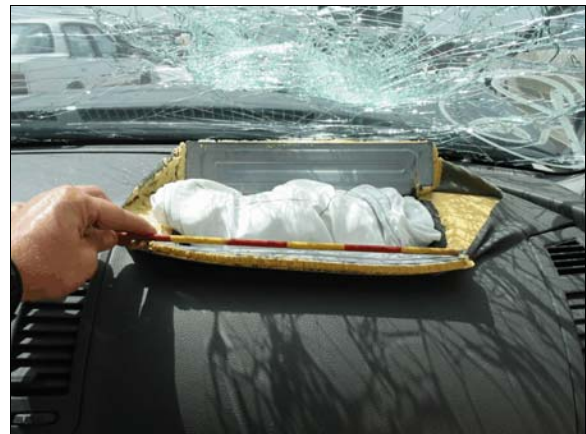
**Figure 12:** Case vehicle's front right passenger air bag module flaps, windshield is fractured due to contact by deploying front right passenger air bag

(i.e., seat track in full rear position, seat back slightly reclined) and the front surface of the air bag at approximate full excursion was 26 centimeters (10.2 inches). The front right air bag contacted and fractured the windshield during its deployment; however, no damage to the air bag was observed due to this contact. A possible makeup transfer was found on the top right portion of the air bag (**Figure 14**). No other evidence of occupant contact to the air bag was observed.

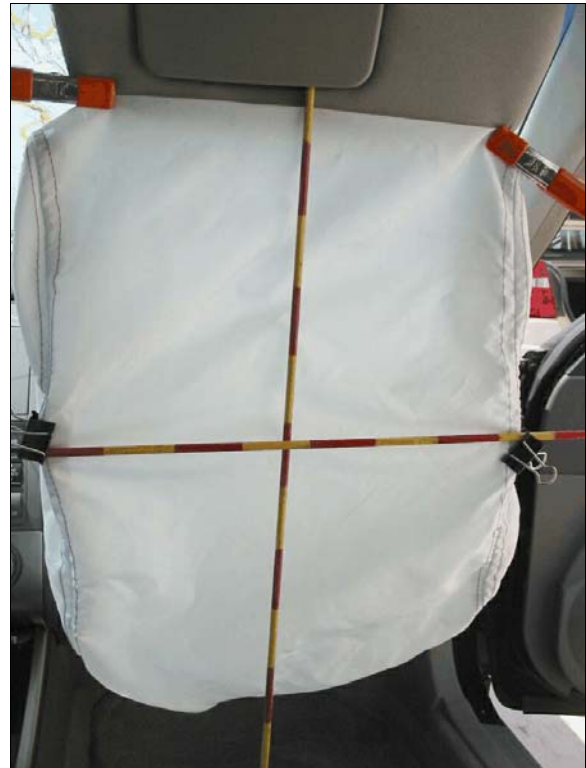
**Figure 13:** Overview of front right passenger's air bag

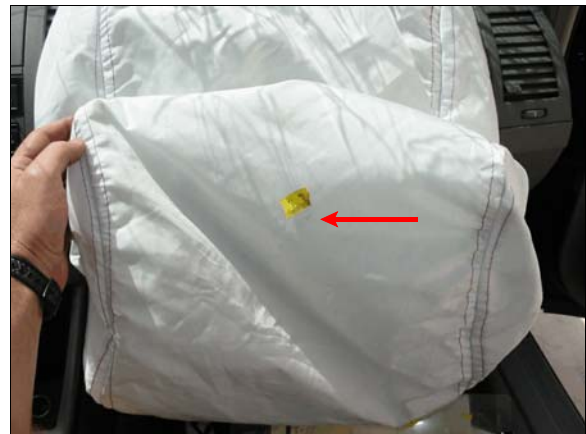
**Figure 14:** Overview of location of possible makeup scuff (arrow) at top central portion of front right air bag

The passenger loaded the safety belt and her face and chest contacted the deployed front right passenger air bag. Her contact with the air bag left a possible makeup scuff on the top central portion of the air bag. Following the impact, the passenger most likely rebounded back into her seat. The front right passenger was most likely able to exit the case vehicle under her own power following the crash. The front right passenger's use of her three-point, lap-and-shoulder safety belt and the deployment of her air bag mitigated her interaction with the case vehicle's frontal interior components.

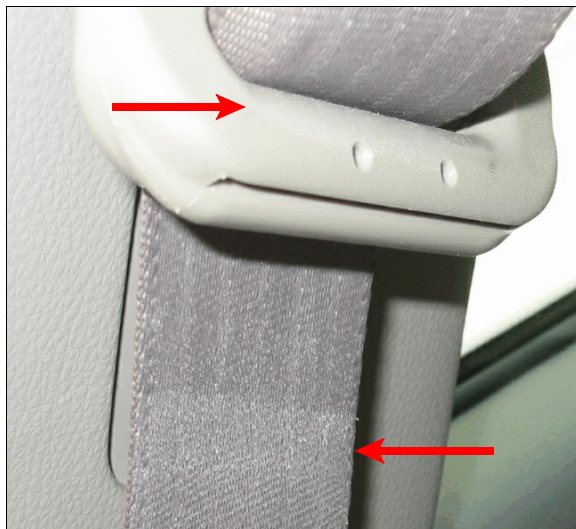
The front right passenger was restrained by her manual, three-point, lap-and-shoulder safety belt system. A load abrasion was found on the shoulder belt in a position on the belt consistent with usage in the crash, and a corresponding load abrasion was found on the “D”-ring (**Figure 15**). In addition, the retractor-mounted pretensioner had activated, and the retractor was jammed with a length of safety belt extended out of the retractor (**Figure 16**).

**Figure 15:** Load abrasions on case vehicle’s front right passenger “D” ring and shoulder belt (arrows)

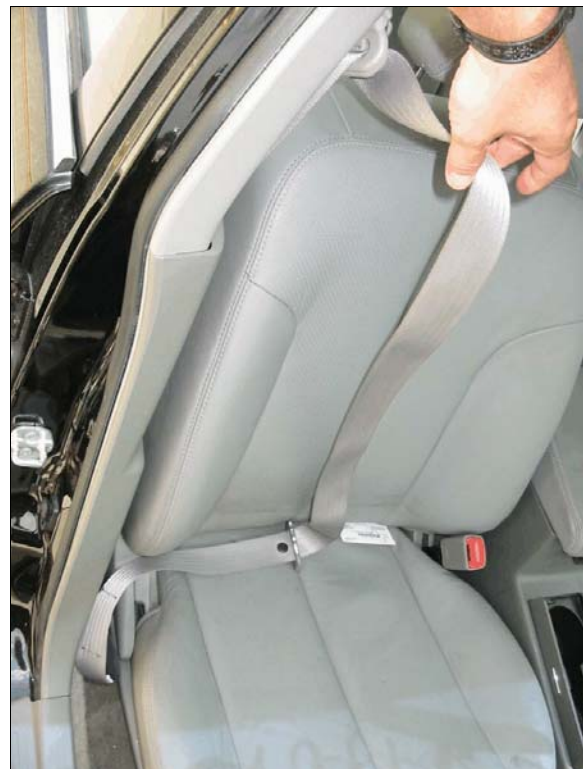
**Figure 16:** Front right passenger safety belt, retractor jammed with belt extended out of retractor, indicating activation of pretensioner while belt was in use
