## ON-SITE SIDE IMPACT INFLATABLE OCCUPANT PROTECTION INVESTIGATION

CASE NUMBER - IN-05-025  
LOCATION - WISCONSIN  
VEHICLE - 2004 MAZDA 6S  
CRASH DATE - July 2005

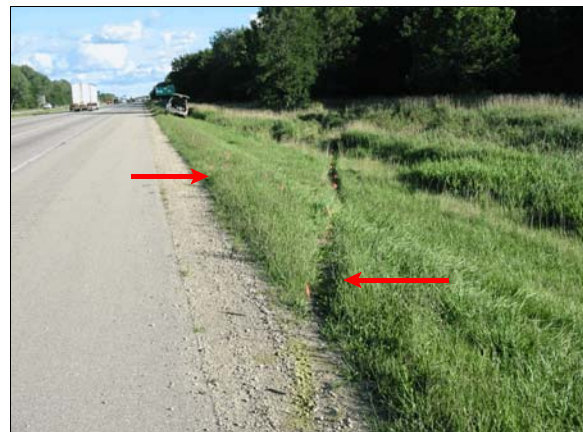
**Figure 2:** Area of case vehicle's roadway departure. Arrows show left front wheel furrow on right, left rear wheel furrow on left

**Crash:** The case vehicle was rotated approximately 65 degrees from its original travel heading as it departed the roadway and entered the grass (**Figure 2** above). The case vehicle continued to rotate clockwise and traveled an additional approximate 27 meters (89 feet) tripped and rolled over driver side leading (**Figures 3, 4 and 5**). The case vehicle rolled over at least two full rolls (i.e., 8 quarter rolls) across a distance of approximately 25 meters (82 feet). During the last portion of the rollover, the case vehicle impacted a wire fence (**Figure 6**).

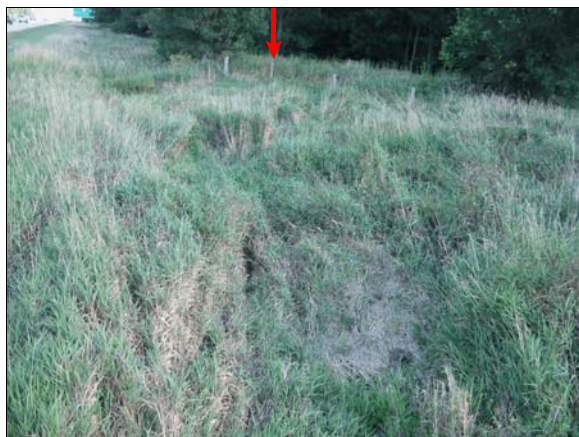
**Figure 3:** Area of rollover, arrow shows area of final rest on other side of fence

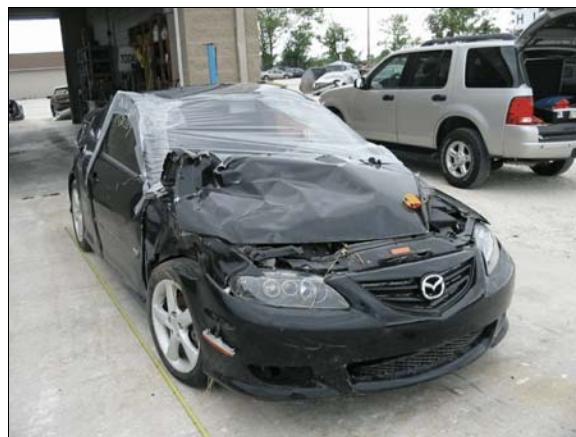
**Figure 4:** Overview of rollover damage to hood, roof and right side of case vehicle

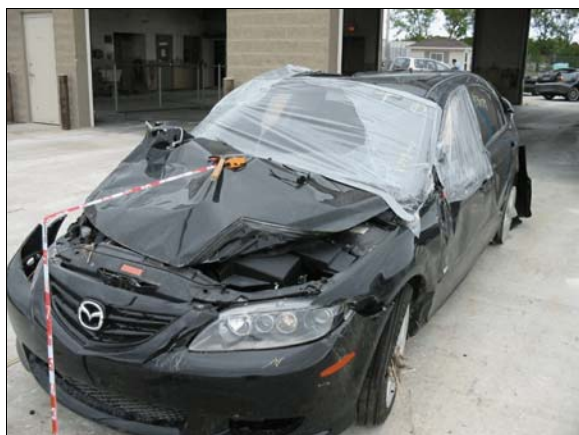
**Figure 5:** Overview of rollover damage to hood, roof and left side of case vehicle

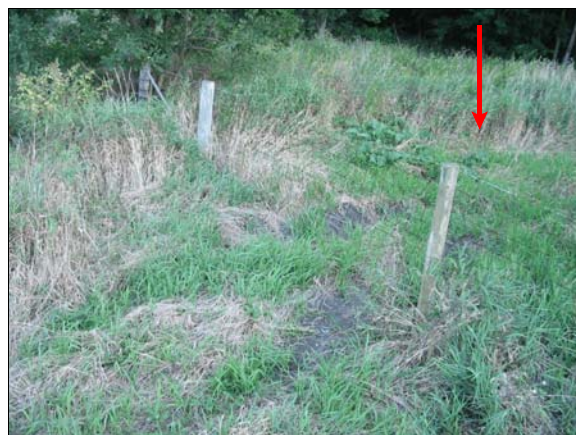
**Figure 6:** Area of fence impact (fence repaired), arrow shows area of final rest of case vehicle

**Post-Crash:** The case vehicle came to rest on its wheels heading northeast (**Figure 6**). The driver remained in the case vehicle and was removed by rescue personnel.

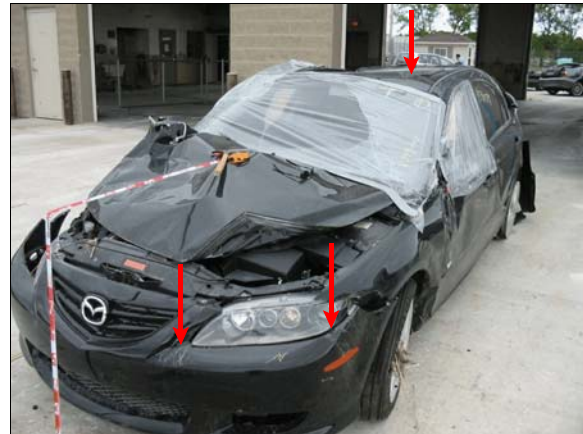
**Exterior Damage:** The direct damage from the rollover involved the case vehicle's front bumper, hood, roof, and the totality of both sides of the vehicle (Figures 7 and 8). In addition, the left and right edges of the hatch were directly damaged in a few areas. Impact with the fence during the rollover scratched the top of the left portion of the front bumper, the roof near the left "A"-pillar (Figure 7) and the left fender and left front door (Figure 9). The damage in the area of the left side view mirror appeared to be due to impact with one of the wooden fence posts.

Figure 7: Overview of rollover damage to front and left side of case vehicle, arrows show scratches from fence impact

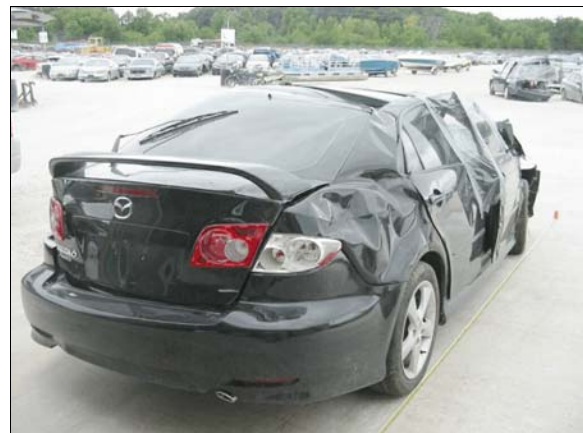
Figure 8: Overview of rollover damage to roof and right side

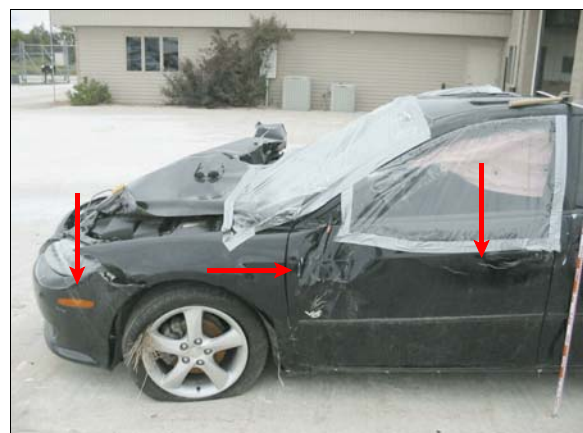
Figure 9: Arrows show damage to left fender and door from fence impact

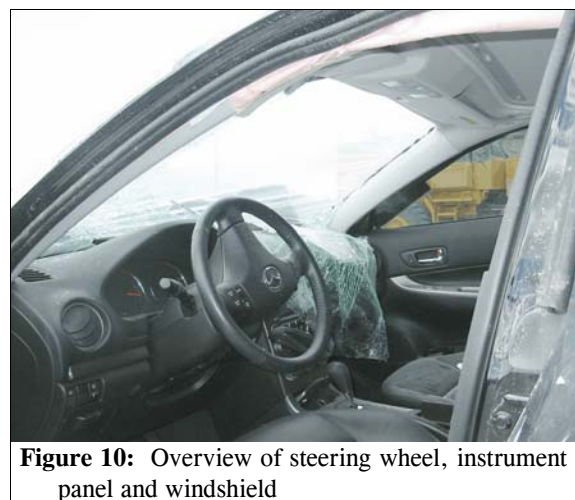
**Vehicle Interior:** Inspection of the case vehicle’s interior (**Figure 10**) revealed a few black scuff marks on the left roof side rail; however, they did not appear due to occupant contact. There were also a few scuff marks and blood spots on the driver’s seat back-mounted side impact air bag. The blood spots were most likely the result of blood drops striking the air bag, not the result of direct transfer due to occupant contact to the air bag. No other evidence of occupant contact was observed to any other interior surfaces or components. The case vehicle sustained several intrusions of the passenger compartment including 19 centimeters (7.5 inches) of vertical roof intrusion into the front right seat position, and 16 centimeters (6.3 inches) of vertical roof intrusion into the back right seating position. There was no intrusion into the driver’s seating position. Lastly, there was no evidence of compression of the energy absorbing steering column, and no deformation of the steering wheel rim was observed (**Figure 10**).

**Figure 10:** Overview of steering wheel, instrument panel and windshield

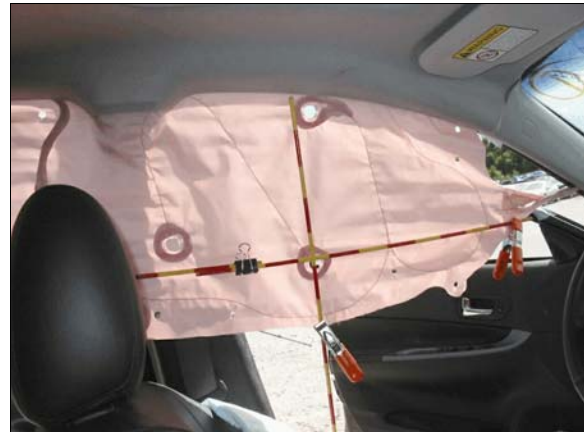
**Figure 11:** Case vehicle's driver's side curtain air bag

The left side curtain air bag (**Figures 11** and **12** below) was located along the left roof side rail under the headliner. The air bag was 142 centimeters (55.9 inches) in length and 36 centimeters (14.2 inches) in height. It was attached to the left "A"-pillar by an anchor strap approximately 24 centimeters (9.4 inches) in length. The air bag was irregular in shape and constructed without vent ports or tethers. The air bag stitching formed several inflatable chambers adjacent to the driver and back left passenger's seat positions and was designed to provide head protection in the event of a side impact. Inspection of the air bag revealed no evidence of damage due to deployment. In addition, there was no evidence of occupant contact to the side curtain air bag, although the driver's head most likely impacted the side curtain air bag during the crash.

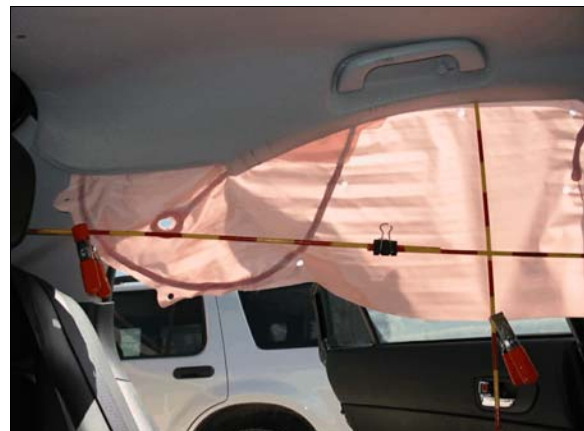
**Figure 12:** Back left passenger's side curtain air bag

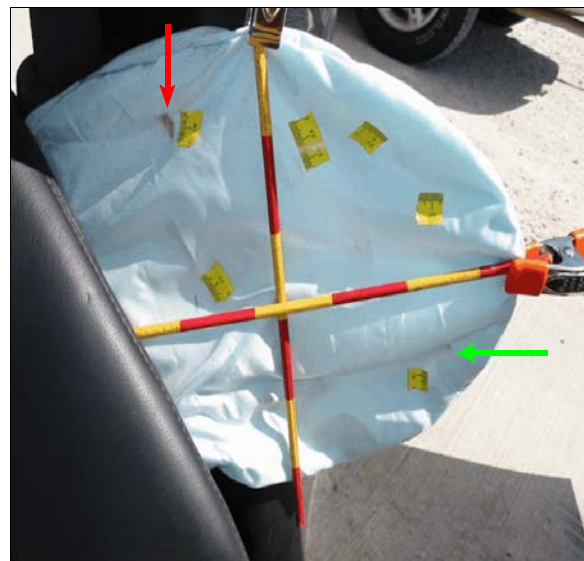
The case vehicle driver's seat back-mounted side impact air bag (**Figure 13** and **Figure 14** below) was located in the outboard side of the driver's seat back. An inspection of the air bag and the single air bag module cover flap (**Figure 15** below) revealed that the cover flap opened as designed, and there was no evidence of damage during the deployment to the cover flap or the air bag fabric. The deployed side impact air bag was approximately oval in shape and was constructed without tethers and had a single vent port (**Figure**

**Figure 13:** Driver's seat back-mounted side impact air bag, arrow shows blood spot, yellow pieces of tape show small scuffs, green arrow shows brown discoloration

14) 2 centimeters (0.8 inch) in diameter located on the outboard side near the front bottom edge of the air bag. The air bag was 29 centimeters (11.4 inches) in length and 28 centimeters (11 inches) in height. A blood spot, several thin scuffs and a brown discoloration were observed on the inside surface of the air bag (Figure 13 above). Several blood spots and an area of brown discoloration were also noted on the outboard side of the air bag (Figure 14). The blood spots were most likely the result of blood drops striking the air bag, not the result of direct transfer due to occupant contact to the air bag.

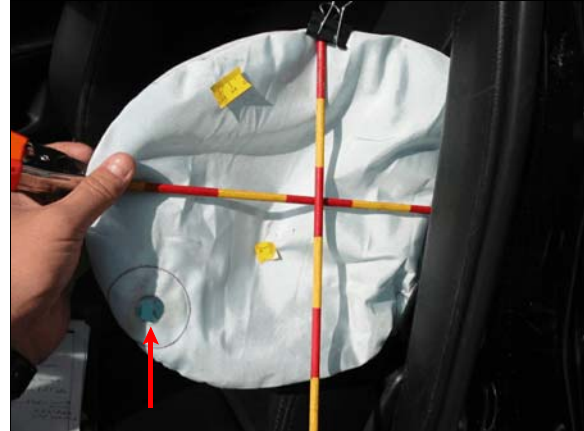
Figure 14: Outboard side of case vehicle's seat back-mounted side impact air bag, arrow shows vent port, blood spots at yellow tape near center

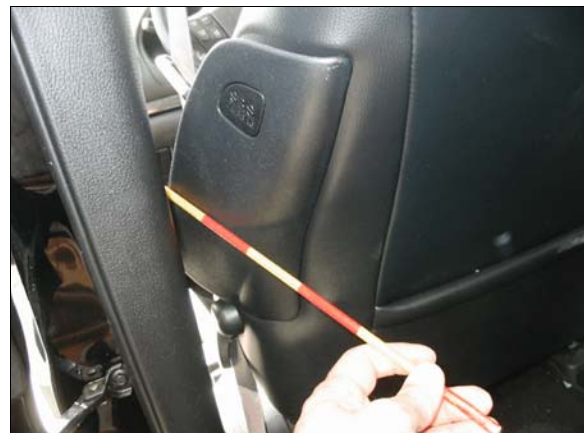
Figure 15: Driver's side impact air bag module cover flap

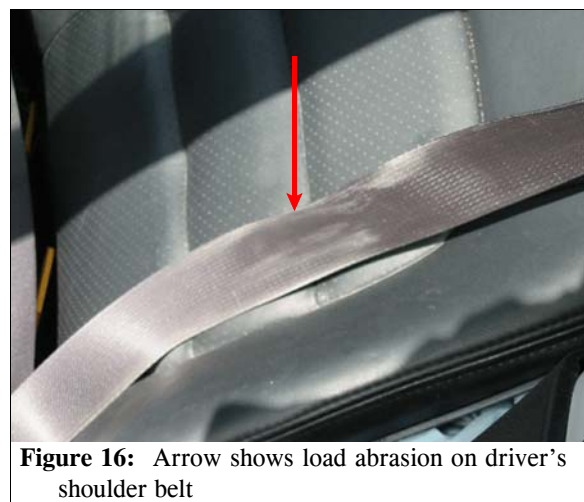
The case vehicle's driver was restrained by her manual, three-point, lap-and-shoulder safety belt system. Inspection of the safety belt assembly revealed load abrasions on the shoulder belt (Figure 16). The driver stated she was wearing the lap belt low on her lap and the shoulder belt over her left shoulder.

Figure 16: Arrow shows load abrasion on driver's shoulder belt
