Rollover/Electronic Stability Control Investigation/Vehicle to Vehicle
Dynamic Science, Inc./Case Number: DS05028
2005 Cadillac Escalade
Arizona
June 2005

1. Report No. DS05028		2. Government Accession No.		3. Recipient Catalog No.	
4. Title and Subtitle Rollover/Electronic Stability Control Investigation				5. Report Date May 15, 2006

Dynamic Science, Inc.
Crash Investigation
Case Number: DS05028

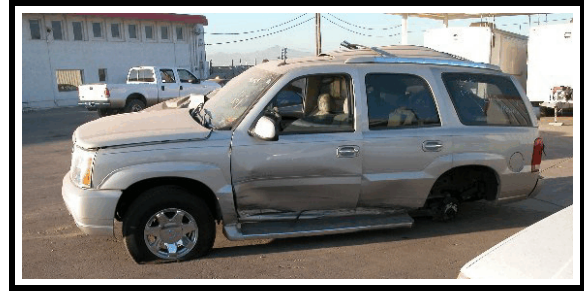
Figure 1. Cadillac Escalade, left side damage

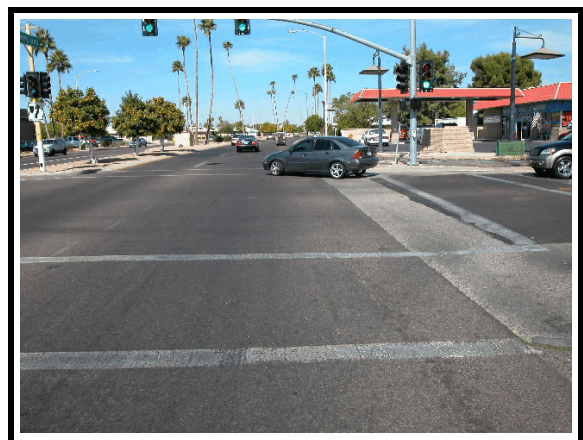
As the Accord continued its turn, it struck the left side of the Cadillac (11LPEW2) with its front end. This contact extended into the Escalade's left rear wheel well and the left rear tire was torn away.

Figure 4. Area of impact. Also shows area of impact with traffic signal pole.

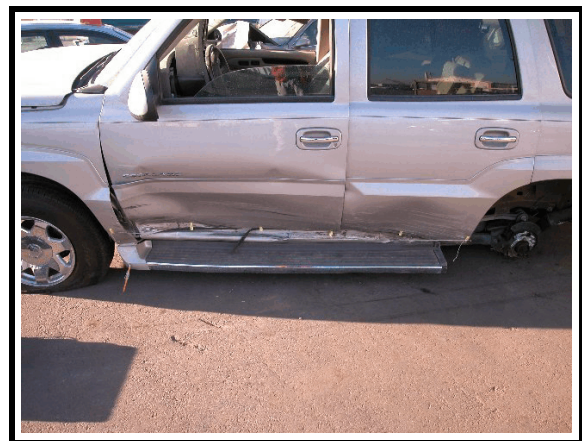
The 2005 Cadillac Escalade sustained moderate left side damage as a result of the impact with the Honda. The direct damage began 51.0 cm (20.0 in) rear of the left front axle and extended 196.0 cm (77.1 in) rearward along the left side plane. The damage was at the sill level and extended into the left rear wheel well. The left rear tire was torn from the vehicle. The combined direct and induced damage location began and ended at the same locations as the direct contact. Six crush measurements were documented at the sill level as follows: C1 = 0.0 cm (0.0 in), C2 = 7.0 cm (2.7 in), C3 = 10.0 cm (3.9 in), C4 = 14.0 cm (5.5 in), C5 = 16.0 cm (6.3 in), C6 = 0.0 cm (0.0 in). The Collision Deformation Classification (CDC) for the impact with the Honda was 11LPEW2.

Figure 5. Left sill damage from impact with Honda

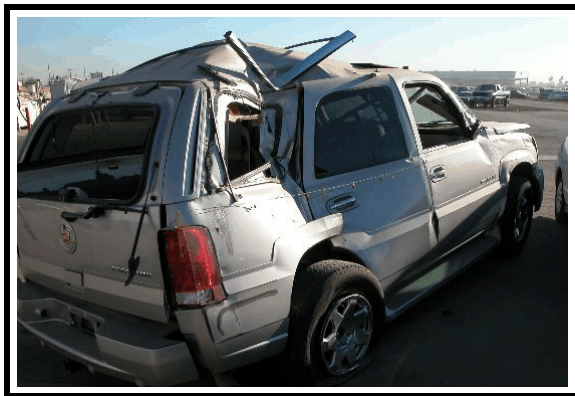
There was moderate damage to the right side of the Escalade from the impact with the pole. The direct damage began 27.0 cm (10.6 in) forward of the rear axle and extended 22.0 cm (8.6 in) forward along the right side plane. The combined direct and induced damage began 114.0 cm (44.9 in) forward of the rear axle and extended rearward along the right side plane. The maximum lateral crush was located 14.0 cm (5.5 in) rearward of C4 and measured 30.0 cm (11.8 in). Six crush measurements were documented at the belt line as follows: C1 = 0.0 cm (0.0 in), C2 = 3.0 cm (1.2 in), C3 = 17.0 cm (6.7 in), C4 = 24.0 cm (9.4 in), C5 = 9.0 cm (3.5 in), C6 = 0.0 cm (0.0 in). The CDC for the impact with the pole was 03RPAN3. There was 14.0 cm (5.5 in) lateral and 8.0 cm (3.1 in) vertical crush at the C pillar.

There was 455.0 cm (179.1 in) of direct contact damage along the entire right side from contact with the ground during the rollover. The damage began 68.0 cm (26.7 in) forward of the front axle and extended rearward to the end of the vehicle. The CDC for the rollover was 00RDAO2.

Figure 6. Right side pole and rollover damage

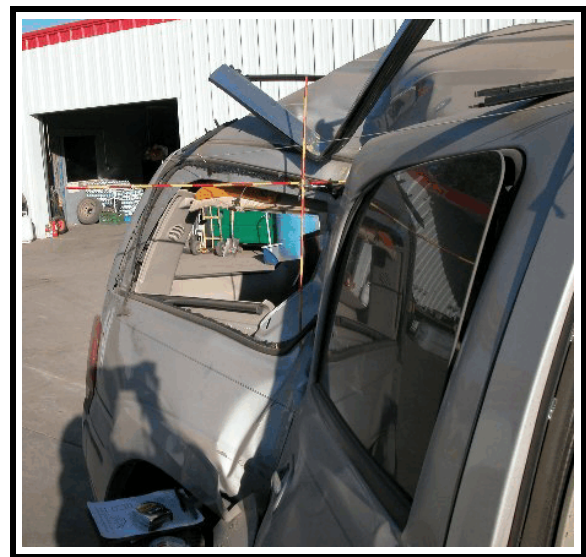
Figure 7. Lateral/vertical crush at the C pillar

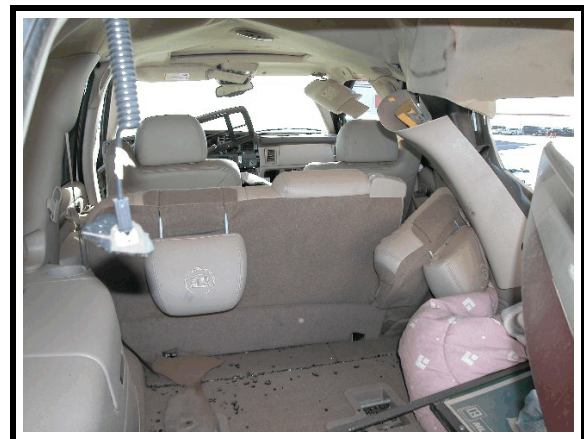
The 2005 Cadillac Escalade sustained moderate interior damage as a result of passenger compartment intrusion and occupant contacts. The right C pillar, right roof header, right front door, and left sill sustained lateral intrusion. The second row right seat had been compressed laterally to the left and towards the rear of the vehicle by the C pillar intrusion.

Figure 8. Overview of right side intrusion

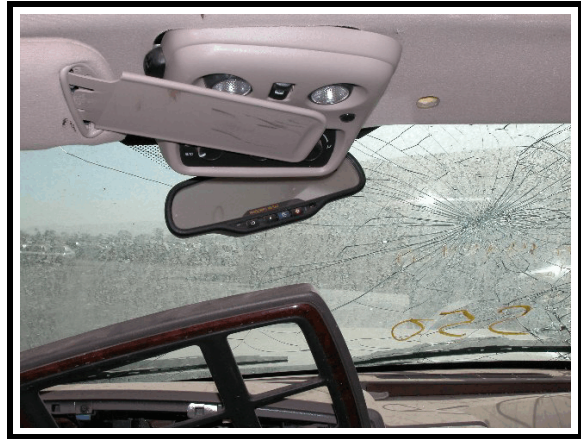
The windshield cracked on the right side from occupant contact. There were blood contacts and smears found on the second row right window, the right door, along the right front head restraint, the roof, the right B pillar, along the roof rail, and on the front right passenger seat belt webbing. The left side of the center console had been contacted by the driver's right hip and moved laterally to the right. The instrument panel fascia on the left side had been dislodged.

Figure 10. Right side windshield contact
