## ON-SITE ADAPTIVE CONTROL-EQUIPPED VEHICLE INVESTIGATION

CASE NUMBER - IN-05-030  
LOCATION - INDIANA  
VEHICLE - 1998 FORD E-150 ECONOLINE VAN  
CRASH DATE - September 2005

September 26, 2006  
Revised: April 8, 2008

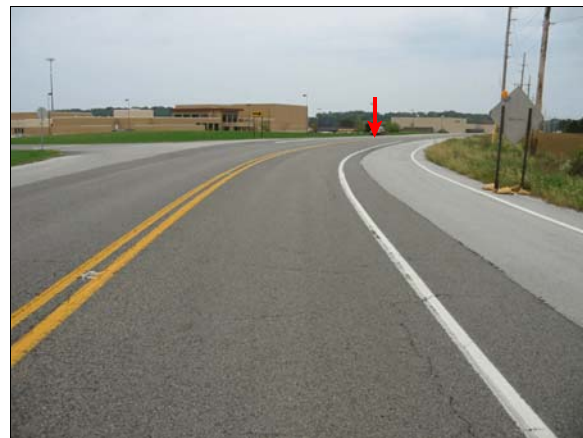
**Figure 1:** Approach of case vehicle northeastbound to area of impact (arrow)

**Pre-Crash:** The case vehicle was traveling northeast (**Figure 1** above) and the driver was negotiating the right curve. The evidence indicates that the case vehicle began to cross the centerline and travel into the opposing lane as the case vehicle was exiting the curve. The Honda was traveling southwest (**Figure 2** below) and the driver was intending to continue southwestbound through the curve. Based on witness statements, it does not appear that the driver took any actions to avoid the crash. A witness that was traveling behind the case vehicle indicated he did not see any brake lights from the case vehicle prior to the crash. In addition, there was no indication of locked wheel braking or anti-lock braking marks from the case vehicle visible in the police on-scene photos. The crash occurred in the southwestbound lane of the roadway at the approximate end of the curve (**Figure 3** below).

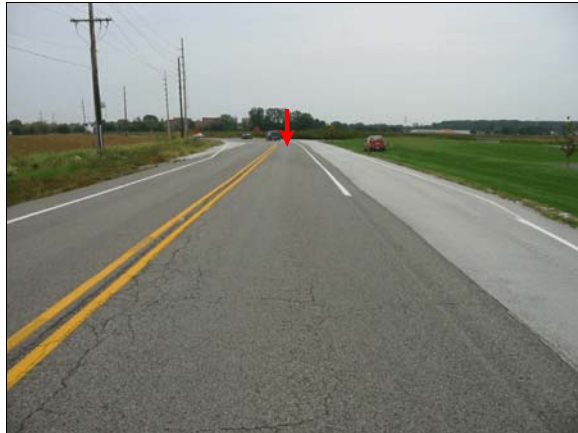
**Figure 2:** Approach of Honda southwest to area of impact (arrow)

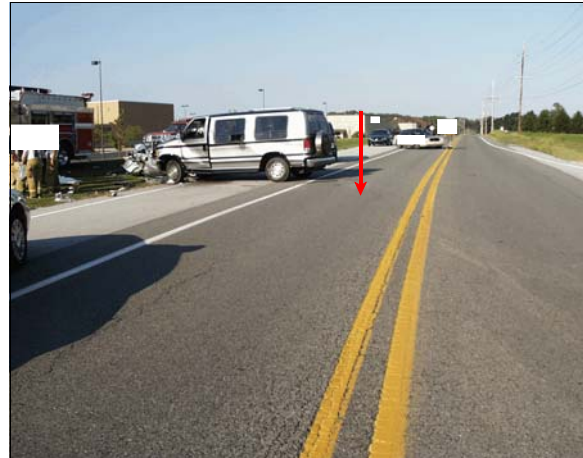
**Figure 3:** Police on-scene photo showing overview of impact area (arrow) and final rest of case vehicle from case vehicle’s approach

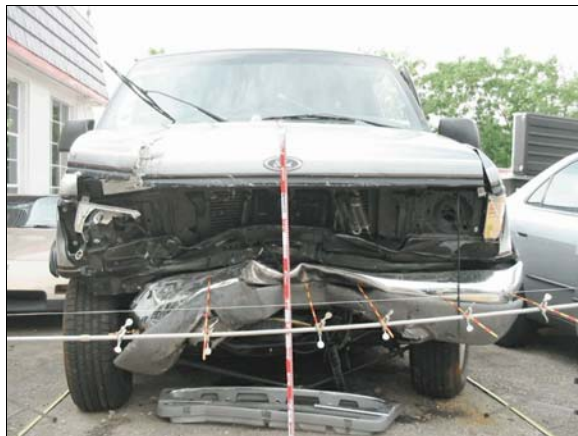
The CDC for the case vehicle was determined to be: **12-FDEW-3 (10 degrees)**. The maximum residual crush to the front of the case vehicle was measured as 42 centimeters (16.5 inches) occurring at C<sub>4</sub>. The left side wheelbase was shortened 9 centimeters (3.5 inches) while

**Figure 4:** Damage to front of case vehicle from impact with the Honda, numbers on vertical scale are tenths of meter, each increment on rods is 5 cm (2 in)

**Crash:** The front of the case vehicle (**Figure 4**) impacted the front of the Honda (**Figure 5**), causing the case vehicle’s driver and front right passenger air bags to deploy. The Honda’s driver and front right passenger air bags also deployed in the crash.

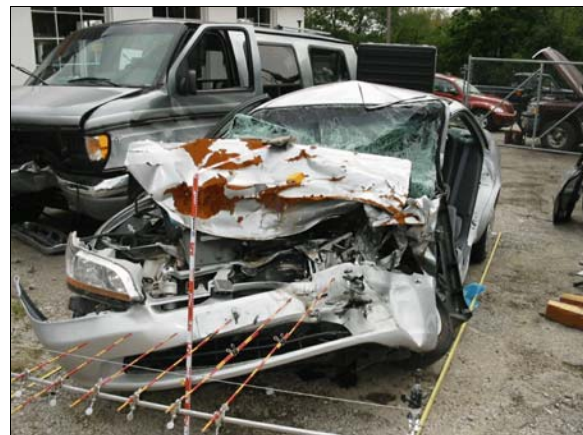
**Figure 5:** Damage to front of Honda

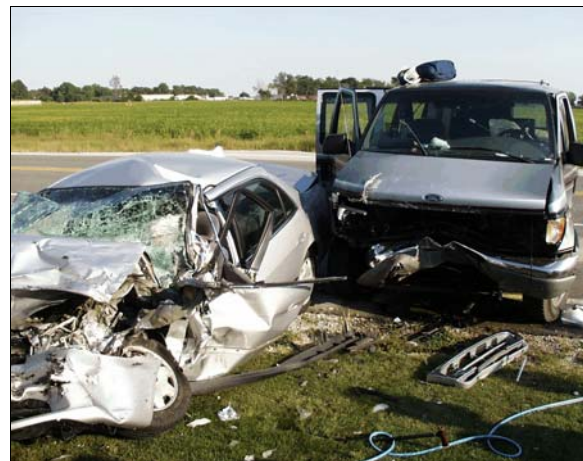
**Post-Crash:** As a result of the impact, the case vehicle rotated approximately 90 degrees counterclockwise and came to final rest approximately perpendicular to the roadway

**Figure 6:** Police photo of final rest positions

heading slightly northwest with the front of the case vehicle off the north roadside (**Figure 6** above). The Honda rotated approximately 90 degrees clockwise and came to final rest off the roadway on the north roadside heading slightly northwest with its back wheels on the paved shoulder (**Figure 6** above).

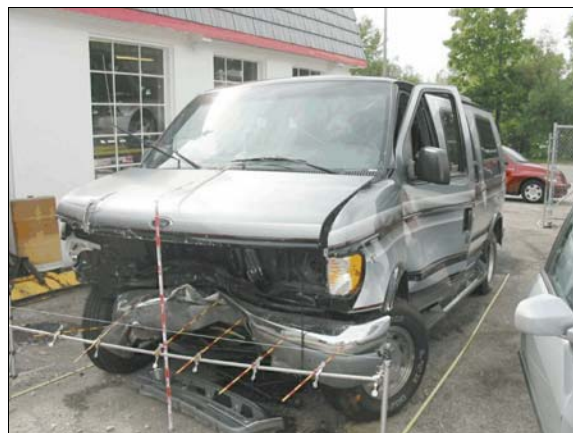
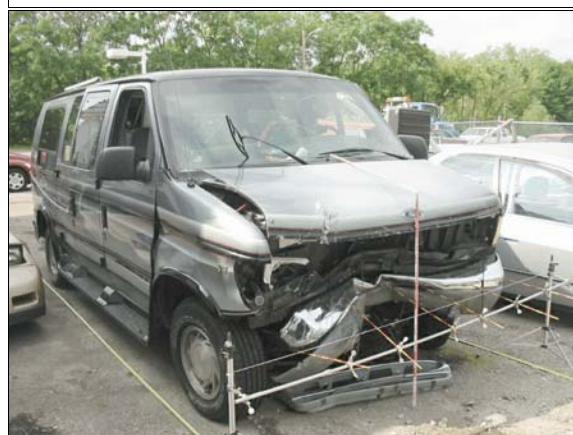
**Figure 7:** Front left overview of damage to case vehicle

**Figure 8:** Front right overview of damage to case vehicle

**Exterior Damage:** The case vehicle’s contact with the Honda involved the entire front plane of the case vehicle (**Figures 7 and 8**). The bumper, grille, radiator, hood, both headlamp/turn lamp assemblies, and the front of both fenders were all directly damaged and crushed rearward. The direct damage began at the front right bumper corner and extended 156 centimeters (61.4 inches) across the bumper. Residual maximum crush was measured as 42 centimeters (16.5 inches) occurring at C<sub>4</sub>. The table below shows the case vehicle’s front crush profile.

The case vehicle’s left side wheelbase was shortened 9 centimeters (3.5 inches) while the right side wheelbase was extended 3 centimeters (1.2 inches). There was induced damage to the hood, both fenders, the left front door, the left side panel rear of the door, and the windshield was cracked. No other obvious induced damage or remote buckling was noted to the remainder of the case vehicle’s exterior.

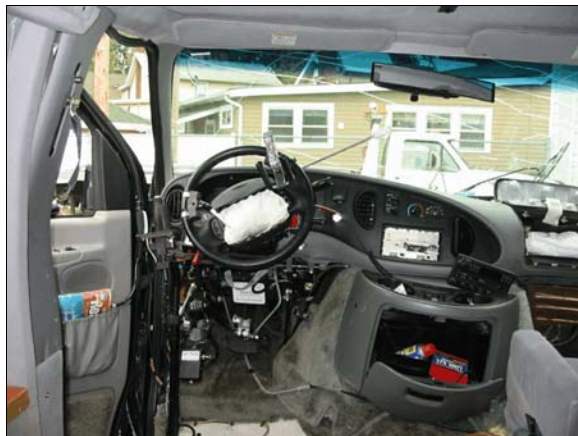
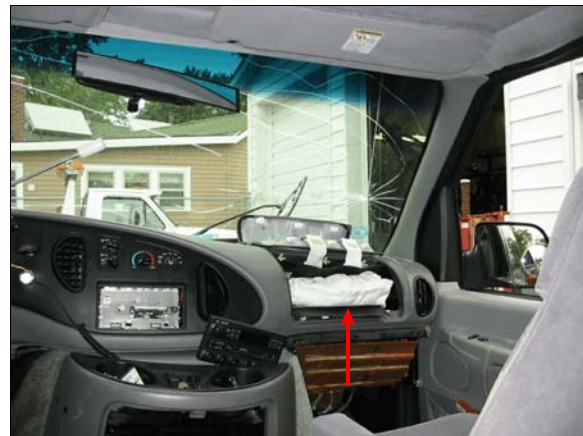
**Vehicle Interior:** Inspection of the case vehicle’s interior (**Figures 9 and 10**) revealed a possible driver right knee contact to the instrument panel and right leg contact to the brake actuator rod. No other evidence of occupant contact was observed to any interior surfaces or components. In addition, no occupant compartment intrusion was observed, and there was no deformation of the steering wheel or compression of the energy absorbing steering column. The driver’s shoulder belt had been cut by rescue personnel

**Figure 9:** Overview of case vehicle’s steering wheel, instrument panel, windshield and adaptive control equipment

**Figure 10:** Overview of case vehicle’s center and right instrument panel, windshield and location of front right passenger air bag (arrow)

The front right passenger's air bag was located in the middle of the instrument panel (**Figure 10** above). An inspection of the front right air bag module's cover flap and the air bag's fabric revealed that the cover flap opened at the designated tear points. There was no evidence of damage during the deployment to the air bag or the cover flap. However, the cover flap impacted and fractured the windshield.

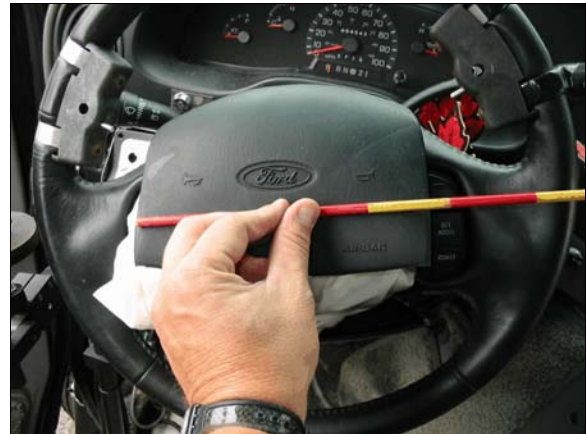
The case vehicle's driver air bag was located in the steering wheel hub. An inspection of the air bag module cover flaps and the air bag fabric revealed that the cover flaps opened at the designated tear points (**Figure 11**), and there was no evidence of damage during the deployment to the air bag or the cover flaps. In addition, no damage was observed due to interaction of the air bag with the "Tri-Pin" type adaptive steering device that was attached to the steering wheel. The air bag module cover consisted of two semi-pliable vinyl cover flaps. The top cover flap was rounded at the top and rectangular at the horizontal tear seam. It was 19.5 centimeters (7.7 inches) in width and 11 centimeters (4.3 inches) in height at the center. The bottom cover flap was rectangular in shape and was 19.5 centimeters (7.7 inches) in width and 8 centimeters (3.2 inches) in height. The driver's air bag was designed with two tethers, each approximately 12 centimeters (4.7 inches) in width. The driver's air bag had two vent ports (**Figure 12**), each approximately 3.5 centimeters (1.4 inches) in diameter, located at the 11 and 1 o'clock positions. The deployed driver's air bag (**Figure 13** below) was round with a diameter of 63 centimeters (24.8 inches). An inspection of the driver's air bag fabric revealed no evidence of occupant contact.

**Figure 11:** Case vehicle driver's air bag module cover flap

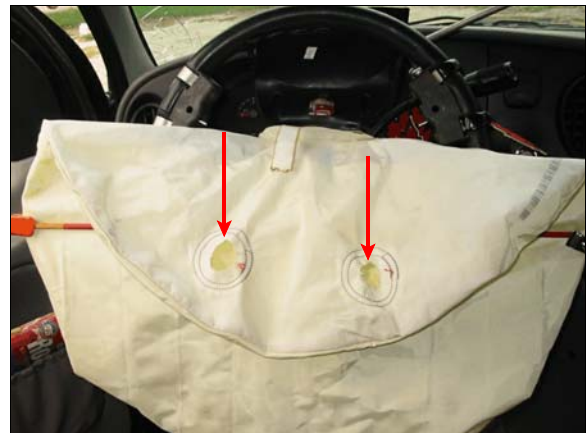
**Figure 12:** Case vehicle driver's air bag vent ports

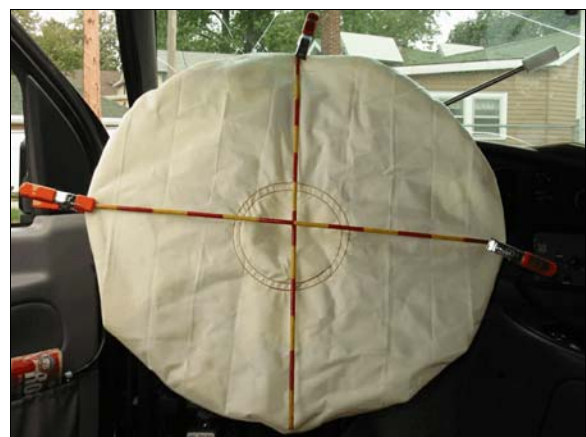
**Figure 13:** Case vehicle driver's air bag

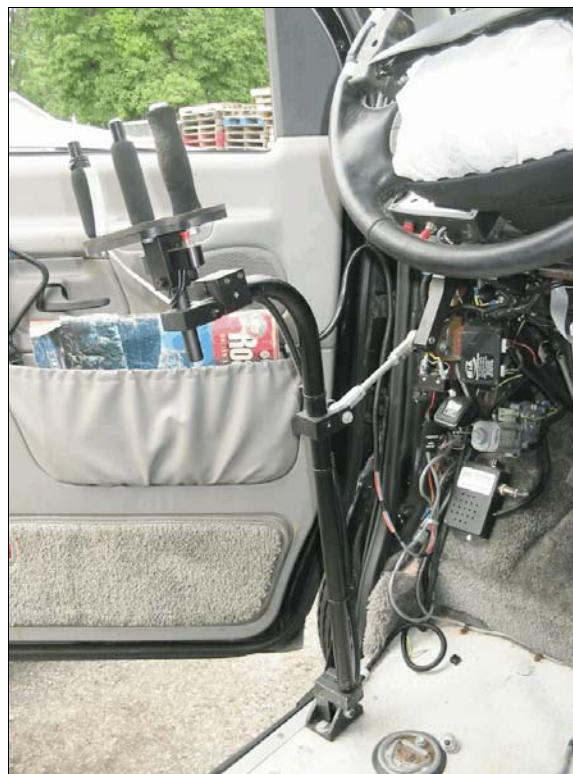
The case vehicle was equipped with several devices that allowed for operation of the vehicle without the use of lower extremities. The hand control (**Figure 14**), manufactured by Crescent Industries, was located on top a “joystick” that was positioned to the left of the driver between the left front door and the steering wheel. The “joystick” assembly was bolted to the floor. The hand control consisted of a thick foam grip with two foam covered support posts in which the wrist was placed. If the hand control was tilted to the right or left, it depressed a red button. A voice module (**Figure 15**) located under the driver’s instrument panel would then cycle through different options such as left turn signal, right turn signal, wiper, dimmer switch, etc. Once a desired option was electronically voiced, the driver would tilt the hand control once again, depressing the red button, which would then activate the selection. All equipment is programmed for each individual, so it is unknown exactly how many options the case vehicle had. Connected to the joystick, approximately 46 centimeters (18 inches) off the floor, was a connector rod that was attached to a horizontal bar running parallel to the instrument panel (**Figure 15** below). Two control rods were attached to this bar. One was attached to the brake pedal and the other to the accelerator pedal (**Figure 16** below). Braking was achieved by moving the joystick forward and acceleration by pulling it backward. Inspection of the system revealed that the actuator rods to the accelerator and brake pedals would not function. The joystick would move backward and forward, making the horizontal bar rotate, but this action would not cause any movement of the accelerator or brake actuator rods. It is likely that these functions were compromised as a result of the crash. The joystick was overextended forward during the crash to the extent that it impacted and damaged the accessories control box mounted on the instrument panel directly in front of it (**Figure 17** below). The accessories control box was equipped with switches that controlled the heater, left and right front windows, the head lights and the dome light.

**Figure 14:** Overview of hand control, “joystick” and connector rod

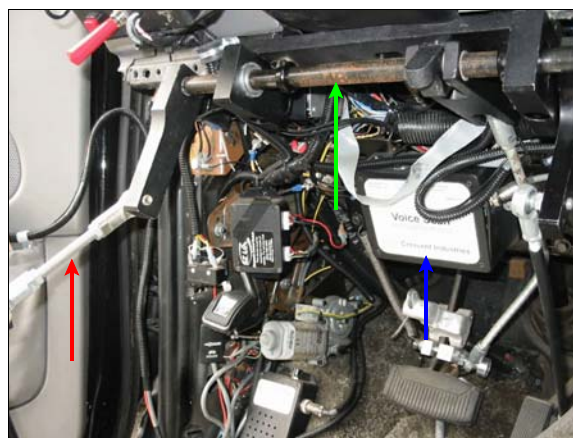
**Figure 15:** Red arrow shows connector rod from “joystick” to horizontal bar (green arrow) that connected to brake and accelerator actuator rods, blue arrow shows voice module

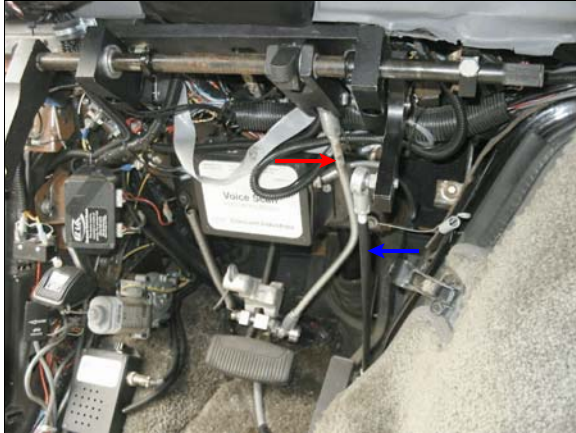
**Figure 16:** Red arrow shows brake actuator rod, blue arrow shows accelerator actuator rod, bend in brake actuator rod is not from occupant contact, it is bent to clear voice module

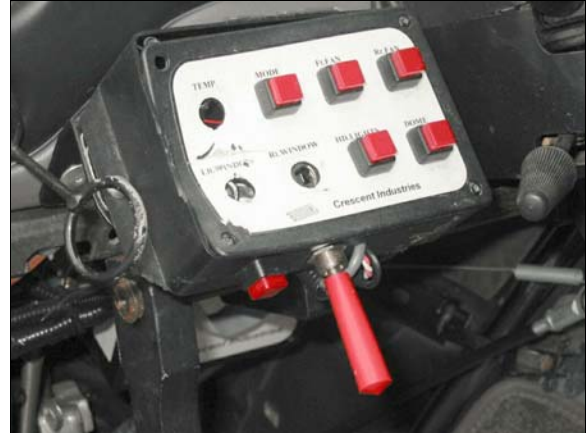
**Figure 17:** Damage to accessories control box mounted on left side of the steering wheel

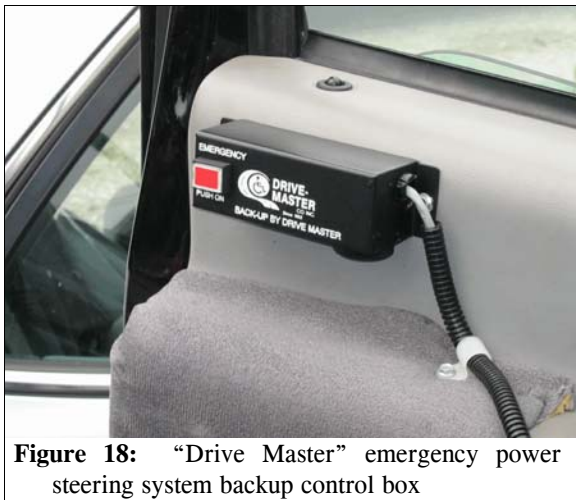
**Figure 18:** “Drive Master” emergency power steering system backup control box

Other adaptive control equipment included a Drive-Master backup steering system. The backup steering control box was mounted on the left front door (**Figure 18**). In the event of a power steering failure, the system activates audio and visual alarms to alert the driver, and the backup system instantaneously activates. The case vehicle was also equipped with a reduced effort steering system. The ignition key was attached to a large handle allowing for more leverage when starting the vehicle (**Figure 19**), and the gear shift lever had an extension lever attached to it to facilitate gear selection (**Figure 19**). The steering wheel was equipped with a “Tri-Pin” type adaptive steering device (**Figure 19**), which allowed one-handed steering. This device is designed for drivers with no grip or diminished wrist stability. The device consisted of two pins and what appeared to be a modified palm grip (**Figure 20** below). The two pins supported the wrist and were covered with a rubber pad. The palm grip was mounted on its end and had duct tape wrapped around it, which closed the opening in the grip and appeared to be used as a hand grip by the driver. The “Tri-Pin” device was attached to the inside of the steering wheel at the 2 o’clock position by a mounting bracket. A second mounting bracket was also installed at the 10 o’clock position. The “Tri-Pin” device was attached to the mounting bracket by a pin which

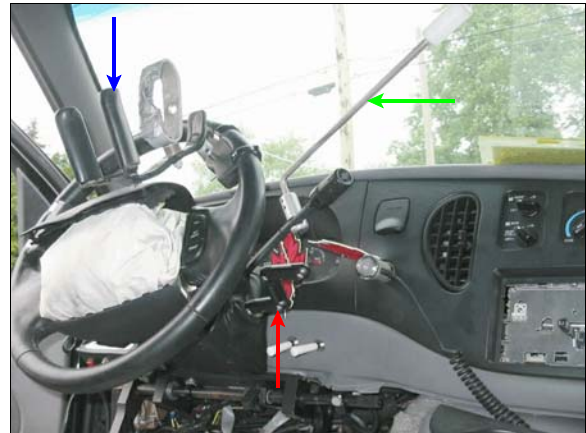
**Figure 19:** Overview of ignition key extension (red arrow), gear shift lever extension (green arrow) and “Tri-Pin” type adaptive steering device on steering wheel (blue arrow)

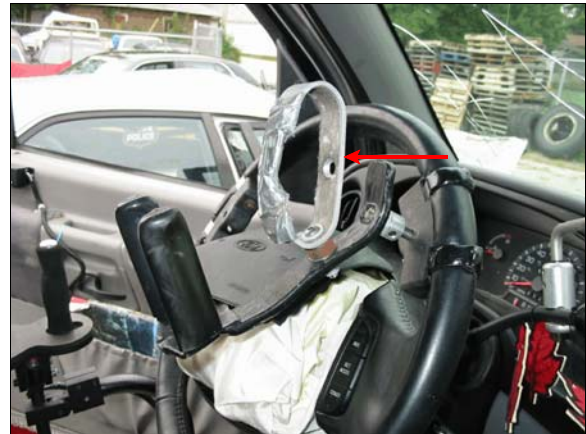
allowed the device to swivel allowing steering with one hand. The location of the “Tri-Pin” device slightly overlapped the right side of the air bag module. There was no evidence on the air bag of any damage during the deployment. The case vehicle was also equipped with an “EZ Lock” wheelchair securement device (model BL 6290), which was bolted to the floor (**Figure 21**) in the driver’s seating area. In addition, a wheelchair lift was installed in the right rear door. Lastly, the case vehicle’s stock three-point, lap-and-shoulder safety belt system had been removed and was replaced with a two-point safety belt with a locking latch plate (**Figure 22** below). The safety belt’s upper anchor was bolted to the “B”-pillar in the same location as the original upper anchor. The lower anchor was bolted to the floor near the left rear corner of the transmission tunnel adjacent to the floor-mounted wheelchair securement device. Lastly, the driver was seated in an Invacare Mark IV powered wheelchair equipped with a lap belt. It was purchased new in 2002. The wheelchair was not inspected.

**Figure 20:** “Tri-Pin” type adaptive steering device attached to steering wheel, arrow shows palm grip modified with duct tape and apparently used as a hand grip

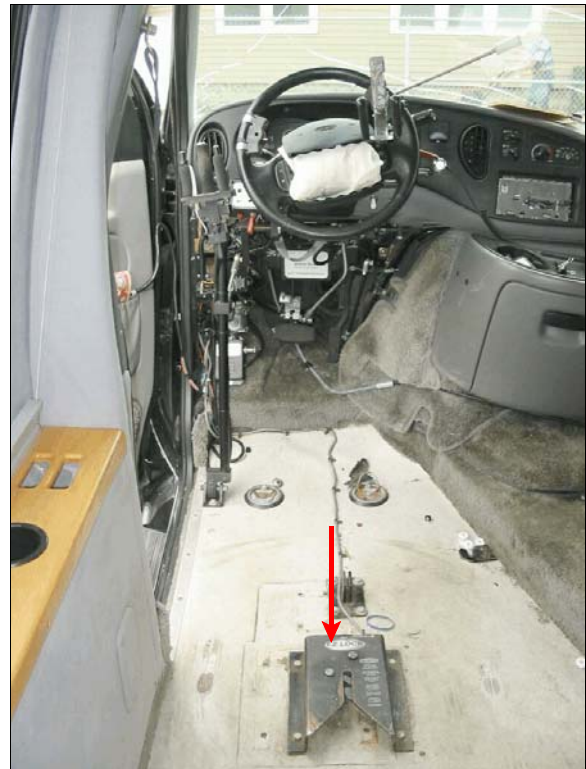
**Figure 21:** Overview of wheelchair anchor (arrow) and adaptive control equipment

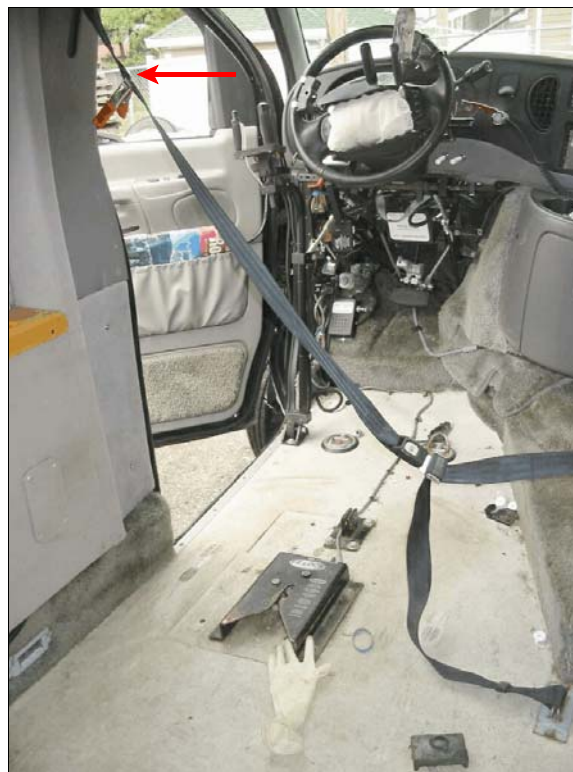
Based on this contractor's vehicle inspection, interview data and the police crash report, the case vehicle's driver was restrained by the after-market, two-point shoulder belt system and the wheelchair's two-point lap belt. Based on these sources of information, there was no indication that either belt was mis-positioned. The driver's husband indicated that the driver wore the lap belt low on her lap. No load marks were observed on the shoulder belt, but it had been cut by rescue personnel to facilitate driver removal (**Figure 22**), which suggested the belt was used in this crash.

**Figure 22:** Overview of case vehicle driver's safety belt, belt is clamped together at location belt was cut by rescue personnel (arrow)

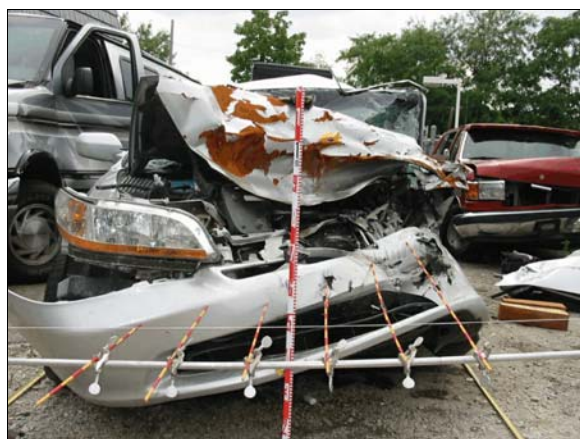
**Exterior Damage:** The Honda’s impact with the case vehicle involved approximately two-thirds of the front plane (**Figure 23**). The front bumper, grille and hood were directly damaged and crushed rearward. Direct damage also involved the entire left fender, front portion of the left front door and the left portion of the windshield. In addition, the left “A”-pillar was severely crushed rearward (**Figure 24**). Direct damage began at the left bumper corner and extended 93 centimeters (36.6 inches) across the bumper. The maximum residual crush was measured as 71 centimeters (28 inches) occurring at C<sub>1</sub> (**Figure 24**). The table below shows the Honda’s crush profile.

**Figure 23:** Damage to front of Honda from impact with case vehicle

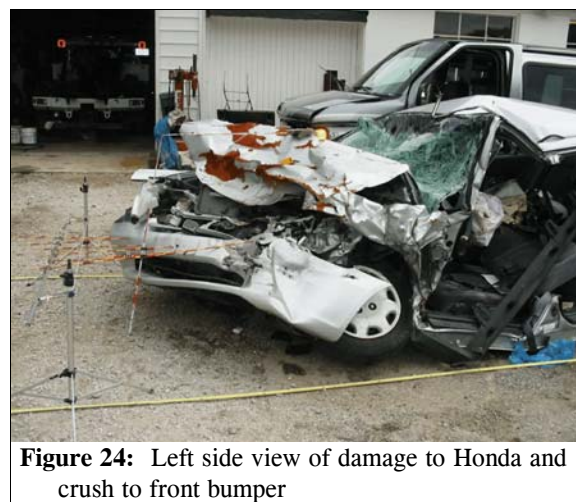
**Figure 24:** Left side view of damage to Honda and crush to front bumper

The Honda’s left side wheelbase was reduced 43 centimeters (16.9 inches) while the right side wheelbase was extended 1 centimeter (0.4 inch). Induced damage involved the hood, roof, left front door, left rear door and right fender. In addition, the windshield was broken and holed.
