Certified Advanced 208 Compliant Vehicle Investigation / Vehicle to Vehicle  
Dynamic Science, Inc. / Case Number: DS05031  
2006 Toyota Tacoma  
Colorado  
November 2005

1. Report No. DS05031		2. Government Accession No.		3. Recipient Catalog No.	
4. Title and Subtitle  Certified Advanced 208 Compliant Vehicle Investigation				5. Report Date May 30, 2006

**Dynamic Science, Inc.**  
**Crash Investigation**  
**Case Number: DS05031**

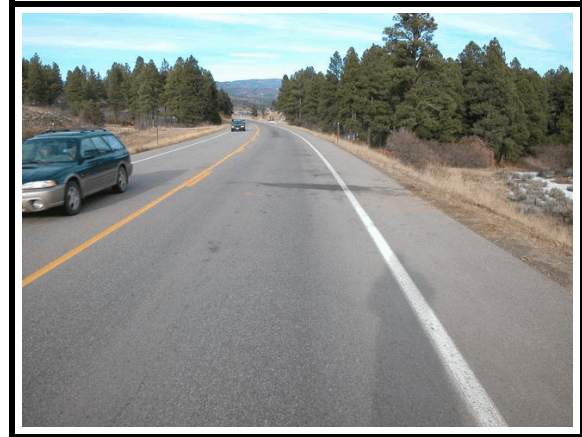
**Figure 2.** Area of impact—facing east

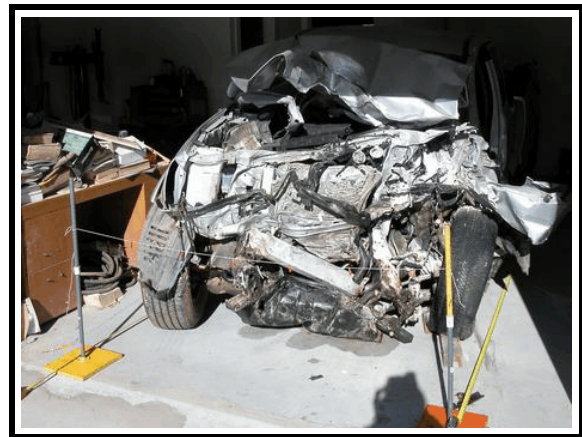
**Damage Description:** The 2006 Toyota Tacoma sustained major front end damage as a result of the impact with the Ford pickup. The direct damage began at the front left bumper corner and extended laterally across the front end 114.0 cm (44.8 in). The wheelbase on the left side was shortened by 32.0 cm (12.6 in).

Six crush measurements were documented at the bumper level as follows: C1 = 109.0 cm (42.9 in), C2 = 77.0 cm (30.3 in), C3 = 45.0 cm (17.7 in), C4 = 44.0 cm (17.3 in), C5 = 37.0 cm (14.6 in), C6 = 31.0 cm (12.2 in).

**Figure 3.** Front left, Toyota Tacoma

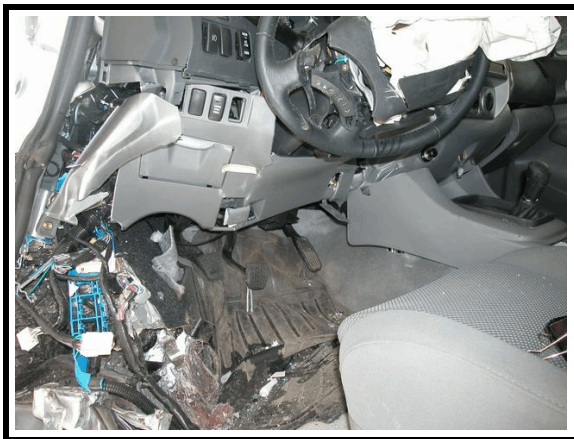
The 2006 Toyota Tacoma sustained moderate interior damage due to intrusion, occupant contacts, and extrication efforts. There was longitudinal intrusion to the driver's position through the toe pan, lower A pillar and the floor. The windshield was fractured in multiple locations due to damage. The driver's door had likely been jammed post-crash and was removed during extrication efforts. The front right door remained closed and operational. The steering wheel rim completely collapsed (8.0 cm [3.1 in] of movement) with the bottom portion of the rim pushed further forward than the top. The distance from the seat back to the top of the rim was 71.0 cm (27.9 in). The distance from the seat back to the bottom of the rim was 63.0 cm (24.8 in). The lower instrument panel/knee bolster was cracked and deformed—primarily on the left side from the driver's left knee.

**Figure 4.** Front left interior damage

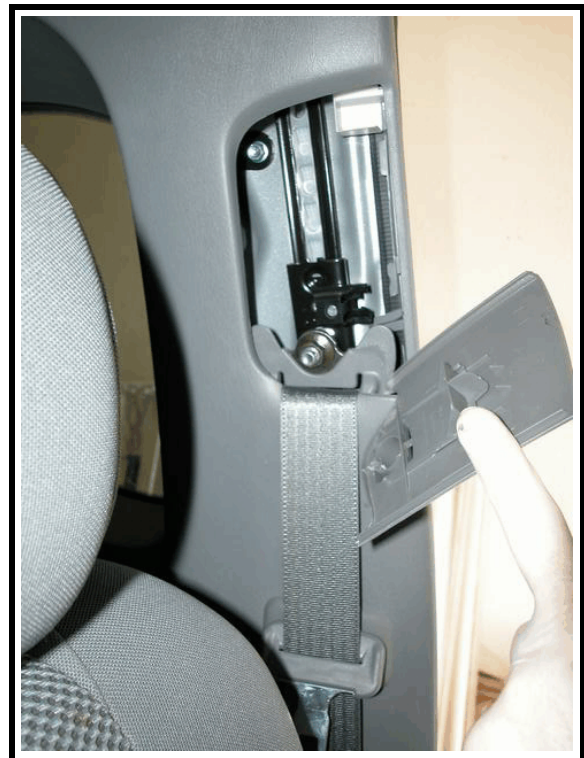
**Figure 5.** D ring adjuster, driver's side

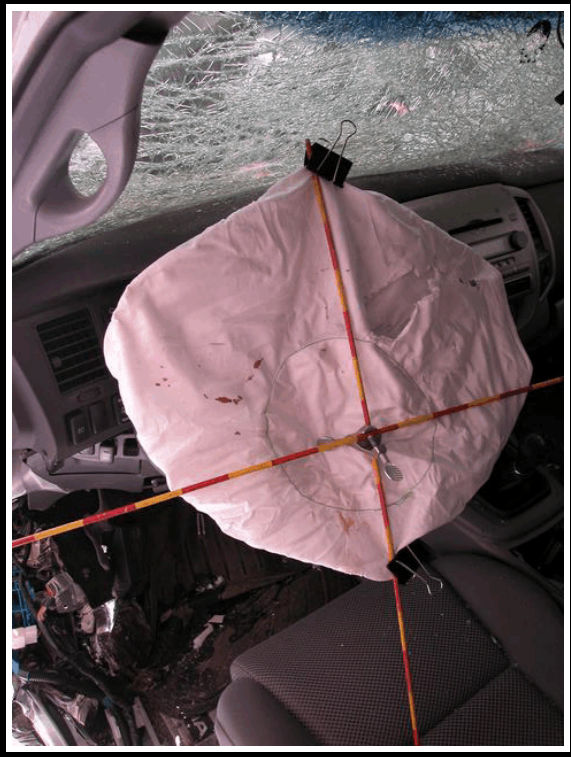
The driver's air bag deployed from the center of the steering wheel hub through H-configuration module cover flaps. The upper flap measured 13.0 cm (5.1 in) at the bottom and 11.0 cm (4.3 in) on each side. The bottom flap measured 13.0 cm (5.1 in) at the top and 8.0 cm (3.1 in) on each side. At the time of the vehicle inspection, the top flap was found trapped behind the steering wheel rim. The deployed driver's air bag measured 60.0 cm (23.6 in) in diameter in its deflated state. The air bag was tethered by a single internal strap. Two circular vent ports were located at the 11 and 1 o'clock positions on the rear of the air bag. There was a 6.0 x 13.0 (2.4 x 5.1 in) hole in the right upper quadrant on the air bag face. There was a melted 5.0 cm (1.9 in) hole at the top right seam. Portions of the bottom center of the air bag were melted to the inflator face. The distance from the module to the seam on the top was 26.0 cm (10.2 in), but the measurement for the bottom was 15.0 cm (5.9 in). There were blood drops across the left side of the air bag face and blood/saliva drops on the bottom.

**Figure 6.** Face of driver's air bag

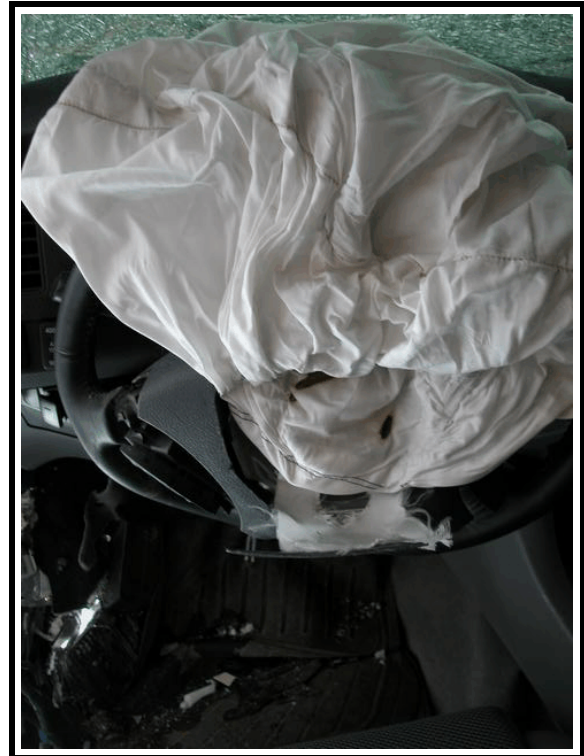
At impact with the Ford pickup the driver's air bag deployed. At the time of the vehicle inspection, the air bag was damaged by heat and was partially melted to the inflator. As a result, the air bag appears to have only partially deployed. It is possible that the air bag deployed fully and the burning/melting occurred as the air bag was overloaded by the driver. This would explain the damage near the inflator, but would not explain the burn/tears to the upper right seam. A more likely scenario is that the driver loaded the air bag while it was deploying and prevented a full inflation.

**Figure 7.** Air bag fabric melted to inflator

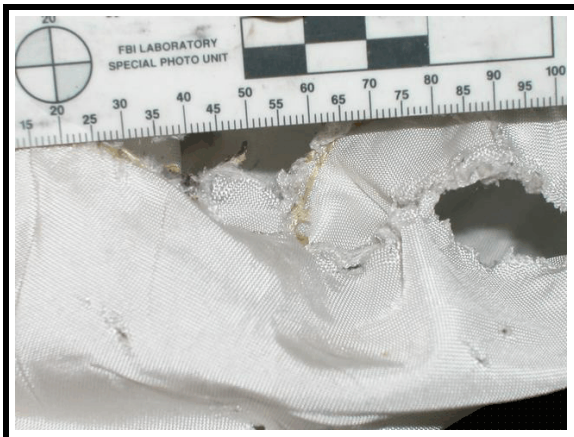
**Figure 8.** Burn/tear to upper right seam

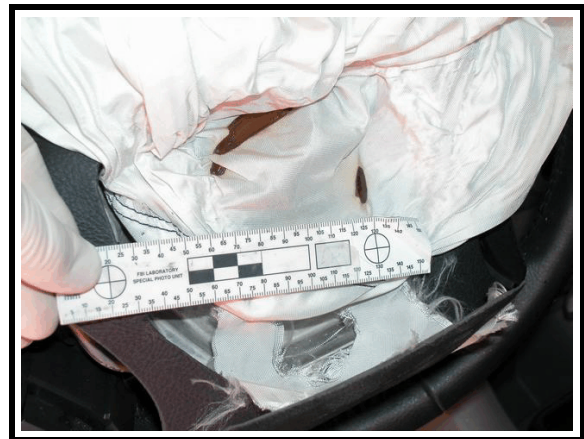
**Figure 9.** Melted portion of air bag at inflator

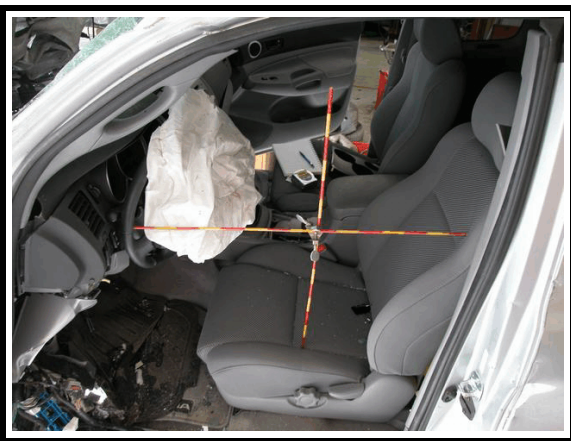
**Figure 10.** Distance from SW rim to seat back

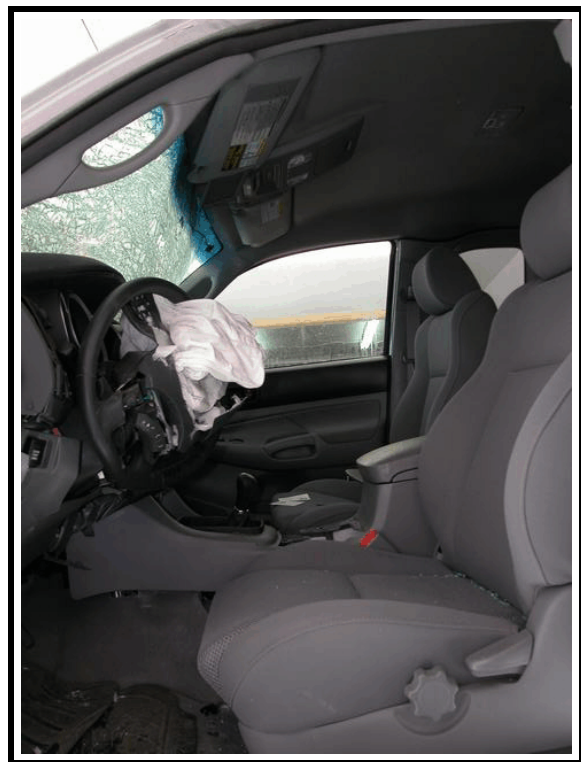
**Figure 11.** Driver's seated area
