**CALSPAN ON-SITE CERTIFIED ADVANCED 208-COMPLIANT
VEHICLE CRASH INVESTIGATION**

SCI CASE NO: CA05-033

**VEHICLE: 2005 BUICK LACROSSE
LOCATION: PENNSYLVANIA
CRASH DATE: MAY 2005**

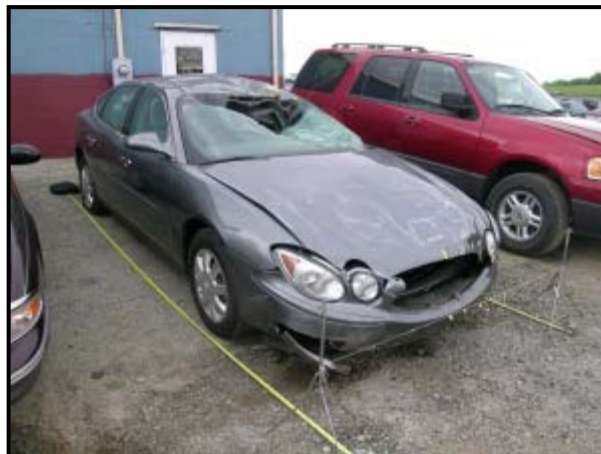
Figure 1: Right oblique view of the Buick.

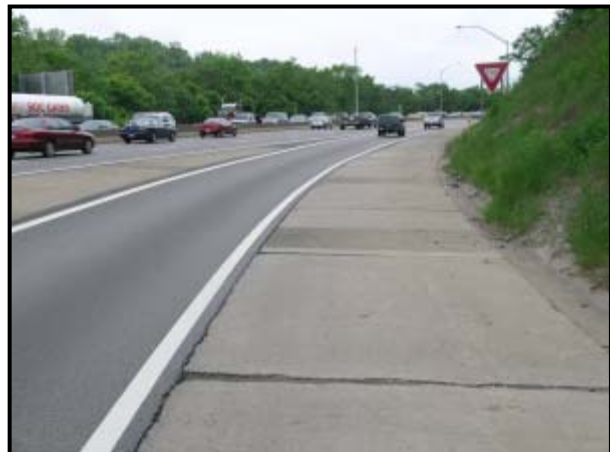
Figure 2: Southbound trajectory view of the crash site.

positive grade greater than two percent. On the east side of the ramp there was a gore area prior to merging into the interstate. A 3.7 m (12 ft) wide concrete shoulder bordered the west side of the ramp. There was a positive 65 degree embankment located immediately outboard of the shoulder. The positive slope of the embankment contributed to the vehicle's fall-over crash. The speed limit on the entrance ramp was 89 km/h (55 mph). The SCI scene inspection took place one month after the crash due to the delay in crash notification. There was no physical evidence related to the subject crash that identified the specific point of impact or final rest location of the Buick.

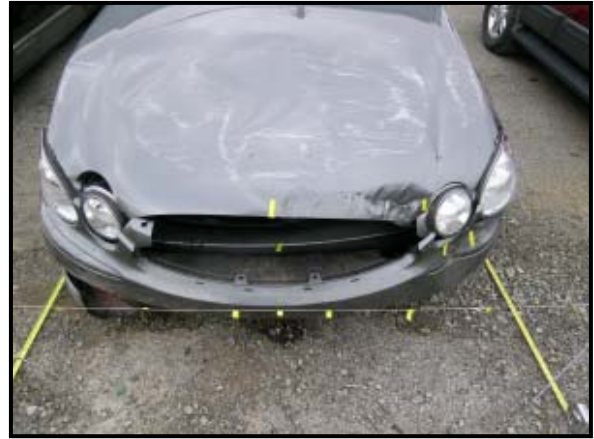
Figures 3 and 4 are exterior views of the damaged Buick. The front plane of the vehicle exhibited minor direct contact damage as a result of a long continuous impact with the embankment. This contact enabled the algorithm in the EDR and resulted in the Non-Deployment event. The frontal damage began at the right corner and then extended across the

full 152 cm (60 in) frontal width of the Buick as the crash developed. The right aspect of the fascia was fractured and abraded. The contact pattern also wrapped around the right corner and continued 53 cm (21 in) along the left side of the fascia. As the vehicle climbed the embankment and began to fall-over, the center and left aspects of the front plane contacted the embankment. This direct contact pattern began on the vehicle's center line and extended 67 cm (26.5 in) to the left. Within this contact pattern there was a localized 13 cm (5 in) contact to the left corner that resulted in deformation of the bumper reinforcement bar. Immediately above this contact pattern was a 50 cm (19.5 in wide) longitudinal contact pattern to the leading edge of the hood. The direct hood contact began on the centerline and extended to the left ending immediately inboard of the left headlamp assembly. The entire bumper fascia and the foam absorber were rotated down exposing the reinforcement bar. The residual crush profile measured along the bumper reinforcement was as follows: C1 = 11 cm (4.3 in), C2 = 8 cm (3.1 in), C3 = 3 cm (1.2 in), C4 = 1 cm (0.4 in), C5 = 1 cm (0.4 in), C6 = 0 cm (0 in). The center grille was fractured and missing. The Collision Deformation Classification (CDC) of the front impact was 12-FDEW1.

Figure 3: Frontal damage to the Buick.

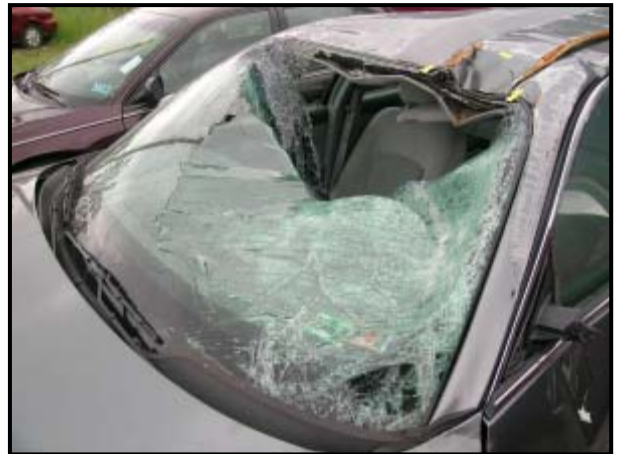
The damage associated to the two-quarter turn fall-over (Event 2) consisted of abrasions and minor deformation to the body panels of the left and top planes. The left front fender, left upper A-pillar, roof and hood exhibited scratches/abrasions oriented in a lateral direction. The mount for the left exterior mirror fractured and the mirror was separated from the Buick. The left rear wheel cover also exhibited abrasions. There was localized rollover damage to the left front aspect of the roof at the windshield header junction, **Figure 4**. The damage began 32 cm (12.5 in) left of center measured 17 cm x 15 cm (6.5 in by 6 in), width by length. The residual depth of the crush measured 6 cm (2.5 in). The top left aspect of the windshield fractured and separated from the header. The windshield sagged post-crash due to its exposure to the elements. There was no measurable change to the wheelbase dimensions. All the doors remained closed during the crash and were operational at the time of the inspection. The CDC of the rollover damage was 00-TDDO-2.

Figure 4: View of the roof deformation.

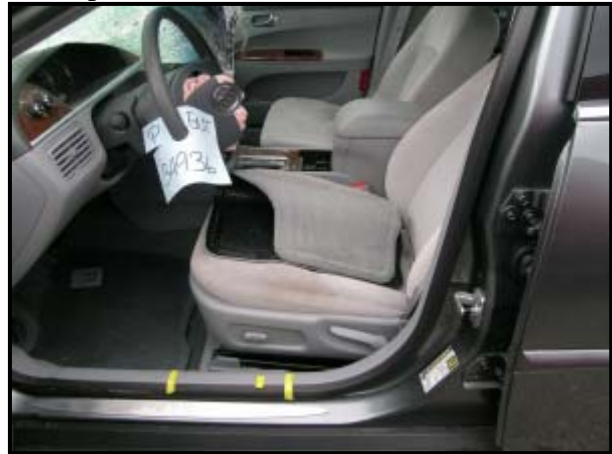
The interior damage to the Buick was limited to the deployment of the advanced CAC driver air bag and the 6 cm (2.5 in) intrusion of the windshield header. There was no other intrusion or interior damage related to the exterior force of the impact. There were no identified interior occupant contacts. **Figure 5** is a view of the left front interior.

The six-way powered driver seat was adjusted to a rear track position at the time of the inspection. The seat position measured 6 cm (2.5 in) forward of full rear. The total track adjustment measured 25 cm (9.8 in). The seat back was reclined 20 degrees aft of vertical. The head restraint was adjusted up 3 cm (1 in). The horizontal distance from the seat back to the center of the steering wheel rim measured 67 cm (26.5 in). This distance was measured 41 cm (16 in) above the seat bight. The four-spoke tilt steering wheel was adjusted to the center position. There was no deformation of the steering wheel rim. There was no displacement of the steering column shear capsules.

Figure 5: Left front interior view.

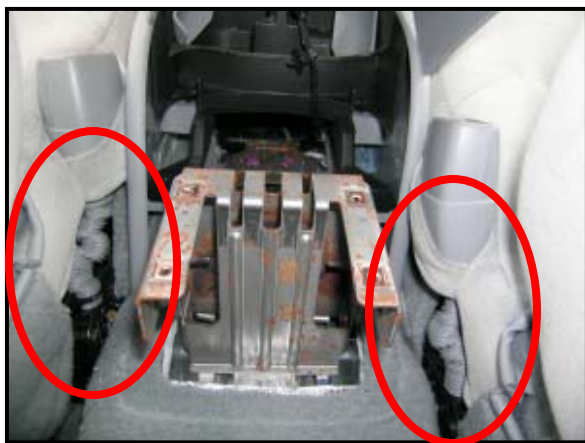
During the course of the manual restraint inspection, it was observed that the height of both the driver's and front right passenger's seat belt buckles was compressed to the level of the seat cushion. Detailed inspection of each buckle revealed that the accordion sleeve surrounding the buckle stalk was compressed, **Figure 6**. It was determined that both front seat pretensioners had actuated. The compression of the buckle height was an estimated 5 cm (2 in).

Figure 6: View of the fired buckle pretensioners.

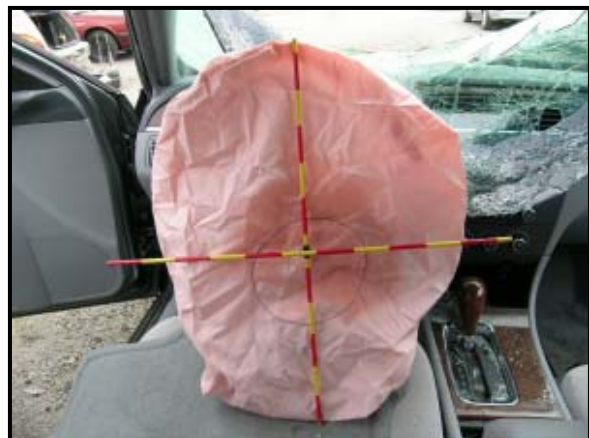
The driver air bag deployed from an I-configuration module located in the center hub of the steering wheel rim. The cover flaps were asymmetrical. The left cover flap incorporated the Buick logo design and measured 10 cm x 16 cm (4 in x 6.2 in), width by height, respectively. The right cover flap had a cut-out for the logo and measured 5 cm x 16 cm (2 in x 6.2 in). The flaps opened at the designed tear seams during the deployment sequence and were not damaged. There was no evidence of occupant contact to the flaps. **Figure 7** is a view of the driver air bag. The driver air bag measured 66 cm (26 in) in diameter in its deflated state. The bag was tethered by two 5 cm (2 in) wide straps in the 6/12 o'clock sectors and was vented by two 3 cm (1.2 in) diameter ports located in the 11/1 o'clock sectors. The deflated bag was water-soaked from rain that had infiltrated the interior through the windshield separation. There was no residual evidence of occupant contact to the driver air bag.

Figure 7: Deployed driver air bag.

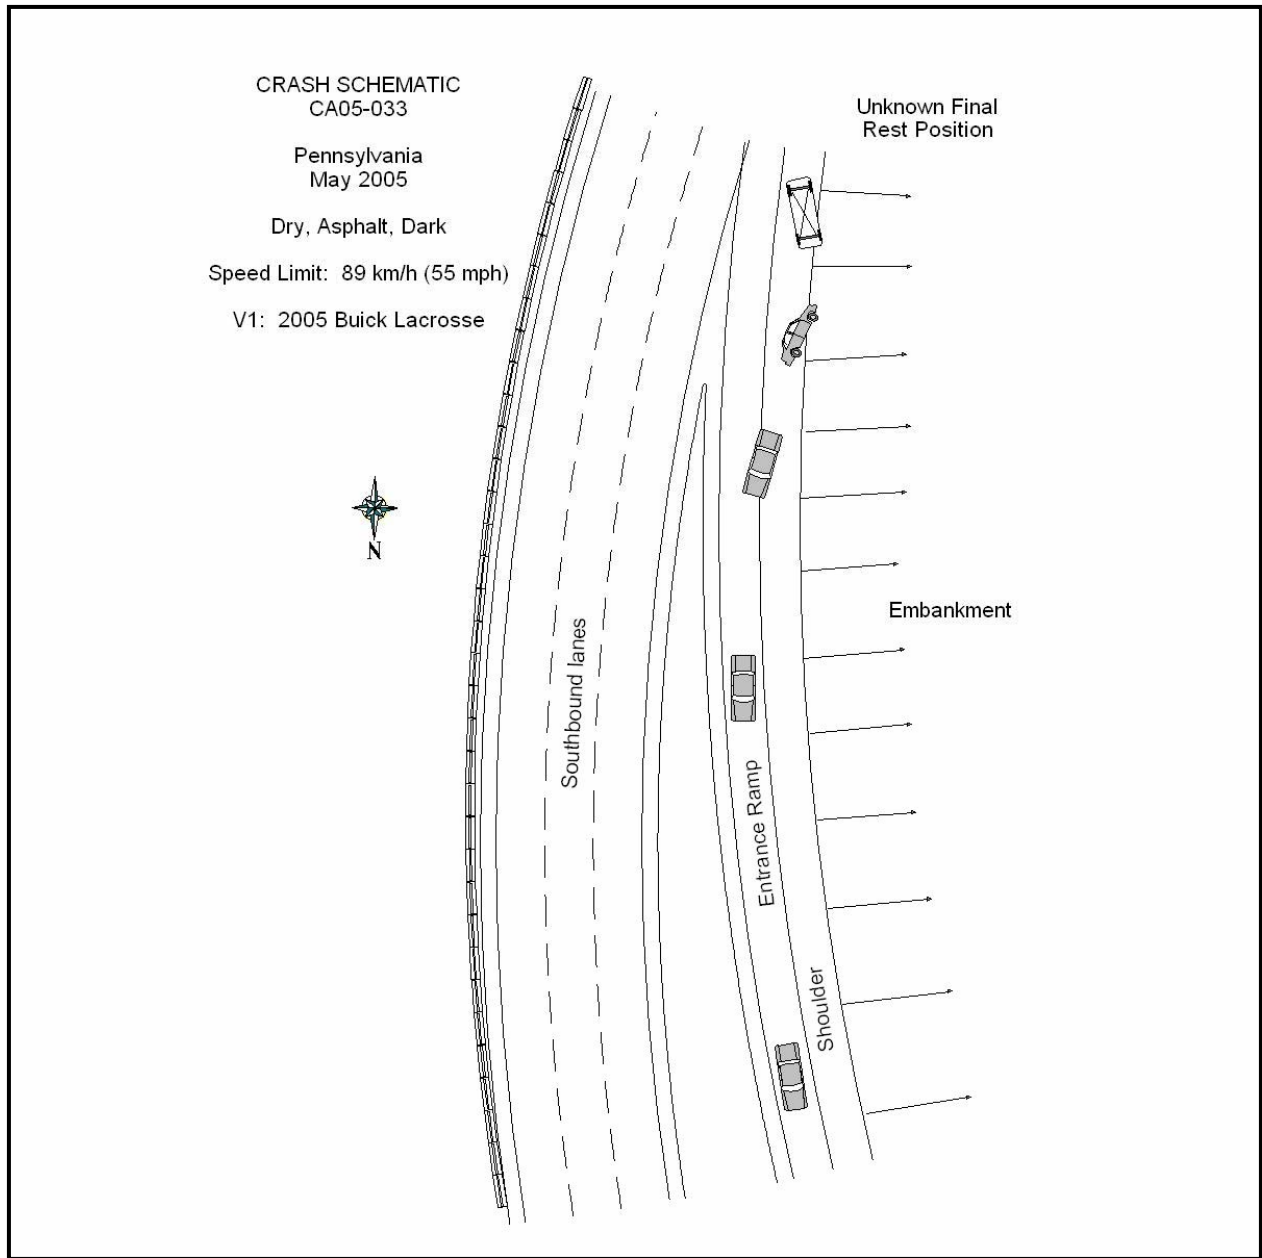
Figure 8: Crash Schematic.
