ON-SITE CERTIFIED ADVANCED 208-COMPLIANT VEHICLE INVESTIGATION

CASE NUMBER - IN-05-038

VEHICLE - 2005 TOYOTA TACOMA

CRASH DATE - September 2005

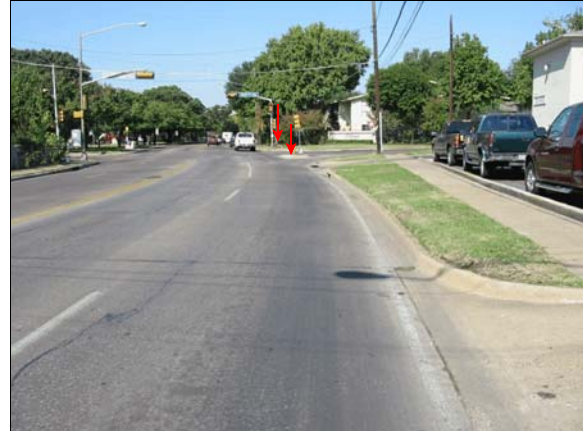
Pre-Crash: The case vehicle was traveling northwest in the outside through lane (**Figure 1**). The driver was intending to continue northwestbound through the intersection. The case vehicle's driver stated that a car crossed his path through the intersection on a red light. The driver stated he steered right to avoid a crash. The case vehicle entered the traffic island on the southeast corner of the intersection where the crash occurred.

Figure 1: Approach of case vehicle northwestbound in outside lane, arrows show locations of impacted traffic signal poles

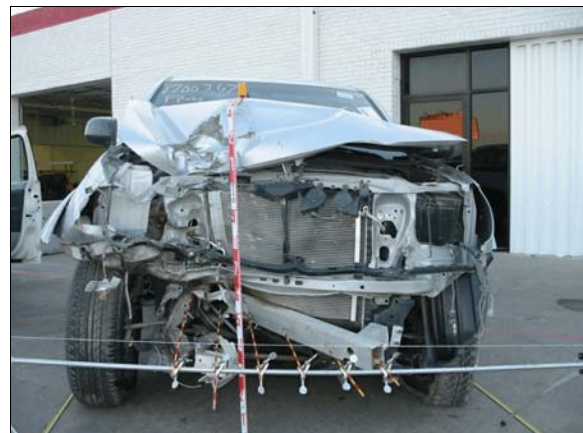
Crash: The front right of the case vehicle (**Figure 2**) impacted a metal traffic signal pole (**Figure 3**) causing the case vehicle's driver air bag to deploy. It is likely that only the first stage of the dual stage air bag deployed. The case vehicle's front right passenger air bag did not deploy because there was no front right passenger in the vehicle at the time of the crash. The impact broke the signal pole off its base, and the case vehicle continued across the intersection. The case vehicle then departed the northeast corner of the intersection, and the front right of the vehicle impacted a second metal traffic signal pole displacing the pole on its base.

Figure 2: Overview of damage to front of case vehicle from impact with metal traffic signal poles, front bumper cover and grille have been removed, vertical scale in tenths of meters

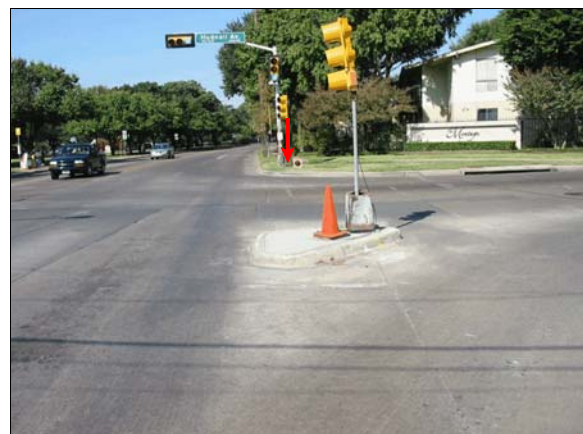
Post-Crash: The case vehicle came to rest on the northeast corner of the intersection facing northwest with the front of the case vehicle against the traffic signal pole (**Figure 3**).

Figure 3: Overview of location of two struck traffic signal poles, pole in foreground was broken off its base, pole in background was displaced, arrow shows case vehicle's area of final rest

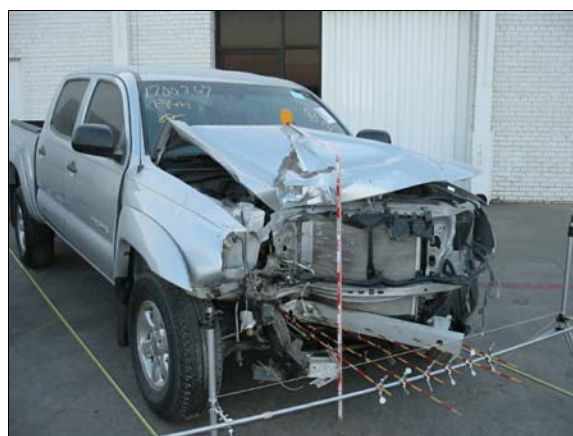
Figure 4: Overview of damage to case vehicle from front right corner

Exterior Damage: The case vehicle’s impacts with the two metal traffic signal poles involved the front right portion of the case vehicle. The front bumper, grille and hood were directly damaged (Figure 4) and crushed rearward. The two damages could not be separated, so the totality of the damage from both impacts was measured. The direct damage began 29 centimeters (11.4 inches) left of the front right bumper corner and extended approximately 50 centimeters (19.7 inches) across the front bumper. Crush measurements were taken at the bumper and the maximum residual crush was measured as 60 centimeters (23.6 inches) occurring at C₅ (Figure 5). The table below shows the case vehicle’s crush profile.

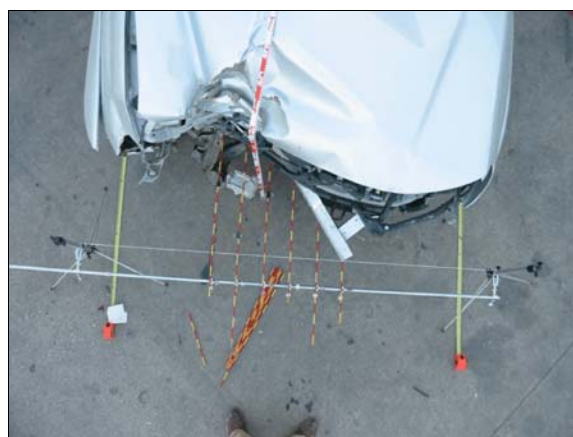
Figure 5: Top view of crush to case vehicle’s front bumper bar, each increment on measurement rods is 5 cm (2 in)

The case vehicle’s right side wheelbase was reduced 5 centimeters (2 inches). The left side wheelbase was extended 4 centimeters (1.6 inches). Induced damage involved the left portion of the front bumper, grille, hood and right fender. In addition, the windshield was cracked.

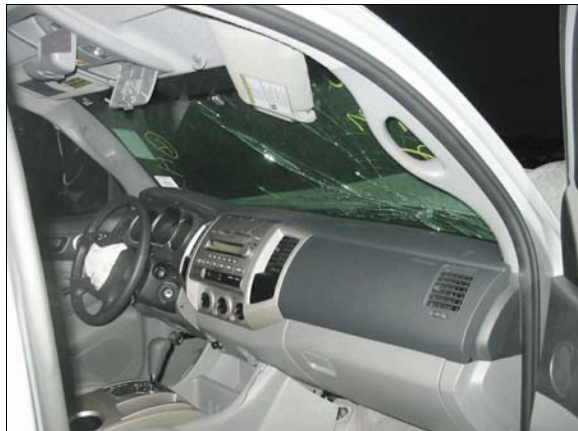
Vehicle Interior: Inspection of the case vehicle’s interior (**Figure 6**) revealed no occupant contact marks on any interior surfaces or components. The energy absorbing steering column appeared to be slightly compressed; however, no deformation of the steering wheel rim was observed (**Figure 7**). Lastly, there was no intrusion of the case vehicle’s passenger compartment.

Figure 6: Overview of instrument panel, steering wheel and windshield

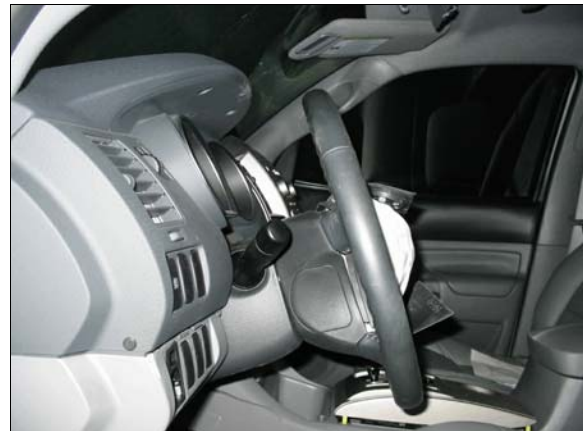
Figure 7: Left side view of case vehicle’s steering wheel and steering column

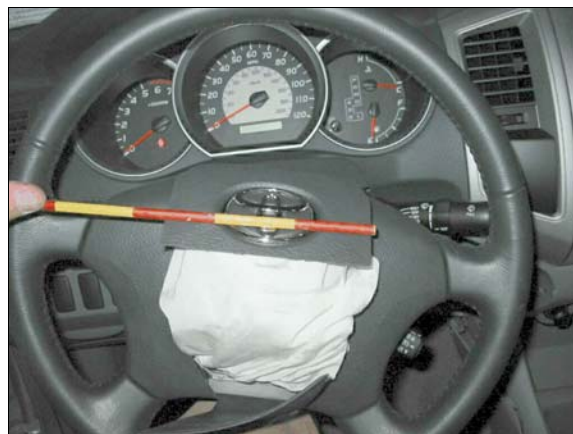
The case vehicle's driver air bag was located in the steering wheel hub. An inspection of the air bag module cover flaps and the air bag fabric revealed that the cover flaps opened at the designated tear points. There was no evidence of damage during the deployment to the air bag module cover flaps (**Figure 8**) or the air bag. The air bag module cover consisted of two cover flaps constructed of semi-pliable vinyl. The top flap was approximately rectangular in shape with angled upper corners. It was 13 centimeters (5.1 inches) in width and 7 centimeters (2.8 inches) in height. The deployed driver's air bag (**Figure 9**) was round with a diameter of approximately 62 centimeters (24.4 inches). The air bag was designed with two tethers, each approximately 6.5 centimeters (2.6 inches) in width and had two vent ports (**Figure 10**), each approximately 3 centimeters (1.2 inches) in diameter, located at the 11 and 1 o'clock positions. Inspection of the air bag fabric revealed no evidence of occupant contact.

Figure 8: Case vehicle driver's air bag module cover flaps

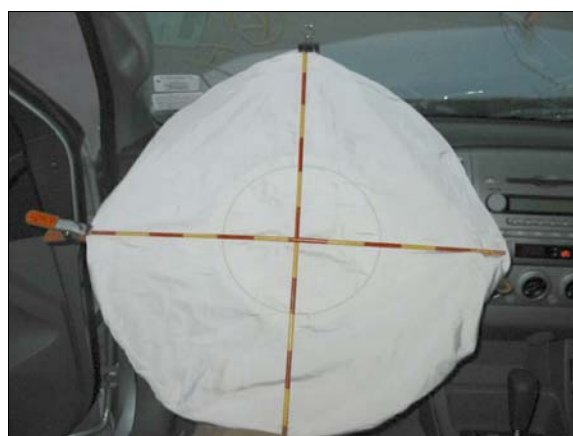
Figure 9: Case vehicle driver's air bag

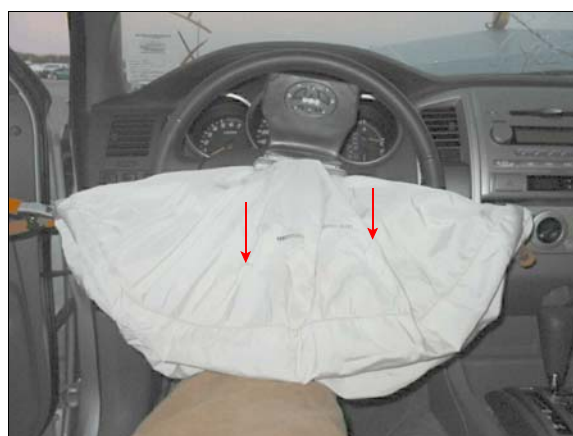
Figure 10: Arrows show locations of case vehicle's driver air bag vent ports

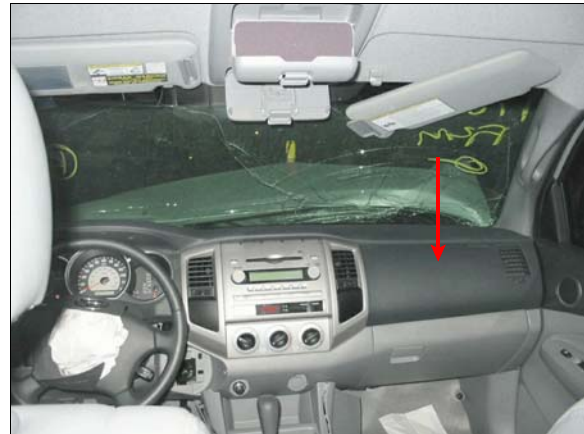
The front right passenger air bag was located in the middle of the instrument panel (Figure 11). The deployment of the front right passenger air bag was properly suppressed by the case vehicle's advanced occupant protection system because there was no front right passenger in the case vehicle at the time of the crash.

Figure 11: Overview of instrument panel, windshield and location of front right passenger's air bag, above glove box door

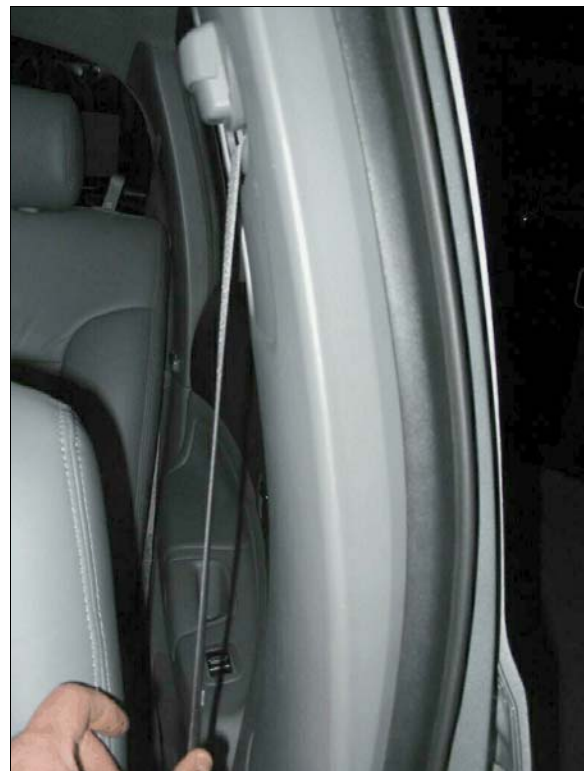
The evidence observed during the vehicle inspection indicates the case vehicle's driver was not restrained by his manual, three-point, lap-and-shoulder safety belt system. The pretensioner had activated during the crash pulling the driver's safety belt tight and jamming it in the retracted position (Figure 12).

Figure 12: Case vehicle driver's safety belt jammed tightly in the retracted position indicating activation of the pretensioner
