**ON-SITE CERTIFIED ADVANCED 208-COMPLIANT
VEHICLE CRASH INVESTIGATION**

CALSPAN CASE NO: CA05-042

**VEHICLE: 2005 VOLKSWAGEN NEW BEETLE CONVERTIBLE
LOCATION: VIRGINIA
CRASH DATE: JUNE 2005**

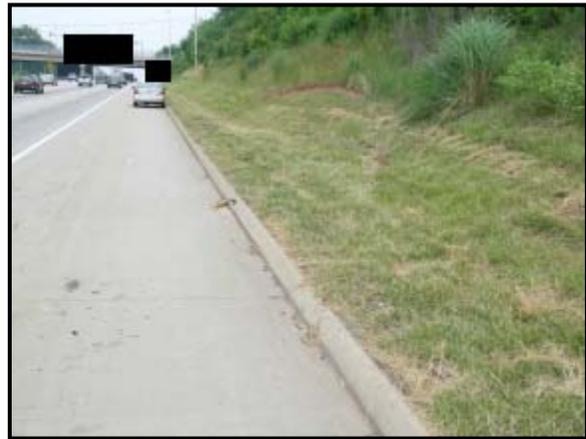
Figure 3: View at the point of roadside departure.

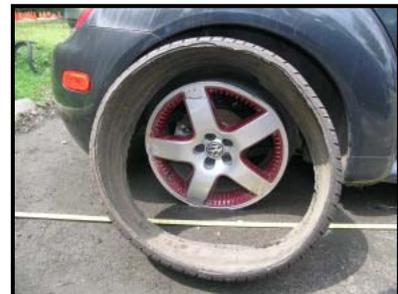
At an unknown point in time and unbeknownst to the driver, the right rear tire was punctured by a nail resulting in a slow decrease in its inflation pressure. Over time, the tire deflated and the under-inflated tire overheated during the vehicle's operation. This overheating resulted in a circumferential separation of the tread from the tire's sidewall at the shoulders, **Figure 4**. The sudden change in the vehicle's dynamic behavior induced a left steer in the Volkswagen that resulted in a reported partial lane change to the left.

Figure 4: View of the separated right rear tire.

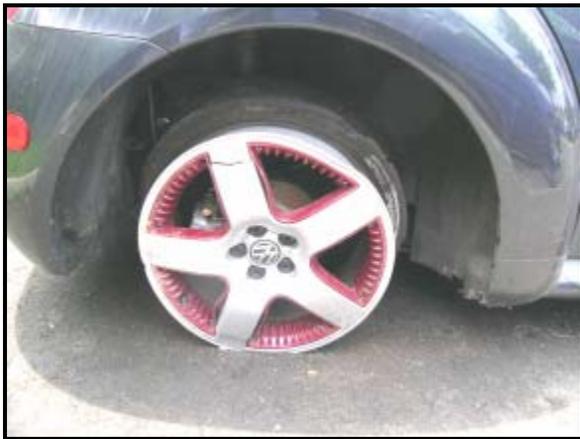
As noted earlier in this report, the right rear tire tread was punctured at an unknown point in time by a nail. The deformed nail was still embedded in the tread post-crash. The tire slowly deflated. During the vehicle's operation, the under-inflated tire overheated and over stressed the plies of tire's sidewalls. The tread of the right rear tire separated from its sidewalls circumferentially. The subject tire's DOT number was M67R ENOR 3004. The sidewall was constructed of two polyester cord plies. The tread was constructed of five plies (two polyester, two steel, one nylon). The tread wear, traction and temperature ratings were 260, A, A, respectively. **Figure 6** is a view of the alloy rim and sidewalls. **Figure 7** is a close-up view of the heat stressed sidewall cords. The police investigator indicated the right rear wheel rim was damaged during the towing of the vehicle and was not crash related.

Figure 6: Right rear wheel.

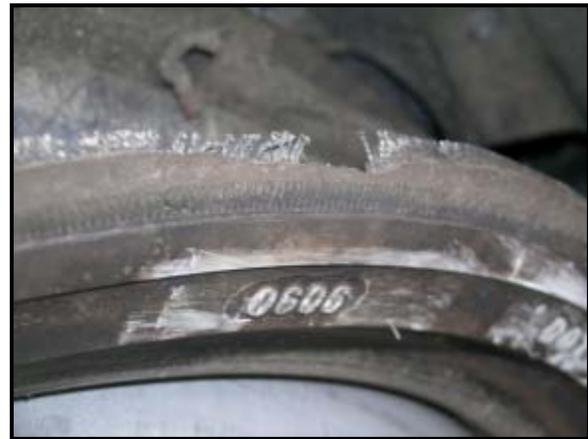
Figure 7: Close-up view of the sidewall.

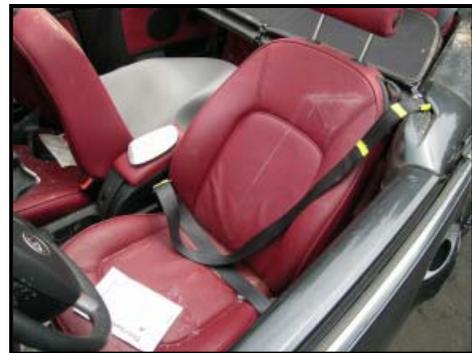
Figure 8 is a view of the driver's manual three-point restraint in the buckled position. The restraint consisted of a sliding latch plate, continuous loop webbing and a B-pillar mounted Emergency Locking Retractor (ELR) with pretensioner. There was no D-ring due to the vehicle's convertible features. Upon initial inspection, the driver's webbing was extended from the retractor and the retractor was jammed. However, after manipulation, the webbing freely extended and retracted from the spool. The pretensioner did not actuate in the rollover crash. It was noted in the vehicle owner's manual that the pretensioner would not actuate in a side impact or rollover crash. Inspection of the webbing revealed indicators of use during the crash. A 4 cm (1.5 in) webbing abrasion began 78 cm (30.5 in) above the outboard anchor. This abrasion was located at the latch plate in the buckled condition. The plastic turning loop of the latch plate exhibited a corresponding abrasion. An 9 cm (3.5 in) abrasion was located at the exit of the B-pillar trim, 109 cm (43.0 in) above the anchor. This abrasion was related to frictional contact with the trim surface after the ELR retractor had locked at the time of the crash.

Figure 8: Driver's manual restraint.

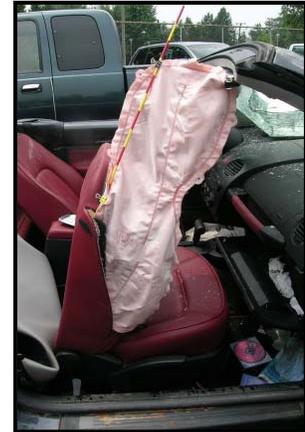
During the first quarter turn of the right side leading rollover sequence, the right side impact air bag deployed, **Figure 9**. The deflated head/thorax bag measured 71 cm x 25 cm (28 in x 10 in), height by width. The bag's excursion longitudinally forward of the seat bolster measured 18 cm (7 in). The bag was not tethered and there were no external vent ports. There was no evidence of occupant contact to the air bag.

Figure 9: Right side impact air bag.

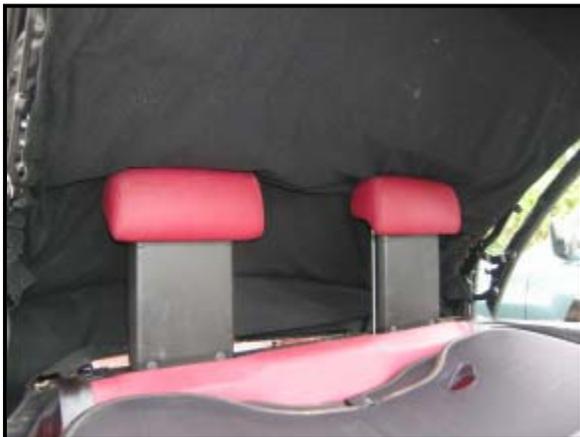
Figure 10 is a view of the ARPS in its deployed condition. **Figure 11** is a close-up of the construction and released mechanism on its rear aspect. The ARPS was constructed of 16 cm x 5 cm (6.3 in x 1.9 in) telescoping aluminum sections that deployed 22 cm (8.5 in) vertically upon release. A locking lever engaged a rack gear (attached to the rear aspect of the ARPS) and locked the ARPS in the deployed position. By releasing the lever, the head restraint could be pushed down against spring pressure. The ARPS could be mechanically re-set.

Figure 10: View of the deployed ARPS.

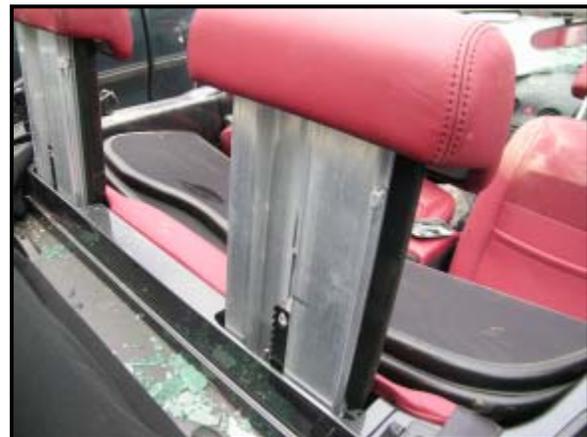
Figure 11: Rear aspect of the ARPS.
