**CALSPAN ON-SITE AIR BAG NON-DEPLOYMENT INVESTIGATION**

**CASE NO: CA05-049**

**VEHICLE: 2005 CHEVROLET COBALT**

**CRASH DATE: JULY 2005**

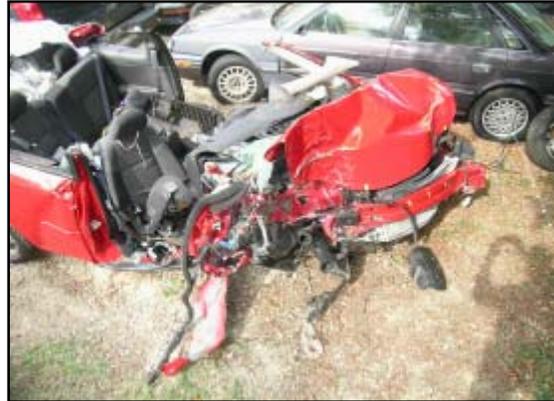
**Figure 1. Subject vehicle 2005 Chevrolet Cobalt.**

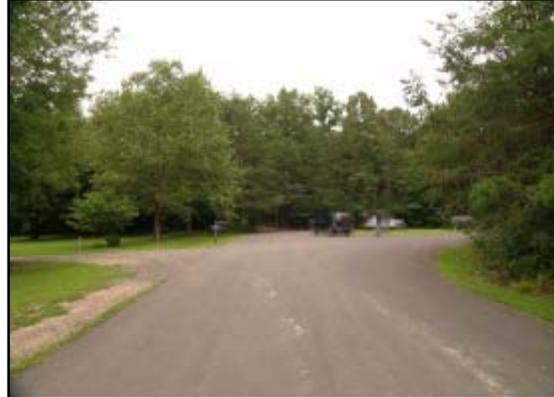
The 16-year old female driver was attending a house party at a residence located at the mouth of the cul-de-sac. She was under the influence of alcohol with a toxicology reported BAC of .17. The driver was not restrained by the manual 3-point lap and shoulder belt safety system. The lack of belt usage was determined from the vehicle inspection and EDR data. She left the party alone during the nighttime hours and attempted to exit the rural subdivision. For an unknown reason, the driver returned toward the cul-de-sac, traveling in a southerly direction on the left side of the two lane non-delineated roadway (**Figure 2**).

**Figure 2. Pre-crash travel direction and overall view of the crash site.**

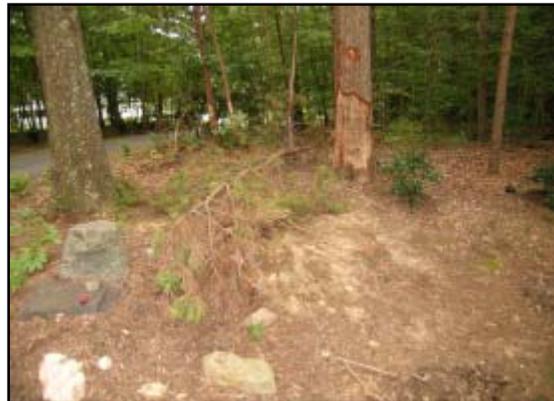
As the Cobalt traversed the mouth of the driveway, the undercarriage overrode the landscaping, which consisted of flush mounted rocks within the dirt and mulch. The front left area of the vehicle narrowly missed a large rock that was positioned vertically within the landscaped area. The Cobalt continued forward in a tracking mode and impacted a 13 cm (5") diameter pine tree with the front left area of the vehicle. The resultant direction of force for this impact event was 12 o'clock. The impact uprooted the tree, but did not fracture the 13 cm (5") trunk. The Cobalt carried the tree forward as this impact produced a minimal velocity change to the vehicle. (The delta V could not be calculated due to the masking of damage by the subsequent impact). **Figure 3** is an overall view of the crash site.

**Figure 3. Overall view of the crash site.**

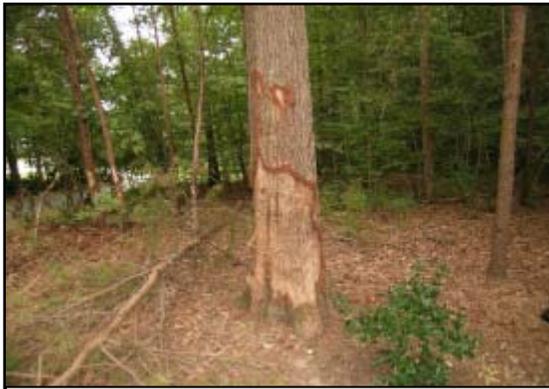
The Cobalt continued forward an additional 2.3 m where it struck a 51 cm (20") diameter hardwood tree with the front right area (**Figure 4**). At impact, the vehicle was in a near tracking attitude, and may have rotated slightly counterclockwise as a result of the initial

As the front bumper beam crushed to a depth of 110 cm (43.4"), the right front tire and wheel engaged the tree. The engagement fractured the alloy wheel and axle, and front suspension components, separating the wheel and brake assembly. The crush extended onto the right side plane of the Cobalt, engaging the right A-pillar and leading edge of the right door. The damage algorithm of the WinSMASH program computed a total velocity change of 61 km/h (37.9 mph) with longitudinal and lateral components of -60 km/h (-37.3 mph) and -11 km/h (-6.8 mph) respectively. The EDR recorded a maximum velocity change of 80 km/h (49.99 mph) at 300 msec of Algorithm Enable (AE). The frontal air bag system did not deploy. Due to the offset right crash, the Cobalt began to rotate in a clockwise (CW) direction as it separated from the tree.

**Figure 4. Impact with the 51 cm (20") diameter hardwood tree.**

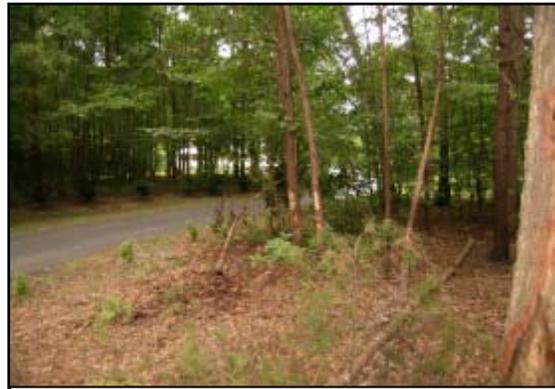
**Figure 5. Area of impact with the four small diameter trees and final rest.**

As the Cobalt rotated CW, the left side area impacted four small diameter trees that were located 2.8-4.6 m (9-15') south of the 51 cm (20") diameter tree (**Figure 5**). The lateral impact deflected the trees, which resulted in a ramping effect as the undercarriage of the Cobalt rode up the trees. This ramping effect resulted in an overturn (flip-over) of the Cobalt as it rolled one-quarter turn onto its right side. The Cobalt continued to rotate approximately 40 degrees about its longitudinal axis prior to coming to rest on its side.

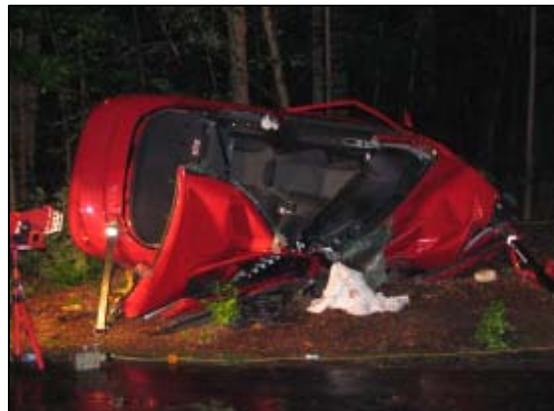
The Cobalt came to rest on its right side, facing in a northeasterly direction (**Figure 6**). At rest, the vehicle was facing in a direction that was nearly opposite of its initial travel direction. Volunteer fire

**Figure 6. On-scene image of the Cobalt at final rest.**

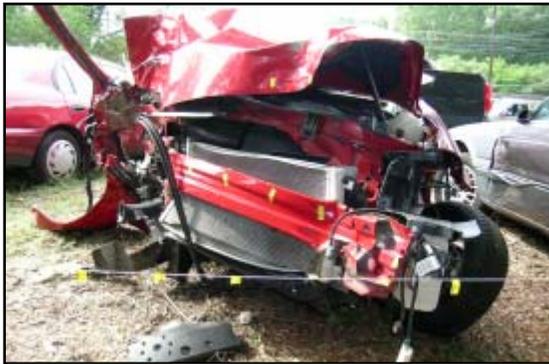
The initial impact with the 13 cm (5") diameter tree was located on the front left area of the vehicle (**Figure 7**). The direct contact damage began 29 cm (11.4") left of center and extended 11 cm (4.25") to the left. The impact dented the hood face to a maximum depth of 10 cm (4.0"). The damage and resulting crush to the bumper system was masked by the subsequent impact with the large diameter tree. The Collision Deformation

Classification for the impact was 12-FLEN-1.

**Figure 7. Damage from the 13 cm (5") tree.**

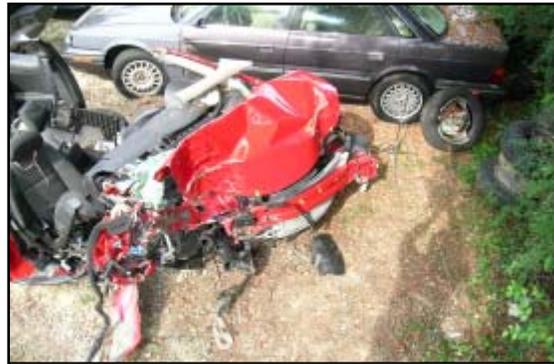
**Figure 8. Overhead view of the damage from the 51 cm (20") tree.**

The Cobalt uprooted and overrode the small diameter tree as it continued 2.3 m (7.5') forward and impacted the 51 cm (20") hardwood tree with the front right area (**Figure 8**). The direct contact damage began 41 cm (16.25") right of center and extended 33 cm (13") to the front right corner. The damage was concentrated outboard of the right frame rail and initially involved the corner of the bumper beam and sheet metal components. As the vehicle crushed, the right front tire/wheel and axle assembly engaged the tree followed by the right A-pillar area. The right corner impact deformed the full width of the frontal structure. The combined induced and direct contact damage at the bumper level measured 67 cm (26.5"), extending from corner-to-corner of the bumper beam. Maximum crush was measured at 110 cm (43.4"), located at the front right corner of the bumper beam. The crush profile at the level of the bumper beam was as follows: C1 = 12

cm (7.6”), C2 = 48 cm (18.75”), C3 = 56 cm (21.9”), C4 = 67 cm (26.5”), C5 = 80 cm (31.4”), C6 = 110 cm (43.4”).

As the Cobalt continued forward and began to rotate in a clockwise direction, the right front tire and wheel engaged the tree. This contact fractured the inner aspect of the alloy wheel rim and fractured the right front axle and suspension. The tire/wheel and brake assembly separated from the Cobalt. The right A-pillar engaged the tree and crushed the base of the pillar approximately 67 cm (26.5”) rearward. (It should be noted that the investigating officer stated that this area of the vehicle was pulled forward using hydraulic equipment as the officer interrogated the vehicle in search of the air bag control module.) The welded section of the right A-pillar, toe/floor pan, and the right sill separated due to the extensive crush and induced deformation. The CDC for this event was 12-FREE-7.

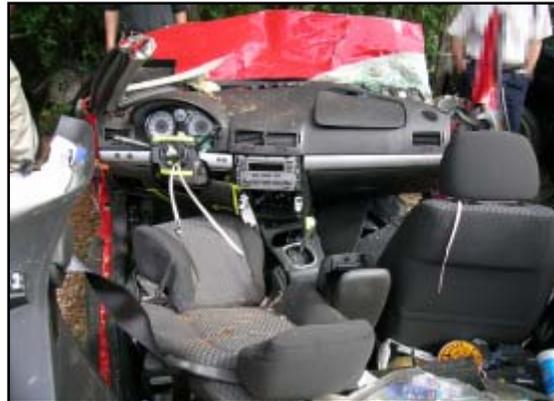
The steering wheel rotated upward as the cowl of the vehicle intruded rearward. The driver’s abdominal region loaded the lower aspect of the steering wheel rim. Her loading force fractured the mounting flange of the alloy wheel, thus resulting in complete separation of the steering wheel and air bag module from the column. This assembly was not with the vehicle at the time of the SCI inspection. The separated steering wheel was noted in an on-scene police image of the crash site. In addition to the flange fracture, the driver compressed the energy absorbing steering column as evidenced by 0.6 cm (0.25”) of left shear capsule separation and 2 cm (0.75”) of right capsule compression. **Figure 9** is overall view of the driver’s trajectory and contact points.

**Figure 9. Driver trajectory and contact points.**

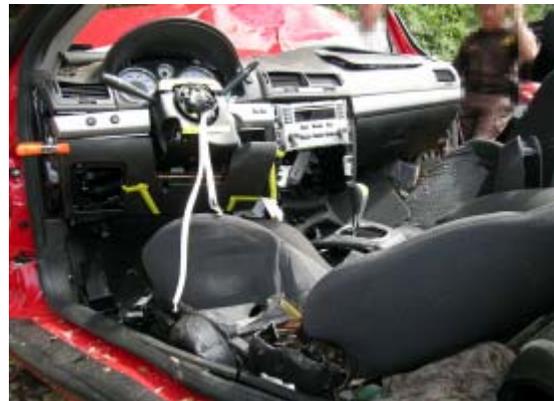
The driver’s knees and lower legs impacted the knee bolster (**Figure 10**). Her left knee scuffed the bolster 15-22 cm (5.75-8.75”) inboard of the left edge of the bolster panel and 15-23 cm (5.75-9.25”) below the top edge of the plastic panel. The right knee contact was located 44-50 cm (17.25-19.75”) inboard of the left edge and 20-24 cm (8-9.5”) below the top edge. A fabric scuff from her right leg was noted to the left side of the mid instrument panel at its juncture with the center console. This triangular fabric transfer was 13 cm (5”) in

**Figure 10. Driver contact to the knee bolster.**

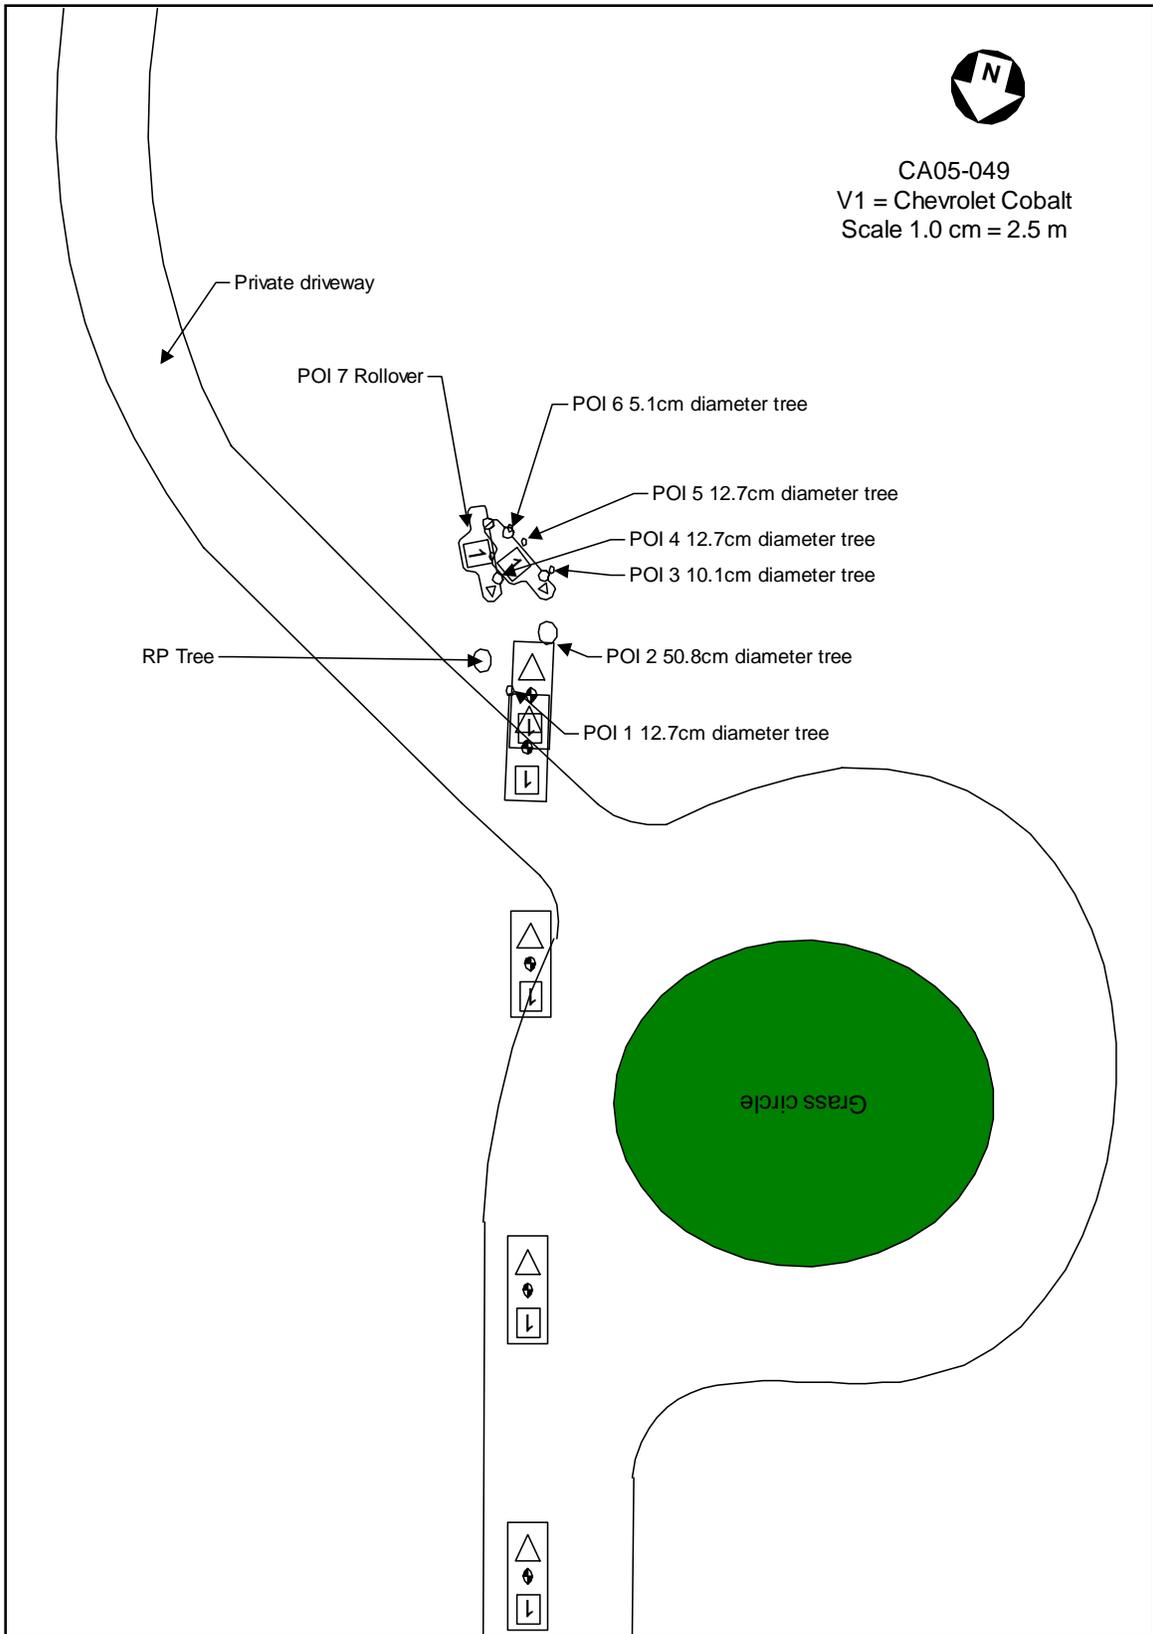
**Figure 11: Scene Schematic**

The crash occurred in a remote, rural residential area at the end of a cul-de-sac roadway during dark, nighttime hours. At the time of the crash, the weather conditions were police reported as overcast with wet environmental surfaces from a previous rainfall. A two-lane asphalt surfaced roadway terminated at a 29.8 m (98') diameter cul-de-sac, which formed a circular loop to the right of the approach roadway. The roadway was 6.4 m (21') in width and was bordered by grass/vegetation with no stabilized shoulders. A 17 m (55.8') diameter grass circle was centered within the cul-de-sac. The posted speed limit for the area was 40 km/h (25 mph). There were no lane lines or edge line markings on the road. A residential driveway intersected the cul-de-sac at the top, left aspect of the circle, with respect to vehicle travel. Numerous trees and a rock-landscaped area bordered the edges of the driveway and the cul-de-sac. At the crash site, the initial impact involved a 13 cm (5") diameter (soft wood) tree, a 51 cm (20") diameter oak tree, and four small trees that ranged in diameters of 5-13 cm (2-5"). The scene schematic is included as **Figure 11**.

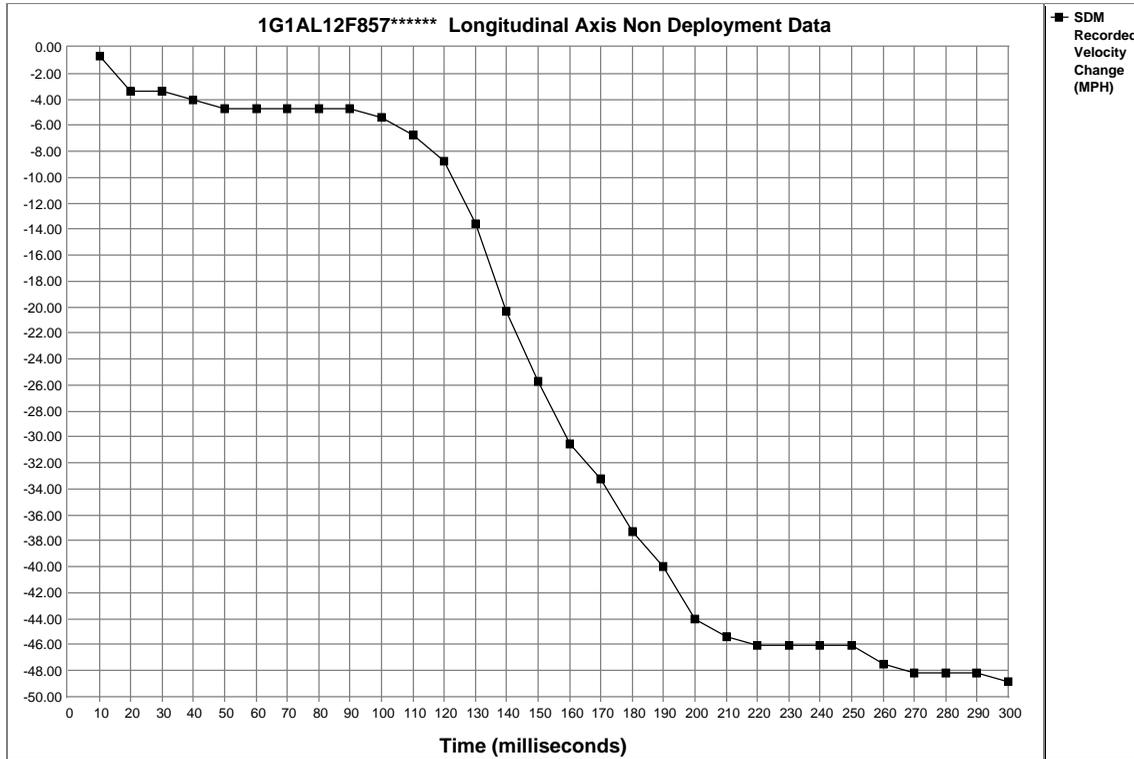
Time (milliseconds)	10	20	30	40	50	60	70	80	90	100	110	120	130	140	150
Longitudinal Axis Recorded Velocity	-0.68	-3.39	-3.39	-4.07	-4.74	-4.74	-4.74	-4.74	-4.74	-5.42	-6.78	-8.81	-13.56	-20.34	-25.76
Time (milliseconds)	160	170	180	190	200	210	220	230	240	250	260	270	280	290	300
Longitudinal Axis Recorded Velocity	-30.50	-33.21	-37.28	-39.99	-44.06	-45.42	-46.09	-46.09	-46.09	-46.09	-47.45	-48.13	-48.13	-48.13	-48.80

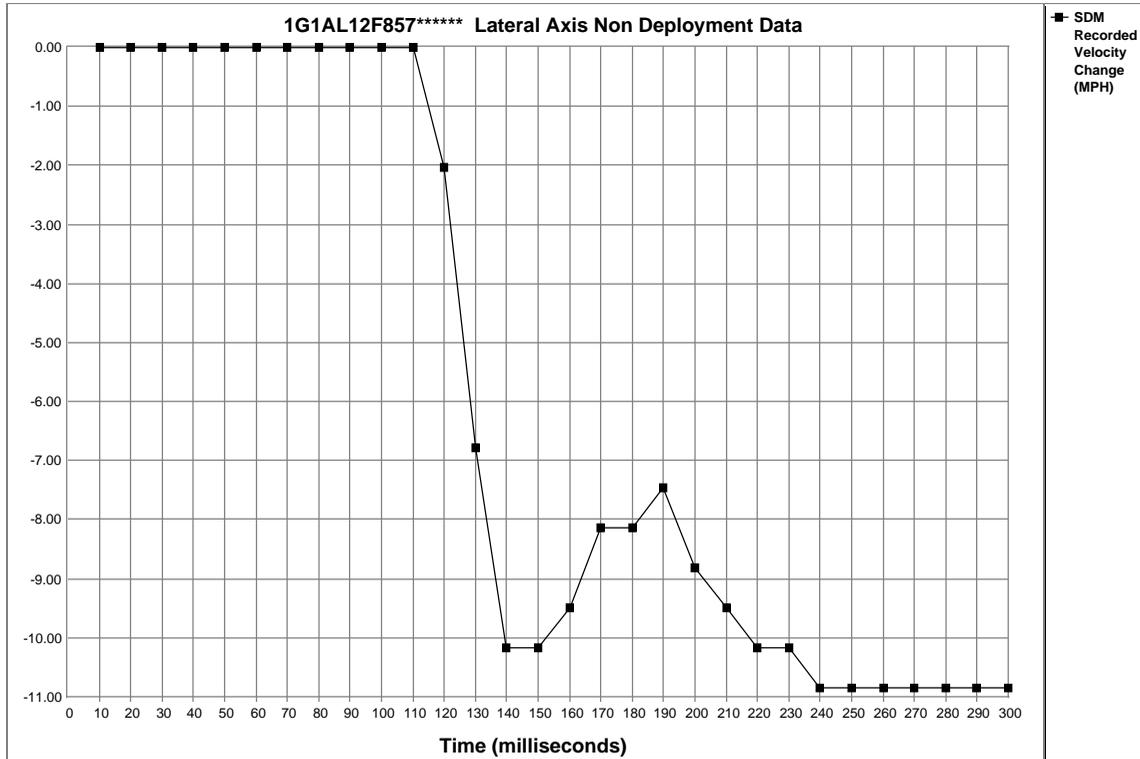
Time (milliseconds)	10	20	30	40	50	60	70	80	90	100	110	120	130	140	150
Lateral Axis Recorded Velocity Change (MPH)	0.00	0.00	0.00	0.00	0.00	0.00	0.00	0.00	0.00	0.00	0.00	-2.03	-6.78	-10.17	-10.17
Time (milliseconds)	160	170	180	190	200	210	220	230	240	250	260	270	280	290	300
Lateral Axis Recorded Velocity Change (MPH)	-9.49	-8.13	-8.13	-7.46	-8.81	-9.49	-10.17	-10.17	-10.85	-10.85	-10.85	-10.85	-10.85	-10.85	-10.85
