**CALSPAN ON-SITE REAR OCCUPANT PROTECTION PROGRAM CRASH  
INVESTIGATION**

**CASE NO. – CA05-063**

**VEHICLE – 2004 CHEVROLET TRAILBLAZER**

**CRASH DATE – DECEMBER 2005**

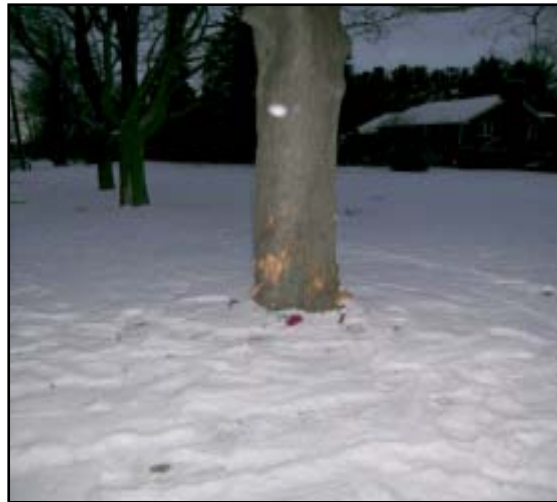
The center frontal area of the Trailblazer impacted the 48.3 cm (19") diameter tree (**Figure 4**) that was located 5.2 m (17') outboard of the east edge line. The crash resulted in an impact force of 12 o'clock. The impact was located between the front frame rails of the TrailBlazer and crushed the bumper beam to a depth of 65 cm (25.5"). The EDR recorded a longitudinal velocity change of 69 km/h (-43.05 mph). The damage algorithm of the WinSmash program computed a total velocity change of 42 km/h (26 mph) with longitudinal and lateral components of -42 km/h (26 mph) and 0 km/h, respectively. The WinSmash damage algorithm under estimated the delta V for this crash due to the narrow impact.

**Figure 4. Struck 48 cm (19") diameter tree**

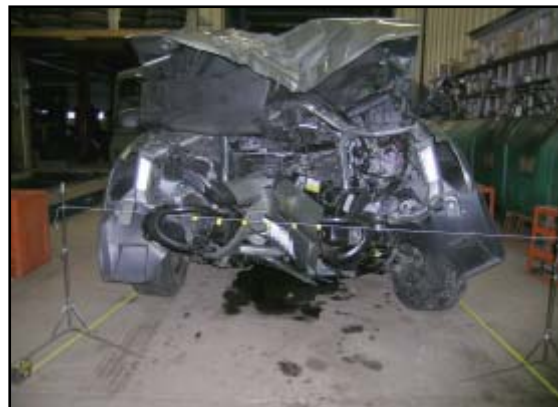
The 2004 Chevrolet TrailBlazer sustained severe frontal damage as a result of the center front tree impact (**Figure 5**). Maximum crush was measured at 65 cm (25.5") at the centerline of the bumper reinforcement beam. The direct contact damage was measured on the hood face as the bumper fascia fractured and partially separated from the bumper beam. The direct contact damage began 29 cm (11.5") right of center, extending 42 cm (16.5") to the left, and ending at a point 13 cm (5.0") left of the vehicle's centerline. The impact, which was centered between the front frame rails, deformed the front bumper beam to a U-shape resulting in a Field L measurement of 50 cm (19.5"). The crush profile measured at the level of the bumper beam was as follows: C1 = 3 cm (1.1"), C2 = 59 cm (23.4"), C3 = 63 cm (24.75"), C4 = 65 cm (25.5"), C5 = 57 cm (22.4"), C6 = 1 cm (0.5"). The Collision Deformation Classification (CDC) for this impact was 12-FCEN-3.

**Figure 5. Frontal damage to the 2004 Chevrolet TrailBlazer.**

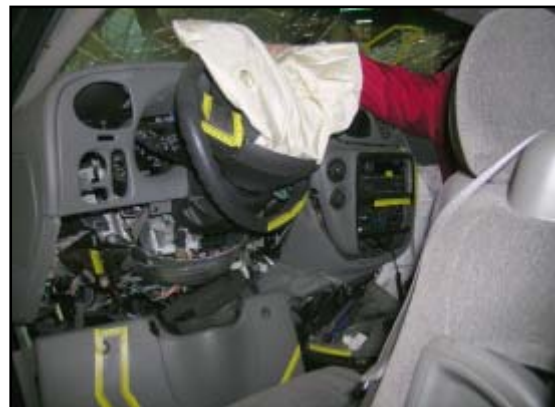
**Figure 6. Driver's contact points to the steering wheel and knee bolster.**

to the damage steering assembly reflect the wheel in this position. **Figure 6** is an overall view of the driver's contact points.

The driver's knees and lower extremities impacted the knee bolster. Pinkish fabric transfers evidenced the contact points. The left knee/lower leg contact was located 20 cm (8") left of the mid point of the steering column and extended 3-23 cm (1.25-9.25) from the top of the bolster panel. The fabric transfer and associated scuff mark was 3 cm (1.25") in width. The driver's right knee impacted the lower right corner of the bolster panel at its junction with the center console. The triangular fabric transfer on the bolster was located 16-23 cm (6.25-9.0") right of the column and 16-28 cm (6.4-11.0") below the top surface of the panel.

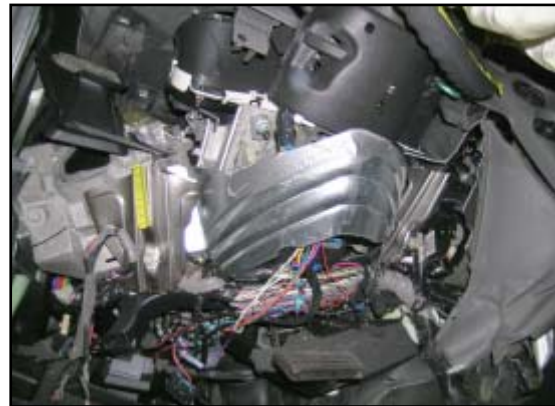
The plastic bolster panel was not fractured; however, it was fractured from its mounting points and was completely separated from the instrument panel. The panel was reinforced by a plastic sub panel that was affixed to the inside surface of the bolster. This panel was not damaged. Two sheet metal energy absorbing brackets backed up the bolster on both sides of the steering column. These brackets were attached to the aluminum sub panel and corrugated for compression. The right bracket was not damaged as the knee contact was located below the level of the bracket. The left bracket was compressed 8 cm (3") as a result of left knee loading in the area of the bracket (**Figure 7**).

**Figure 7. Compressed left bolster energy absorbing bracket and left shear capsule.**

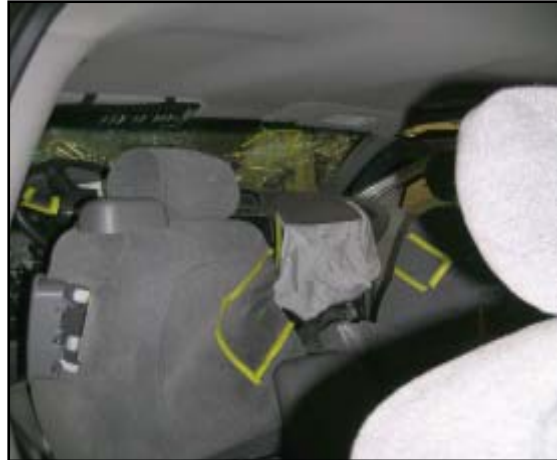
The rear left male passenger was unrestrained. He initiated a forward trajectory and loaded the front seat backs and the rear aspect of the center console (**Figure 8**). He primarily loaded the inboard aspect of front left seat back, bending the seat back frame and deforming the entire seat back forward. The direct contact area on the seat back involved a 18x18 cm (7x7") area at the mid point of the inboard side. The outboard aspect of the seat back was displaced forward approximately 10 cm (3") to a measured angle of 17 degrees while the inboard aspect was displaced approximately 20 cm (8") to a angle of 5 degrees aft of vertical. The front left seat back remained rigid.

**Figure 8. Rear left passenger's trajectory and contact points to the front seat backs.**

The rear left passenger impacted the inboard aspect of the front right seat back. A scuffmark was noted to the inboard side surface of the seat back. Additionally, the seat back was deformed in a forward direction, most notably on the inboard aspect of the seat back. The entire front right seat was rotated forward.

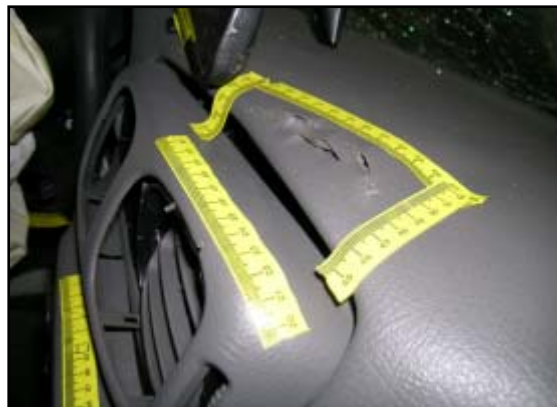
The unrestrained rear left passenger continued forward between the front seat backs and impacted the upper mid instrument panel with his face. Three linear cuts of the top center instrument panel were related to upper teeth contact (**Figure 9**). Immediately below these vinyl cuts was a second area of contact from his lower teeth. This contact to the trim panel surrounding the upper vent louvers displaced the trim panel and was evidenced by several small gouges (teeth marks). His upper arm or torso impacted the center mid instrument panel that surrounded the HVAC and radio controls. The radio face plate was fractured and the trim panel was scuffed.

**Figure 9. Upper center instrument panel contact from the rear left passenger.**

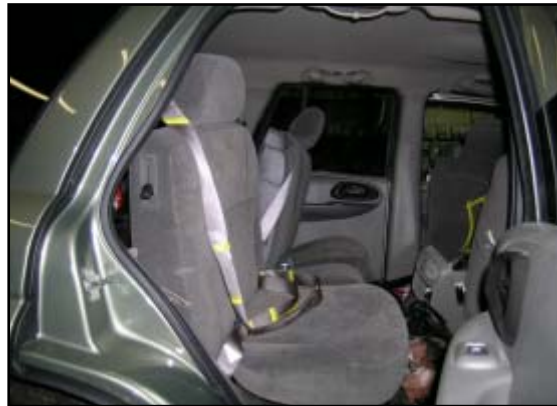
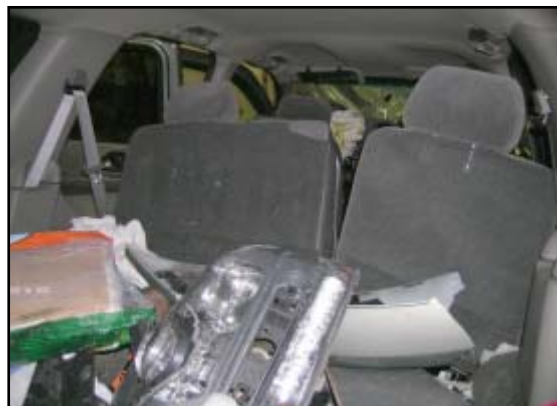
**Figure 10. View of the rear seat backs from the right side.**

**Figure 11. View of deformed rear seat backs from the rear cargo area.**

Both seat back locks were secure post-crash and were examined in this position during this SCI inspection. **Figures 10 and 11** are lateral and rear views from the right side and rear cargo area respectively.

The rear seat backs were deflected forward by the force of the crash and from minimal loading of loose cargo placed in the cargo area of the vehicle. At the time of the SCI inspection, this cargo consisted of several loose leaf notebooks, a skateboard, numerous clothing items, and a partial case of 24 oz water bottles. The case originally contained 28 bottles, however, approximately eight were found in the vehicle post-crash. Abrasions and subtle evidence of impact to the rear seat backs was noted during this investigation.

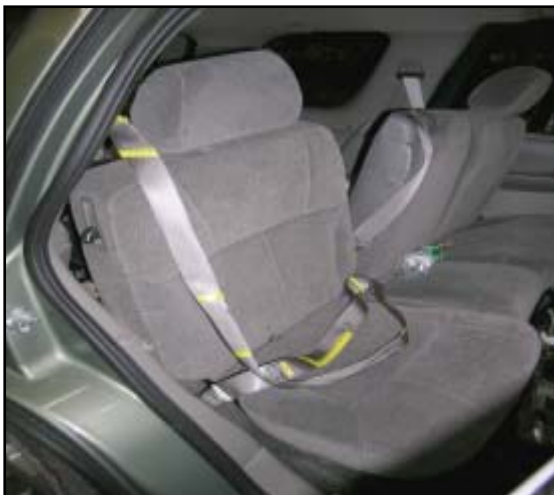
The rear right passenger was restrained by 3-point lap and shoulder safety belt system (**Figure 12**). Belt usage was supported by loading evidence on the webbing and hard points of the manual restraint. Autopsy images that were viewed by the SCI investigators showed safety belt contusions of the abdomen, left lateral flank, diagonally across the chest extending onto the left upper arm. The internal injuries discussed in the Rear Right Passenger Injury section of this report resulted from the safety belt system.

The rear right safety belt system was removed from the passenger intact and partially retracted onto the C-pillar mounted ALR/ELR retractor. Extensive loading evidence was documented for the belt system with all points of interest referenced from the latch plate stop button that was fastened to the mid point of the webbing 44 cm (17.5”) above the outboard seat frame mounted anchor point.

**Figure 12. Rear right safety belt.**

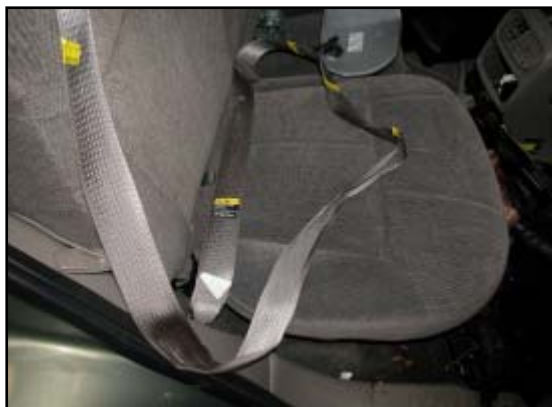
**Figure 13. Loading and creasing of the rear right safety belt.**

With the belt system buckled into the inboard mounted buckle assembly, the referenced stop button was located at the approximate mid pint of the lap belt webbing. Longitudinal creasing of the lap belt webbing began at the stop button and extended 13 cm (5") downstream toward the anchor. A frictional abrasion on the webbing from spooling through the sliding latch plate was located 19-33 cm (7.5-13.0") above the stop button. The full length of the lap belt webbing was curled in an outward direction from occupant loading (**Figure 13**). The shoulder belt aspect of the continuous loop system yielded an outward curling of the webbing that extended 55-131 cm (21.5-51.5") above the referenced stop button. A black diagonally oriented frictional D-ring transfer was located 144-150 cm (56.5-59.0") above the stop button. The D-ring transfer extended full width across the webbing.

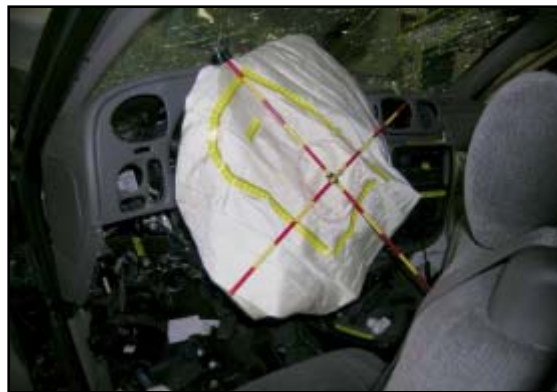
**Figure 14. Deployed driver's frontal air bag.**

Although there was no damage to the bag, a large make-up transfer evidenced the driver's facial contact with the deployed bag. The flesh-tone transfer was located over the face of the bag, encompassing all four quadrants. The transfer extended 8 cm (3") right of the vertical centerline to 10 cm (4") left of the referenced centerline. The vertical dimensions of the transfer extended 8 cm (3") below the horizontal centerline to 20 cm (7.75") above the CL. Located within the make-up transfer, was a black eye make-up transfer. This transfer was located 13-15 cm (5.25-5.75") above the horizontal CL and 0.6-3 cm (0.25-1.25") left of the vertical reference line. It should be

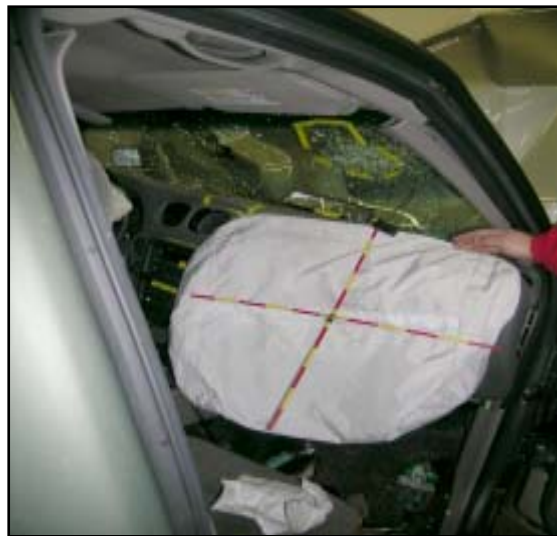
**Figure 15. Deployed front right air bag.**

The deployed front right air bag (**Figure 15**) measured 48 cm (19”) vertically and 52 cm (20.5”) horizontally. A single wide band tether limited the bag to a maximum excursion of 35 cm (14”), measured from the leading edge of the module to the tether location. The bag was vented by two 4 cm (1.5”) diameter ports located at the lateral aspects of the bag. There was no damage or contact evidence noted to the bag. Several post-crash related blood spatters were present, but these were not reflective of occupant contact.
