ON-SITE SIDE IMPACT INFLATABLE OCCUPANT PROTECTION INVESTIGATION

CASE NUMBER - IN-06-002

VEHICLE - 2005 ACURA MDX

CRASH DATE - December 2005

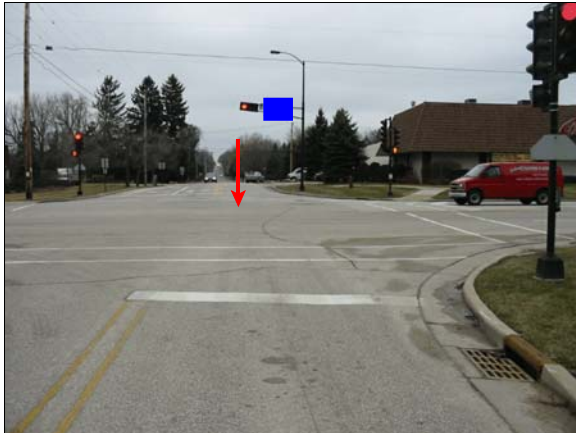
Pre-Crash: The case vehicle was northbound in the northbound through lane (**Figure 1**) and was entering the intersection. The case vehicle’s driver was intending to continue northbound through the intersection. The Jeep was eastbound in the inside through lane (**Figure 2**), and the driver was intending to continue eastbound through the intersection. The Hyundai was westbound stopped at the traffic signal in the right turn lane (**Figure 2**), and the driver was intending to turn right. The case vehicle’s driver stated she did not see the Jeep approaching and took no actions to avoid the crash. The crash occurred within the intersection.

Figure 1: Approach of case vehicle northbound to impact in intersection, arrow shows area of impact

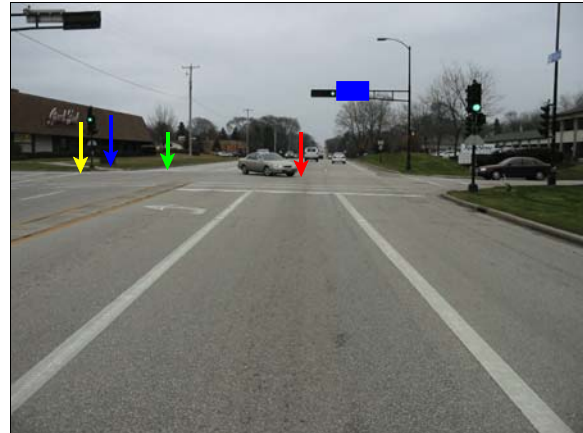
Figure 2: Approach of Jeep to intersection, red arrow shows impact area, green arrow shows location of Hyundai, blue arrow shows final rest area of case vehicle, yellow arrow shows final rest area of Jeep

Post-Crash: Following the impact with the Hyundai, the case vehicle departed the northeast corner of the intersection and came to final rest with the front portion of the vehicle off the roadway heading northeast (**Figure 2** above). The Hyundai remained in the east leg of the intersection and came to final rest heading west. The impact with the case vehicle caused the Jeep to rotate counterclockwise. It traveled northeast across the intersection and came to final rest on the northeast corner of the intersection heading northeast (**Figure 2** above).

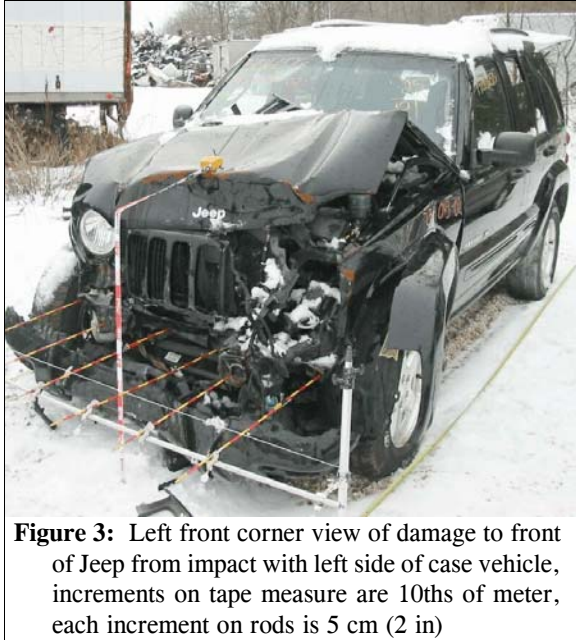
Figure 3: Left front corner view of damage to front of Jeep from impact with left side of case vehicle, increments on tape measure are 10ths of meter, each increment on rods is 5 cm (2 in)

Crash: The front of the Jeep (**Figure 3**) impacted the case vehicle’s left fender and left front door (**Figure 4**) causing the case vehicle driver’s seat back-mounted side impact air bag and side curtain air bag to deploy and the driver’s safety belt pretensioner to actuate. The case vehicle’s front air bag did not deploy. The case vehicle’s crash sensing algorithm most likely determined that the longitudinal deceleration was not severe enough to require deployment of the driver’s front air bag. The case vehicle then rotated counterclockwise and traveled northeast across the intersection, and the right rear corner of the case vehicle sustained a minor impact with the left front corner of the Hyundai.

Exterior Damage: The Jeep’s impact with the case vehicle involved the full frontal width of the Jeep. The front bumper, grill, hood and fronts of both fenders were directly damaged and crushed rearward. Direct damage began at the right corner of the front bumper and extended 152 centimeters (59.8 inches) across the front bumper. The maximum residual crush was measured as 29 centimeters (11.4 inches) occurring at C₃. The table below shows the Jeep’s crush profile.

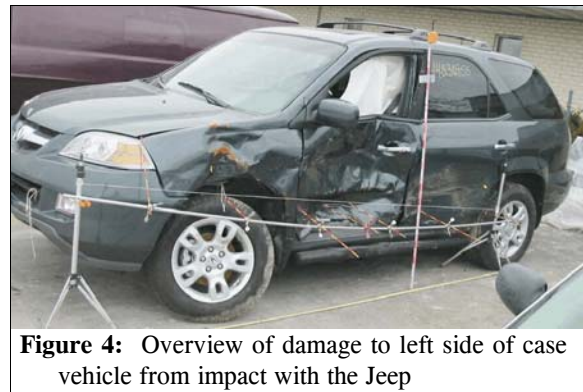
Figure 4: Overview of damage to left side of case vehicle from impact with the Jeep

Exterior Damage: The case vehicle's impact with the Jeep involved the left side of the case vehicle. The left fender, left front door, left rear door and sill were directly damaged and crushed inward. The direct damage began 45 centimeters (17.7 inches) forward of the left rear axle and extended 238 centimeters (93.7 inches) forward along the left side of the vehicle (**Figure 4** above). Crush measurements were taken at the mid-door level, and the maximum residual crush was measured as 31 centimeters (12.2 inches) occurring 19 centimeters (7.5 inches) forward C₃ (**Figure 5**). The case vehicle's right rear corner impact with the Hyundai involved a small portion or the right corner of the case vehicle's back bumper fascia.

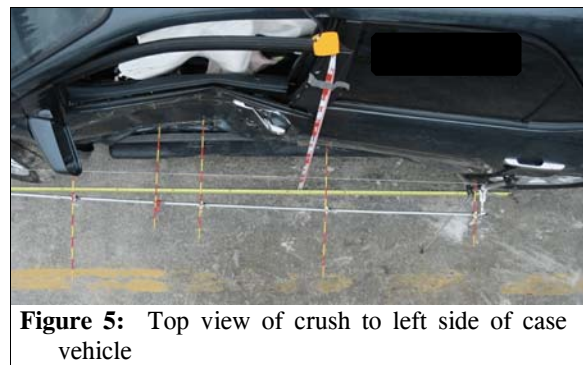
Figure 5: Top view of crush to left side of case vehicle

There was no residual crush from this impact. The table below shows the case vehicle’s crush profile for the left side impact.

The case vehicle’s left side wheelbase was extended 2.0 centimeters (0.8 inches) while the right side wheelbase was unchanged. Induced damage also involved the left fender, left front door, and left rear door as well as the left “A”-pillar, “B”-pillar and the left roof side rail. In addition, the windshield was cracked.

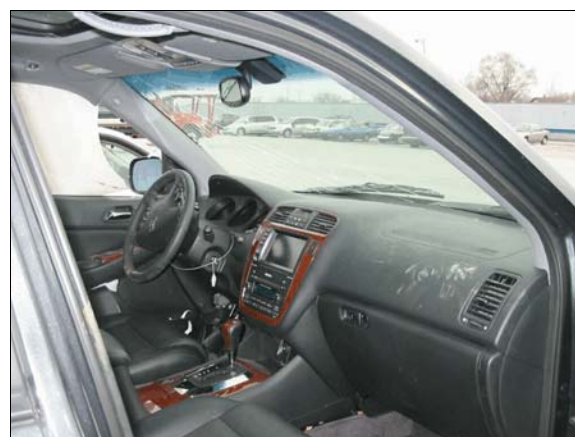
Vehicle Interior: Inspection of the case vehicle’s interior (**Figure 6**) revealed an occupant contact scuff on the driver’s left knee bolster and load mark abrasions on the driver’s safety belt. Two small black marks were observed near the top central portion of the driver’s side curtain air bag. However, they did not appear to be related to driver contact. They appeared to be too high on the air bag to be associated with contact by the restrained, 155 centimeters (61 inches) tall driver. No other occupant contact evidence was found.

Figure 6: Overview of instrument panel, windshield, and steering wheel

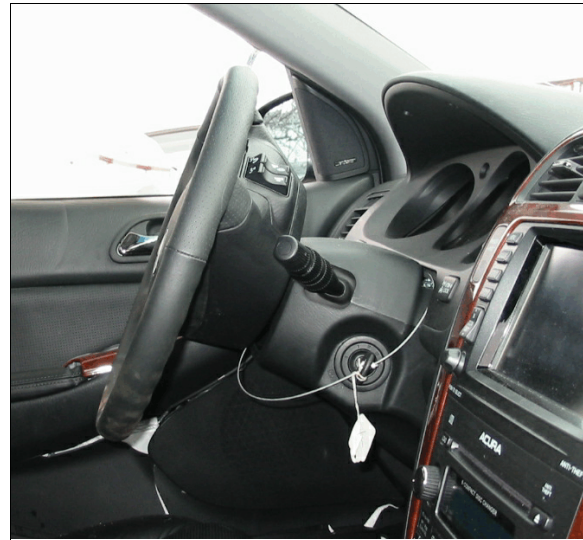
severe intrusions into the driver's occupant space were: 15 centimeters (5.9 inches) of lateral "B"-pillar intrusion and 14 centimeters (5.5 inches) of lateral door panel intrusion. Finally, there was no evidence of compression of the energy absorbing steering column, and no deformation of the steering wheel rim was observed (**Figure 7**).

Figure 7: Right side view of case vehicle's steering wheel and steering column showing lack of deformation

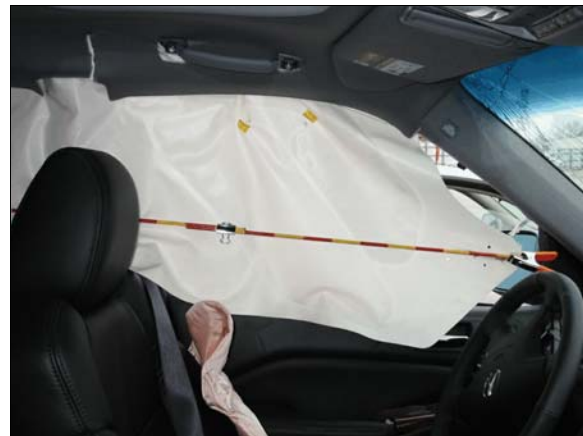
The case vehicle's side curtain air bags were located along the roof side rail (**Figure 8**) and consisted of one continuous air bag that extended the length of the passenger compartment to provide protection to the outboard occupants in all three seat rows. The left side curtain air bag deployed as a result of the impact with the Jeep. There was no evidence of damage to the air bag due to the deployment. The left side curtain air bag was approximately rectangular in shape with an angled contour at the front and back. The air bag consisted of approximately eight inflatable chambers and was 223 centimeters (87.8 inches) in length and 34 centimeters (13.4 inches) in height. The air bag was anchored to the "A" and "D" pillars with a short nylon cord. The air bag was constructed without tethers and there were no visible vent ports. Inspection of the driver's side curtain air bag revealed two small black marks near the top central portion of the air bag. However, they did not appear to be related to driver contact. They appeared to be too high on the air bag to be from the restrained, 155 centimeters (61 inches) tall driver. In addition, there was evidence of post-crash handling of the air bag, which may have been the source of the marks. The air bag's front anchor chord had been cut.

Figure 8: Case vehicle's driver side curtain air bag, each increment on rod is 5 cm (2 inches), yellow tape at top of bag shows two small black marks

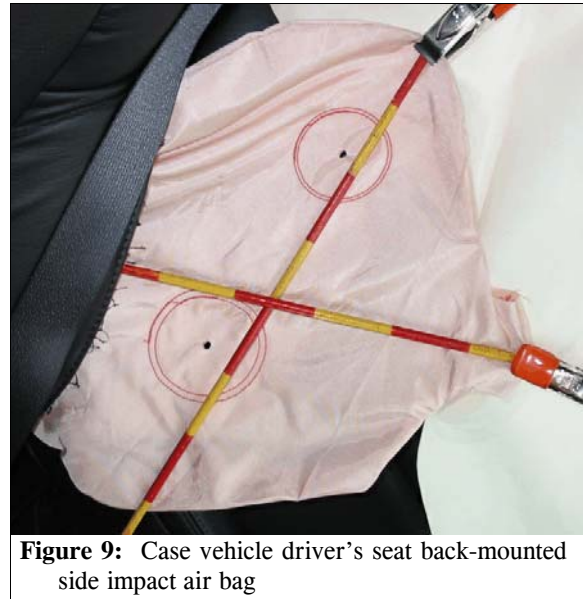
The front seat back-mounted side impact air bags were located in the outboard side of the driver's and front right passenger's seat backs. The side impact air bag deployed through a stitch seam in the side of the seat back. The driver's seat back-mounted side impact air bag deployed in this crash (**Figure 9**). The side impact air bag was approximately oval in shape and measured approximately 37 centimeters (14.6 inches) in height and 30 centimeters (11.8 inches) in width at its widest point and was constructed with a 7 centimeters (2.8 inches) wide loop of material located on its front edge. It was constructed without tethers or vent ports. The inside and outside surfaces of the air bag were sewn together in two areas in circular double-stitched patterns, each approximately 7.5 centimeters (3 inches) in diameter with a 5 millimeter (0.2 inch) hole in the center of each area. Inspection of the side impact air bag revealed no evidence of damage from the deployment, and there were no marks on the air bag from driver contact.

Figure 9: Case vehicle driver's seat back-mounted side impact air bag
