**ON-SITE CERTIFIED ADVANCED 208 COMPLIANT
VEHICLE CRASH INVESTIGATION**

CALSPAN CASE NO: CA06-003

**VEHICLE: 2005 HONDA CR-V
LOCATION: ALABAMA
CRASH DATE: NOVEMBER, 2005**

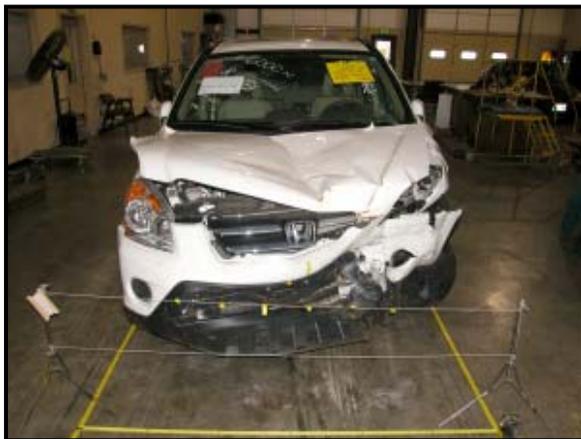
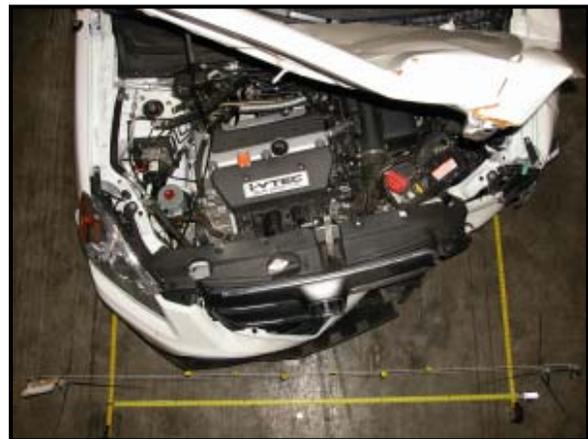
The exterior of the Honda sustained moderate level frontal damage as a result of the impact. **Figures 6 and 7** are the front and overhead views of the vehicle. The Honda's front plane sustained 58 cm (22.8 in) of direct contact damage that began 11 cm (4.3 in) left of center and extended to the left front bumper corner. The combined width of the direct and induced damage extended across the entire 140 cm (55 in) frontal end width. The damaged exterior components included the bumper fascia, reinforcement bar, left headlamp assembly, hood, and left front fender. The residual crush measured along the bumper reinforcement was as follows: C1 = 33 cm (13.0 in), C2 = 43 cm (16.9 in), C3 = 37 cm (14.6 in), C4 = 18 cm (7.1 in), C5 = 8 cm (3.1 in), C6 = 0 cm (0 in). The maximum crush was located at C2. Visual inspection of the vehicle's undercarriage revealed deformation and buckling of the left sub-frame and floorpan rearward to approximately the left B-pillar area longitudinally and laterally inboard to the vehicle's centerline. The right wheelbase dimension was unchanged. The force of the impact fractured the upper control arm of the left front suspension and the left front wheel/tire was displaced rearward impacting the dogleg at the aft aspect of the wheel opening. The left front wheel rim was deformed and the inboard sidewall of the tire was punctured. The left lower aspect of the windshield was fractured due to the deformation of the frontal structure. Minor roof buckling was noted along the left roof rail 8 cm (3 in) forward of the left B-pillar. All the doors were operational post-crash. All the side window glazings were intact with the exception of the right rear (second row). This window was reportedly shattered by the EMS during the rescue operations. The Collision Deformation Classification of the Honda was 12-FYEW2.

Figure 6: Front view of the Honda.

Figure 7: Overhead view.

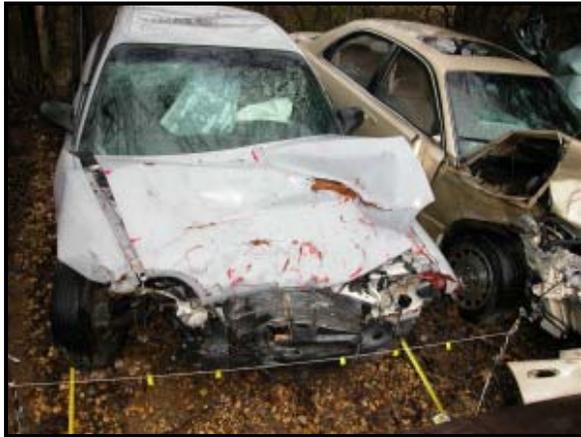
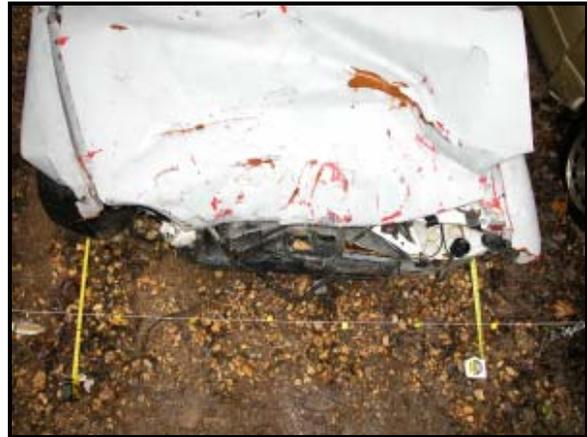
Figures 8 and 9 are views of the frontal damage to the Dodge Neon. During the offset frontal impact, the vehicle sustained 77 cm (30.3 in) of direct contact damage that began at the right front corner and ended 17 cm (6.5 in) left of center. The combined width of the direct and induced damage extended across the entire 137 cm (54 in) frontal end width. The right bias of the frontal crush and lateral deformation of the frontal structures were indicative of the offset nature of the impact and the 1 o'clock direction of force. The front bumper fascia, foam absorber and reinforcement bar separated from the vehicle during the impact. These components were found inside the vehicle. The fascia and absorber were fractured 24 cm (9.5 in) right of center and 17 cm (6.5 in) right of center, respectively, consistent with the impact dynamics. The residual frontal crush profile was as follows: C1 = 11 cm (4.3 in), C2 = 25 cm (9.8 in), C3 = 37 cm (14.6 in), C4 = 31 cm (12.2 in), C5 = 24 cm (9.4 in), C6 = 22 cm (8.7 in). The maximum crush was located at C3. The right wheelbase dimension was unchanged. The left wheelbase was reduced 11 cm (4.5 in). All the doors were operational post-crash. The unrestrained driver responded to the 1 o'clock direction of the impact by translating right and forward. The transmission selector was displaced into the 1 o'clock sector. The right aspect of the windshield was fractured by occupant contact. The Collision Deformation Classification of the Dodge was 01-FZEW2.

Figure 8: Front view of the Dodge.

Figure 9: Overhead view.

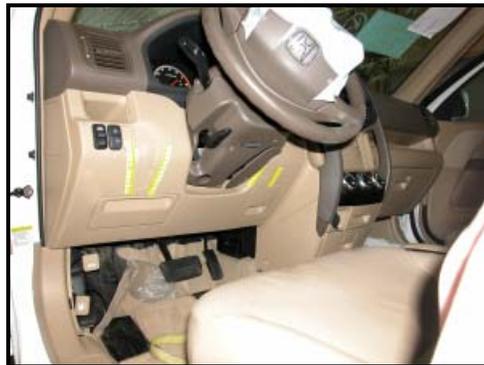
The interior of the Honda, **Figure 10**, sustained minor intrusion as a result of the impact. The longitudinal intrusion of the left corner of the instrument panel measured 2 cm (0.75 in). The outboard aspect of the left toe pan intruded 5 cm (2 in). The floorpan and left frame damage referred to earlier in this report caused minor intrusion of the left sill and left B-pillar. The lateral sill intrusion measured at the base of the left B-pillar was 2 cm (1 in). The intrusion of the B-pillar measured at the belt line was 4 cm (1.5 in). The driver bolster exhibited two areas of contact from the driver's lower extremities.

Figure 10: View of the driver position and bolster contacts.

The bolster was cracked from a left lower extremity contact immediately above the fuse panel access cover.

This contacted was located 20 cm (8 in) left of the steering wheel centerline and 48 cm (19 in) above the floor. A scuff mark located 15 cm (6 in) right of the steering wheel centerline and 46 cm (18 in) above the floor was related to a right lower extremity contact.

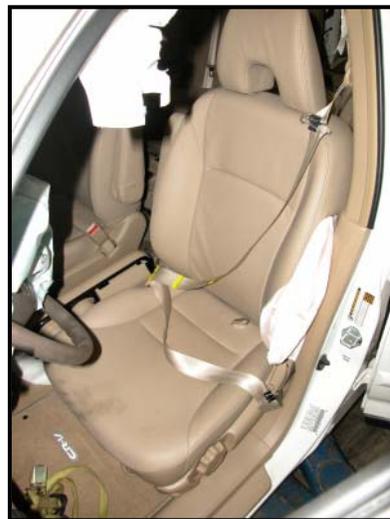
Figure 11: Driver seat and safety belt.

The driver's safety belt was a three-point lap and shoulder restraint with continuous loop webbing, Emergency Locking Retractor (ELR), and a sliding latch plate. A pretensioner was incorporated into the buckle stalk that was attached to the inboard aspect of the seat. The D-ring was adjustable and was in the full-up position. **Figure 11** is a view of the driver seat and restraint. The driver was restrained by the safety belt at the time of the crash. Examination of the restraint revealed the webbing was cut in two places by the first responders during the rescue operations. The webbing was cut 30 cm (12 in) above the fixed outboard anchor and 10 cm (4 in) below the D-ring. The length of the cut webbing section measured 129 cm (51 in) and was comprised of 57 cm (22.5 in) in the lap section and 72 cm (28.5 in) in the section lying across the torso. The location of the latch plate was identified by a crease of the webbing indicative of

loading. An 11 cm (4.5 in) abrasion of the outer surface of the webbing (away from the driver) began 10 cm (4 in) above the latch plate and related to contact with the deployed driver air bag. The ELR retractor was in a locked condition; the webbing would not extend or return. A minor abrasion was identified on the surface of the D-ring indicative of restraint loading. The buckle pretensioner fired as a result of the impact. The height of the buckle stalk was reduced 5 cm (2 cm).

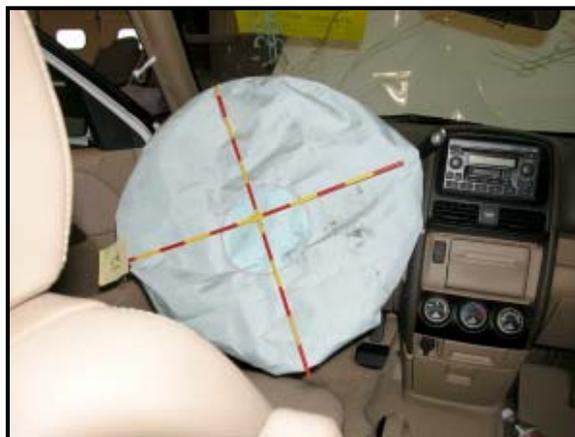
Figure 12: Driver air bag.

The driver air bag, **Figure 12**, deployed as a result of the offset frontal crash. The H-configuration driver air bag module was located in the center hub of the steering wheel rim. The symmetrical upper and lower flaps measured 6 cm x 16 cm (2.5 in x 6.3 in), height by width, respectively. The flaps opened at the designed tear seams during the deployment sequence and were free from occupant contact. The deployed driver air bag measured 61 cm (24 in) in diameter. The bag was tethered by two 6 cm (2.5 in) wide straps in the 6/12 o'clock sectors and was vented by two 4 cm (1.5 in) diameter ports located in the 11/1 o'clock sectors. The face of the bag was soiled from post-crash handling in the 6 o'clock sector and along the perimeter seam in the 3 o'clock sector.

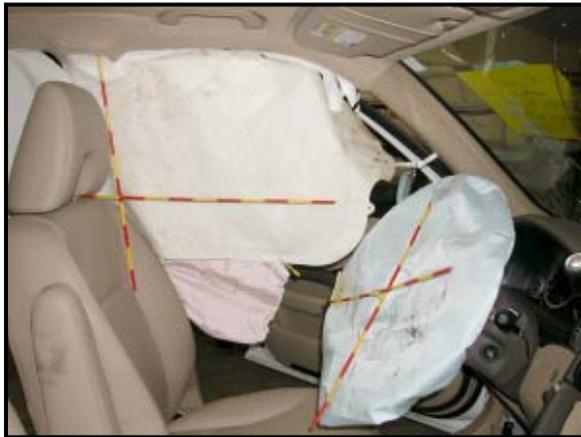
Figure 13: Interior lateral view.

The subject Honda was equipped with front seat back mounted thorax bags and roof rail mounted side curtains. The left side inflatable impact protection deployed as a result of the offset frontal crash. **Figure 13** is a lateral view of the deployed inflatable left side impact protection.

The thorax bag was housed in a module in the outboard bolster of the front seat back and expanded forward. The module measured 23 cm (9 in) in height and the base of the module was 20 cm (8 in) above the seat bight. The deployed bag was rectangular in shape and measured 33 cm x 27 cm (13 in x 10.5 in), length x height respectively. The length dimension was measured to the module recessed within the seat bolster. The bag extended 24 cm (9.5 in) forward of the seat bolster. The bag was tethered by 5 cm (2 in) wide strap. It was vented by two 3.8 cm (1.5 in) ports located on the bag's forward vertical seam. There was no evidence of driver contact to the bag.

The inflatable side curtain deployed downward from the left roof rail. The curtain provided coverage that extended from the A- and C-pillars. Upon deployment, the curtain was inflated by helium stored in a canister located in the C-pillar. The gross overall dimensions of the curtain measured 160 cm x 46 cm (63 in x 18 in), length by height respectively. The curtain was tethered at the A- and C-pillars. During the rescue operations, the first responders cut and removed a 69 cm (27 in) length of the curtain located between the left A- and B-pillar. **Figure 14** is an overall view of the cut section. This section of the bag was found in the interior of the Dodge Neon during its inspection. It was located amidst debris cleaned up from the crash site and placed in the Dodge. The inboard surface of the bag was soiled from post-crash handling and masked any potential contact evidence. There was no direct evidence of driver contact identified.

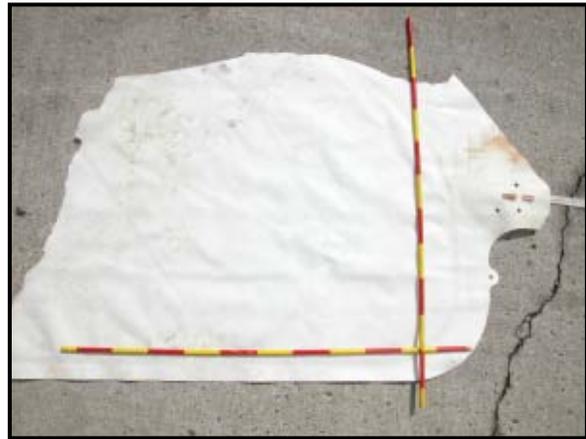
Figure 14: Left curtain section cut by EMS.

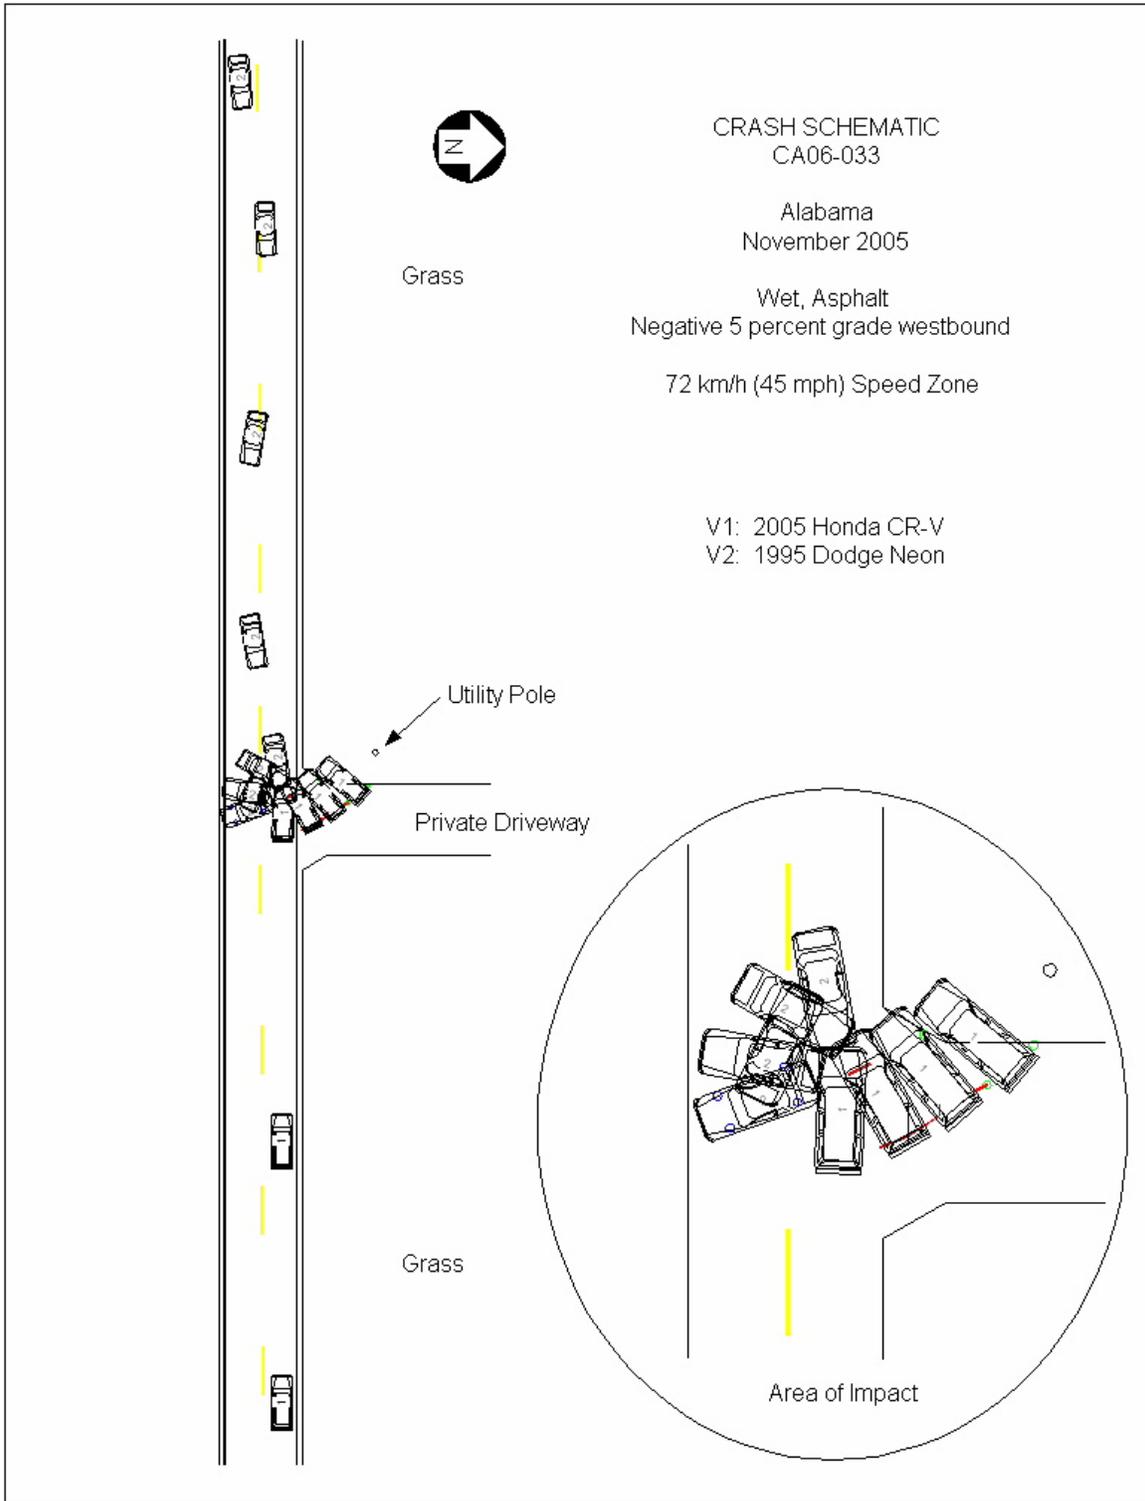
Figure15: Crash Schematic.

The 2005 Honda CR-V was westbound operated by a 54 year old male. He was restrained by the vehicle's three-point lap and shoulder belt and was the vehicle's sole occupant. The 1995 Dodge Neon was eastbound driven by a 37 year old unrestrained female. A witness to the crash reported that the Dodge drifted to the left across the centerline into the westbound travel lane. The driver of the Dodge then steered right in an attempt to reenter the proper travel lane, however, in the process of this maneuver she overcorrected. The driver of the Dodge then counter-steered back to the left and lost directional control of the vehicle. The Dodge reentered the westbound lane directly in the path of the Honda. The combination of the wet road, the mismatched tire size, the worn tread of the front tires, and the speed of the Dodge were contributing factors to the loss of the control. The driver of the Honda had no recollection of the crash; therefore pre-crash maneuvers by the Honda driver are unknown. A schematic of the crash is attached to the end of this narrative report as **Figure 15**.

The right and center aspects of the Dodge's frontal plane impacted the left and center aspect of the front of the Honda in an offset configuration. The directions of force were in the 1/12 o'clock sector for the Dodge and Honda, respectively. The force of the impact caused the Honda driver's seat belt buckle pretensioner to fire, and deployed the driver air bag, the left side impact air bag and left inflatable side curtain. The frontal air bags in the Dodge did not deploy. The offset nature of the impact resulted in a counterclockwise rotation of both vehicles. The Honda separated from the impact with a northwest trajectory and came to rest in the mouth of the concrete driveway. The Honda slid to rest 4.2 m (17 ft) from the impact and had rotated 50 degrees counterclockwise. The Dodge separated from the impact with a southeast trajectory and rapid rotation. The Dodge rotated 280 degrees and slid to final rest in the eastbound lane facing south 4.9 m (16 ft) from the impact. The severity of the impact (delta V) was calculated by the Damage Algorithm of the WINSMASH model. The total delta V Honda was 29.0 km/h (18.0 mph) and the longitudinal and lateral components were -28.6 km/h (-17.8 mph) and 5.0 km/h (3.1 mph), respectively. The total delta V of the Dodge was 41.0 km/h (25.5 mph). Its longitudinal and lateral delta V components were -38.5 km/h (-23.9 mph) and -14.0 km/h (8.7 mph), respectively.
